The proposed upgrade of Storm Water and Environmental Systems in the Port of Saldanha site photographic report.

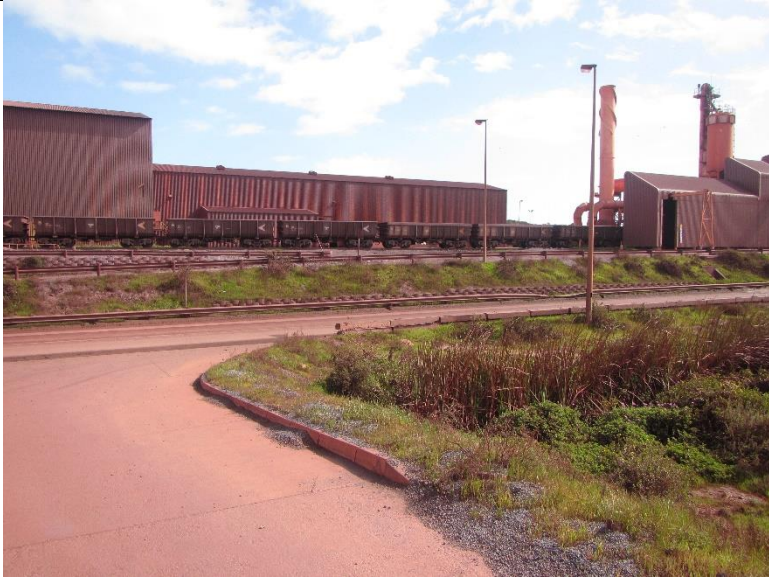
Four points photos - Western side of the port at ponds (Pond 1, 2 and 3) to be upgraded.

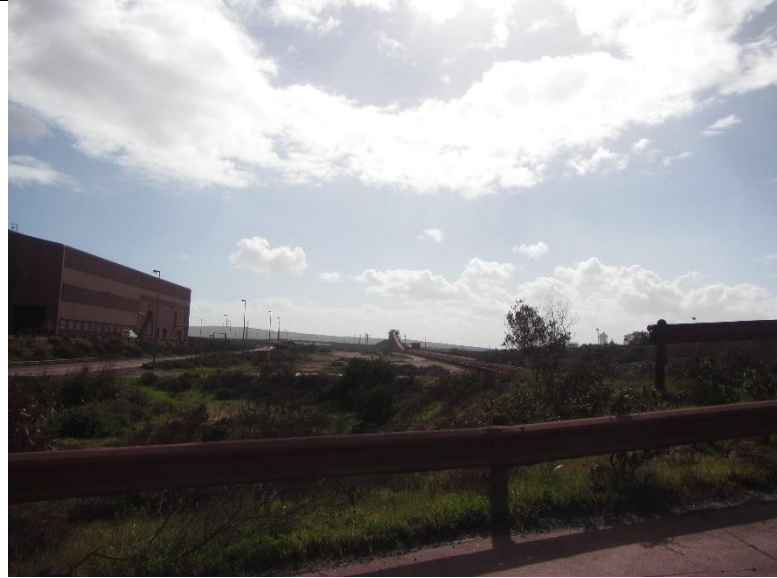
Four points photos - Northern side of the port at ponds (Pond 1, 2 and 3) to be upgraded.

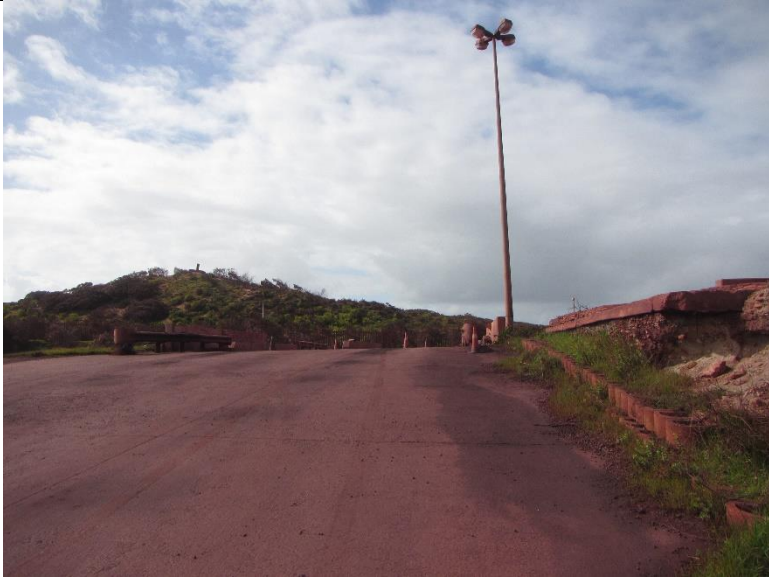
Four points photos - Eastern side of the port at ponds (Pond 1, 2 and 3) to be upgraded.

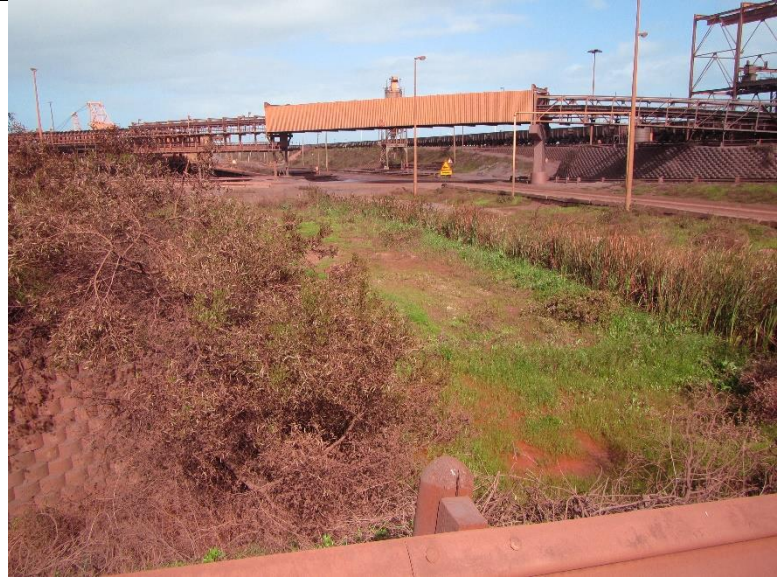
Four points photos – Southern side of the port at ponds (Pond 1, 2 and 3) to be upgraded.

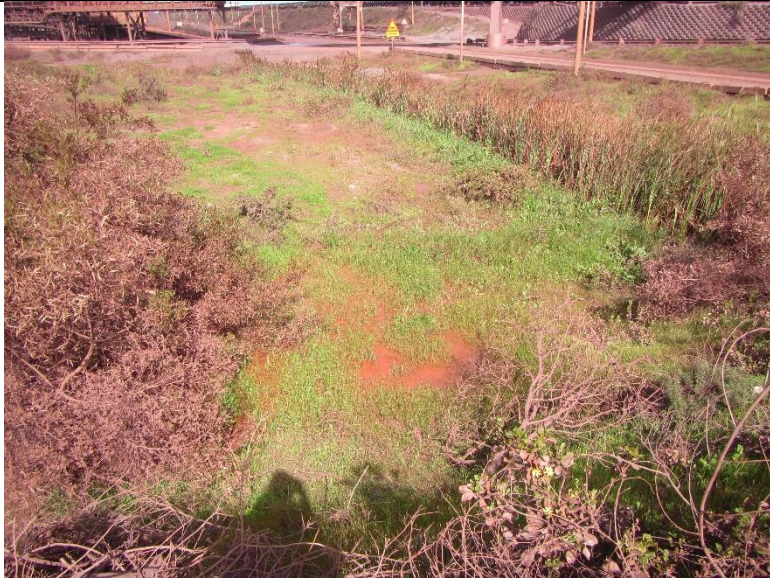
Pond (pond 3) that need to be upgraded.

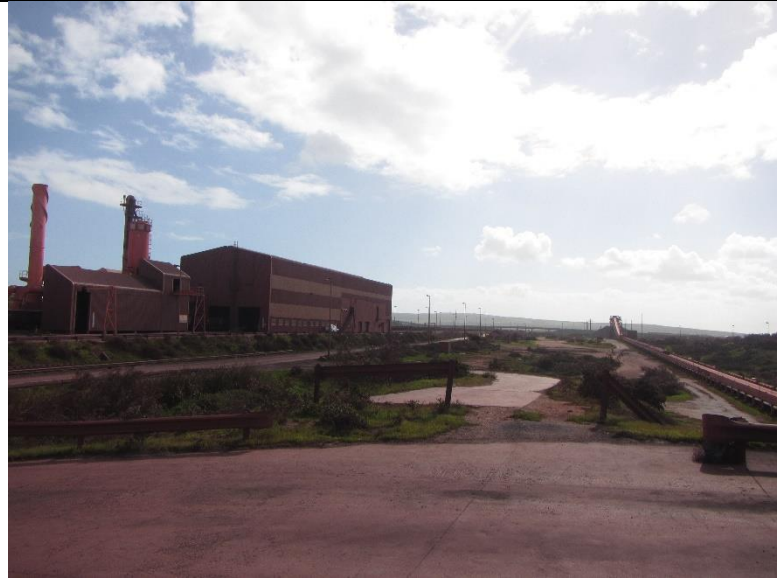
Pond (Pond 2 and 3) that need to be upgraded.

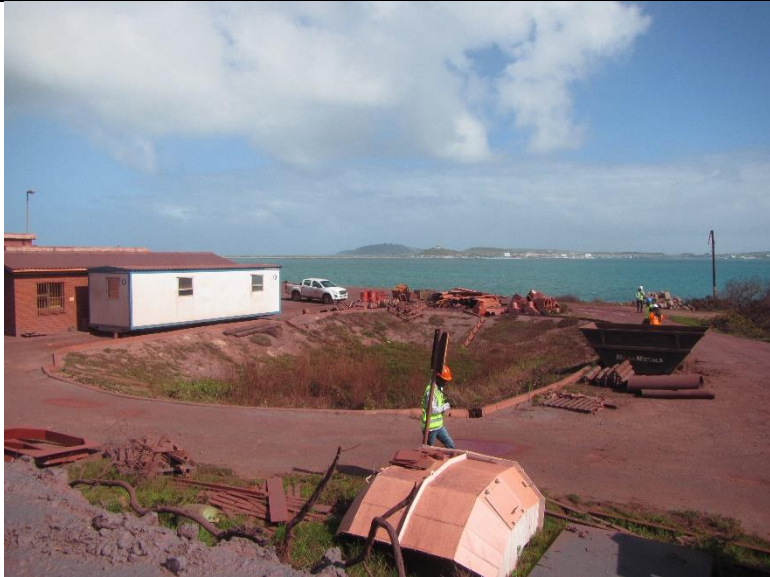
Pond (pond 4) that need to be upgraded.

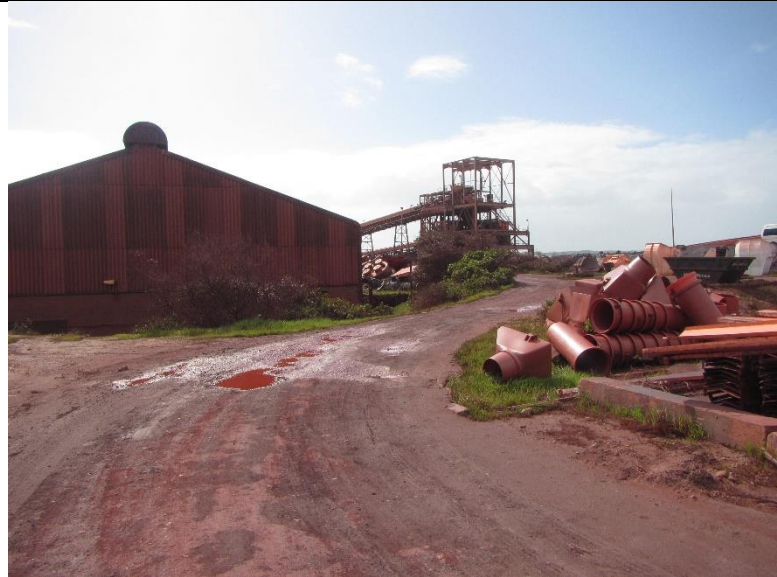
Water that need to be channeled in the ponds ponding on the road.

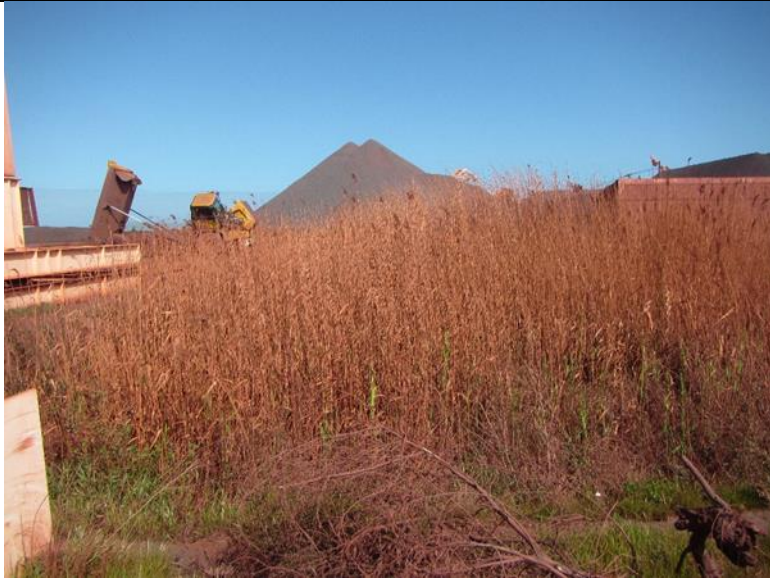
Reeds in the pond that need to be removed.

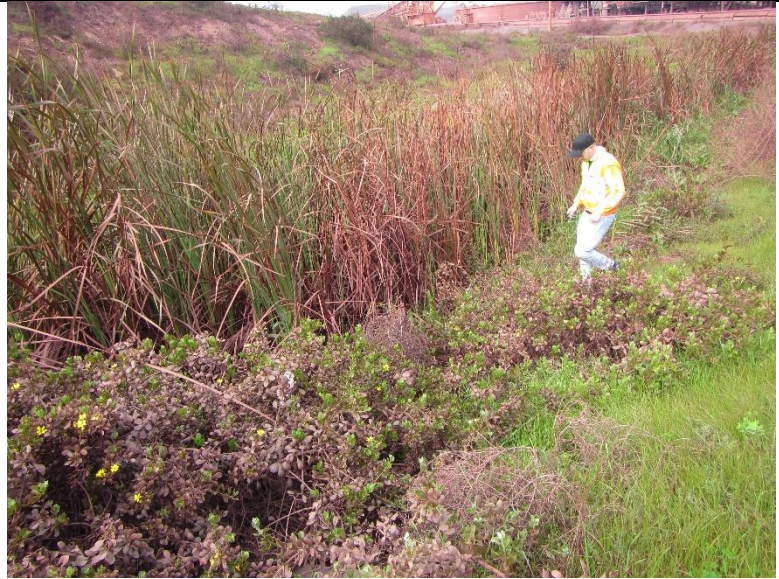
Weeds and alien plants that need to be removed.

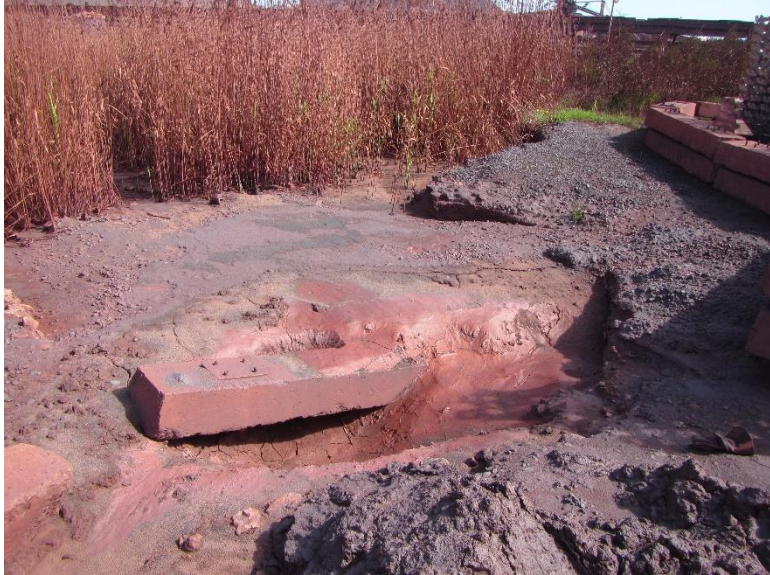
Sludge in the ponds that need to be removed.

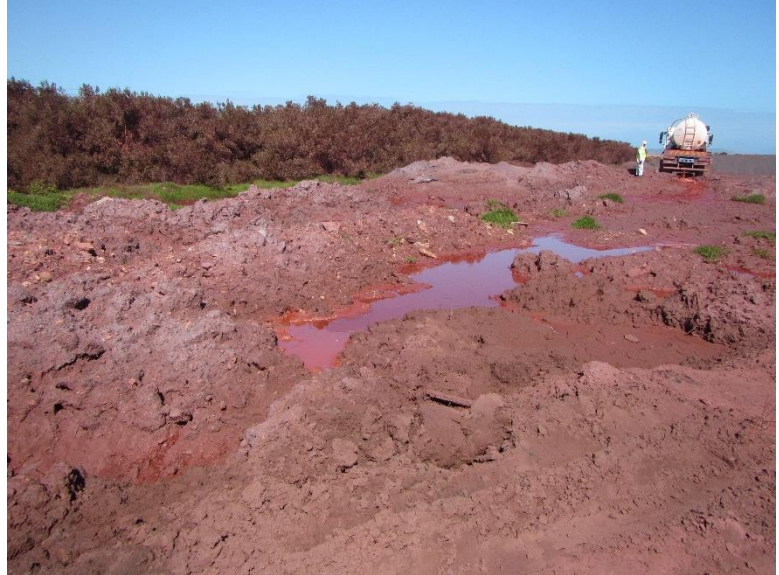
Sludge that is channeled to the natural environment.

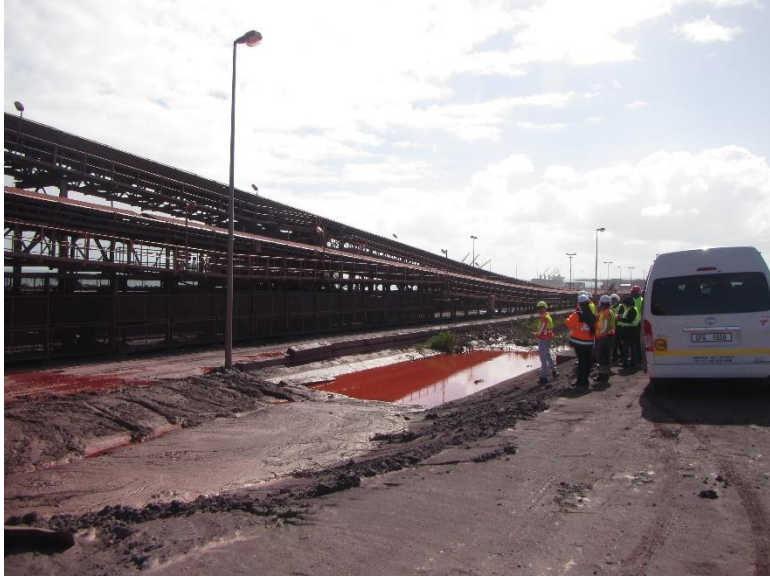
Sludge in the water channel.

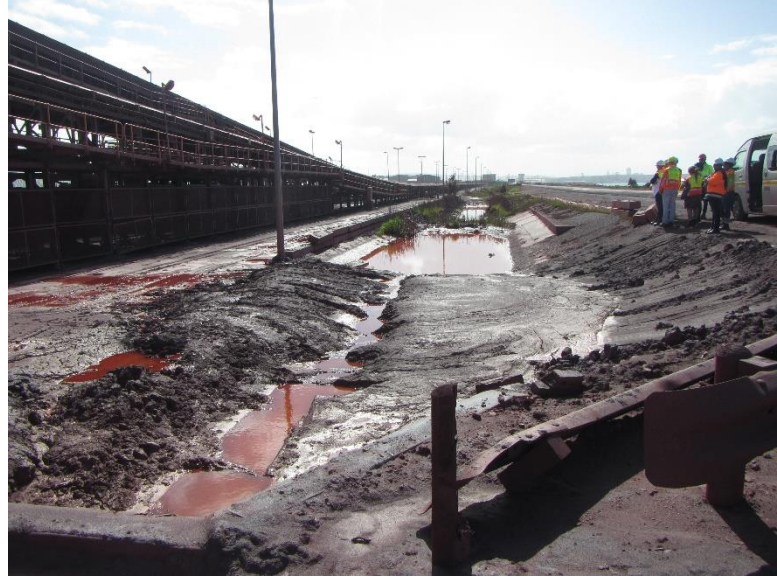
Sludge (contaminated water with iron ore) fill water channel.
