Mr Phillip Hine
SAHRA

31 October 2016

Re: PERMIT APPLICATION FOR THE PROPOSED REHABILITATION OF SITE 2, VELE COLLIERY

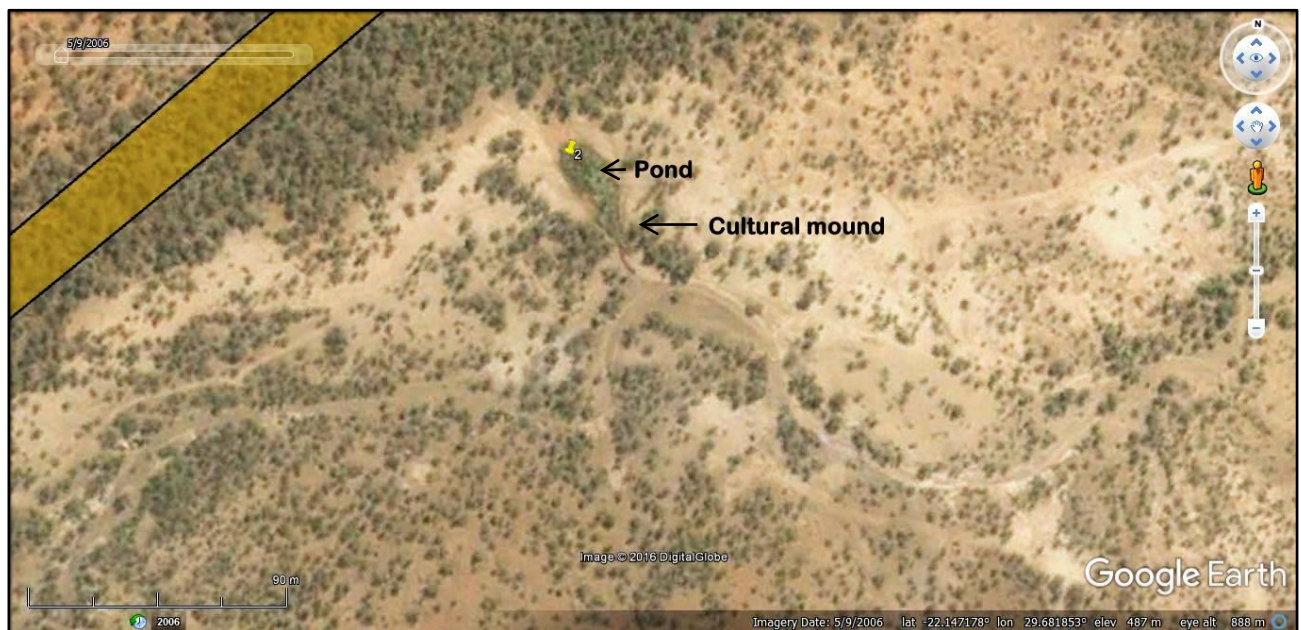
Figure 3 is a historical image dating to 2006 before any mining activity. It clearly shows the pond in its natural state. Figure 4 is an image of 2013 after the food events. Here the waste rock dump and fan-like flood debris was outline while logged onto Google Earth. The historical imagery mode was then used to go back to 2006 with Google Earth retaining the drawn lines in place. This is depicted in Figure 5. This sequence together with figures 6 & 7, which respectively shows the pond in 2008 and 2016, clearly illustrates the disastrous effect of the flooding.

Figure 3. Google historical image, 2006.

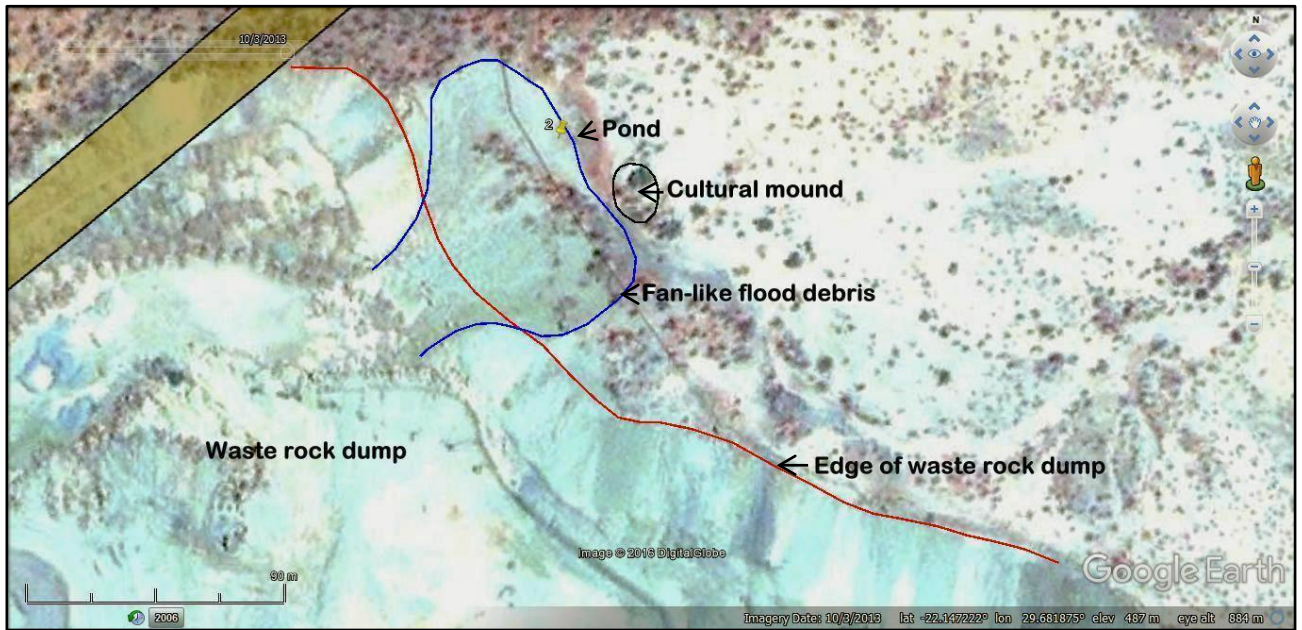
Figure 4. Google image, 2013

- The use of a TLB to create a toe berm, at the foot of the Overburden dump (see figure 4 – line indicating edge of dump) to redirect any water flow from the dump in an easterly direction and this would also facilitate the collection of silt and overburden material. The berm would be built from material on the site and would be situated some 5m from the toe of the dump and be approximately 3m high.

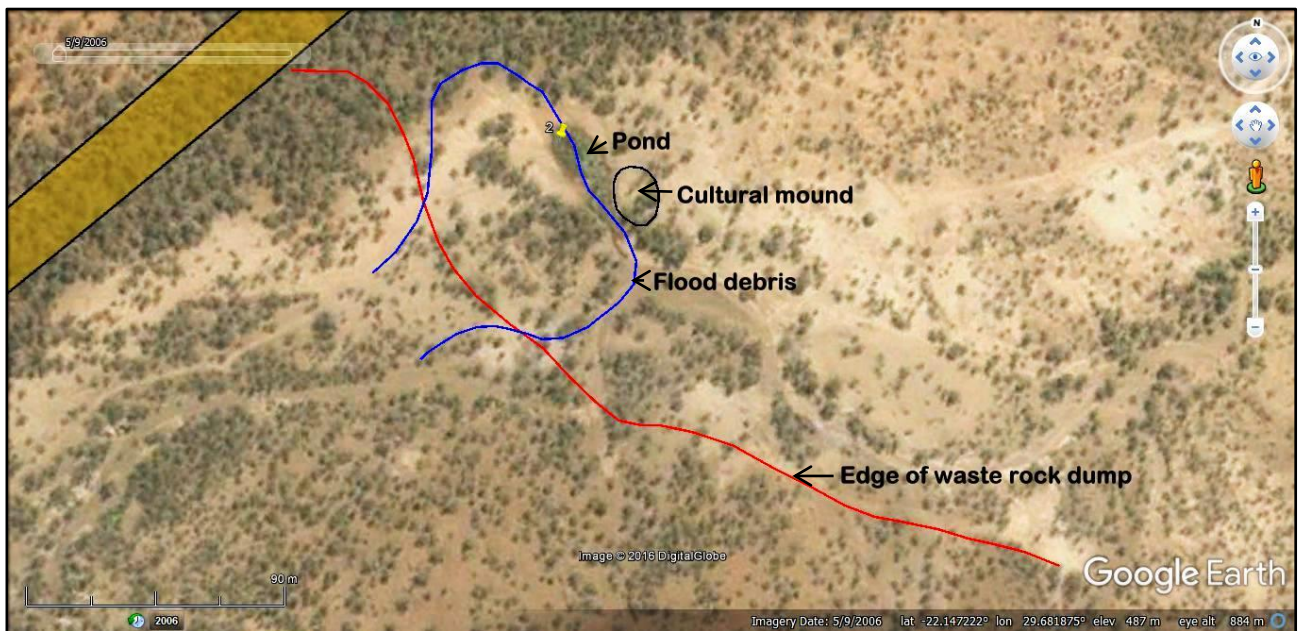
Figure 5. Lines of the 2013 image superimposed on the 2006 image.

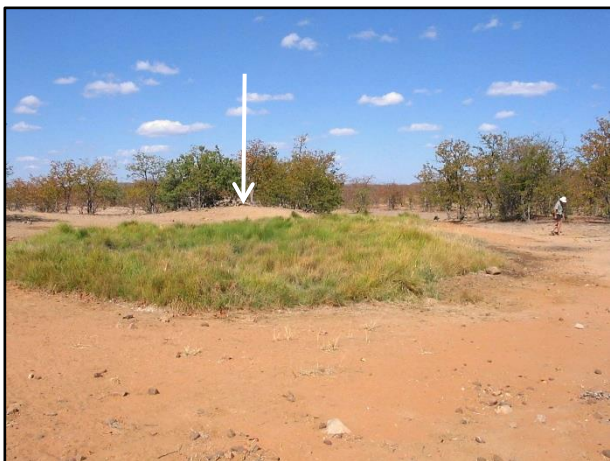
Figure 6. The pond in 2008. The arrow points to the cultural mound.

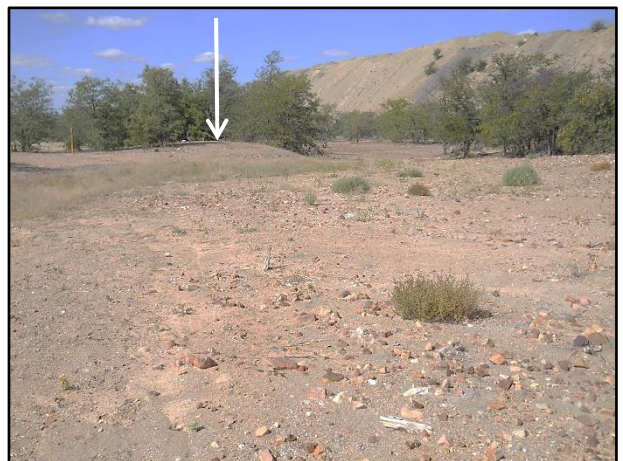
Figure 7. The pond in 2016 standing on the edge of what was the pond in Figure 6. The arrow points to the cultural mound.

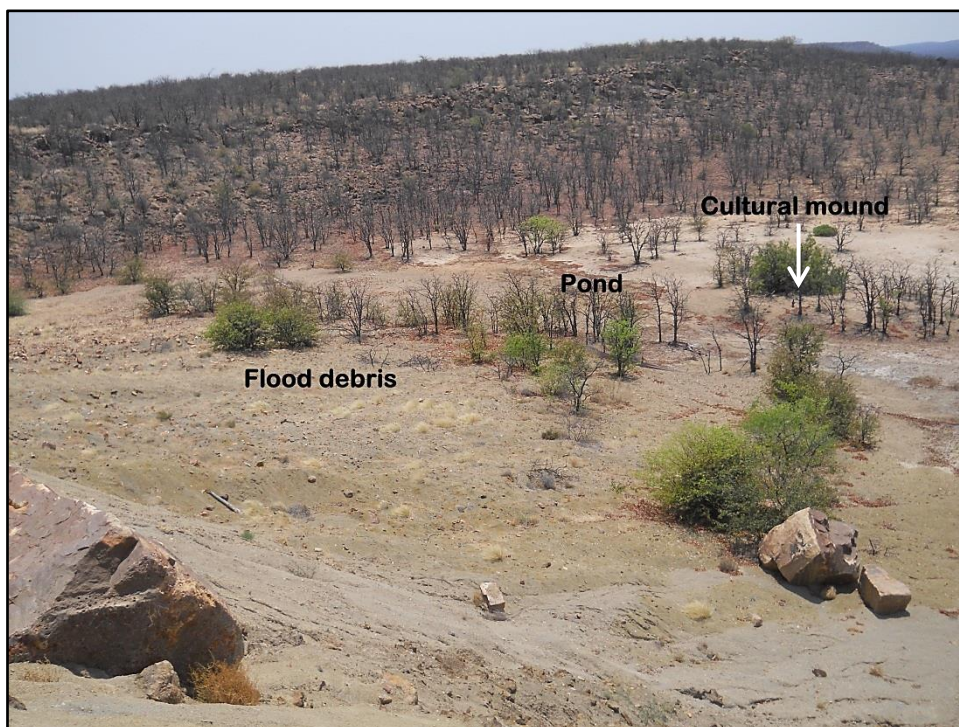
Figure 9. The flood debris is the material to be used for the berm.

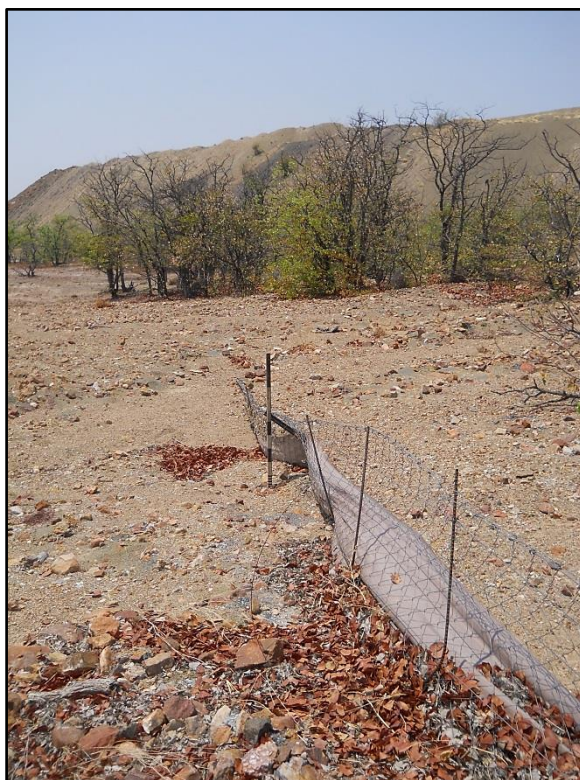
Figure 10. Flood damaged silt trap to be moved to the right into the tree line.

- Repair and redirect the existing silt trap fencing at the site to the new proposed position, which would then utilize the existing vegetation as a backing feature to protect the fence and prevent it from being overwhelmed in the future.

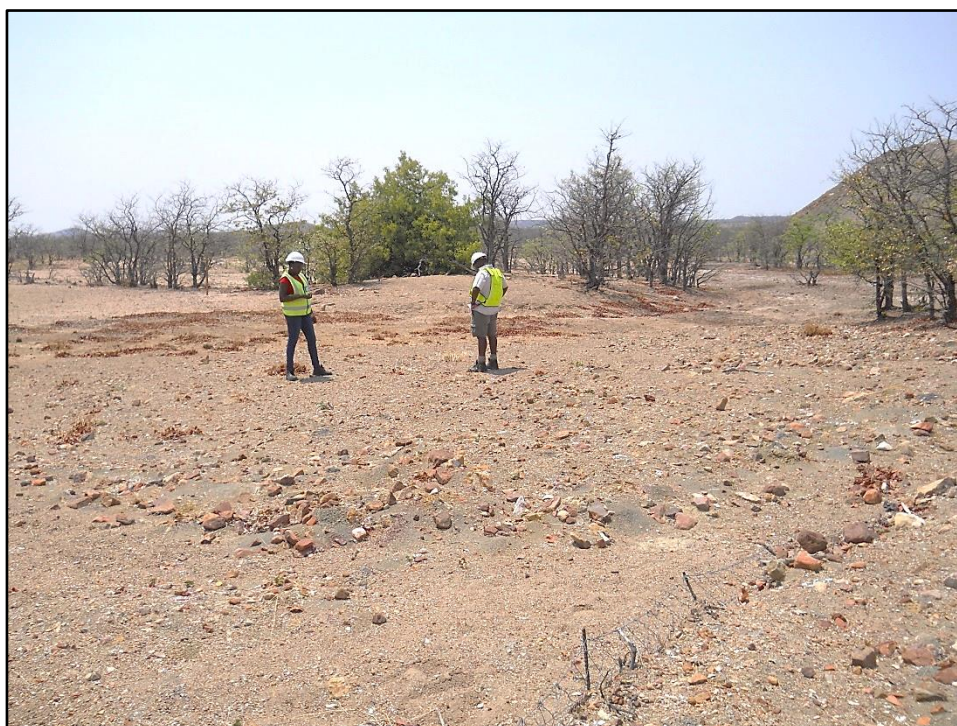
Figure 11. This photo shows the silt in the pond area that will be hand collected.

- To hand collect the extra silt material that has clogged the spring and use the material to compact the new toe berms.

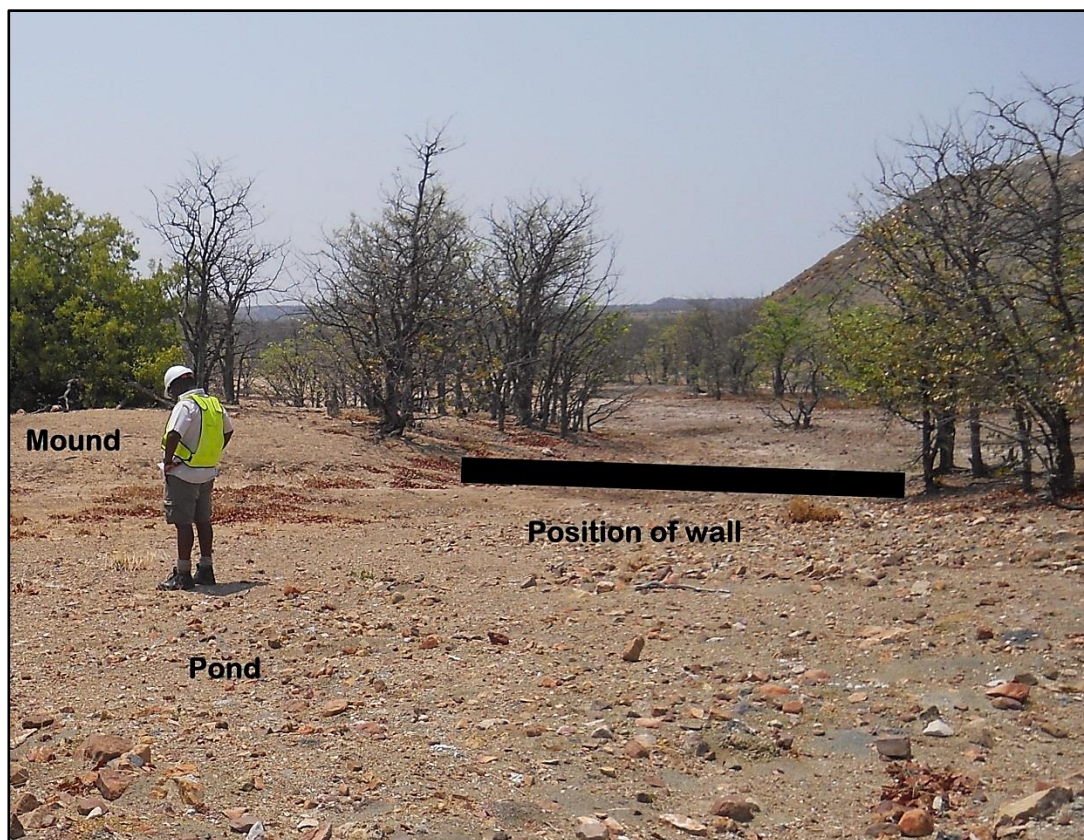
Figure 12. This photo illustrates the position of the retaining wall. Note that the water course beyond the proposed position of the wall had eroded to below the depth of the pond area, which will result in the pond draining without the wall. This erosion was also as a result of the flood.

- To construct a small concrete wall in the water course to facilitate the impediment of the water flow and thus result in the re-ponding of the spring, which would allow for the regrowth of the sedge grass. This wall would be 6m wide and 90cm high and be constructed some 30cm into the water course bed.
