APPENDIX B

SITE PHOTOGRAPHS: HARTSWATER WASTE DISPOSAL FACILITY

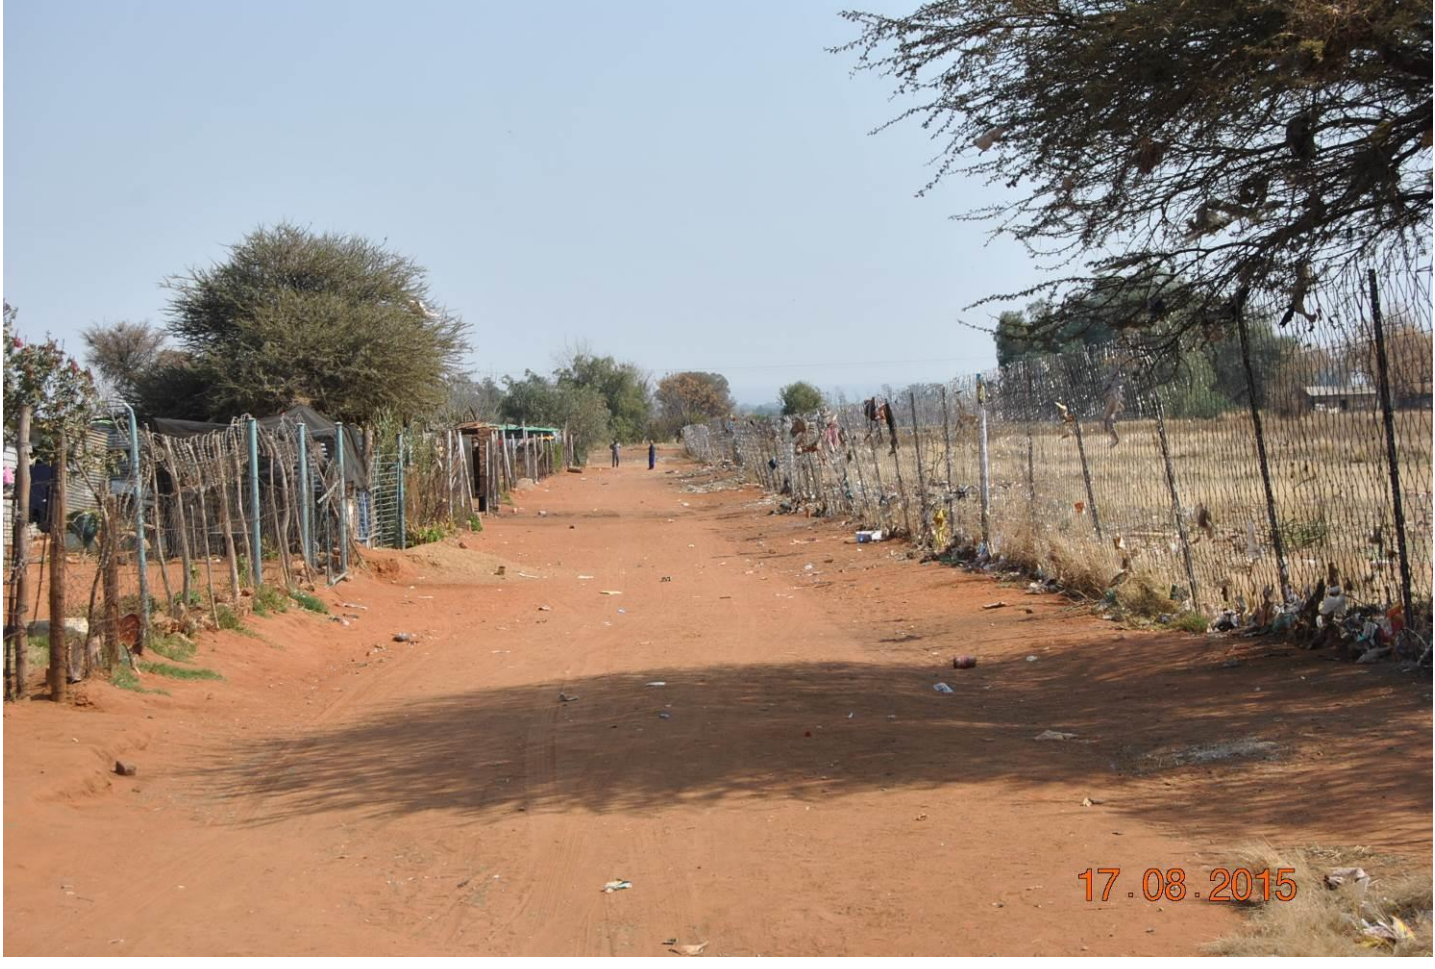
<p>Access road to the landfill, with the landfill to the right and a Semi-formal residential area to the left</p>

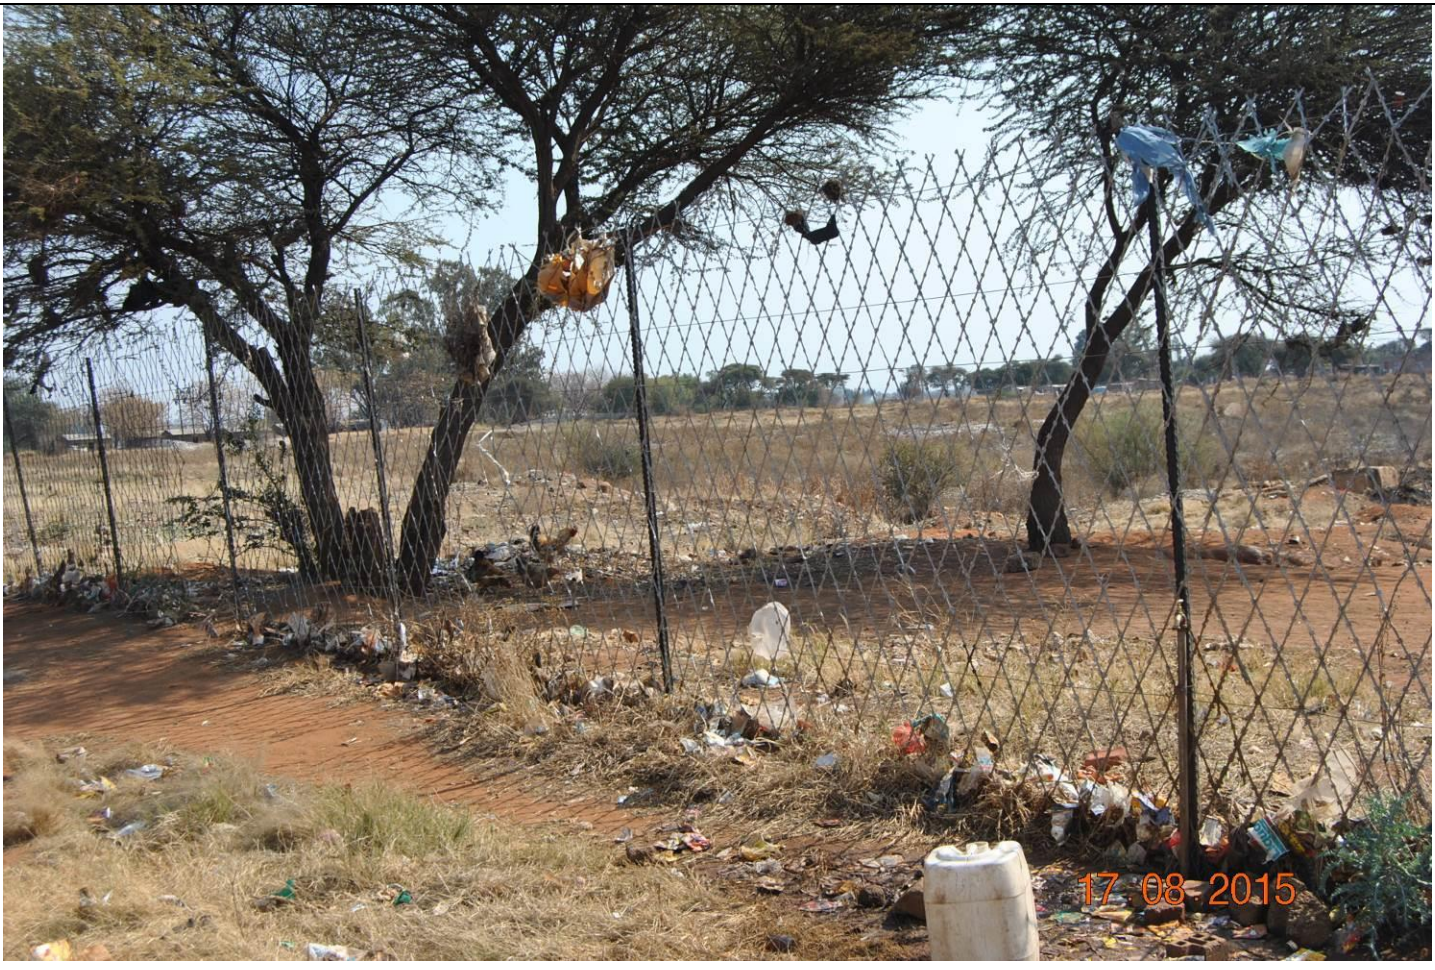
<p>Fence surrounding the landfill on the southern side.</p> <p>Indication of wind-blown litter</p>

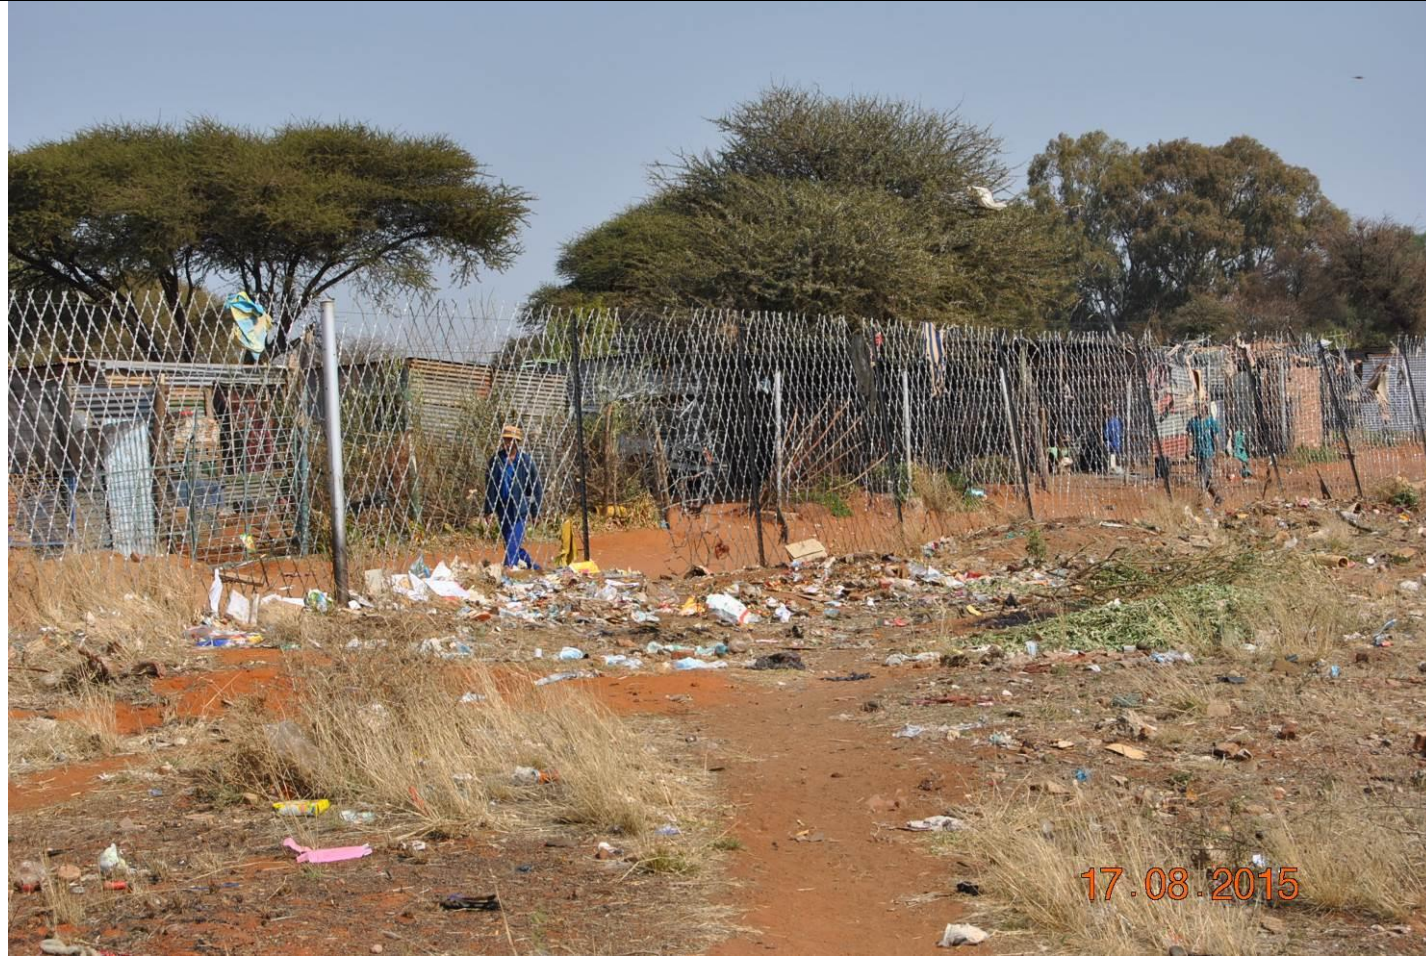
Evidence where the fence on the south-eastern side is cut.

Illegal dumping and littering.

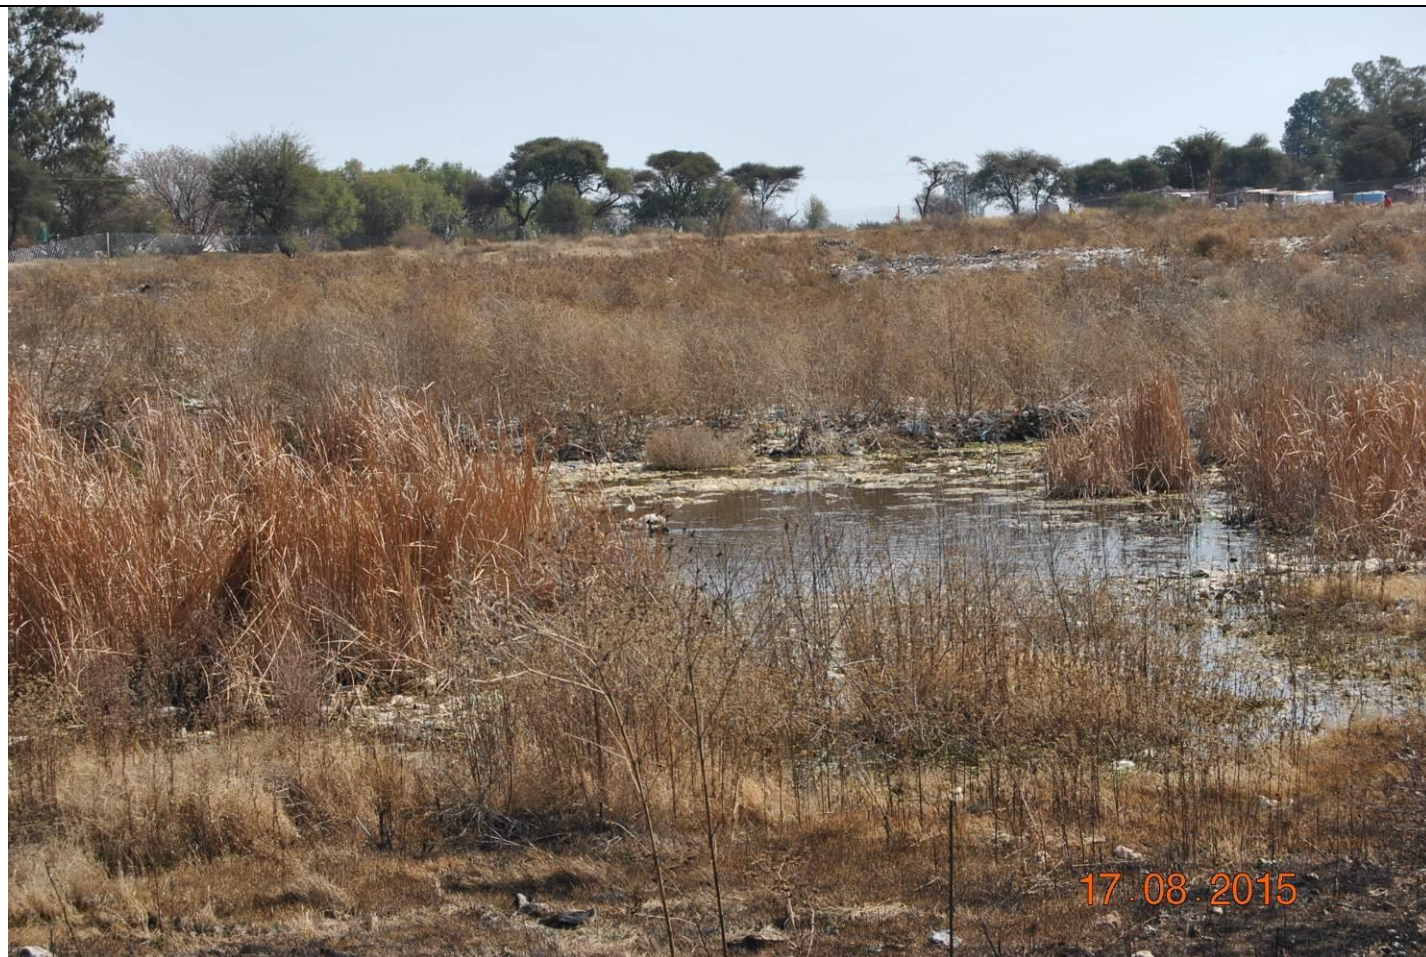
Wetland in the centre of the landfill

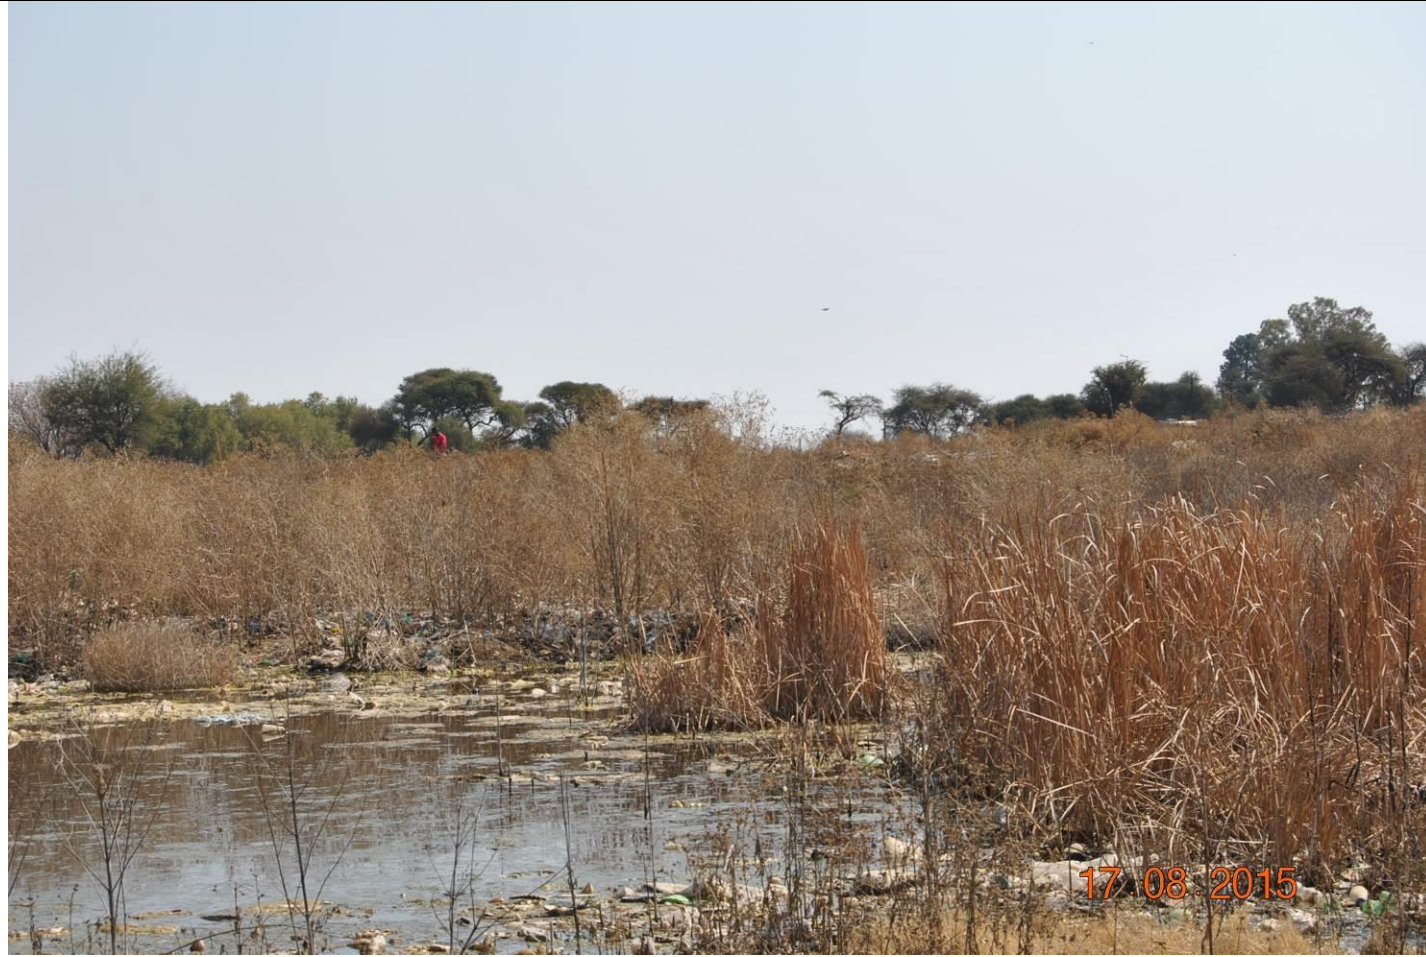
Wetland in the centre of the landfill

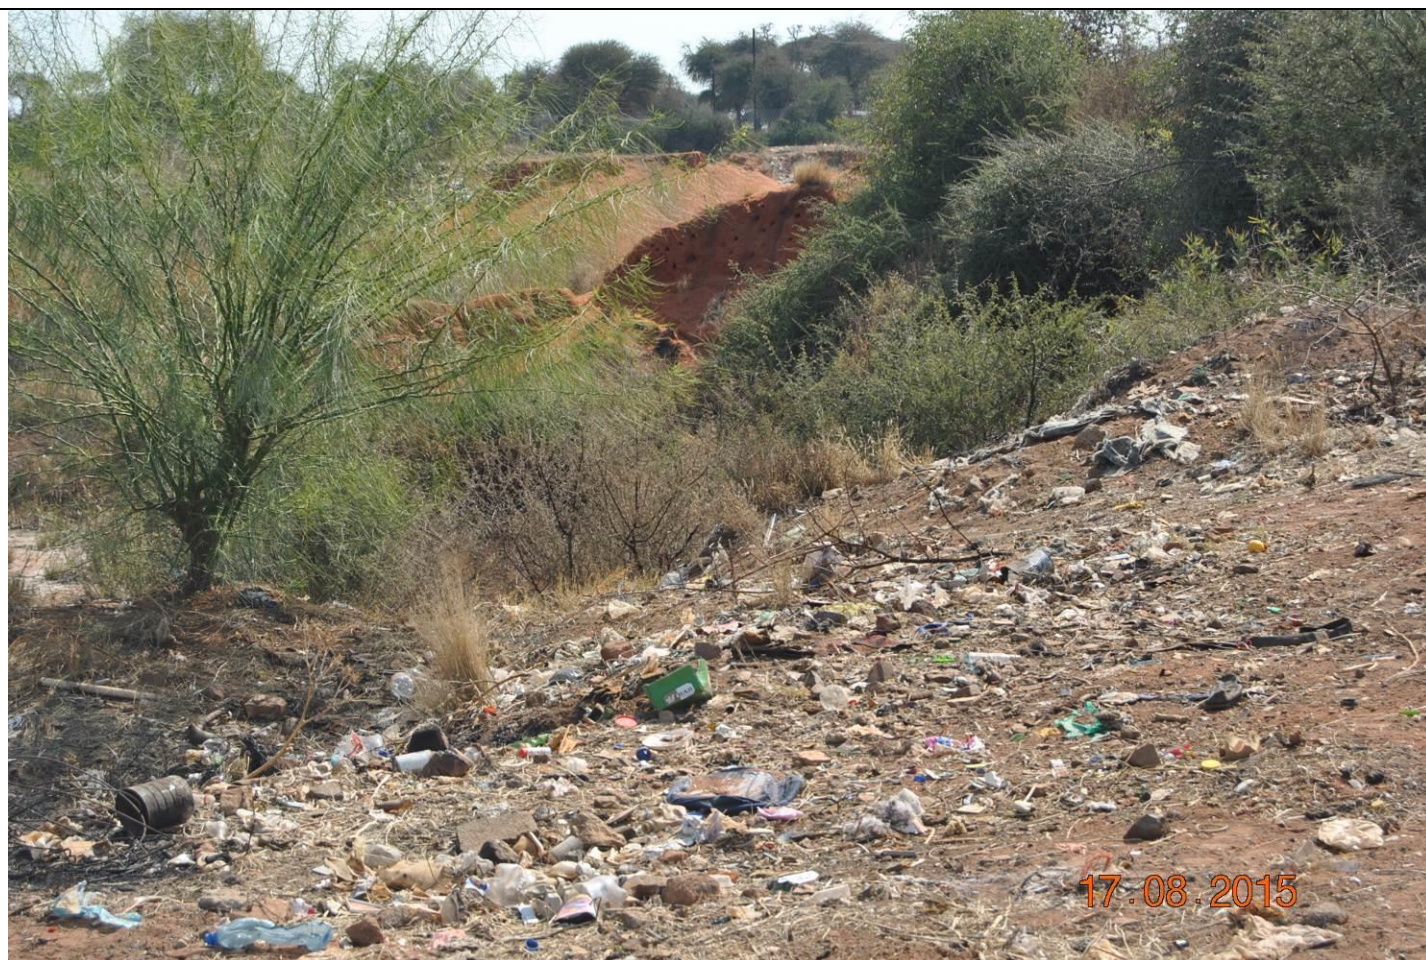
Illegal dumping within the landfill boundaries

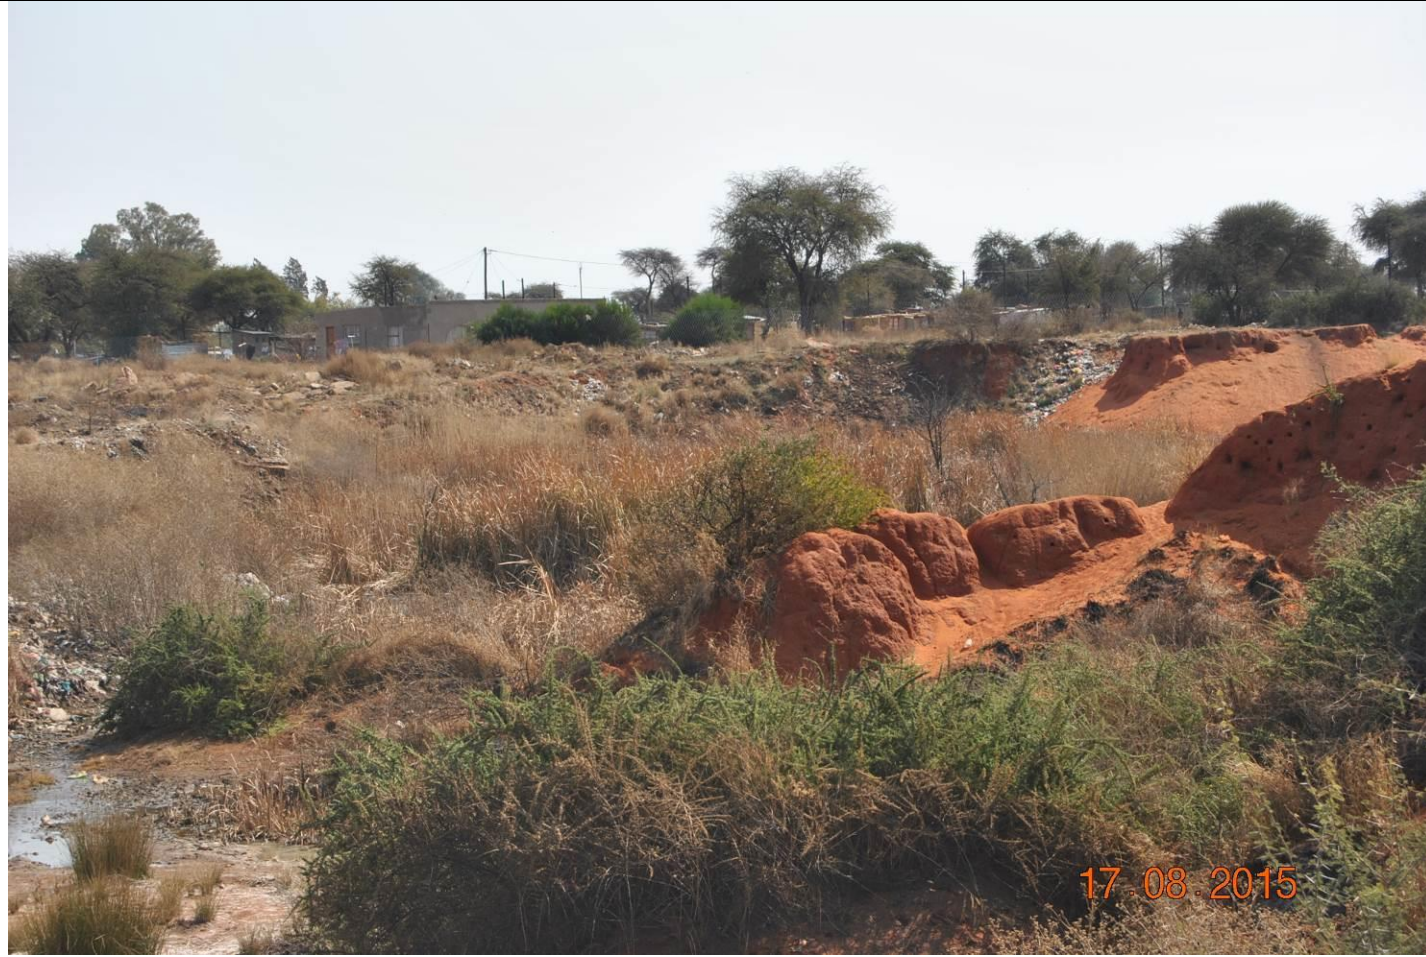
Evidence of the wetland to the left, previous quarrying and erosion to the right.

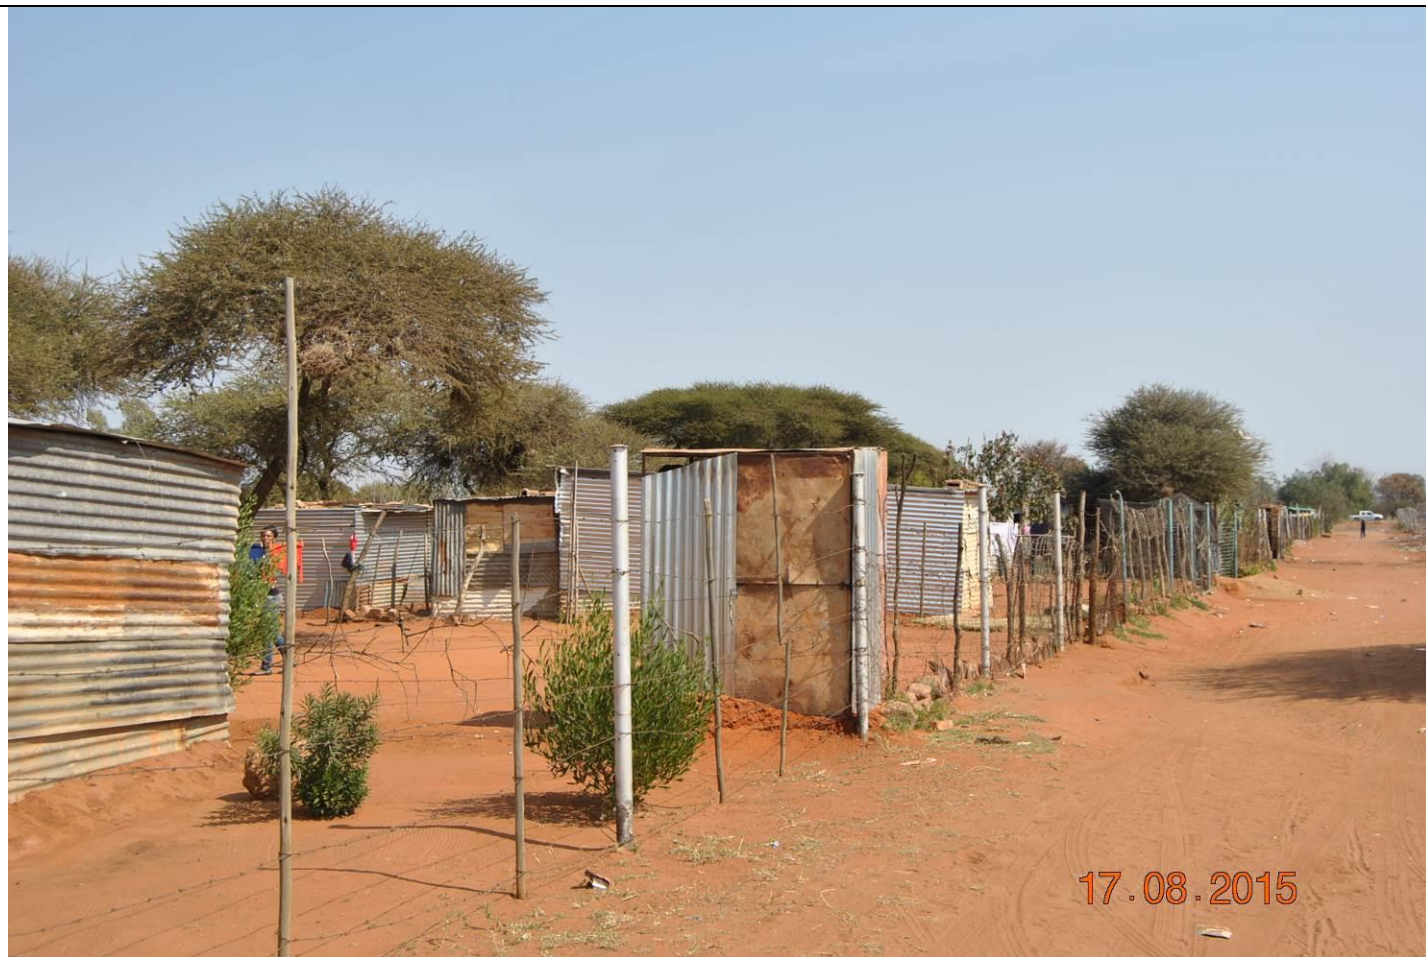
Semi-formal housing within the landfill boundary, on the eastern side.

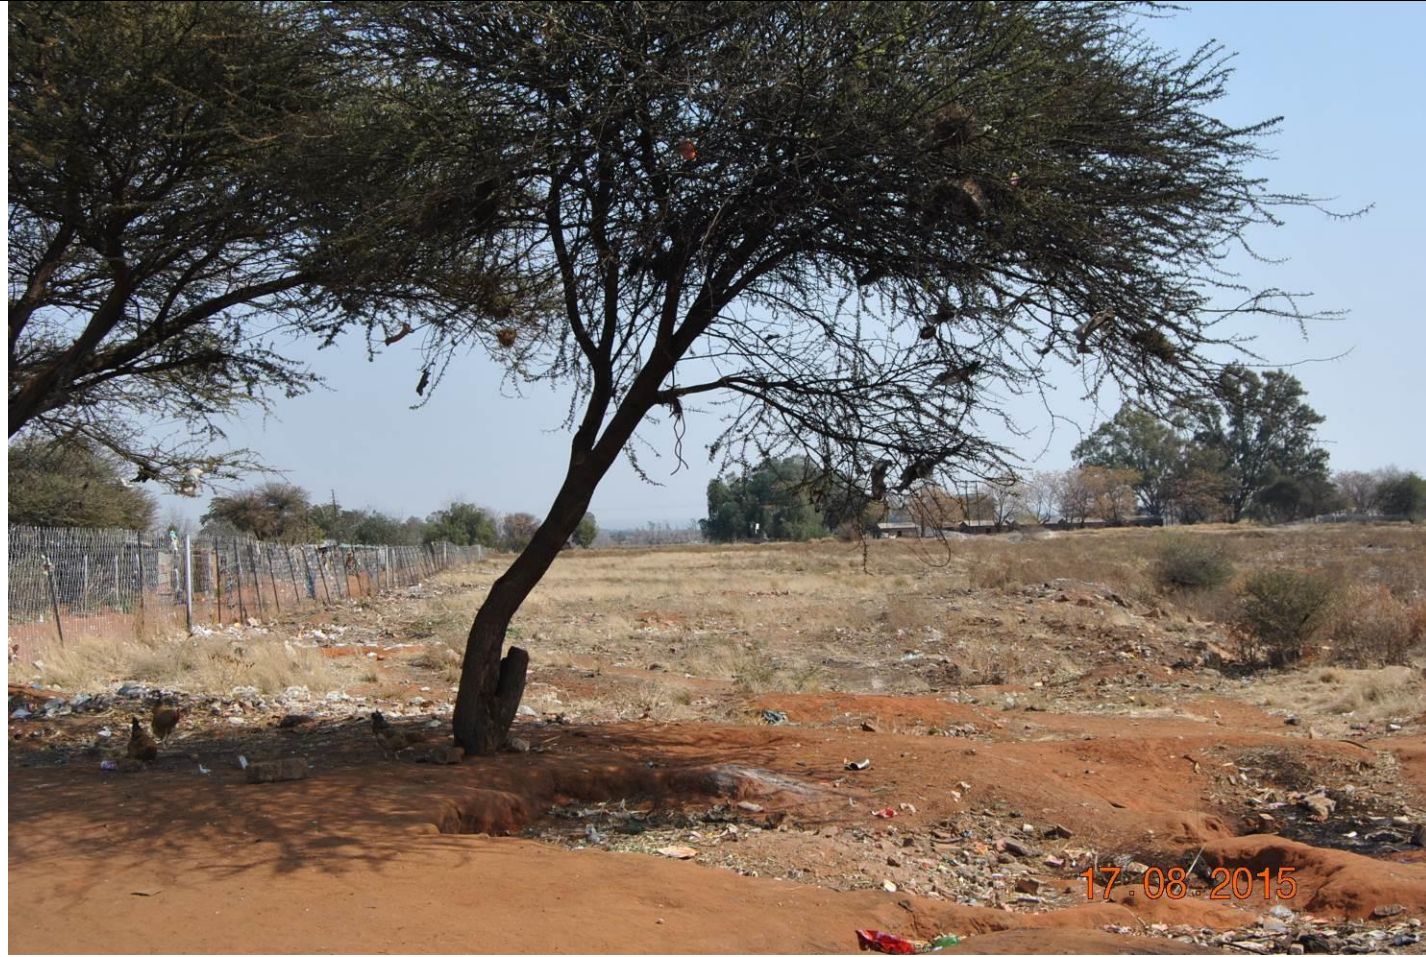
Current status of the landfill to the south-western side.

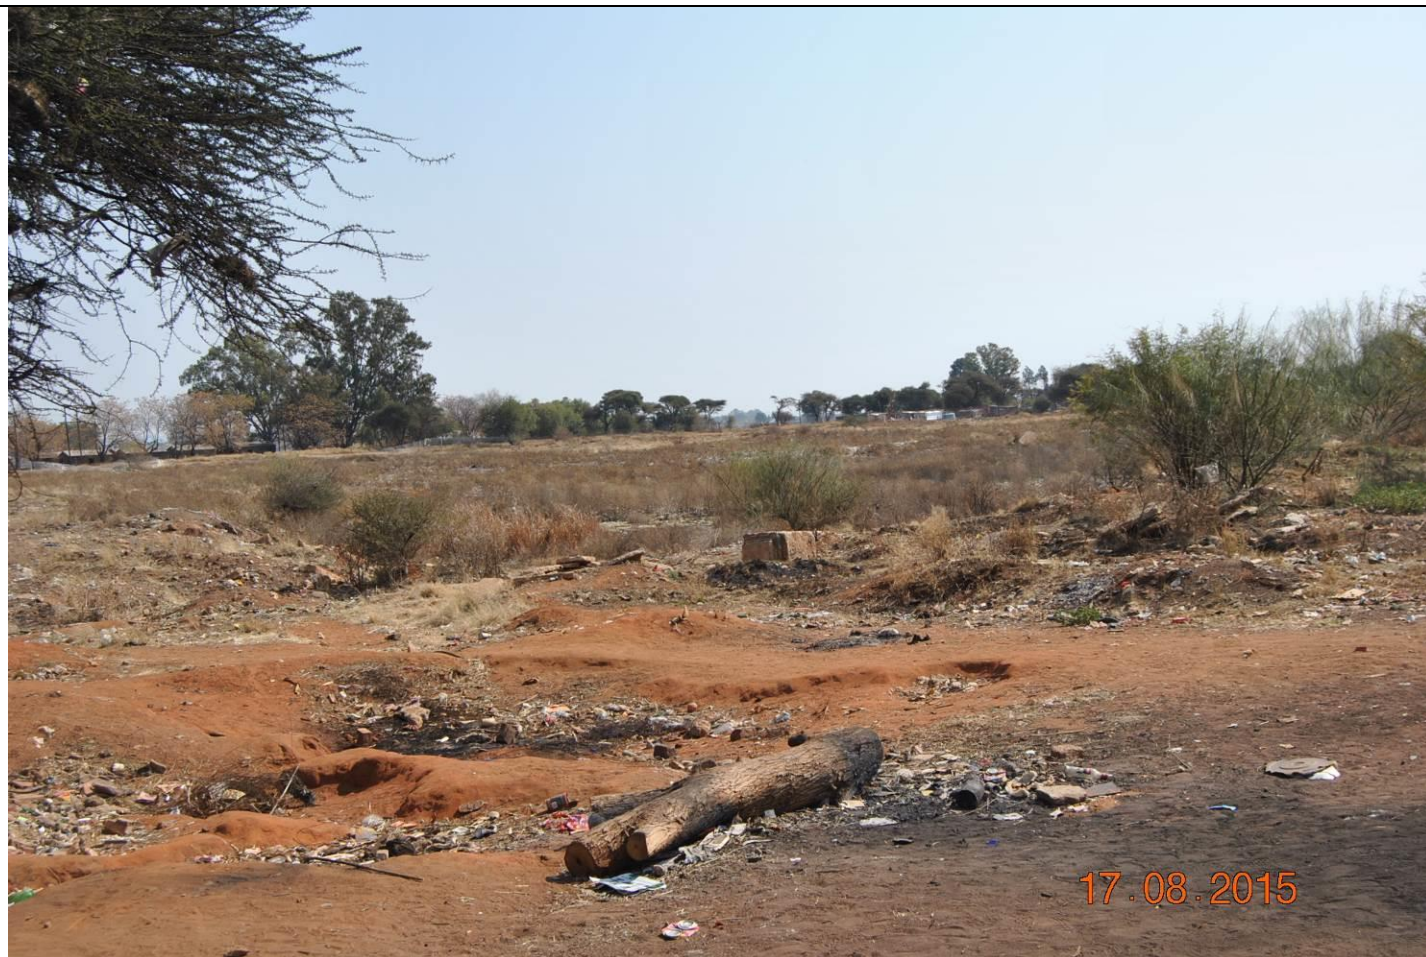
Illegal littering and burning of waste

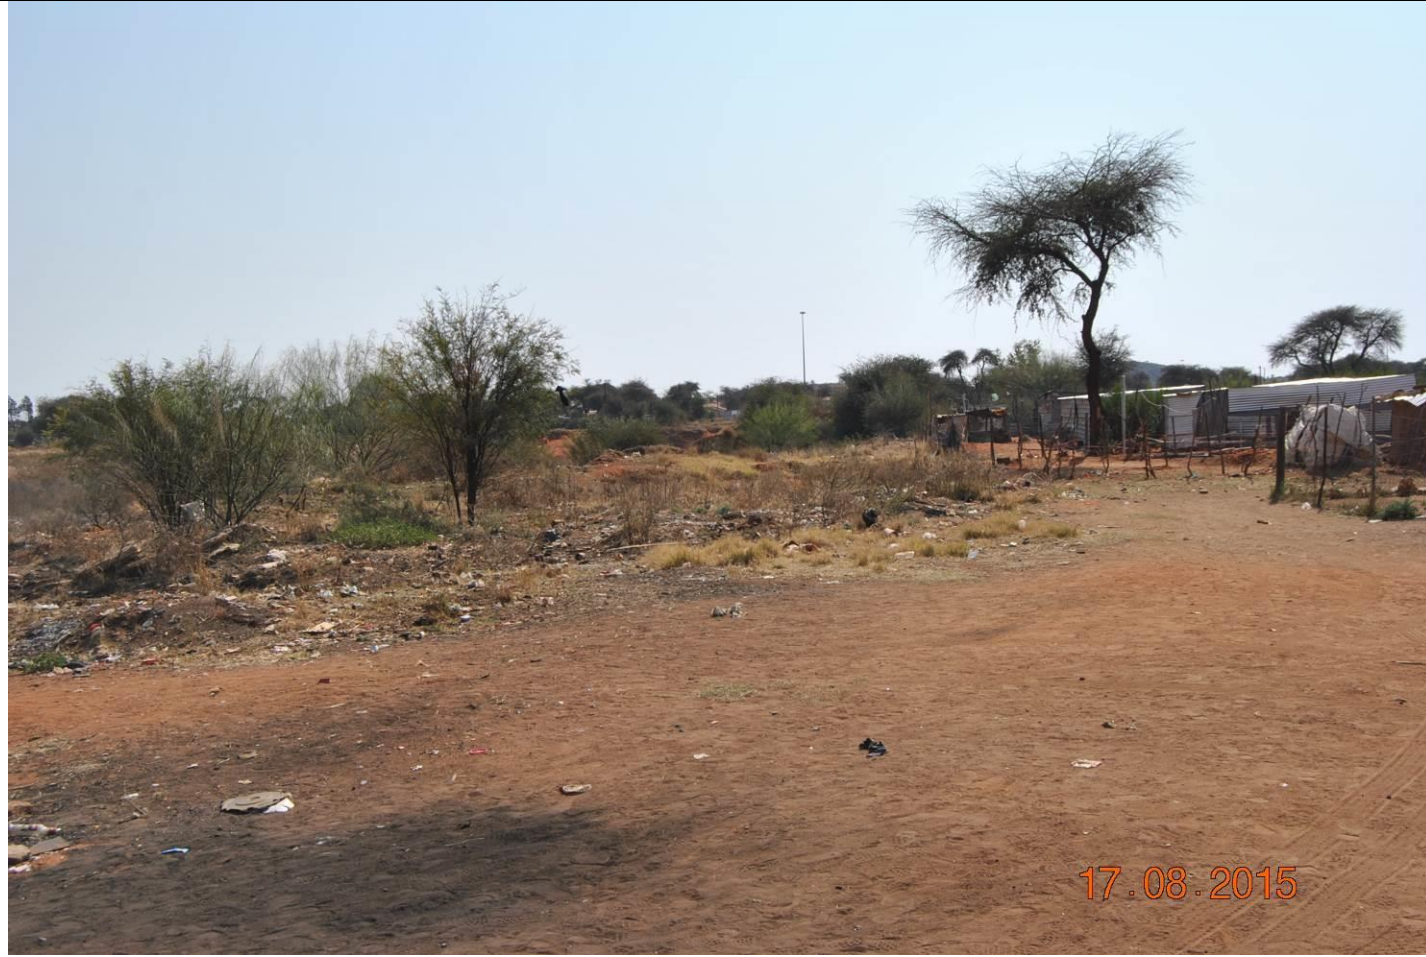
Semi-formal housing within the existing perimeter of the landfill

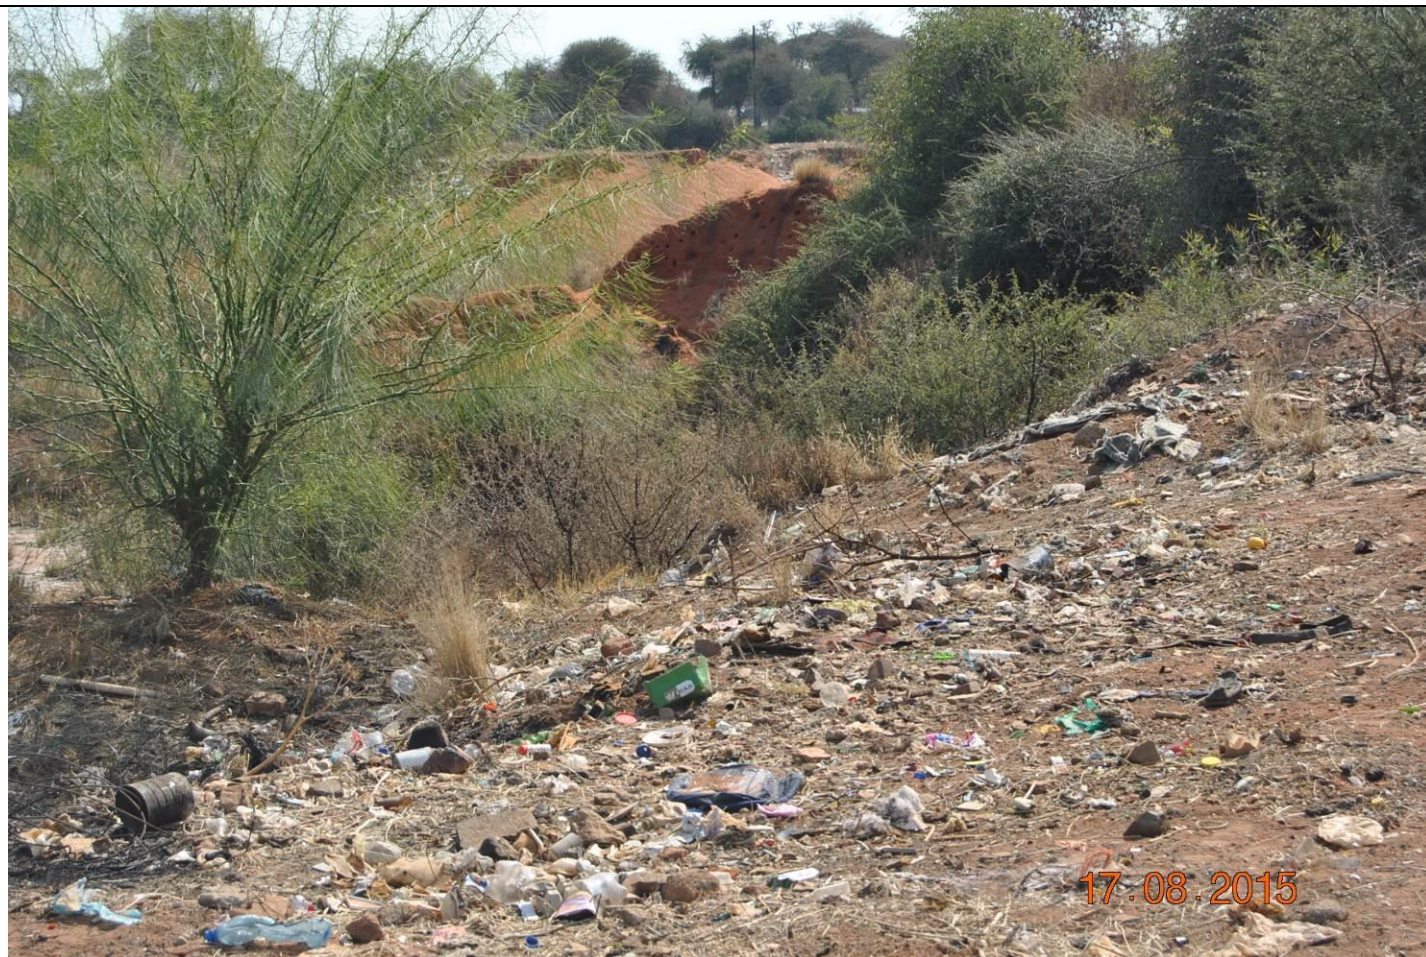
Illegal dumping within the landfill perimeter.
