**APPENDIX B**

**SITE PHOTOGRAPHS: JAN KEMPDORP WASTE DISPOSAL FACILITY**

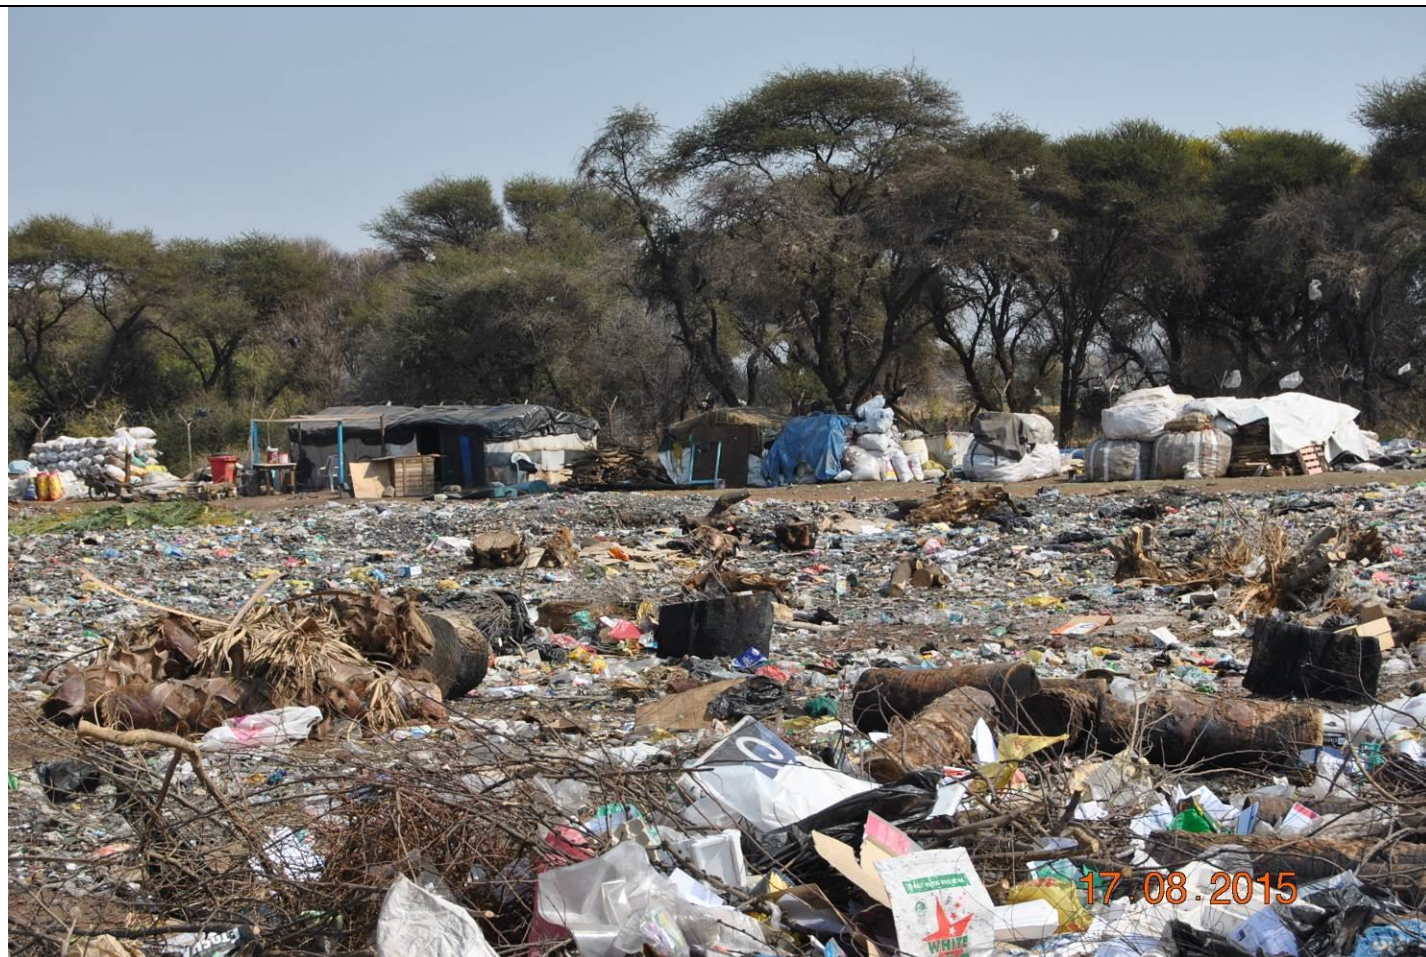
Littering and illegal dumping taking place outside the existing boundaries of the landfill.

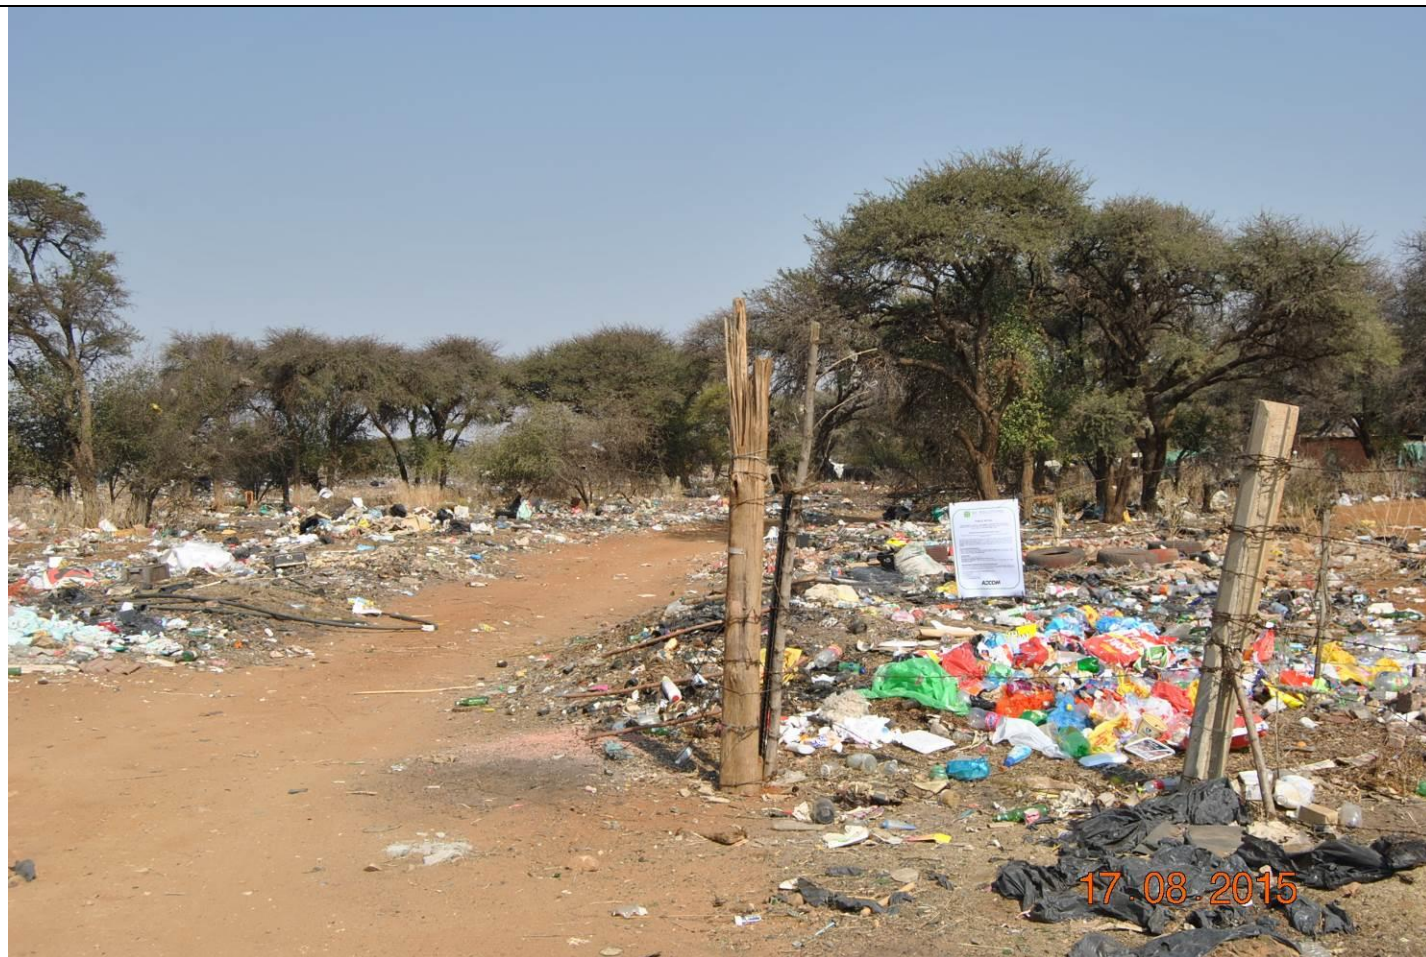
Evidence of littering outside of the landfill footprint.

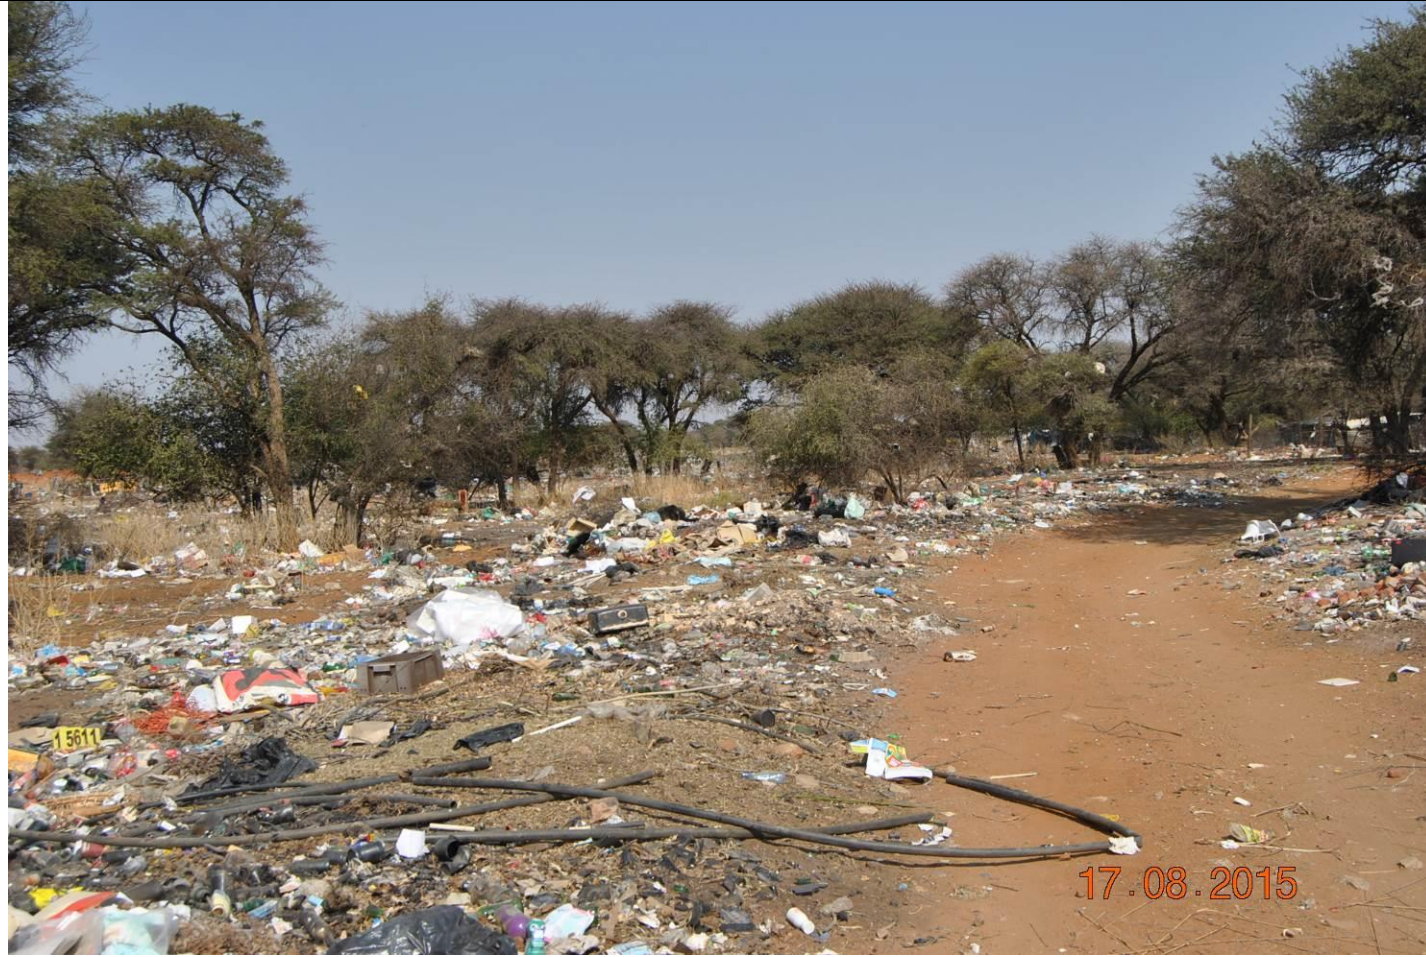
Littering and illegal dumping taking place outside the existing boundaries of the landfill.
