**PROPOSED UPGRADING OF EXISTING MUNICIPAL SEWAGE TREATMENT PLANT AT SEKGOSESE
SECONDARY SCHOOL ON PART OF THE FARM ROERFONTEIN 161-LT, SENWAMOKGOPE, LIMPOPO
PROVINCE – SITE PHOTOS**

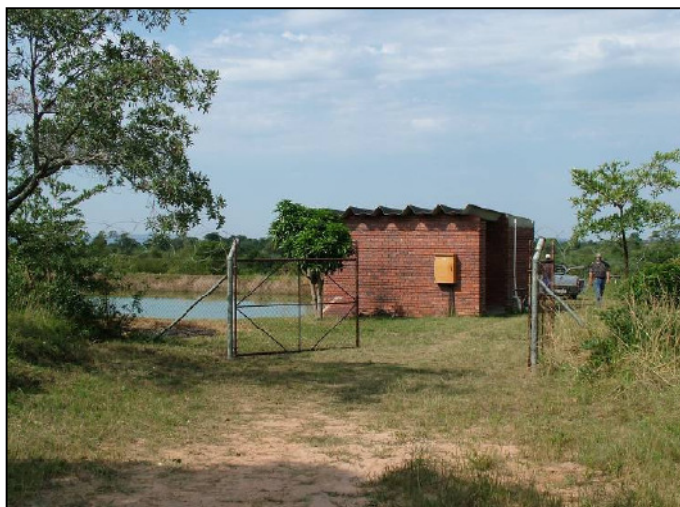
Entrance to the site.

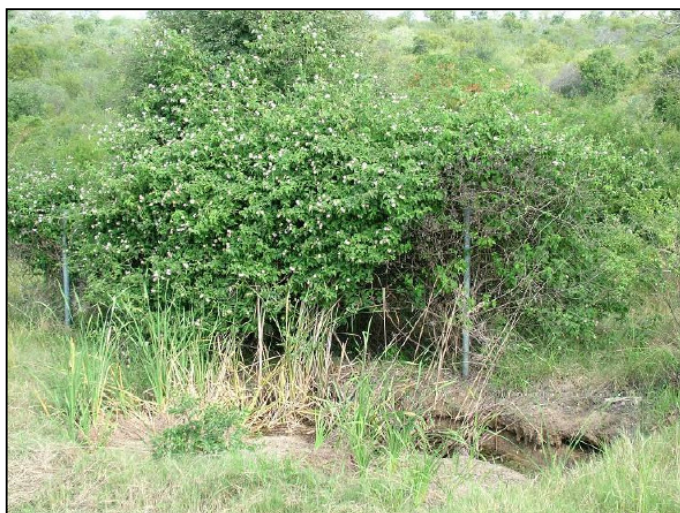
Invasive *Lantana camara* onsite.

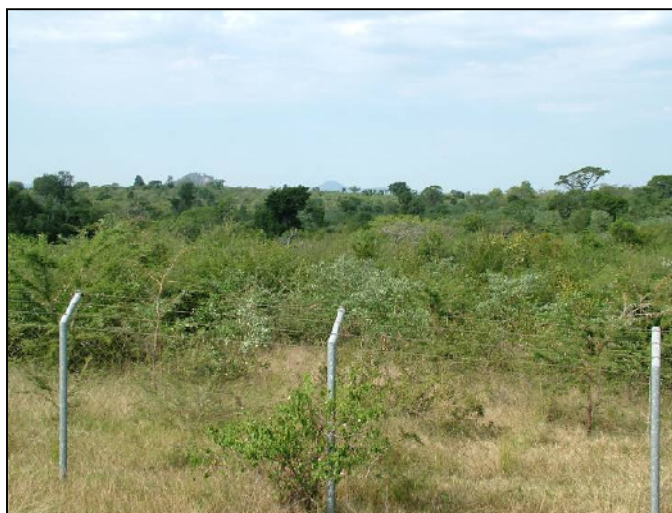
Indigenous vegetation outside the site.

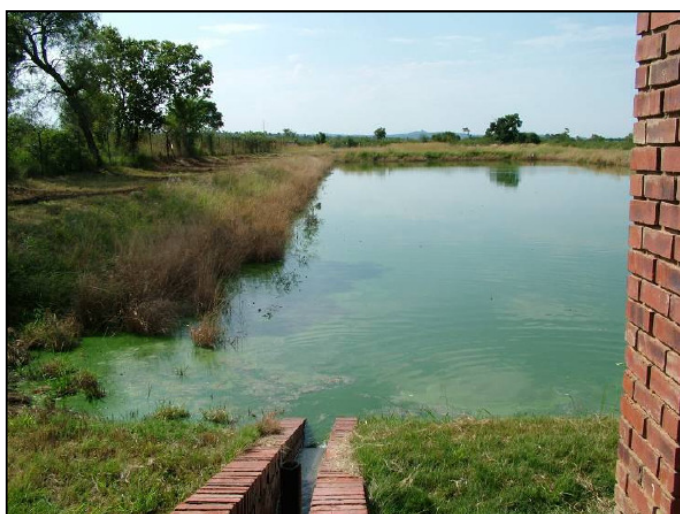
Entry of raw sewage into the primary pond.

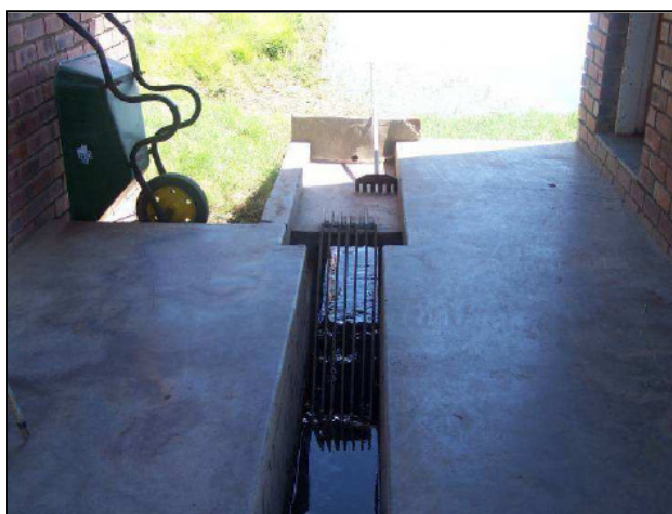
Inlet structure.

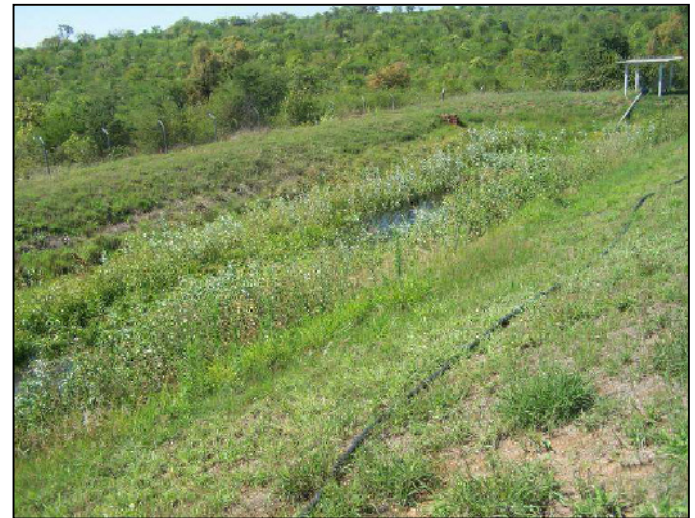
Tertiary pond 3. Bulrushes growing in the pond are aiding in bio-remediation (natural treatment).
