**REPORT OF SITE VISIT AT JAGERSFONTEIN, FREE STATE
TO ASSESS THE PROPOSED INFILLING OF THE MINE PIT
FROM JAGERSFONTEIN DEVELOPMENT INC.**

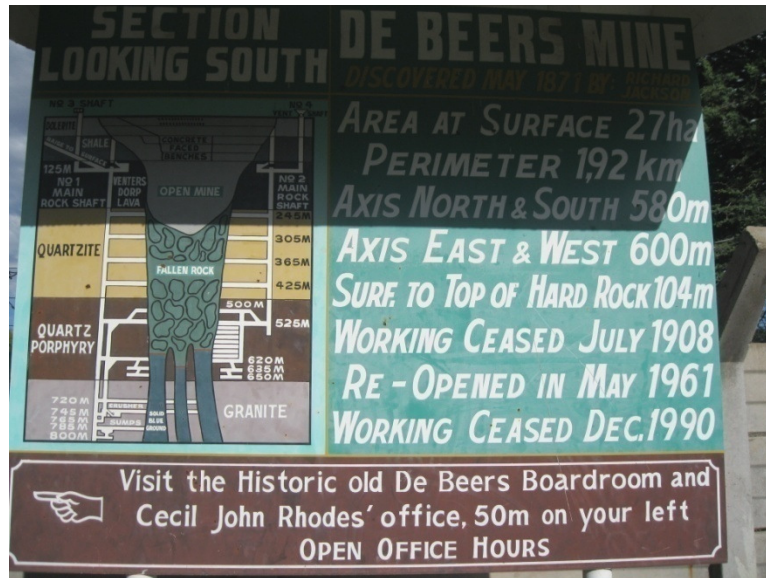
Ms Smuts presented a few pictures taken the previous day in Kimberley (Figs. 1 and 2), where the De Beers pit had been filled from 1994 to 2010 with the reprocessed material of mine tails and slimes and it has now been turned into a wetland. If this option had to be used in Jagersfontein, it might attract some tourists for bird-watching.

Figure 1. Details of the De Beers pit in Kimberley.

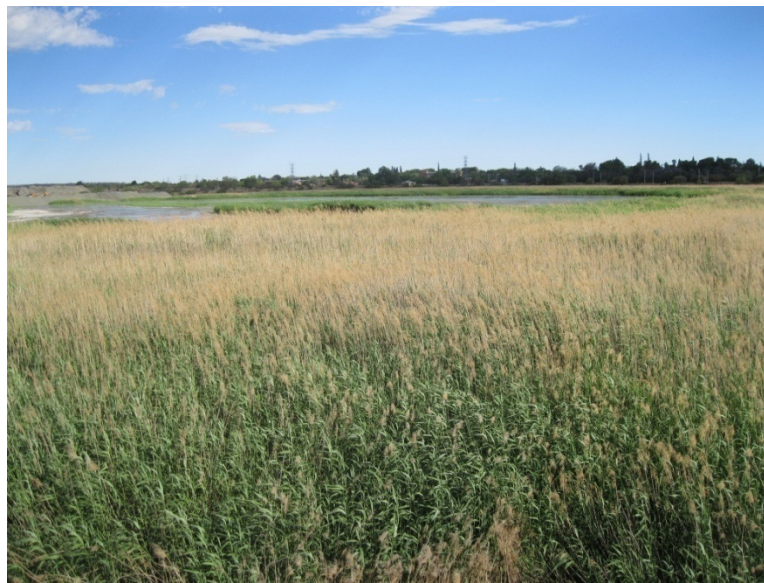
Figure 2. The De Beers pit in Kimberley which had been filled with the waste material from reprocessed mine dumps and turned into a wetland.

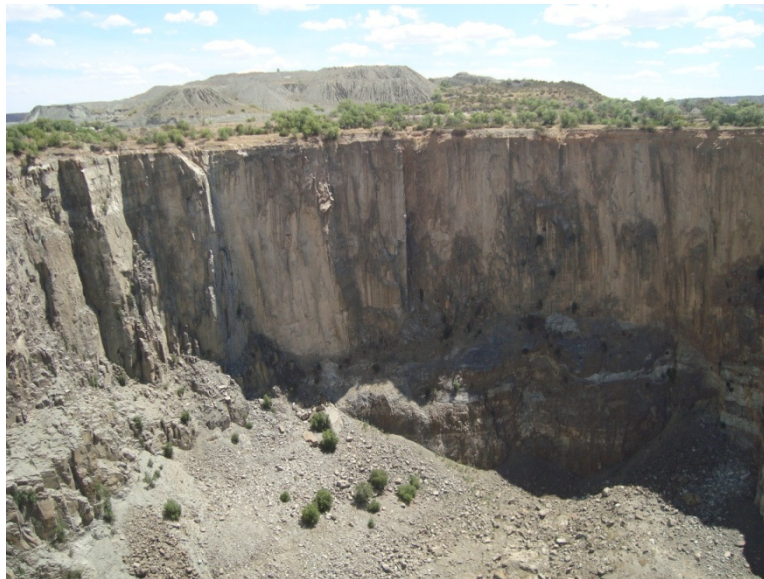
The viewing platform on the pit was closed down about a year ago because of safety issues. The engineering report identified that the platform was not safe enough for people to visit (Fig. 4). During the site visit we did, however, walk on the viewing platform and along the edge of the pit. Some sections along the perimeter of the pit are more fragile than others and cracks are clearly visible in a few spots (Figs. 5-7).

Figure 4. View of the mine pit from the viewing platform

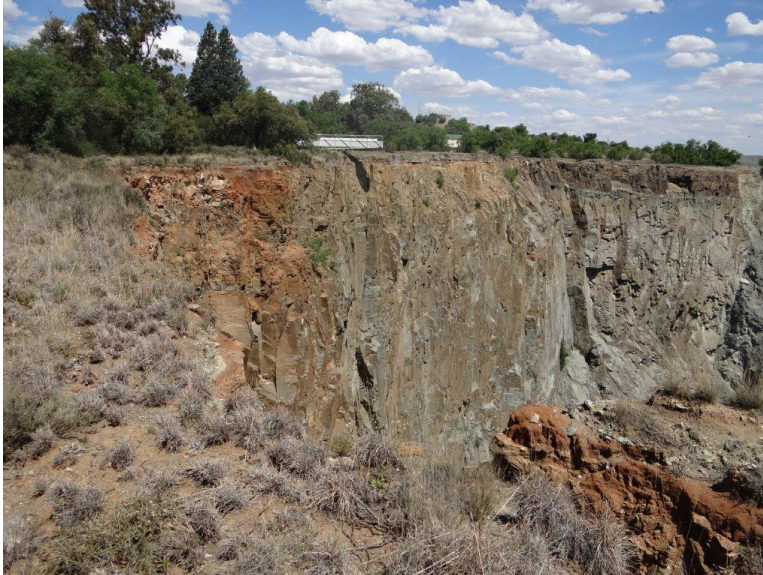
Figure 5. View of the mine pit and of the viewing platform.

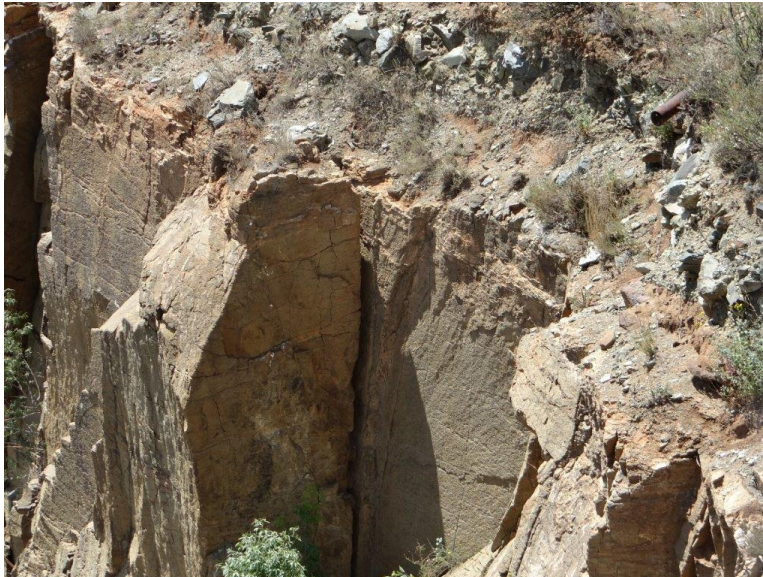
Figure 6. Crack in the side of the mine pit

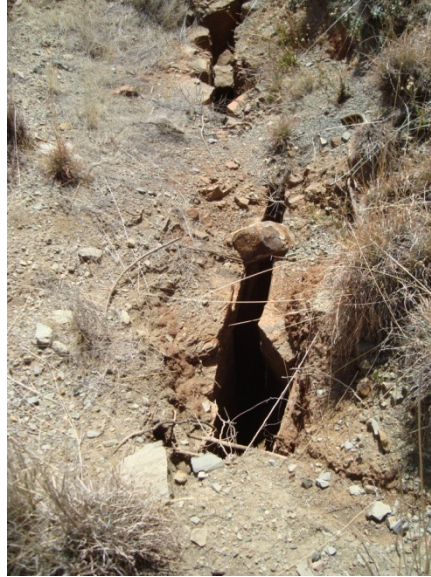
Figure 7. Crack along the perimeter of the mine pit

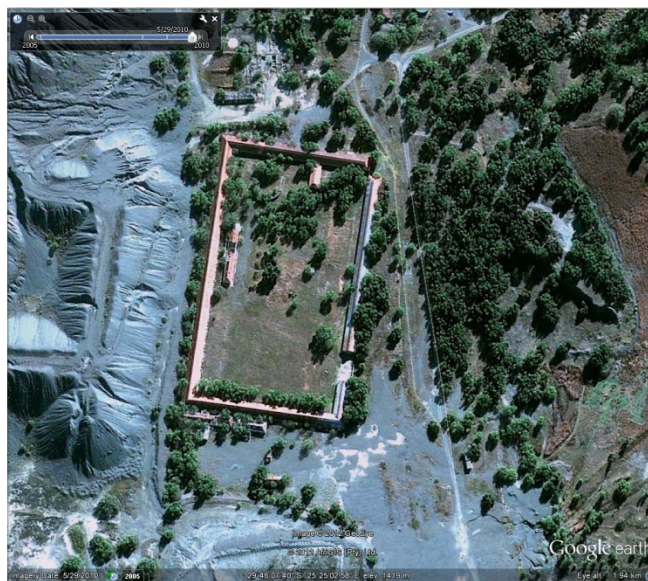
The hostel for the mine workers (Figs. 8-10) had burnt down accidentally in 2010 and thereafter, the damaged wing was demolished to make way for the mining operations and a new processing plant.

Figure 8. Google image view of the compound from 2010 before the southern portion of the workers' hostel burnt down.

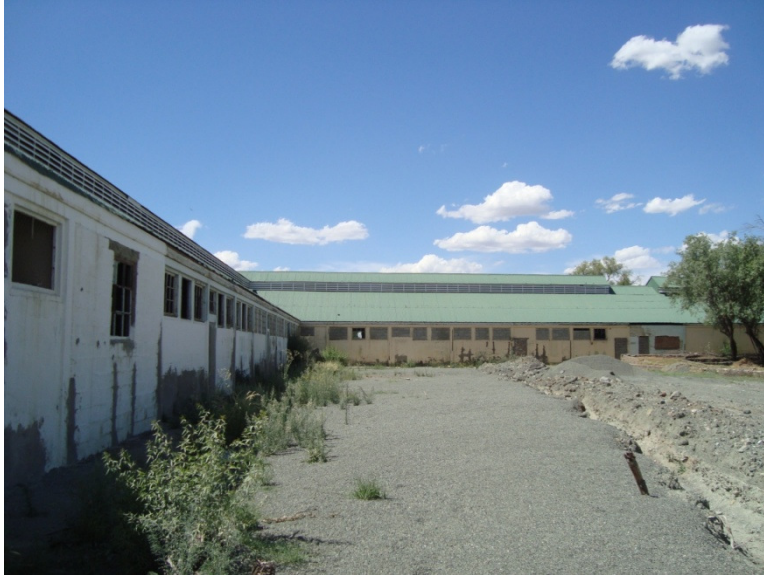
Figure 9. View of the workers' hostel to the north.

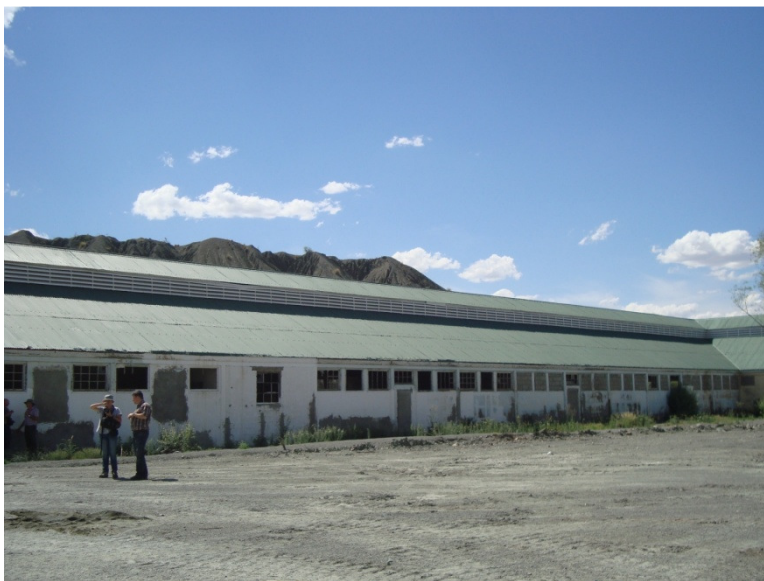
Figure 10. View of the workers' hostel to the northwest.

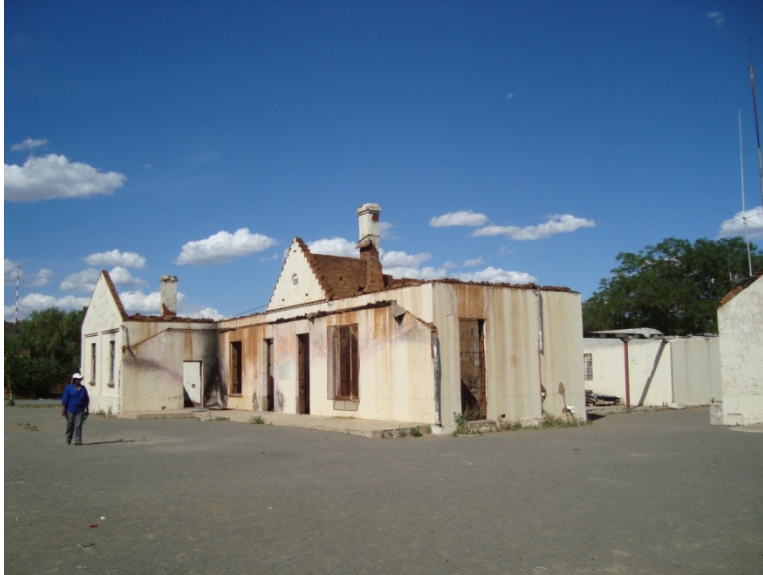
A fire in July 2010 damaged the old municipal town hall, a Herbert Baker building, which was built in 1892 (Fig. 11). No effort has been made to restore the facility (Fig. 12-13) yet. The municipal theatre, a second Baker building, located on the same square, is also in a state of disrepair, although still functional.

Figure 11. View of the town hall after burning down, view to north east.

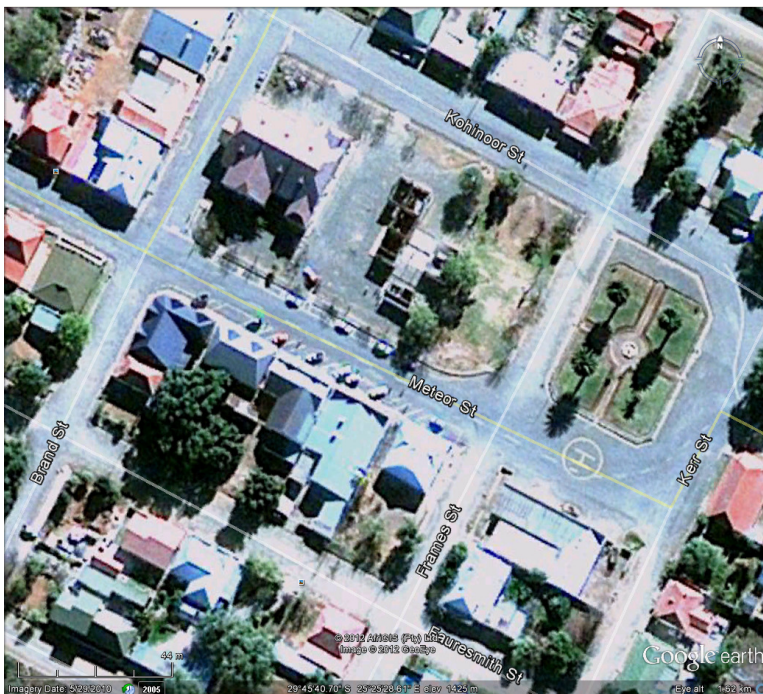
Figure 12. View of the town hall from Google Earth after burning down (2010)

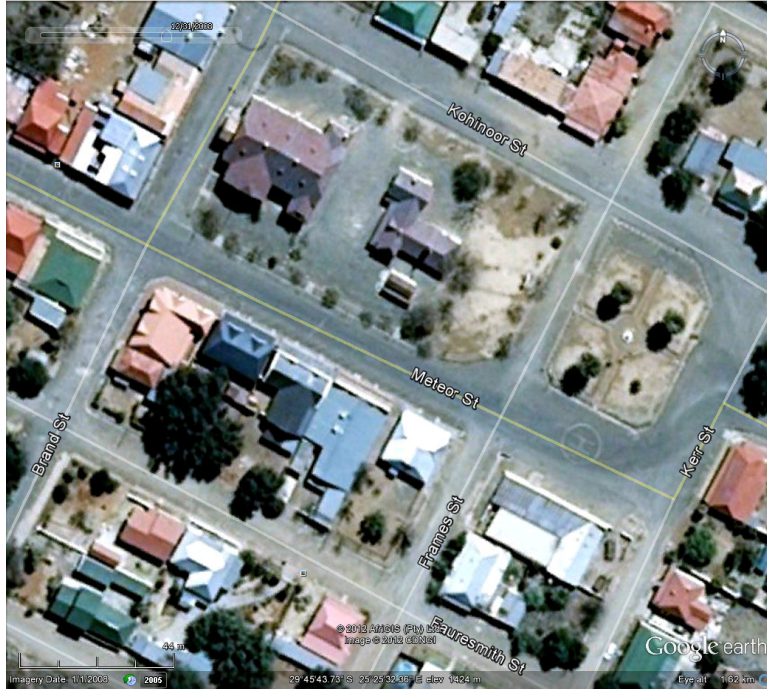
Figure 13. View of the town hall from Google Earth before burning down (2008)
