## REPORT TO THE SOUTH AFRICAN HERITAGE RESOURCES AGENCY

**Date:** 2022-09-12

RE: Authorisation request for the partial demolition of the derelict Strand Jetty

Case ID: 12502

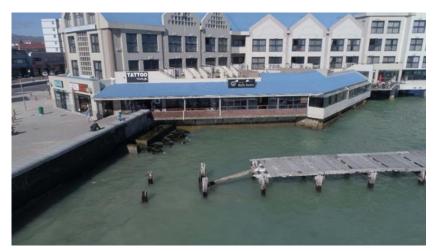
Figure 1: The Jetty after the shoreward section was removed, and the revetment constructed (2021).

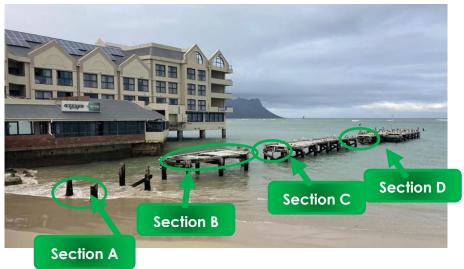
Figure 2: The Jetty after the shoreward section was removed (Section A), and the revetment constructed (2022) with additional damaged sections B, C & D identified for removal.

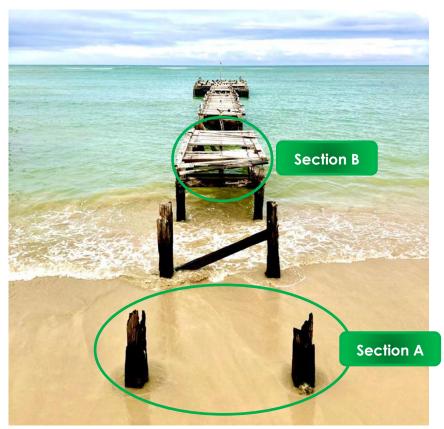
Figure 3:
Dangerous sections of the Jetty that needs to be removed, "Section A & B" (2022). Olds footings are breaking up and at risk of becoming partly submerged and/or covered by sand posing a risk to people. All loose, rotten and partly detached boards and support beams must be removed. Wooden footings will be

left in place, but the severely rotten ones will be removed.

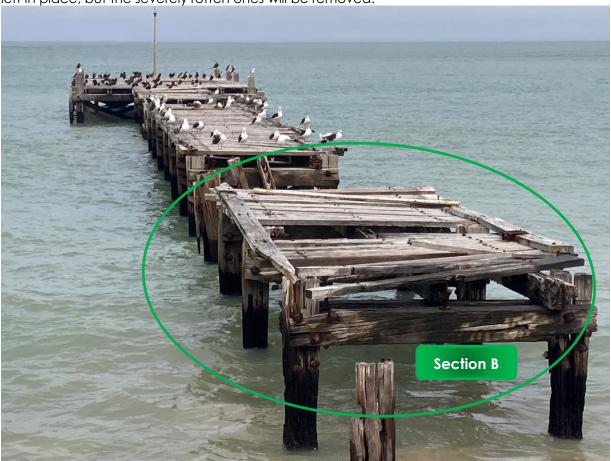
Figure 4: It is recommended that this entire section is dismantled and removed as its completely unstable (Section B)

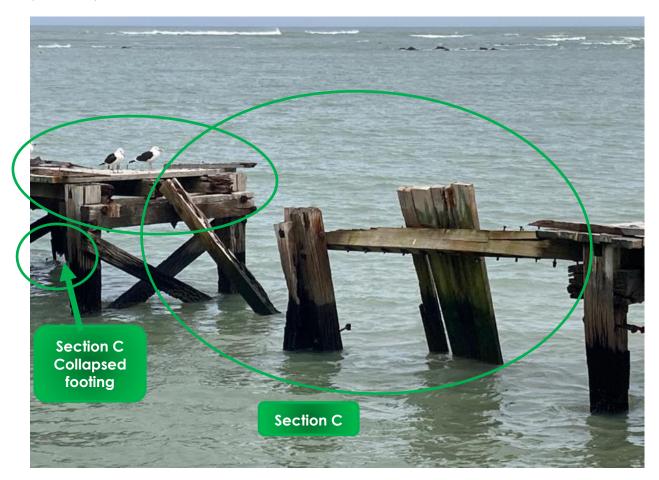
Figure 5: Dangerous sections of the Jetty that needs to be removed, "Section C" (2022). All loose, rotten and partly detached boards and support beams to be removed. Wooden footings will be left in place and only the severely rotten/collapsing ones will be removed. This will include the associated sections of walkway planks.

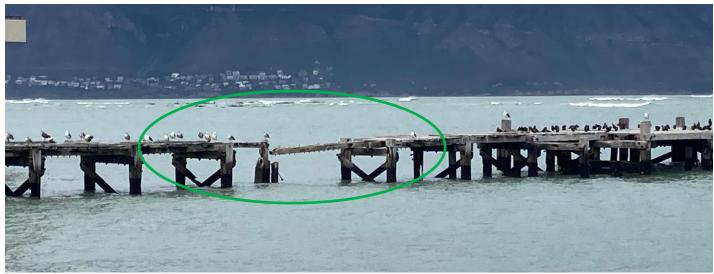
Figure 6: Loose and partly detached support beams to be removed (Section D). Remaining decking needs to be inspected up-close and any rotten/partly or fully detached planks to be removed.
