Jumbo Store 180 Church Street Pietermaritzburg 3201

Email: **Our Ref:** Y2021-039 **Date:** 19 July 2021

RE: STRUCTURAL EVALUATION REPORT

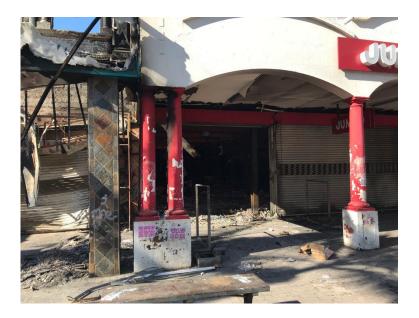
1. The concrete Arch, stubs and precast columns are structurally intact.

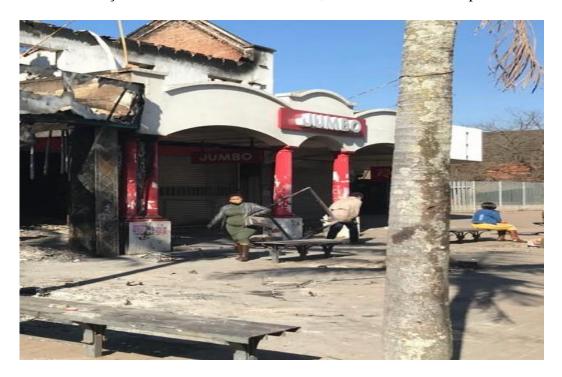
2. The façade of Jumbo store is still intact, the fire did not developed to this area.

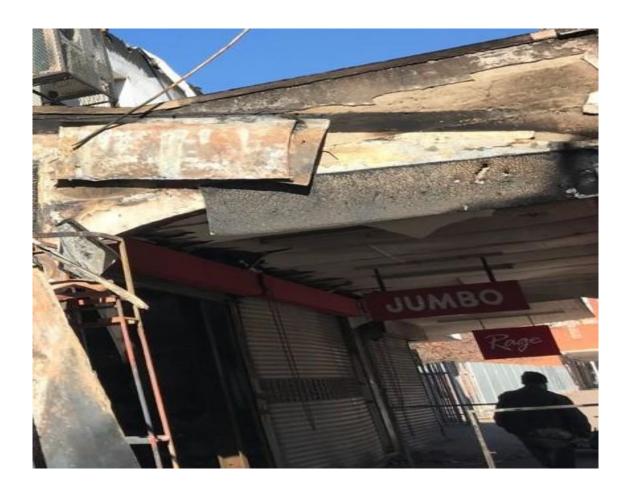
3. Roller shutter door still intact.

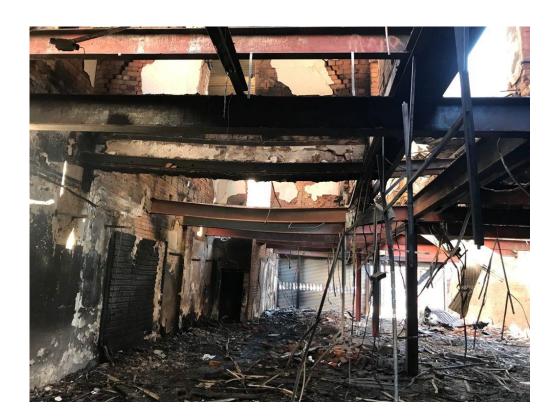
4. The internal of the store is completely damaged as a result of fire developed, steel beams that were supporting high walls are sagging thus they cannot be salvaged or re-used.

Concrete floor is also damaged by the collapse of the suspended ceiling, brick wall and timber roof,

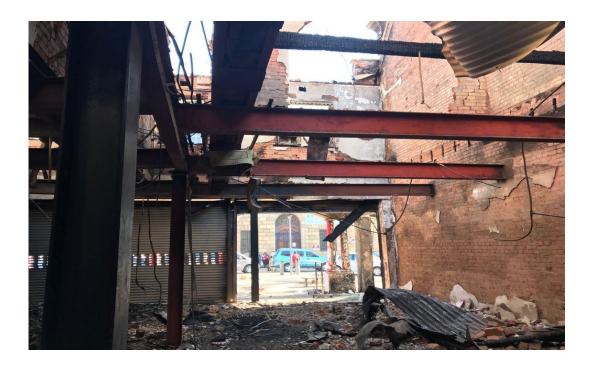
5. Some of the steel beams are in a good shape to be re-used but not to be salvaged for the existing structure, there is a high risk of the walls being crumbled.

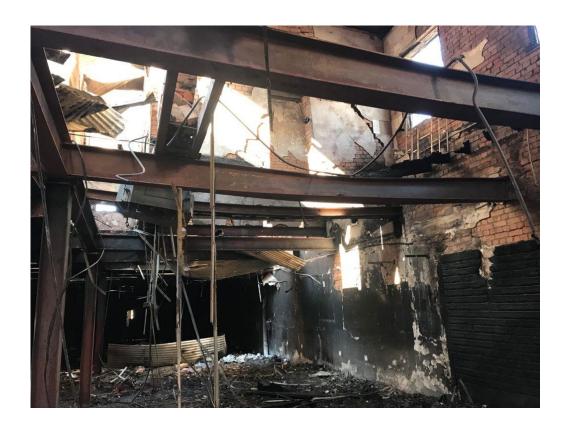
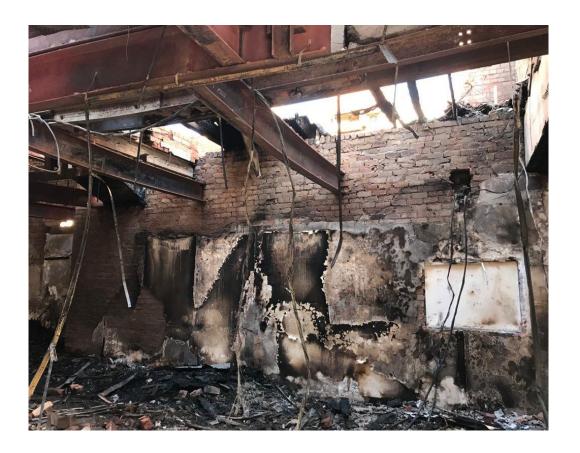
6. The steel members lost almost all the rigidity on the walls thus creating a high risk of collapse and serious deformation of the steel was observed.

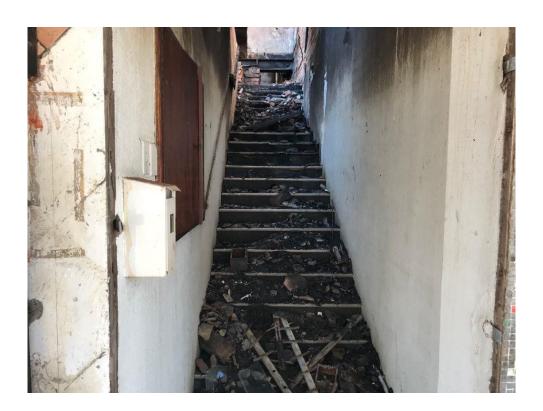
7. The damaged to the staircase is extreme and it must be demolished. The wall compartmentalising Rage store and the staircase is structural sound.

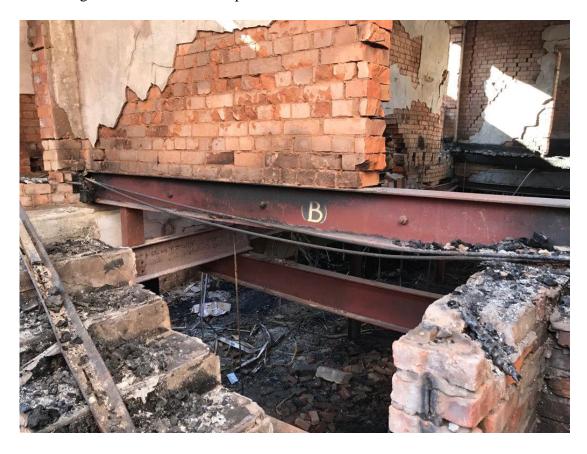
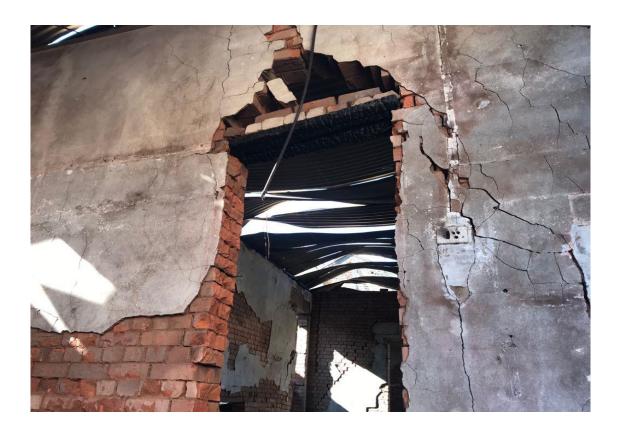
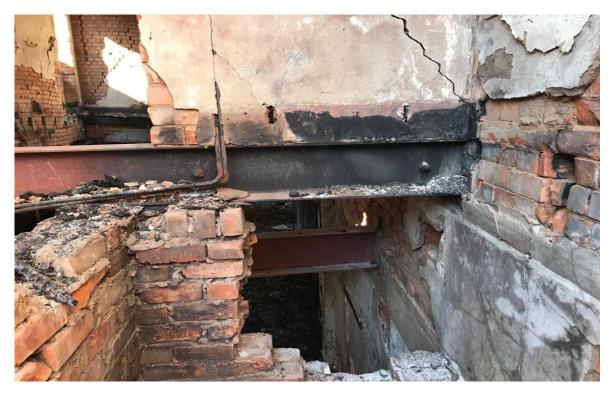
8. All first floor brick walls must be demolished, they are not in good quality to be saved and there is high risk of a further collapse.
