GDB ENGINEERS CC

Inspection of fire damage 287 Church Street Pietermaritzburg

Following our inspection of the fire damaged double storey structure accommodating Bluff Meat supply butchery at 287 Church street, we report :

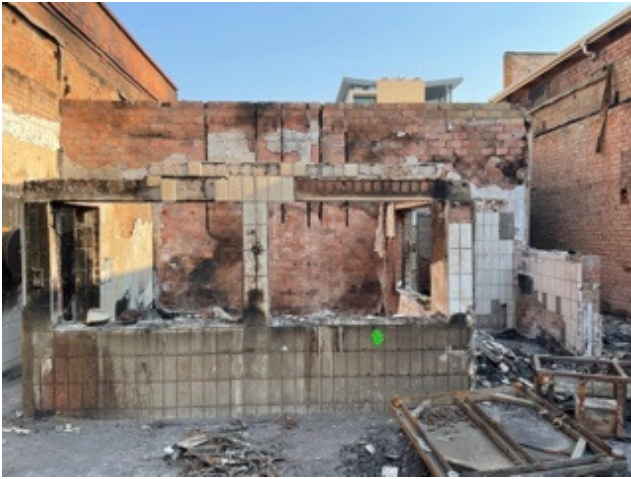
Ablution Area

The internal brickwork fronting the ablution facilities has been fire damaged and will need replacement
The entire ablution area including piping, toilets, basins and wall tiles have been damaged and will need replacement .

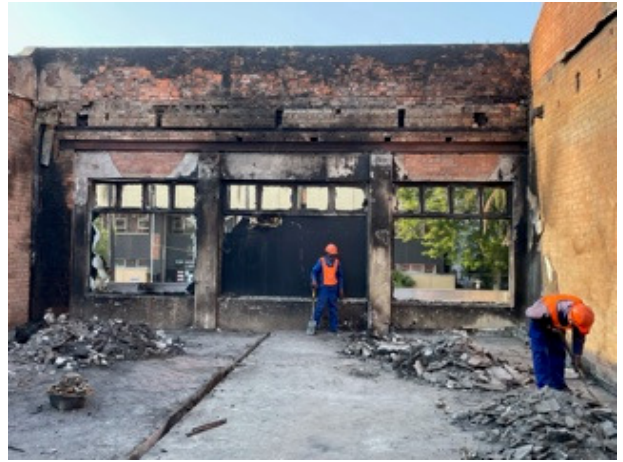
Front Façade

The front façade wall and associated steel lintel beam has been affected by the fire but appears able to be salvaged.

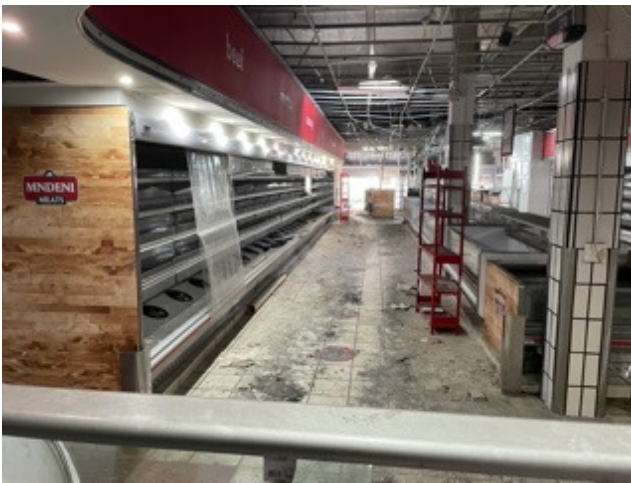
Lower level shop

The ground floor level although seriously damaged by looters does not appear to have suffered any fire damage apart from water damage related to the firefighting which penetrated the first floor plastic pipe drainage system from above.
