O.R. TAMBO HOMESTEAD

STRUCTURAL IMPACT ASSESSMENT REPORT OF EXISTING STRUCTURES Existing Aunt Getty House

9 September 2012

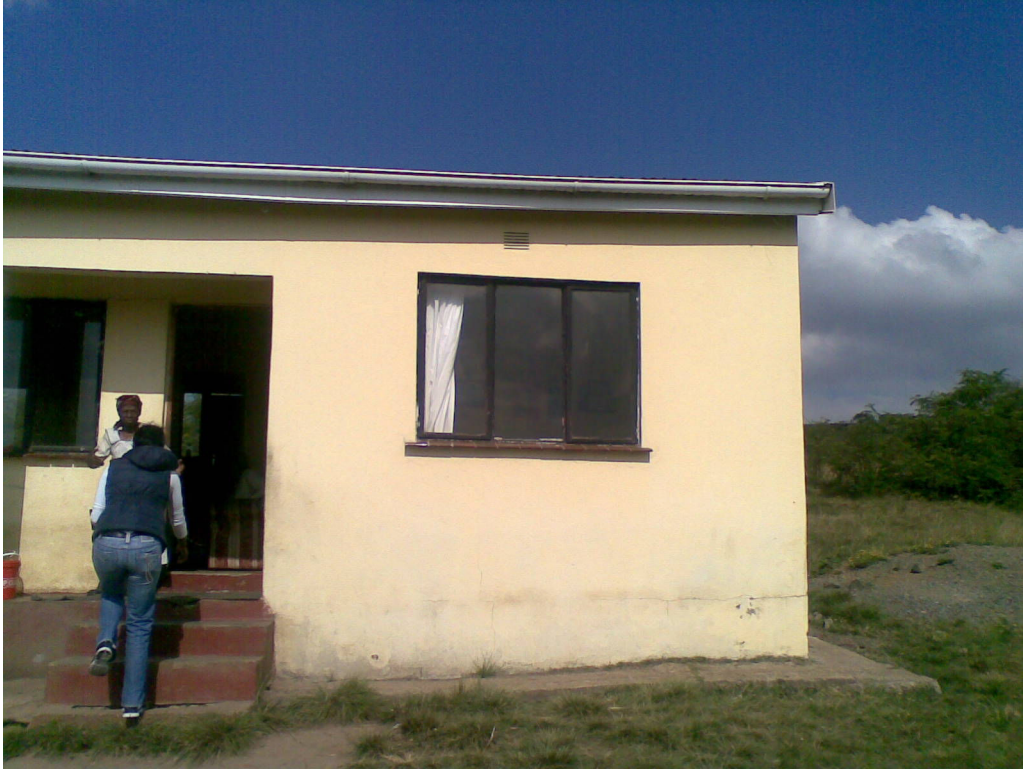
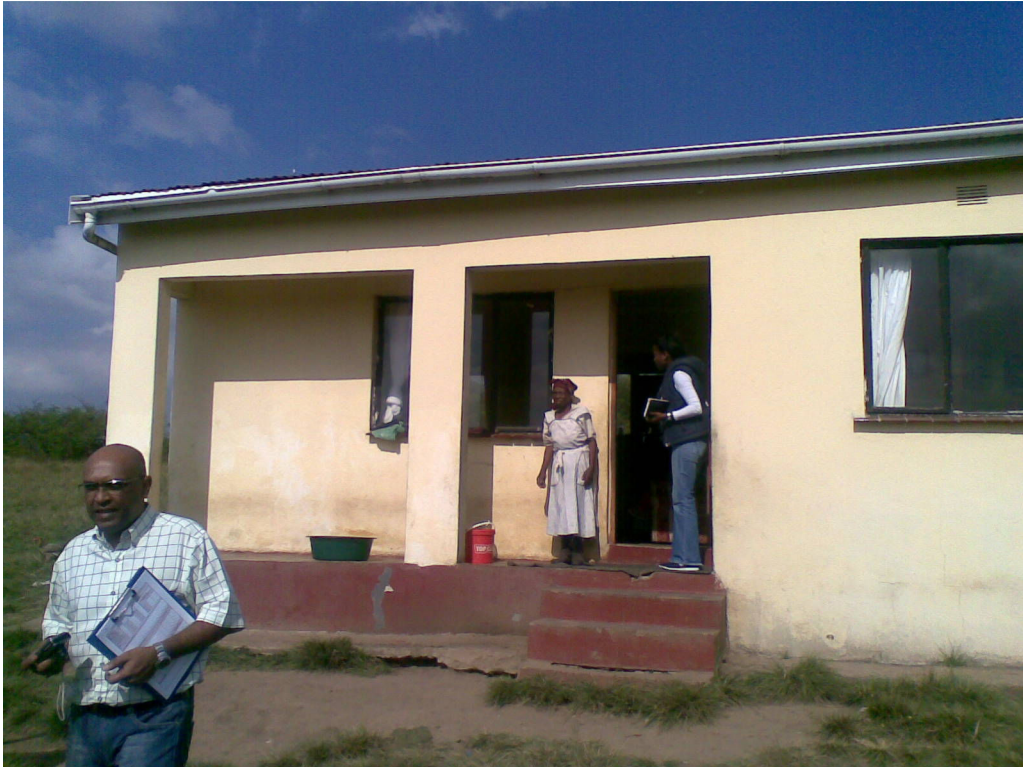
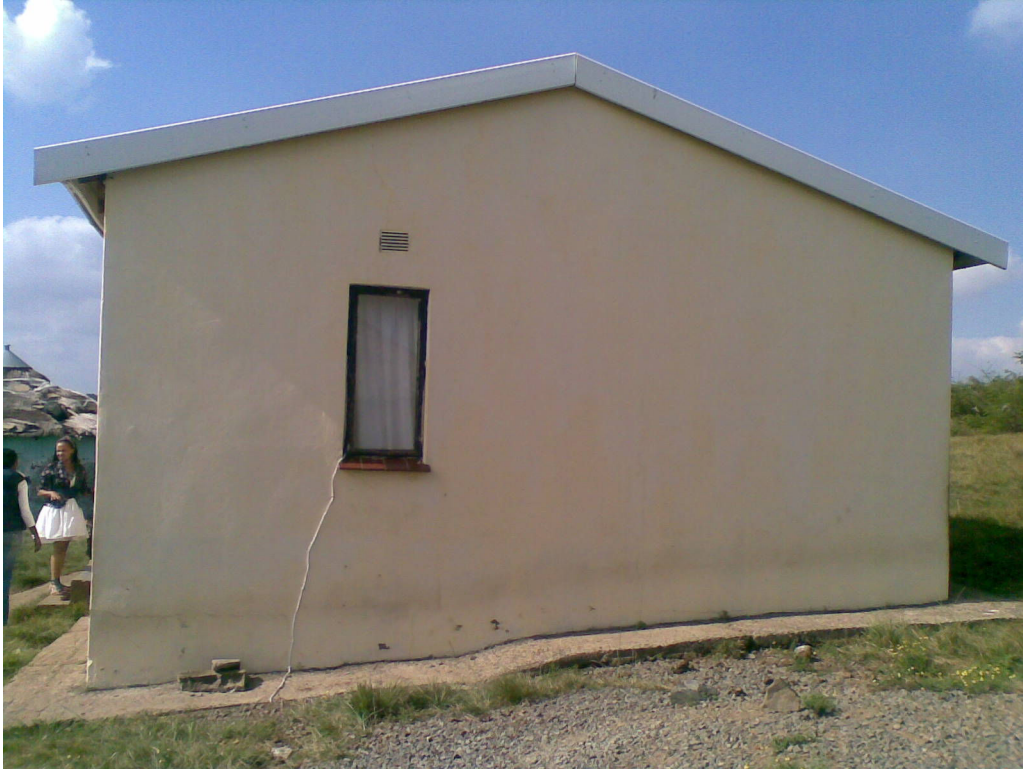
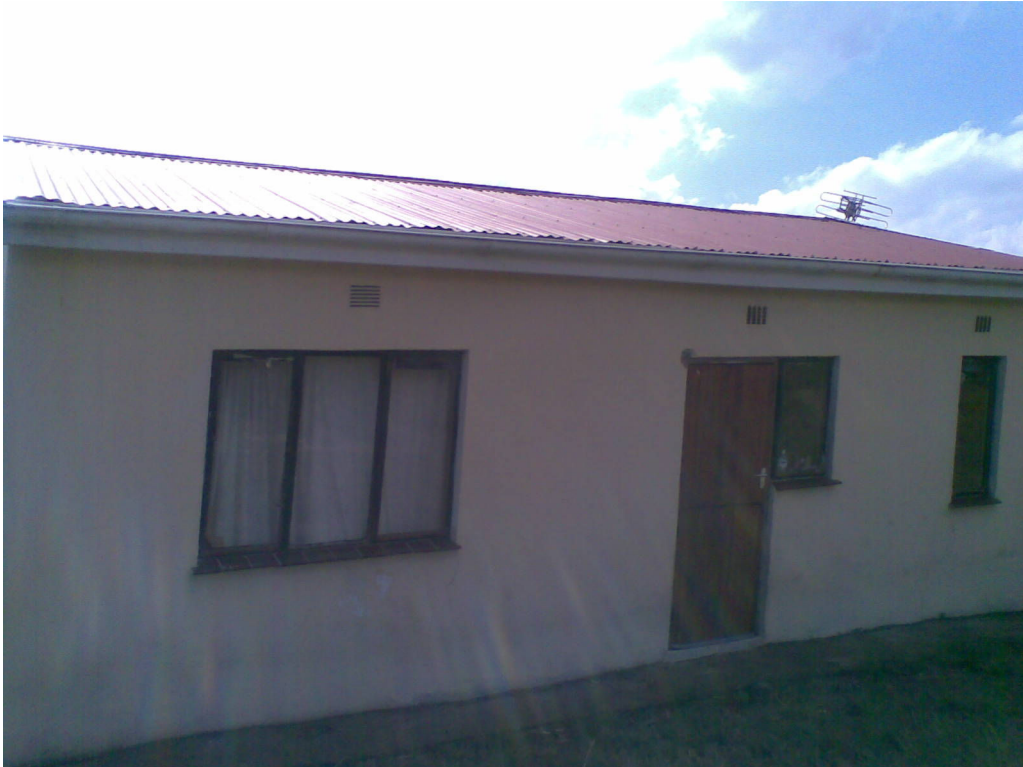
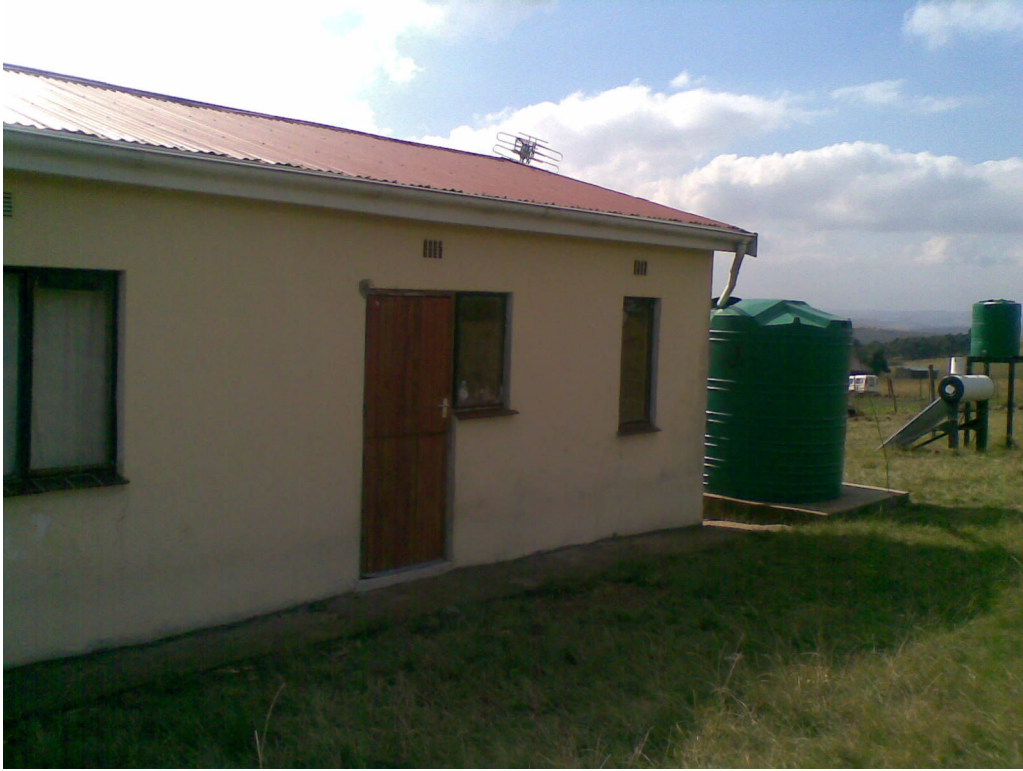
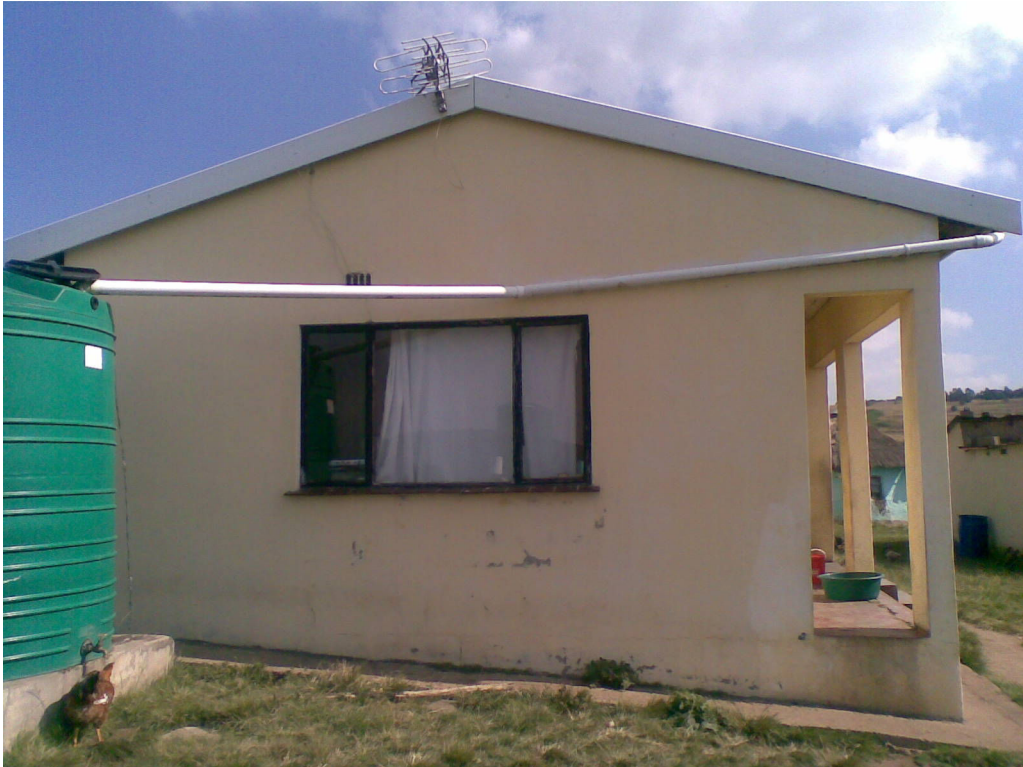
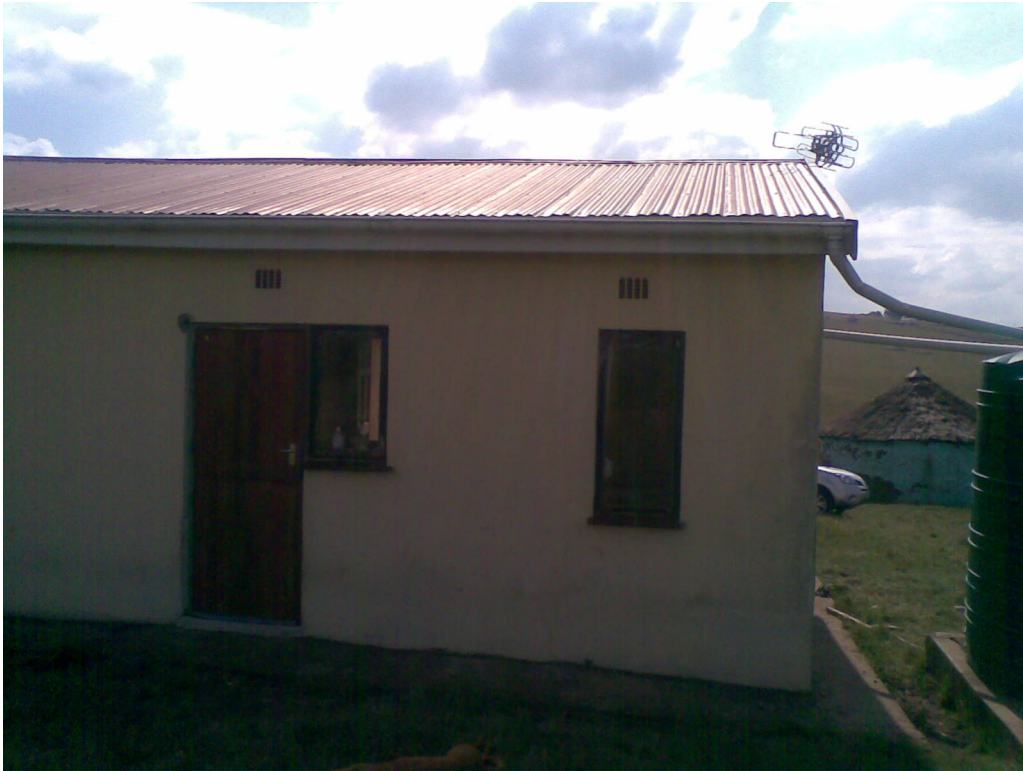
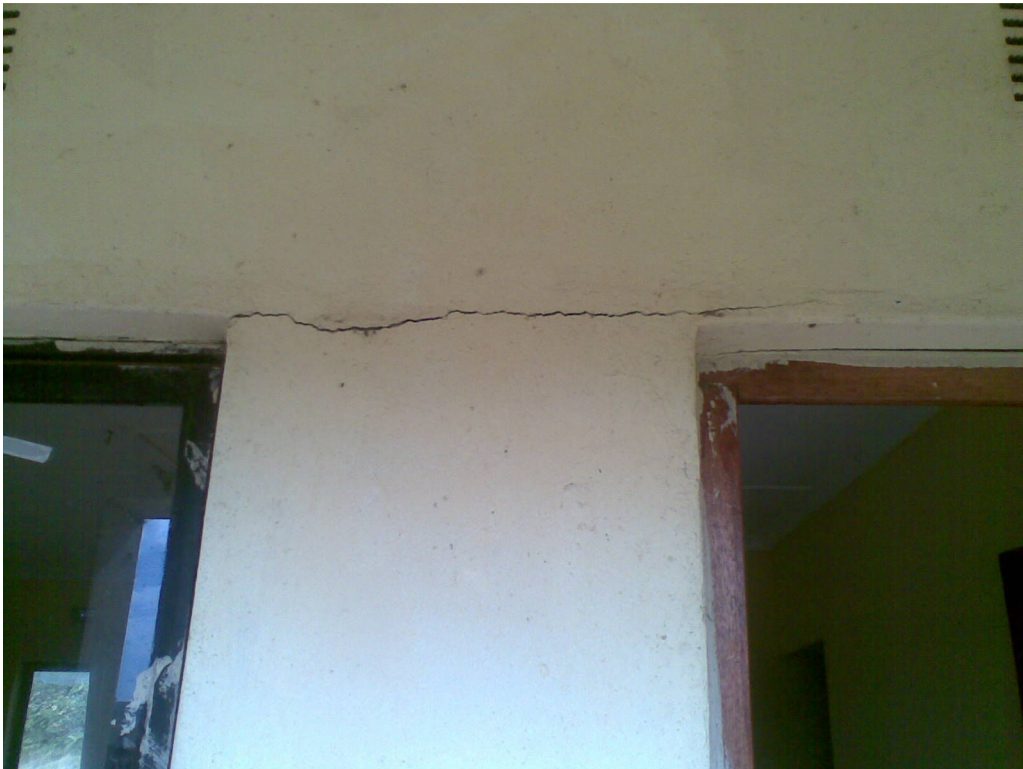
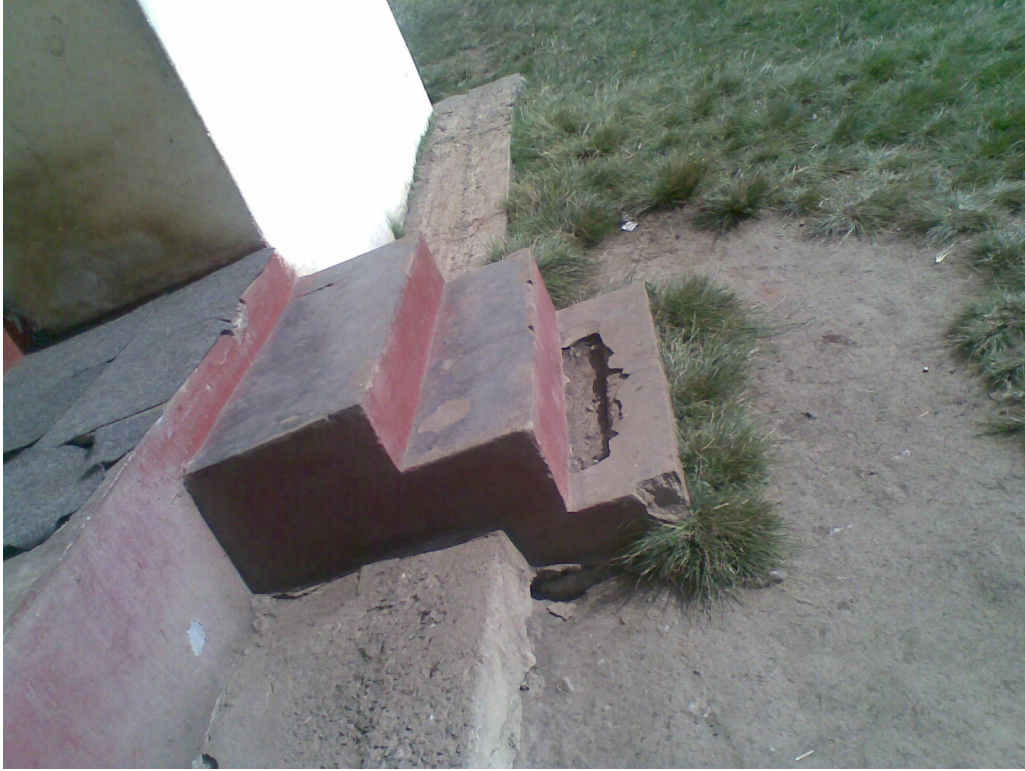
The photographs following on from here show the main house from all sides, externally, indicating the need for cleaning and basic remedial work.

The general integrity and stability of the main house was sound. The foundations to the house were also considered to be stable with no indications of uneven movements. The general work which we recommend would be to clean and restore, with remedial measures applied as necessary.
