**CONSULTING ENGINEERING SERVICES FOR THE
REHABILITATION OF EIGHT STRUCTURES IN THE
TSHWANE REGION WITHIN THE GAUTENG
PROVINCE**

REPORT: BRIDGE REHABILITATION REPORT

BRIDGES: B59 and B649

February 2017

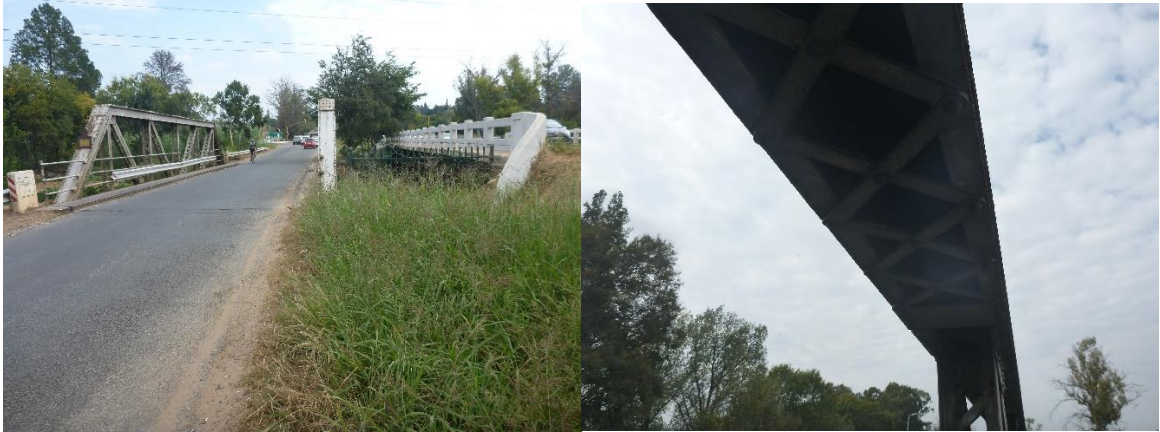
Defect	Photo
Majority of the steel structure has corroded	
Visible accidental Impact damage of truss member. The sight of bridge members in this state of distress could increase the public concern	
Erosion on steel side walk

Defect	Photo
Exposed steel structure at approaches leaves the superstructure vulnerable to impact	 
Drainage scuppers blocked	 
Handrails missing and damaged due to impact	 
Deteriorated expansion Joints

- General clean up with **Low pressure (HP)** waterjet to remove staining on masonry walls.
- Removal of corrosion and old paint with Sand blasting, apply protective coating to all steel components including bearings with a multiple coats matching the colour used for the original construction.
- Restore vertical member (see drawing below and attached) with impact damage to its original geometry using heat straightening techniques and strengthen by adding a new member of 280 x 50 plate channel section.

- Design and construct new concrete end-block to protect the steel structure at the approaches. New concrete end-block to be curved, and similar to the end-block for Bridge 1015, and guardrails to be connected to the end blocks
- Clearing of drainage scuppers
- Replace handrails with similar type to preserve the historical appearance of the bridge structure
- Replace existing expansion joints with new asphaltic plug joint
- Clean debris from bearing seal
- Patch asphalt surface

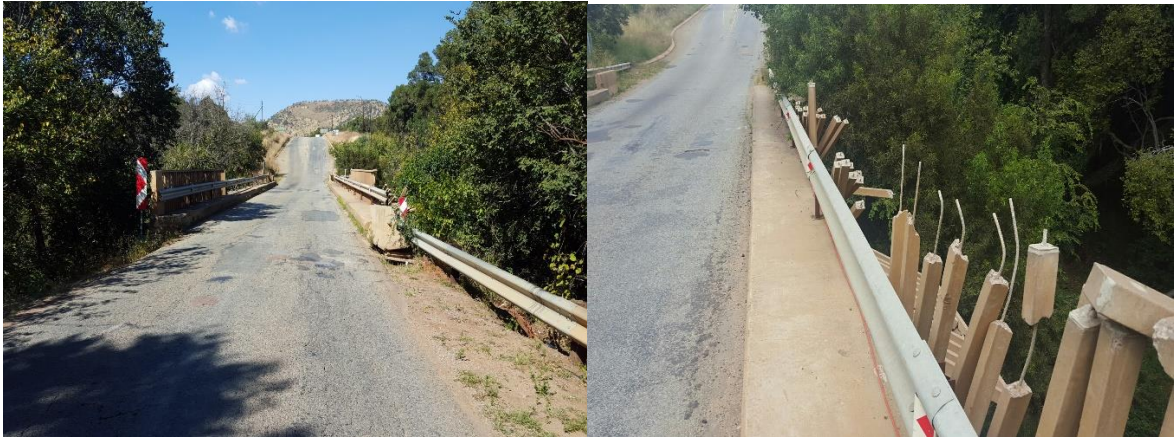
Defect	Photo
<p>Safety is a major concern on this bridge, the bridge is too narrow and it cannot accommodate traffic in both directions</p>	 
<p>Handrails damaged by vehicle impact as the bridge is too narrow</p>	 
<p>Guardrails not connected to the end-blocks on all four sides</p>

Defect	Photo
Edge of side walk not properly aligned with the road	 
High side walk	 
Over grown vegetation
