Geomech Consulting (Pty) Ltd Report No. GEOM13-2019-003

## **ELANDSFONTEIN COLLIERY EXISTING UNDERGROUND WORKINGS SUBSIDENCE INVESTIGATION REPORT**

**OCTOBER 2019**

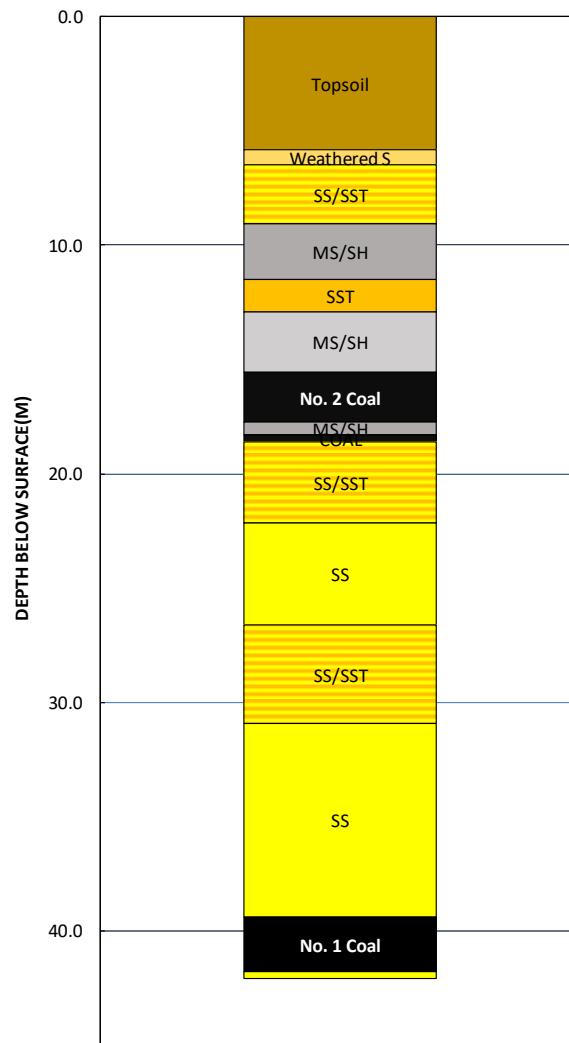
**Figure 2 - Generalised Stratigraphic Column for the Elandsfontein Mining Area**

As can be seen from the information included in **Figure 2** below, the No. 1 Seam (underground mining seam) is usually overlain by a Sandstone layer which is typically between 1.0 m and 14 m thick and has been found based on the available borehole information as well as routine visits to the opencast mining operations at Elandsfontein Colliery over the past Two (2) years to be competent and massive. A thin Coal / Shale layer has however been observed in some areas within the Sandstone later immediately above the No. 1 Seam which could be expected to result in localised roof instability in certain areas but would not be expected to result in extensive failures of the roof across large mining spans.

The Sandstone which overlies the No. 1 Seam is typically overlain by alternating layers of Siltstone / Sandstone and Sandstone which are in turn overlain by the No. 2 Seam. Generally, competent Sandstone layers have been found to constitute between 30 % and 50 % of the No. 1 Seam's overburden within the Elandsfontein mining area.

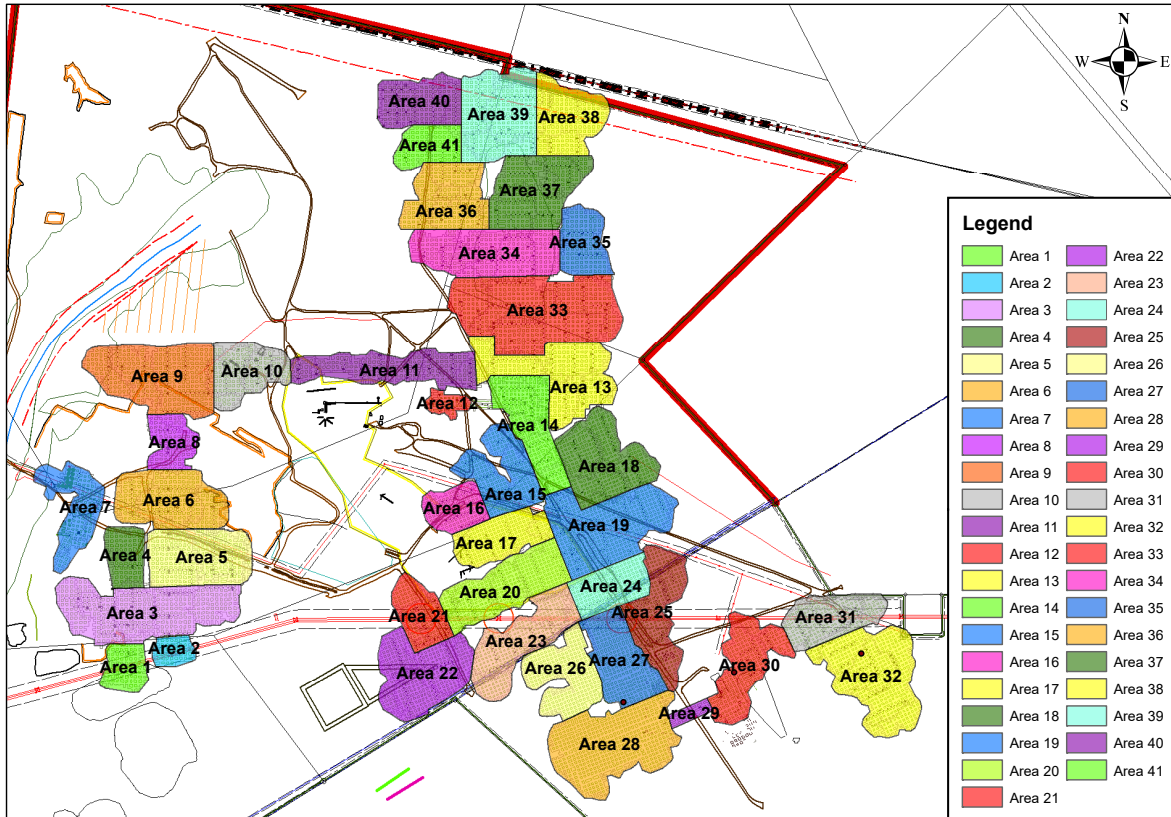
**Figure 3 - Identified Investigation Areas at Elandsfontein Colliery.**

For the purposes of this investigation, due to the geographical extent of the existing underground workings and the variability in pillar centres and mining depth, the existing underground workings within the Elandsfontein mining area have been sub-divided into a total of Forty-One (41) individual areas based on the geology in each area in conjunction with the underground mining layouts (pillar and bord width dimensions). These areas are included in **Table 4** below and were generally named from South-West to North-East. These areas are also illustrated in **Figure 3** below.

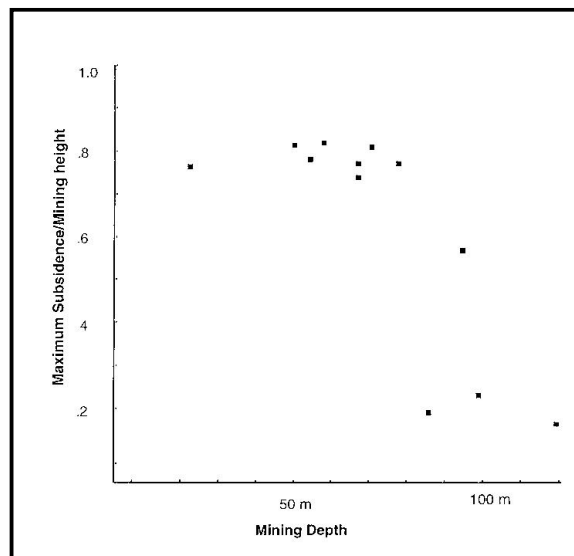
**Figure 4 - Estimated Factor to be applied to the Maximum Amounts of Expected Subsidence based on Mining Depth.**

According to van der Merwe and Madden (2010) **Figure 4** below can be used to adjust the expected maximum amounts of subsidence based on the depth at which mining is taking place.

In the panels under investigation mining took place close to boreholes in which the depth to the coal seam ranged from 13.9 m to 77.6 m.

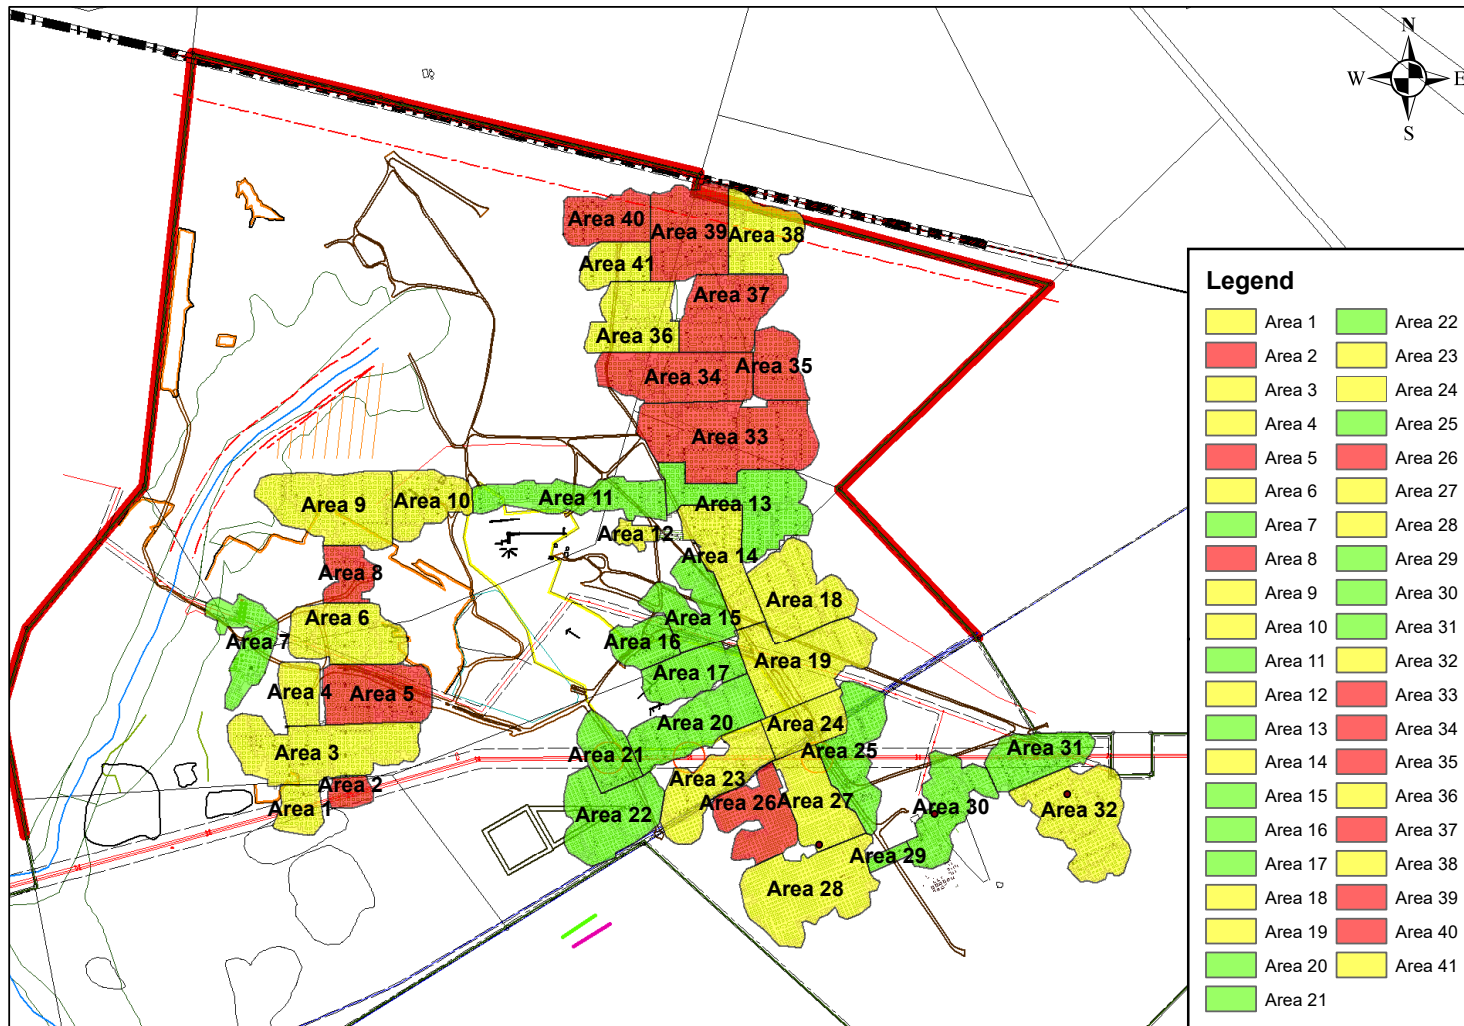
Figure 6 - Illustration of the Calculated Risk Per Investigation Area.

40	Area 40	X	X	X	X	X	4	4	16	Pillar failure likely over time			
41	Area 41	X	X	X	X	X	4	2	8	Pillar failure possible over time

**Table 10 - Results of the Surface Subsidence and Sinkhole Formation Risk Assessment which has been Conducted at Elandsfontein Colliery.**
