## **THE STRACHAN MEMORIAL HALL, MAIN STREET, UMZIMKULU – PHOTOGRAPHS TAKEN ON SATURDAY THE 18 APRIL 2015 BY AMAFA STAFF:**

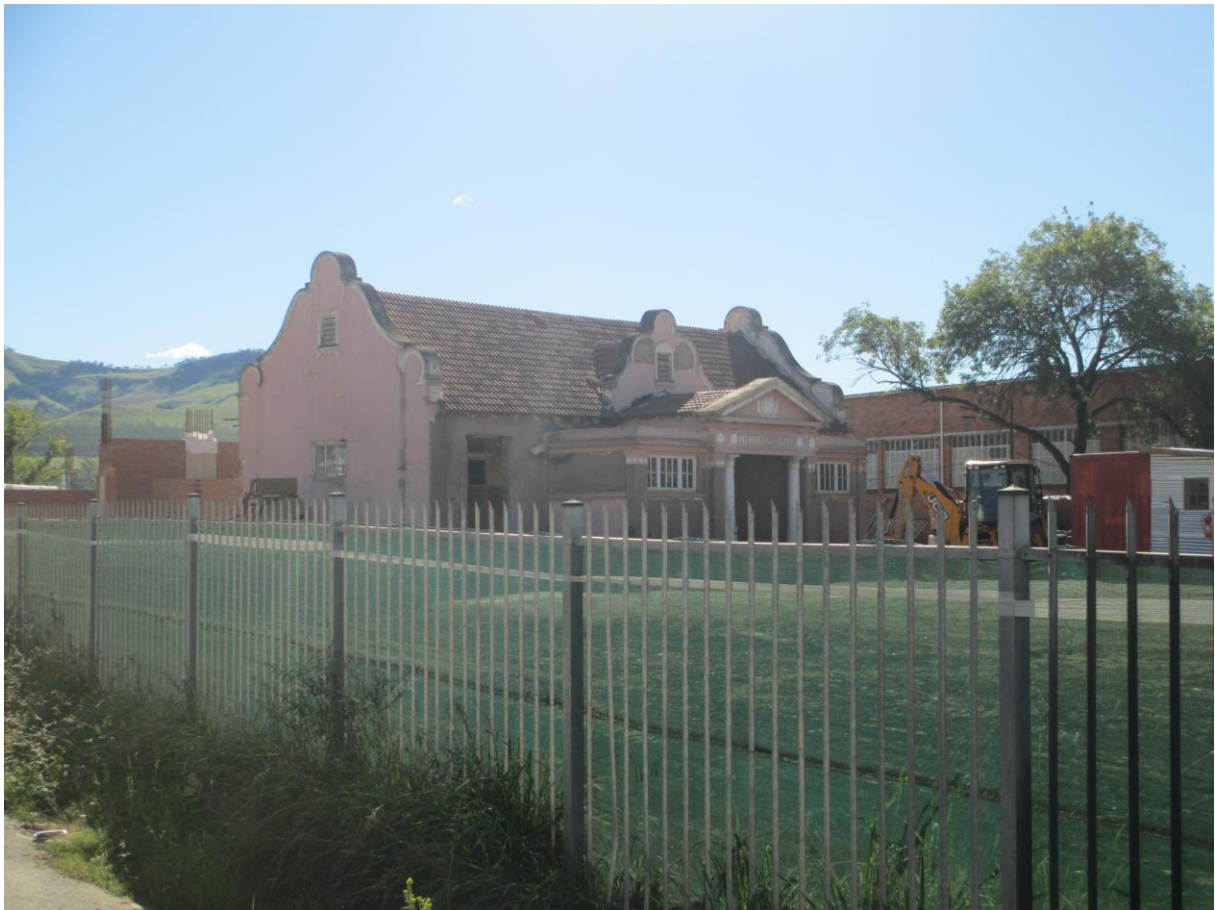
SOUTH AND EAST (FRONT) FACADES OF THE HALL AND ADDITION AS VIEWED FROM THE EDGE OF THE PARKING LOT ON THE SIDE LANE NEAR THE INTERSECTION WITH MAIN ROAD

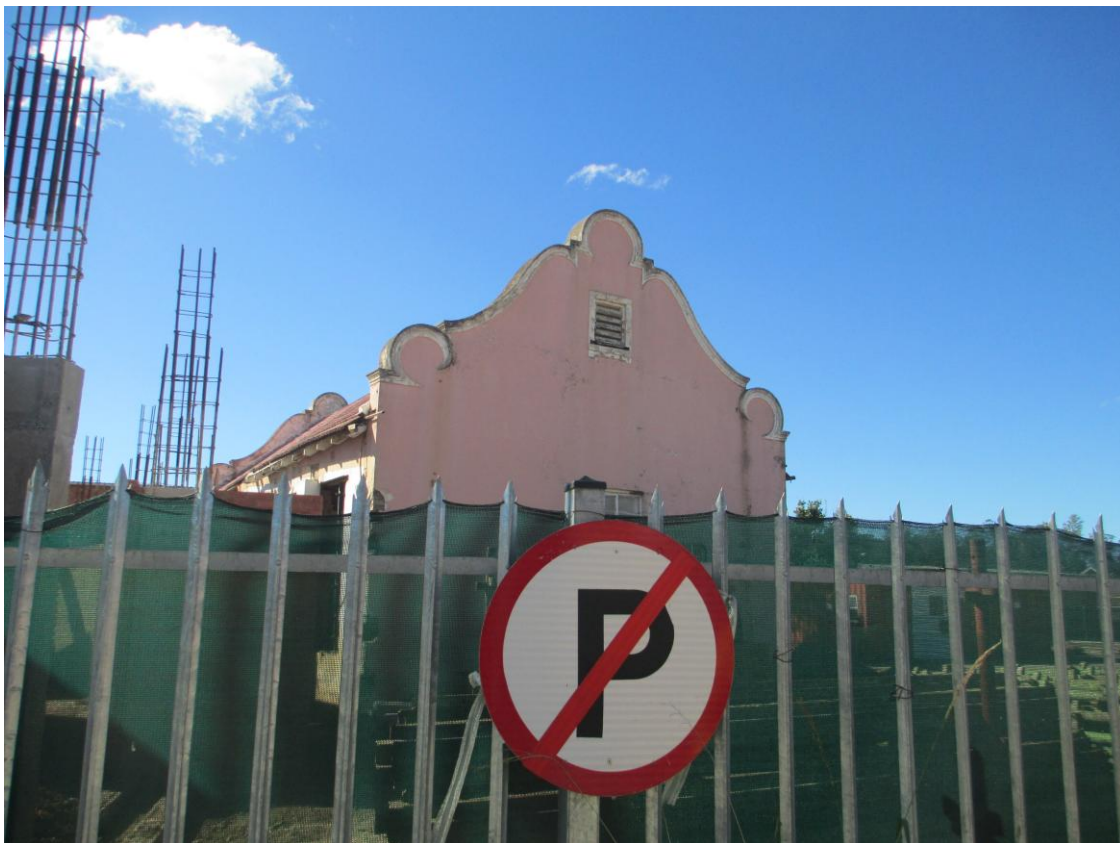
SOUTH FACADE VIEWED FROM THE SIDE LANE

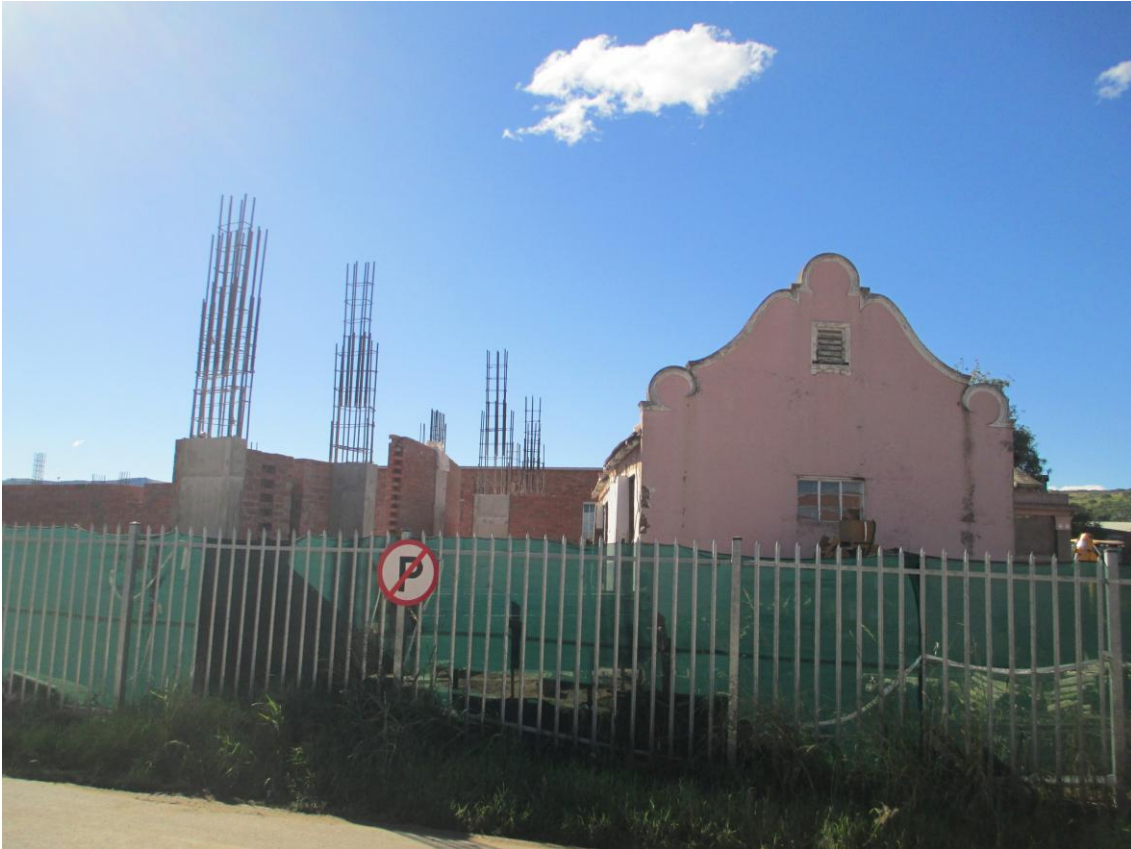
SOUTH AND PARTIAL VIEW OF THE WEST FACADE AND THE NEW BUILDING: THE OPENING ON THE WEST FACADE WHICH USED TO LEAD INTO THE ADDITION THAT WAS DEMOLISHED WERE OF CONCERN TO AMAFA AND WERE NOT EXPLAINED IN THE INITIAL APPLICATION.

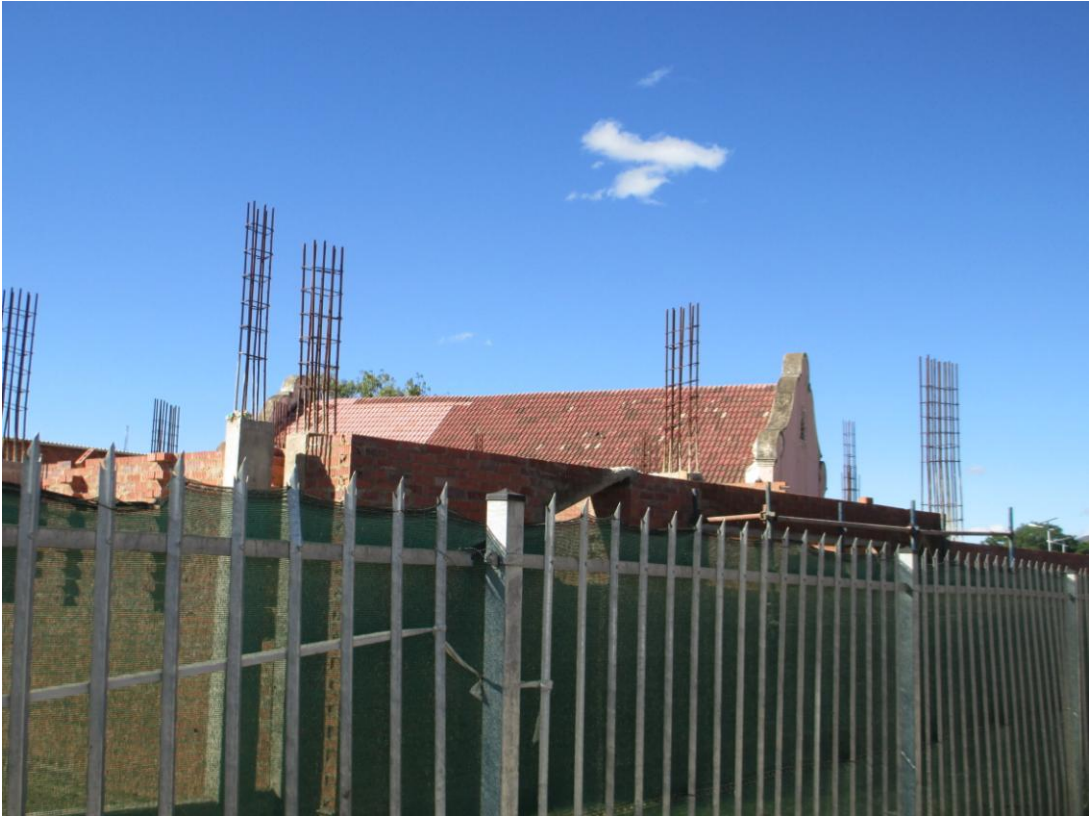
NEW BUILDING WITH HALL IN BACKGROUND TAKEN FROM THE SIDE LANE NEAR THE R56

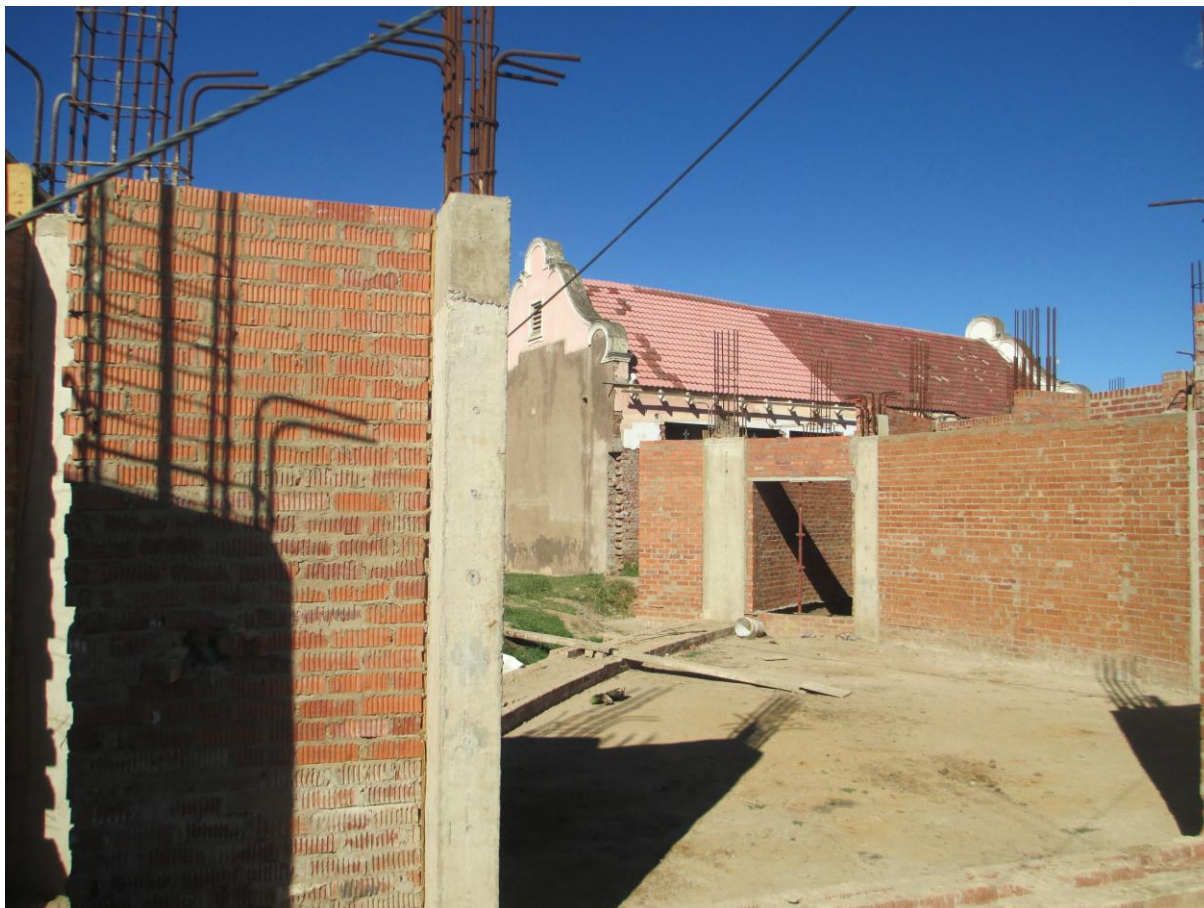
THE HALL THROUGH THE NEW BUILDING AS VIEWED FROM THE R56: THE FORMER JUNCTION WITH THE ADDITION TO THE HALL CAN BE SEEN CLEARLY IN THE CENTRE OF THE PICTURE.

The roof tiles have been replaced with what appears to be double roman concrete tiles to match the existing but the colour is not correct. The opportunity to revert to a more suitable roofing material such as corrugated iron or Marseilles clay tiles has been missed and compromised the restoration process. This would have been avoided if Amafa had been consulted. Some new plasterwork can be seen on the north facade, and plaster has been removed from the former internal wall of the west facade of the hall.

The existing plaster should have been tested for lime content and if present the new plaster should have been a lime/cement mix. This too would have been checked by Amafa had Amafa been given the opportunity to comment on the specifications. The problems with the existing plaster related to rising damp and the cause needed to be addressed before re-plastering.
