VE CONSULTING

STRUCTURAL STABILITY ASSESSMENT – 94 JUNIPER ROAD, OVERPORT, DURBAN.

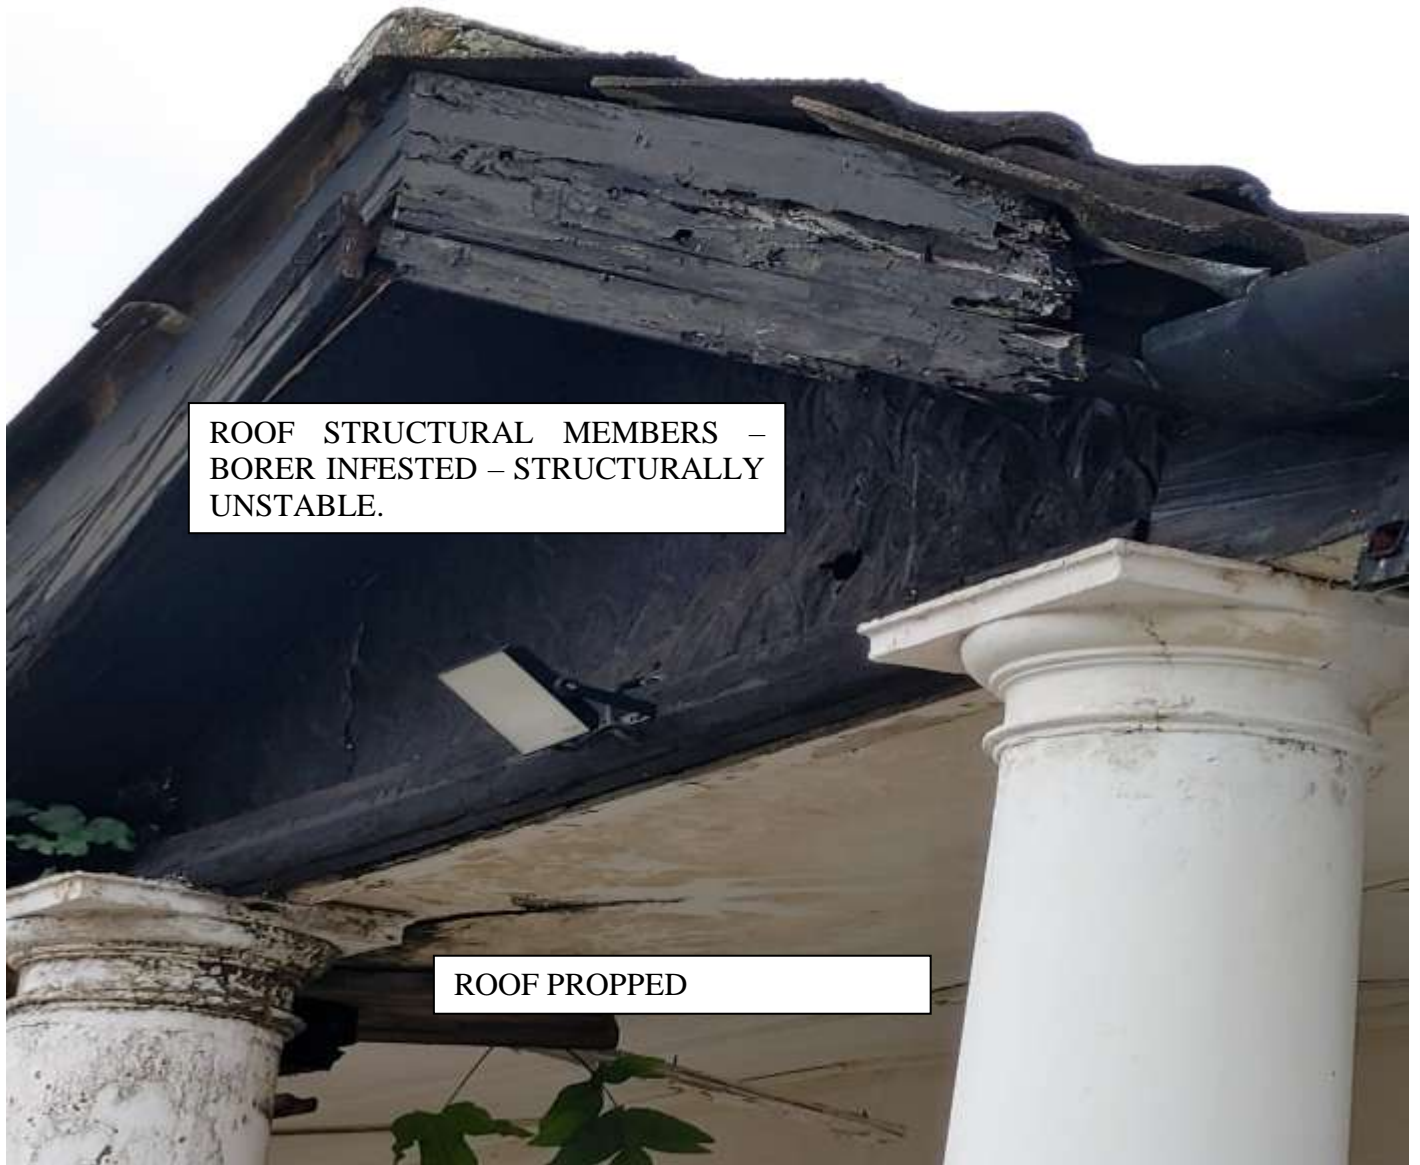
The building is of single storey construction with timber floors and a lightweight timber roof with tiles over. The lightweight roof structure and the timber floors are borer infested and are structurally unstable and must be removed. (see fig 1 to 6 in Annexure A)

ROOF STRUCTURAL MEMBERS –
BORER INFESTED – STRUCTURALLY
UNSTABLE.

ROOF PROPPED

FIGURE 1 : TIMBER FASCIA / ROOF

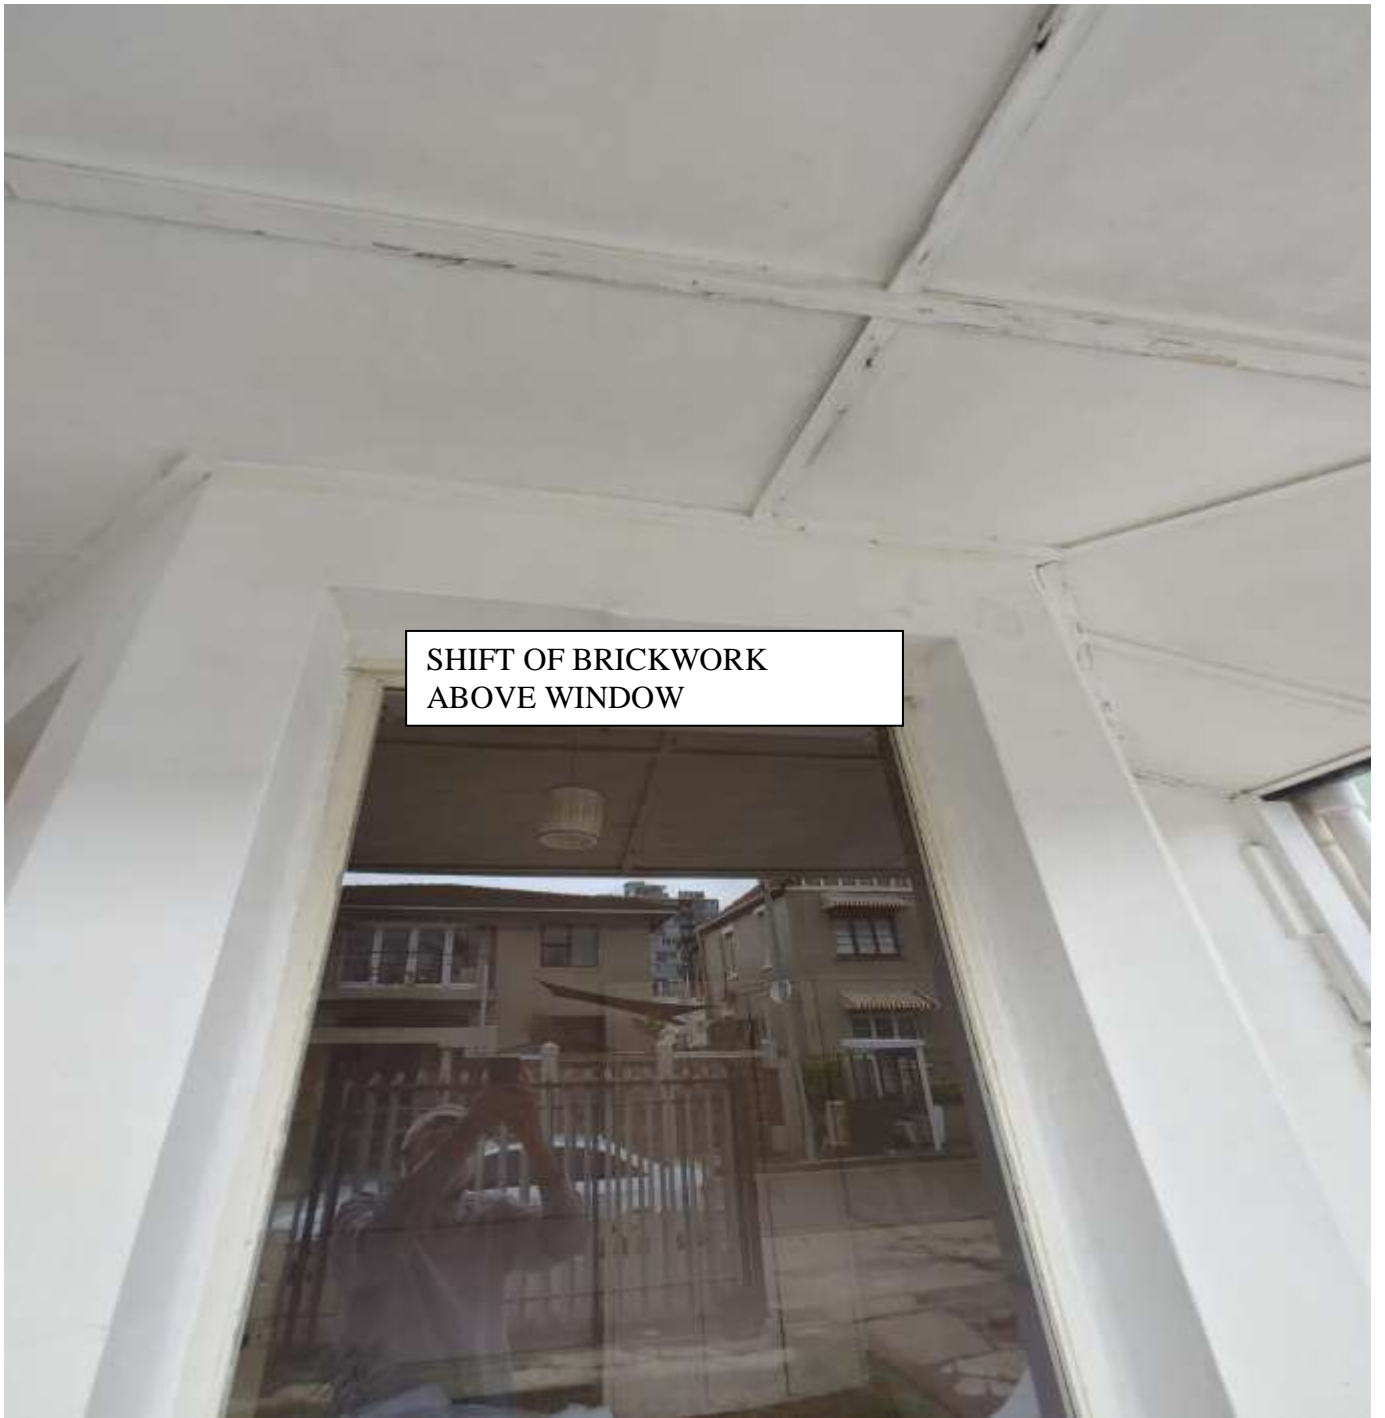
The external walls and foundations show signs of structural distress and must be demolished. The cost of remedial work on the building to ensure structural stability will entail demolition of the building virtually in its entirety and the costs would be exorbitant.

FIGURE 2 : SETTLEMENT OF HEADER COURSE

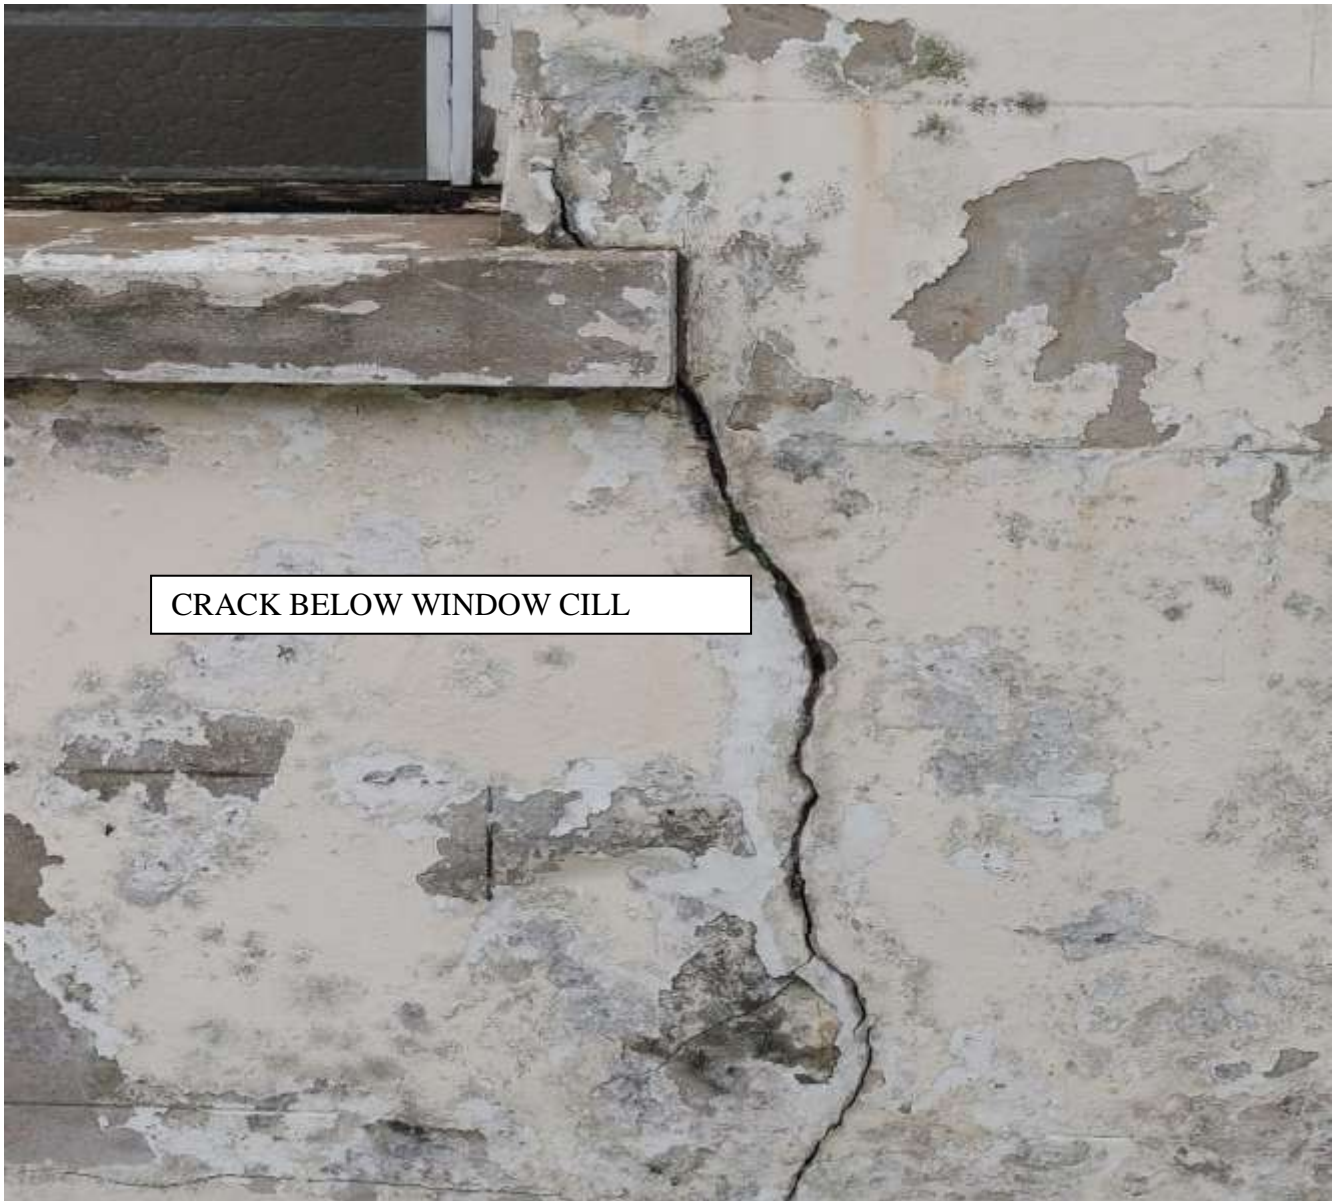
FIGURE 3 : SETTLEMENT OF FOUNDATIONS / CRACKS AT CNR OF WINDOW CILL

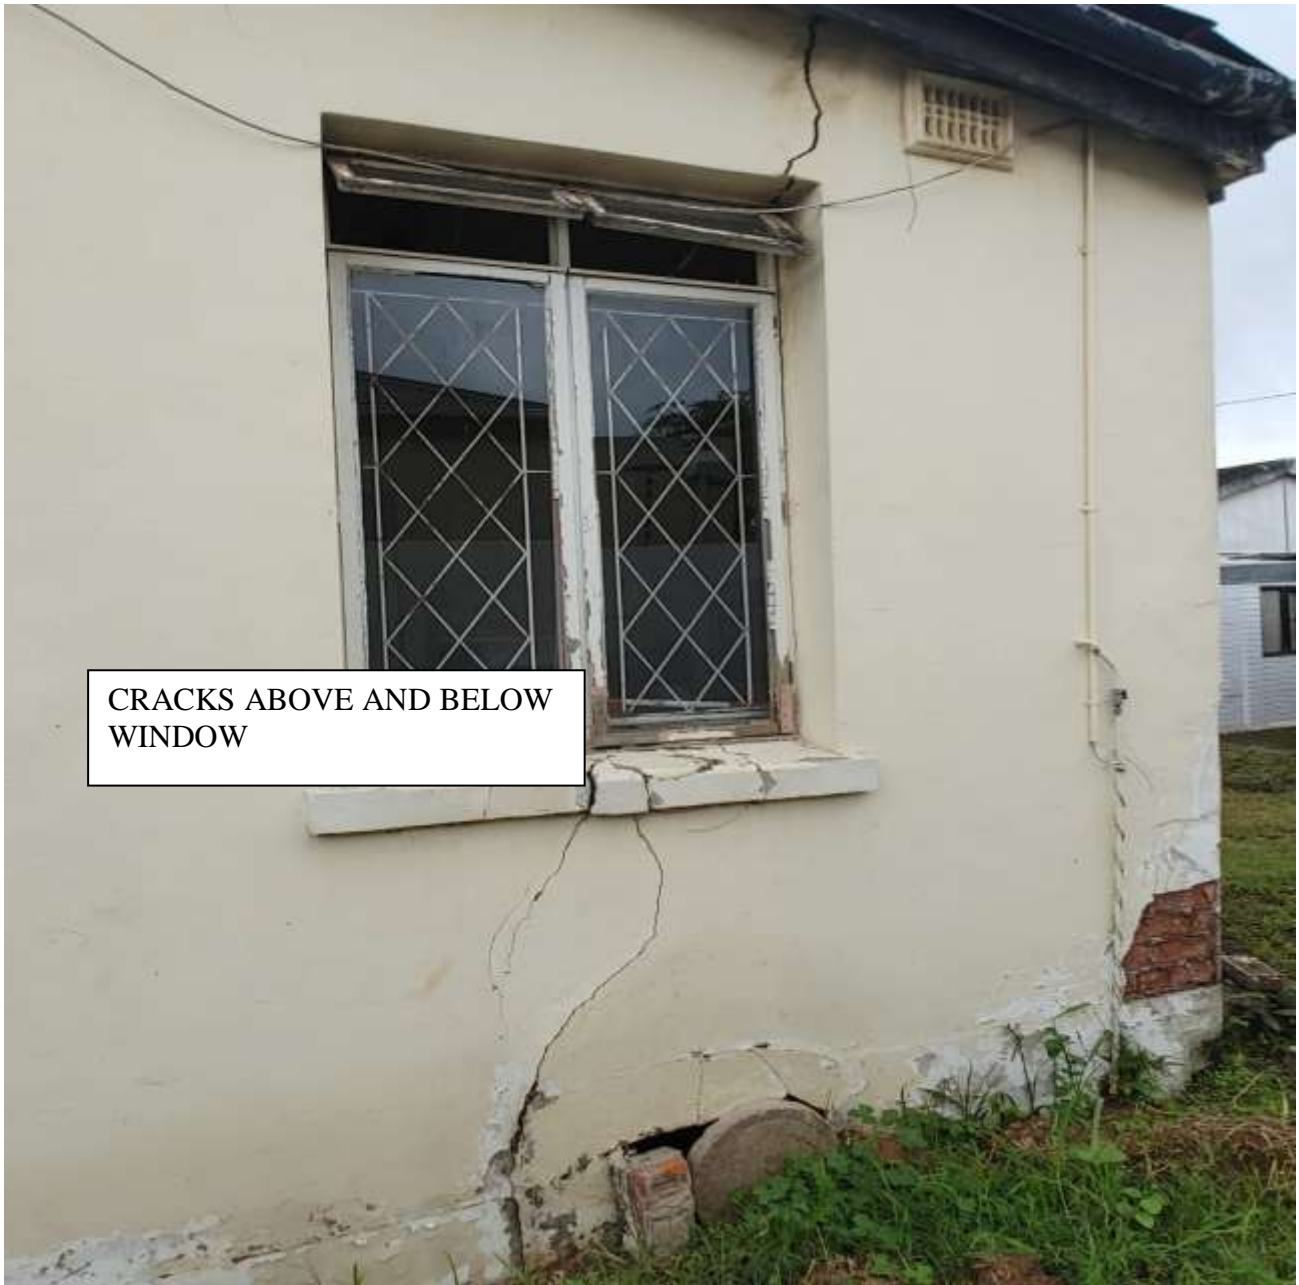
FIGURE 4 : SETTLEMENT OF FOUNDATION / CRACKS

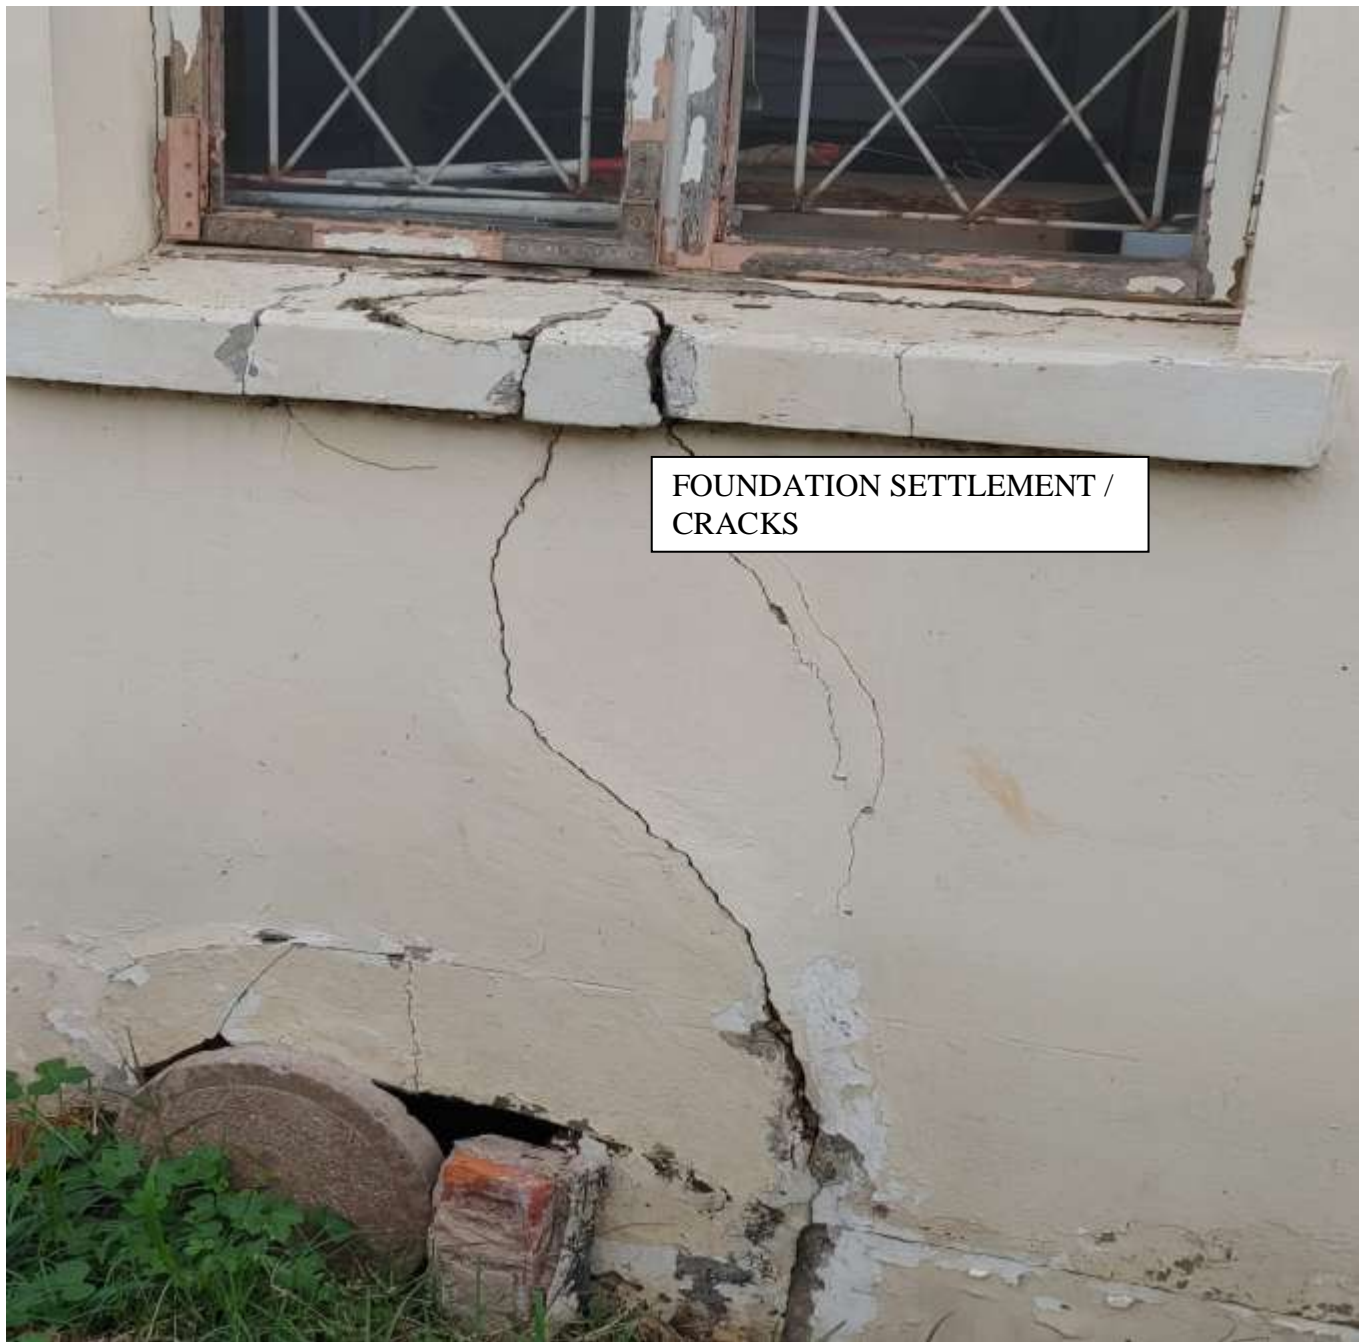
FIGURE 5 : SETTLEMENT OF FOUNDATION / CRACKS

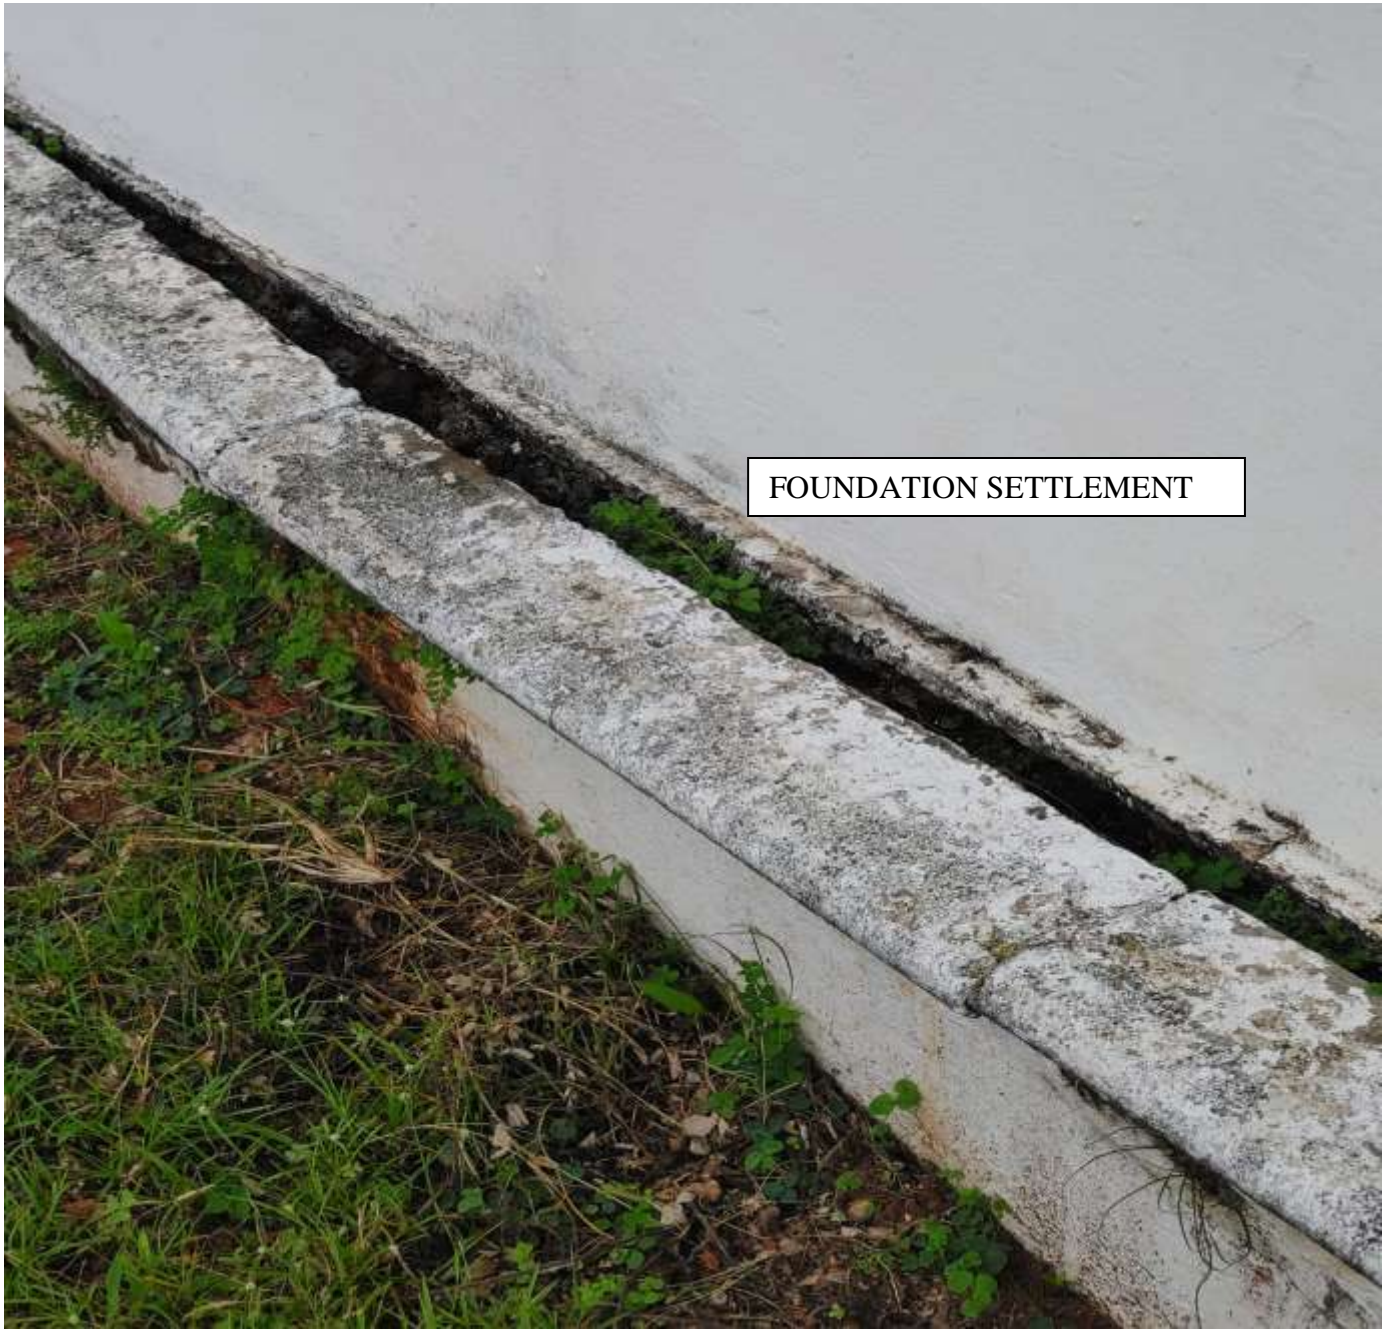
FIGURE 6 : SETTLEMENT OF FOUNDATION / CRACKS
