PROCEDURE FOR ENVIRONMENTAL ASSESSMENT OF RETICULATION AND SUB-TRANSMISSION PROJECTS: ANNEX Q OF CAPITAL INVESTMENT IN THE DISTRIBUTION BUSINESS

Distribution environmental screening document (DESD)
Reticulation Powerlines and Ancillary Services

Project name/Survey VM88-86-152-REFURBISHMENT
project.....
Area BOTHAVILLE
Project number BP (2013) File number
Rural scheme/
Feeder VM Feeder Voltage: 11Kv.....
Supply from... VM88-86-152... Total length.....7031.654m
(Scheme name, pole numbers for tee-off)
Supply to VM88-86-152-37-10-10.....
(Farm name, etc.)

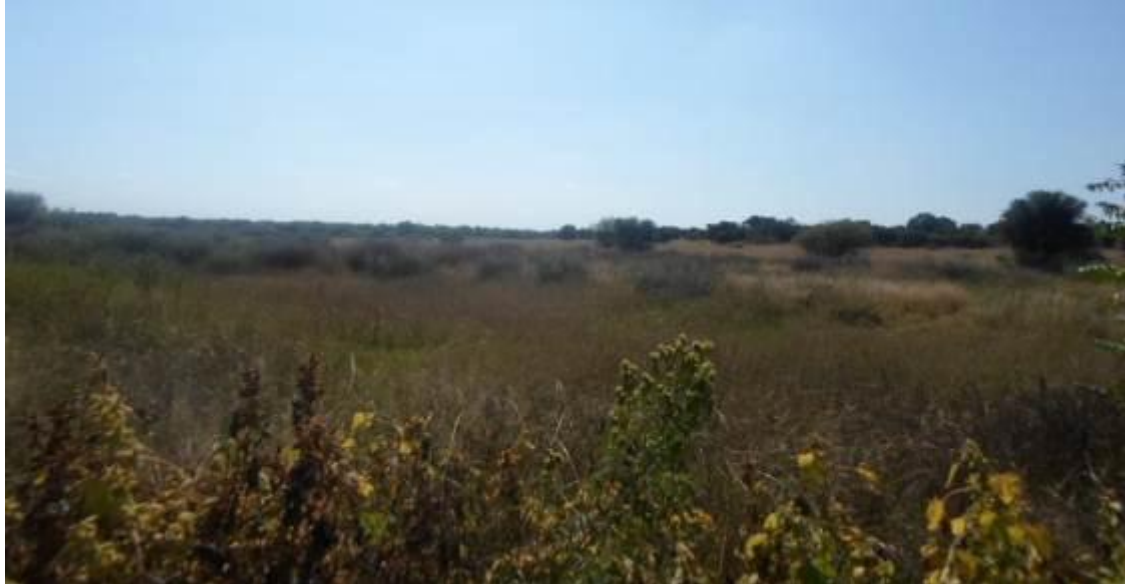
Image 1: non perennial stream on farm Thornvale 147

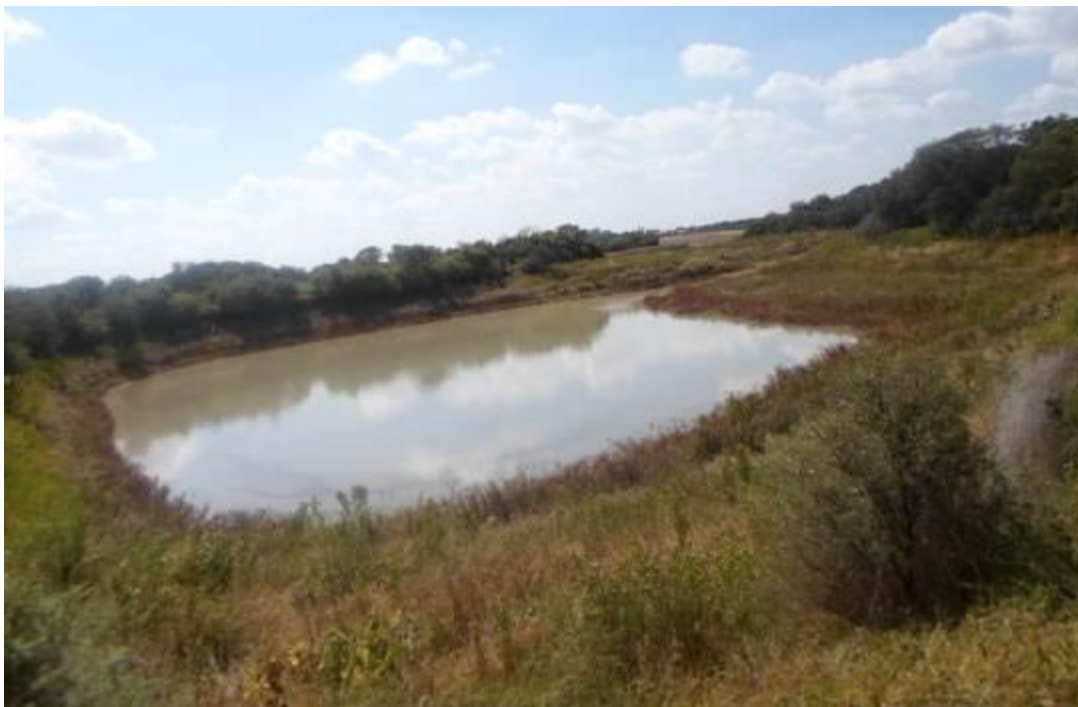
The line between Pole number BW 510-73 and BW 510-73-6 is going to be dismantled at the **Vals River bank**. Pole number BW 510-73-8 is approximately 2m away from Vals River on the river bank. The proposed line is crossing a **non-perennial stream** (S 27° 26' 51.8"; E26°56'14.7") on Farm Thornvale 147 (See image 1). The proposed line is crossing a **dam** (S 27° 27' 18.2"; E26° 58'38.8") on farm Doordraai East 235 (See image 2). There is a **man-**

Image 2: Dam on farm Doordraai East 235

- ❖ In order to avoid the possible need for a Water use licence. **Poles should ideally be planted at least 100m away from the edge of a watercourse or out of the 1:100 year flood line.**

- ❖ No vehicles or construction trucks should drive within a water body or stream.
- ❖ Long powerline spans with higher pole structures must be used to cross the watercourses.

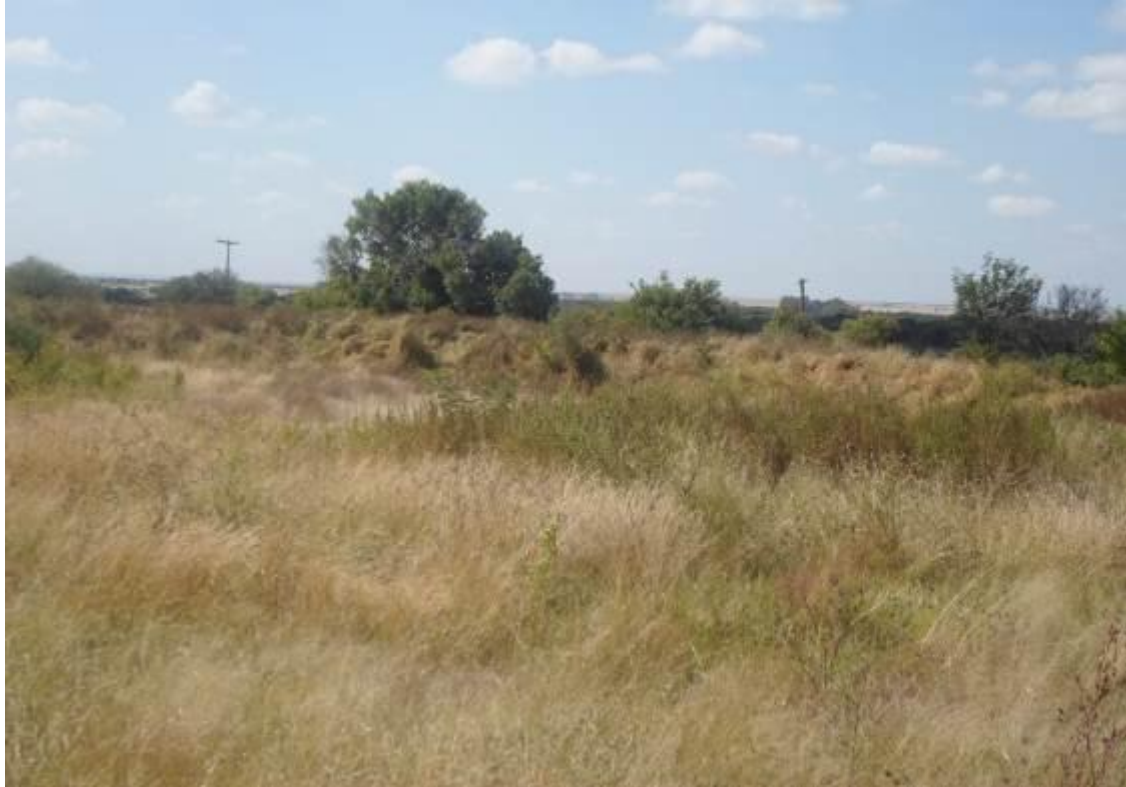
made dam on the Eastern side of Transformer pole BW510-53-2 on farm Doorndraai East 235 (See image 3).

- ✓ The threat of water pollution and environmental degradation by the installation or decommissioning of pole mounted transformers, breakers and kiosk metres in close proximity to watercourses.
- ✓ Water pollution due to oil leaks from construction vehicles and oil filled equipment on site.
- ✓ The decommissioning of Pole Number BW 510-73-6 on the bank of Vals River might pose risk of water pollution and erosion.
- ✓ The construction of the dam crossing on farm Doorndraai East 235 poses a risk of erosion, water pollution and alteration of the banks.

Image 3: Man-made dam wall on farm Doorndraai East 235

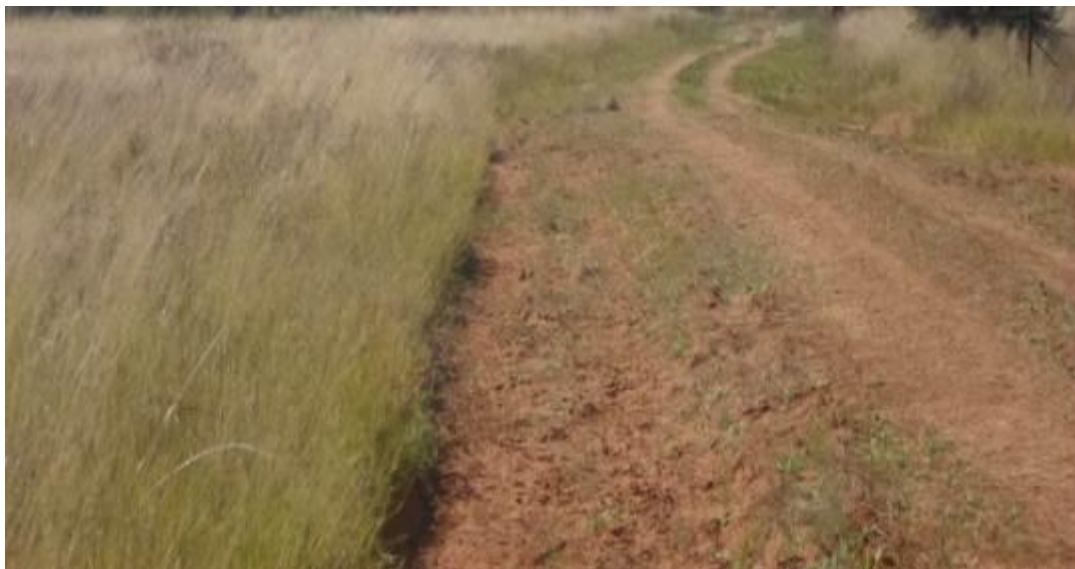
Black and red strongly structured clayey soils with a high base status (See image 4). The redness of the soils indicates a high content of iron (Fe) in the soil and the blackness indicates that the soil is fertile due to high carbon content in it.

Highly fertile top soil could be lost due to vegetation clearance and earthworks for site preparation and the planting of poles. The pollution of land and soil may occur from oil leaks by construction vehicles and oil filled equipment. The contravention of **Section 26, 27 of the NEMA: Waste Act 59 of 2008** might occur due to littering.

Image 4: Red strongly structured soils

- ❖ The movement of vehicles should be kept to a minimum in and around wet areas, cultivated land and **on slopes**.
- ❖ Minimal vegetation removal should take place during site clearance for construction.
- ❖ Soil should be re-deposited in the same order as it is excavated in order to retain the fertile top soil.

- ❖ Soil stockpiles should be kept in a safe place for re-use and re-filling of holes. These stockpiles should be secured by packing or covering them with bricks or any other method that would prevent wind or water erosion.
- ❖ The vehicles must use existing access road to the proposed route and adhere to speed limit (60km/h) on the gravel roads and farm tracks.
- ❖ Vehicles and equipment to be used on site should be serviced regularly to avoid oil leaks.
- ❖ No littering should take place and all waste should be cleaned up and removed from site during site rehabilitation.

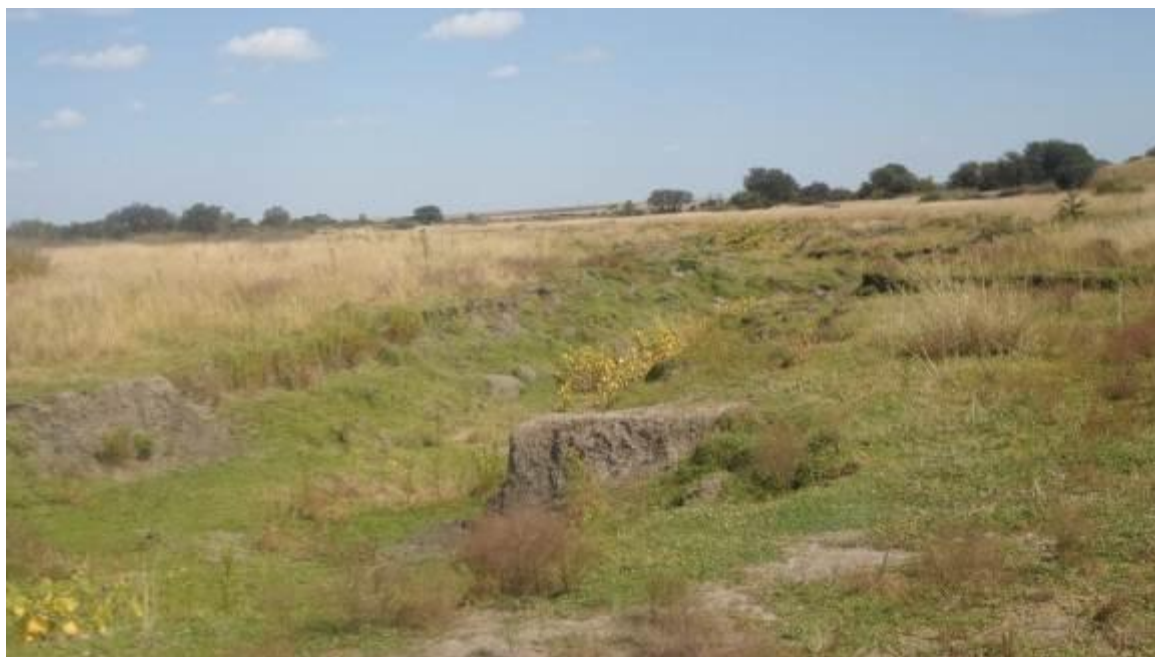
The plain is **gently undulating** along the route of the line. There is a **valley** (S27° 27' 18.2"; E26° 55' 38.8") at the dam on farm Doorndraai East 235. The proposed line is crossing a **donga** (S27° 27' 10.1"; E 26° 55' 36.6") on the North Western side of the dam on farm Doorndraai East 235 (See image 5).

Potential soil erosion by means of water, wind and other means may take place in the area. The **loss of top soil** due to excavations for pole holes on slopes where the vegetation cover is little. Construction vehicles and activities **de-compacts the soil and increase its porosity** and the infiltration of water which will ultimately decrease the run-off of water to other parts of the area. The high clay volume in soil might cause **the poles to stand skew over time**. **Access roads** to the proposed line are likely to be eroded as traffic in the area is going to increase.

Image 5: Dongas on the North Western side of the dam on farm Doorndraai East 235

- ❖ The current vegetation should be left as far as possible in its original state.
- ❖ The creation of multiple access routes to the construction point should be avoided.
- ❖ Vehicles must be driven at a moderate speed (max 60km/h) and steep slopes should be avoided as far as possible.
- ❖ Soil stockpiles should be kept in a place where it cannot be eroded away in order to preserve top soil. These stockpiles should be secured by packing or covering them with bricks or any other method that would prevent wind or water erosion.

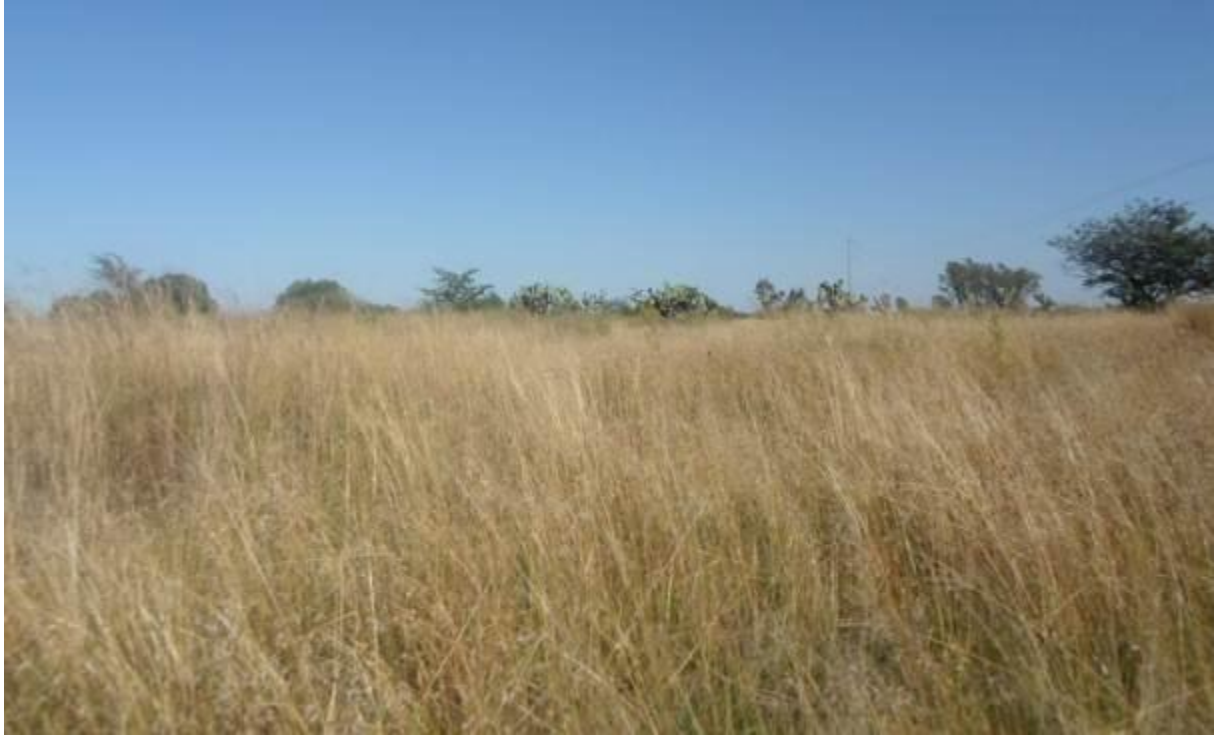
The vegetation cover is mainly moist cold Highveld grassland with *Themeda thiandra* (red grass) (See image 6). Spikelets (**grass flower**) were also observed in the **grasslands**. **Bluegum and poplar trees** were also observed on farms (Image 7). There are **Pine trees** on the farm. **Dwarf shrubs**, Karoo bushes and Karee trees were observed in the area. There is a thorn bushveld present dominated by **sweet thorn trees (Acacia Karoo)** (See image 8). **Melia azedarach (China-berry)** trees are found in the veld and in farmhouse gardens. There is a 'greenbelt' (dense bushes and trees) which is part of the vegetation and ecosystem next

Image 6: Themeda tiandra in grassland

- ❖ Minimal removal of vegetation should take place.
- ❖ No fires should be started in the veld or on cultivated lands.
- ❖ Use the existing roads and tracks and drive with the speed limit of 60km/h on gravel roads according to Eskom rules.
- ❖ Vehicles and equipment must be regularly serviced to avoid chemical fluid leaks in the veld.
- ❖ Refrain from littering at all times

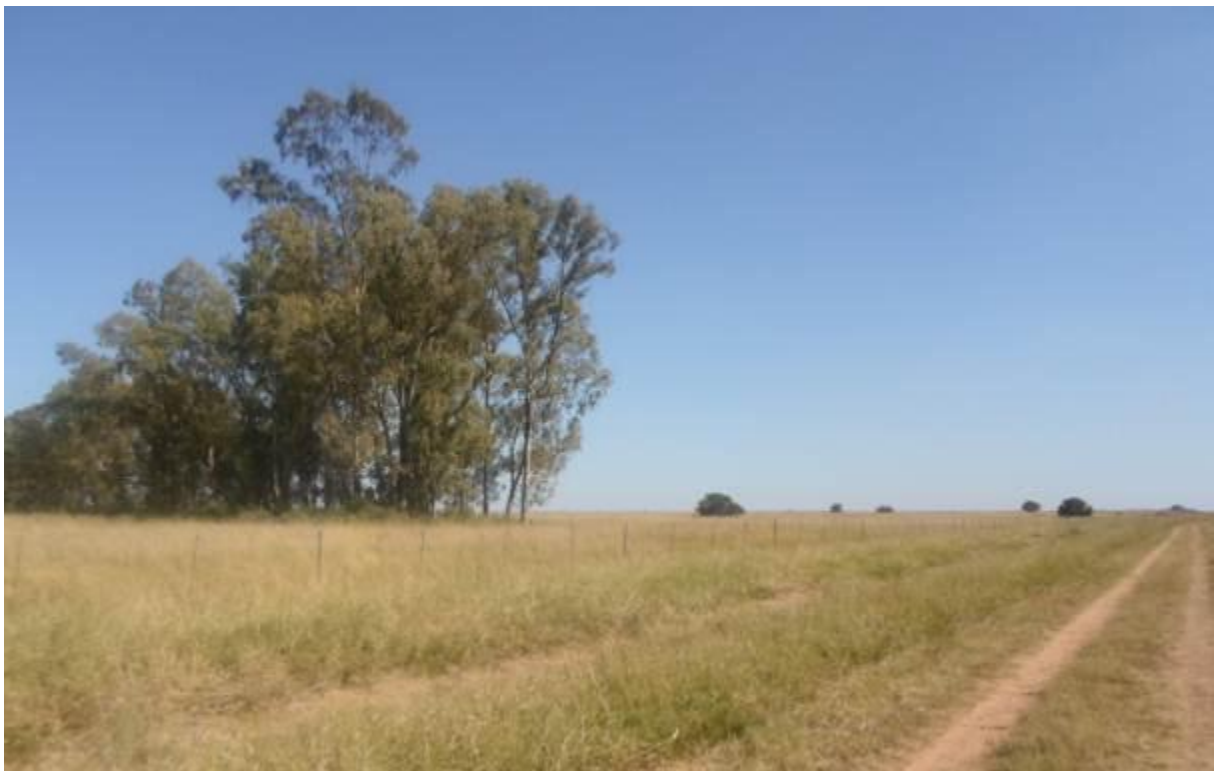
Image 7: Bluegum and Poplar trees along the route on farm Doordraai East 235

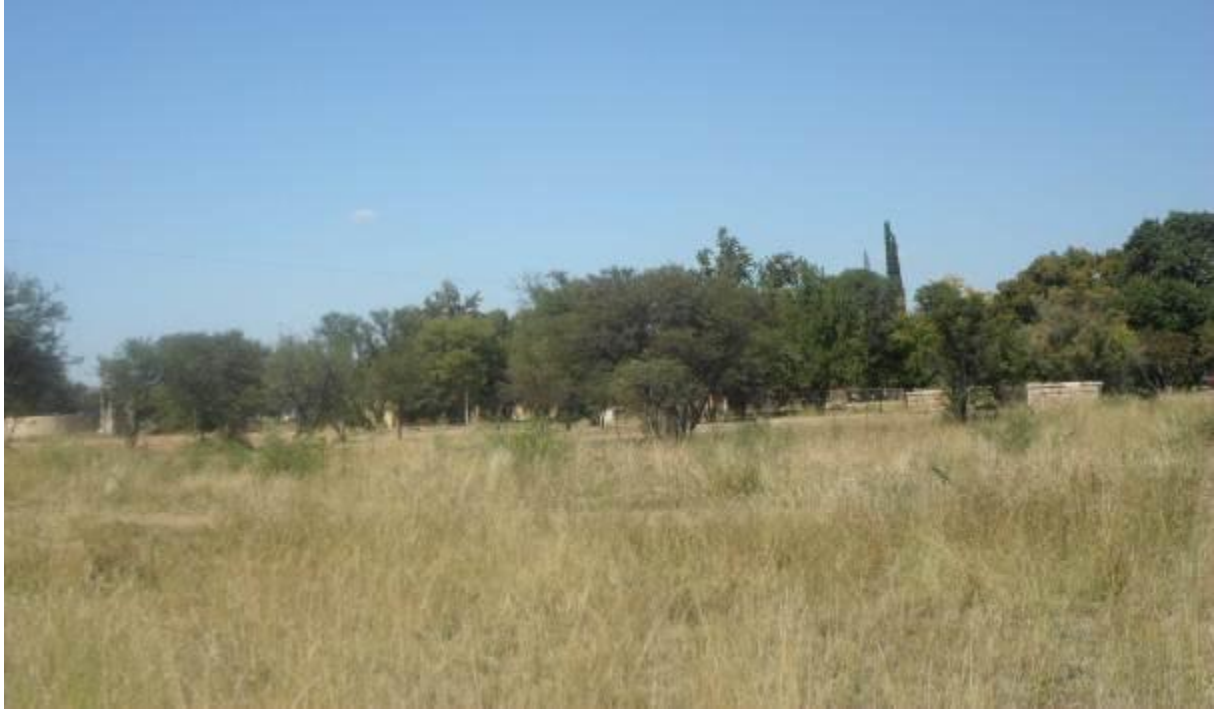
Image 8: Sweet thorn trees (*Acacia karoo*)

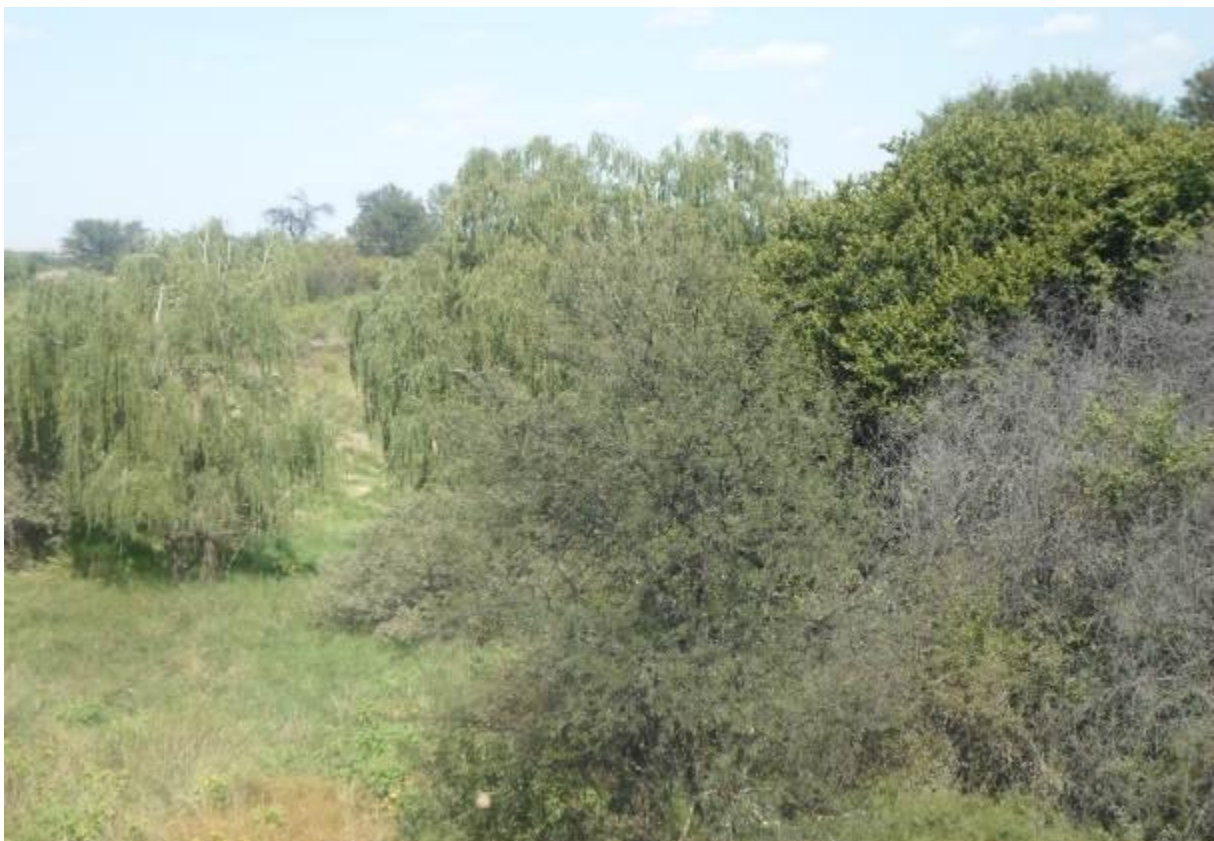
to the Vals River where the proposed line is going to stand. **Weeping willows (Salix babylonica)** are present on the banks of the Vals River (See image 9)

Image 9: Weeping willow trees next to the Vals River

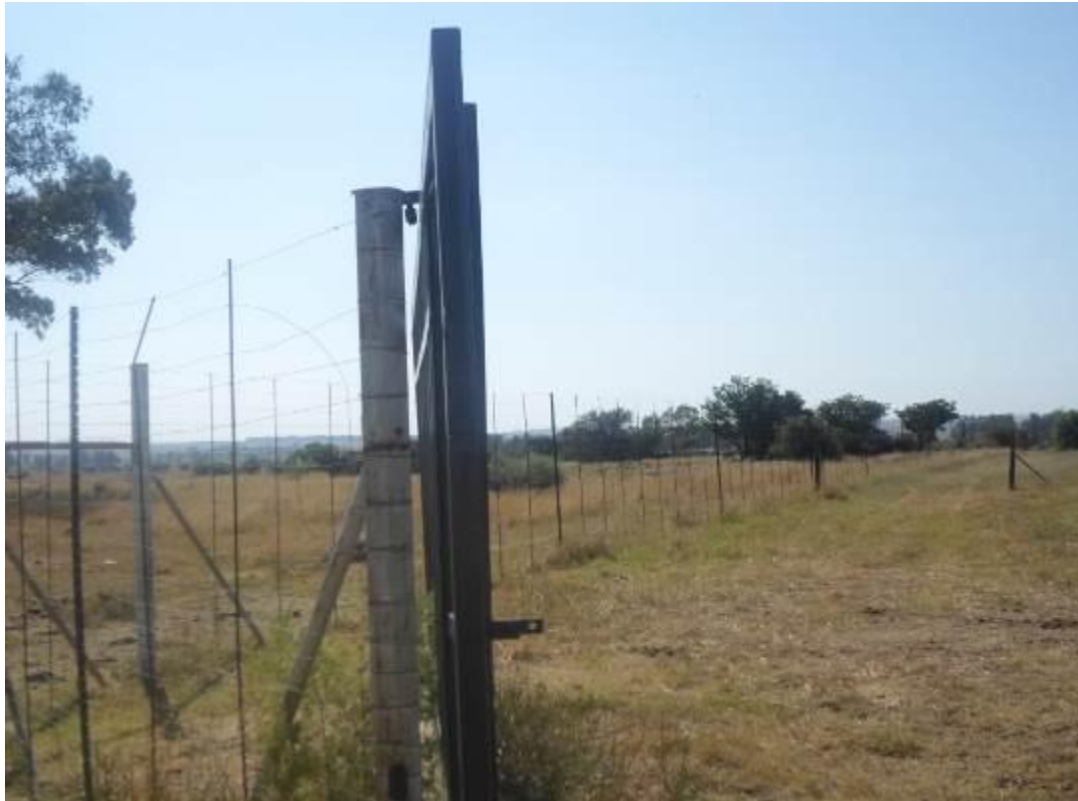
Image 10: Wild camp with wild animals inside on farm Dorndraai East 235

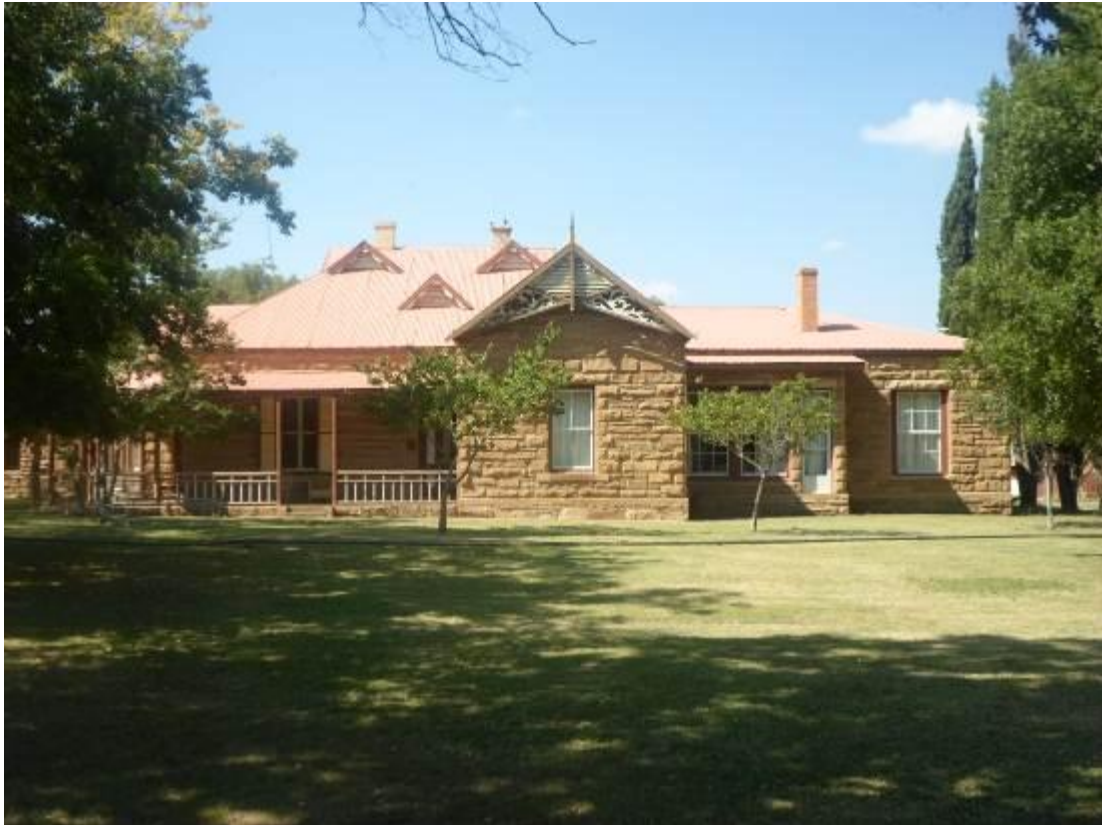
The proposed line in going to stand in close proximity to **farm houses and farm workers houses** on farms Thornvale 147 and Doorndraai East 235 (See image 11, 12). There is also a **footpath** along the Vals River that is used as a **hiking trail** (See image 13).

There is a risk of **noise pollution** and **dust** that can cause a disturbance of the household members. **Vehicle accidents** involving household members, farm workers and the public in the area might take place. The encroachment on safety clearances of the buildings present on the farms.

Image 11: Farm house on farm Thornvale 147

- ❖ Barricading of construction site to avoid the injuring of public.
- ❖ Vehicles must drive at a moderate speed.

-
- ❖ Construction must take place during the day to avoid disturbance of residents at night.
 - ❖ The members of public should not be engaged with by contractor workers.
 - ❖ The landowner should be informed of when construction is going to start.
 - ❖ Gates should be opened and closed according to the landowner's request.
 - ❖ Do not touch or move any farm equipment or buildings without consultation with the landowner.
 - ❖ Keep the correct safety clearances from buildings

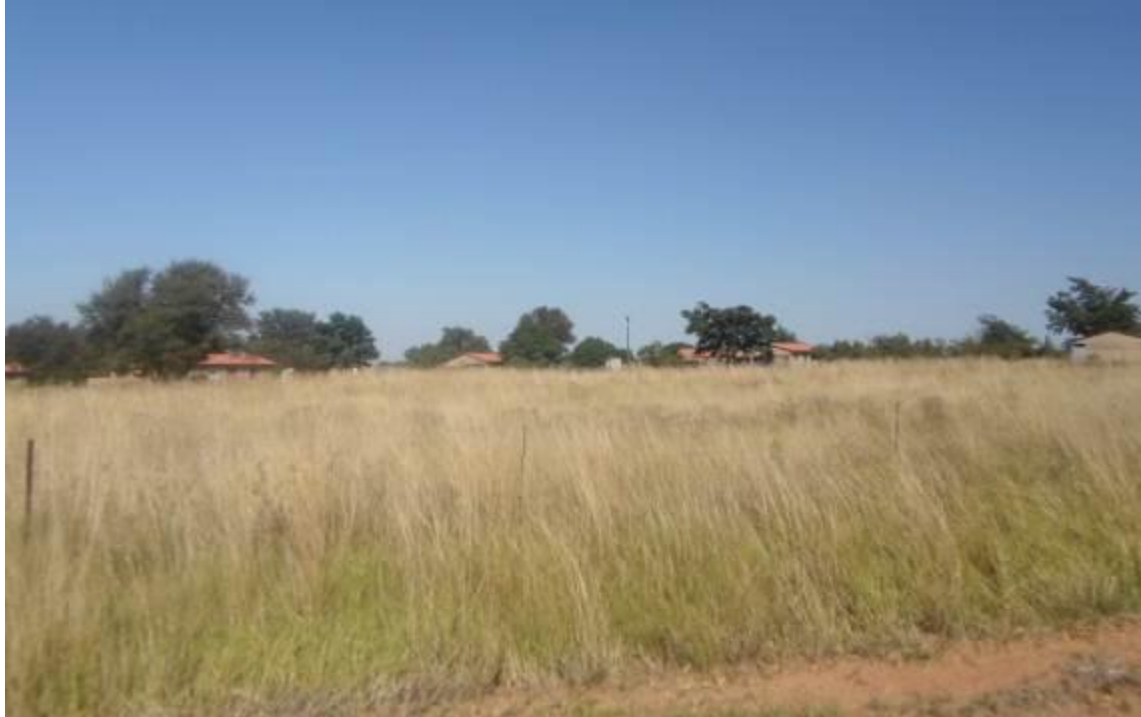
Image 12: Farm workers houses

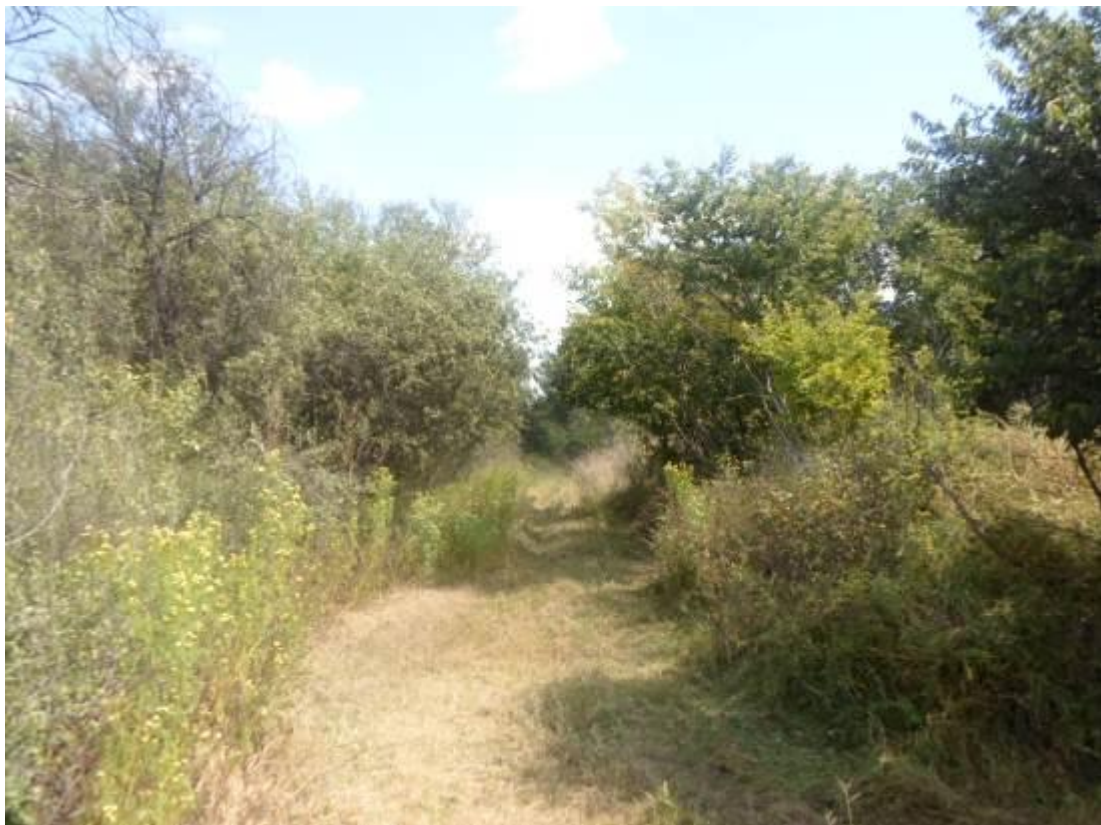
Image 13: Footpath next to Vals River

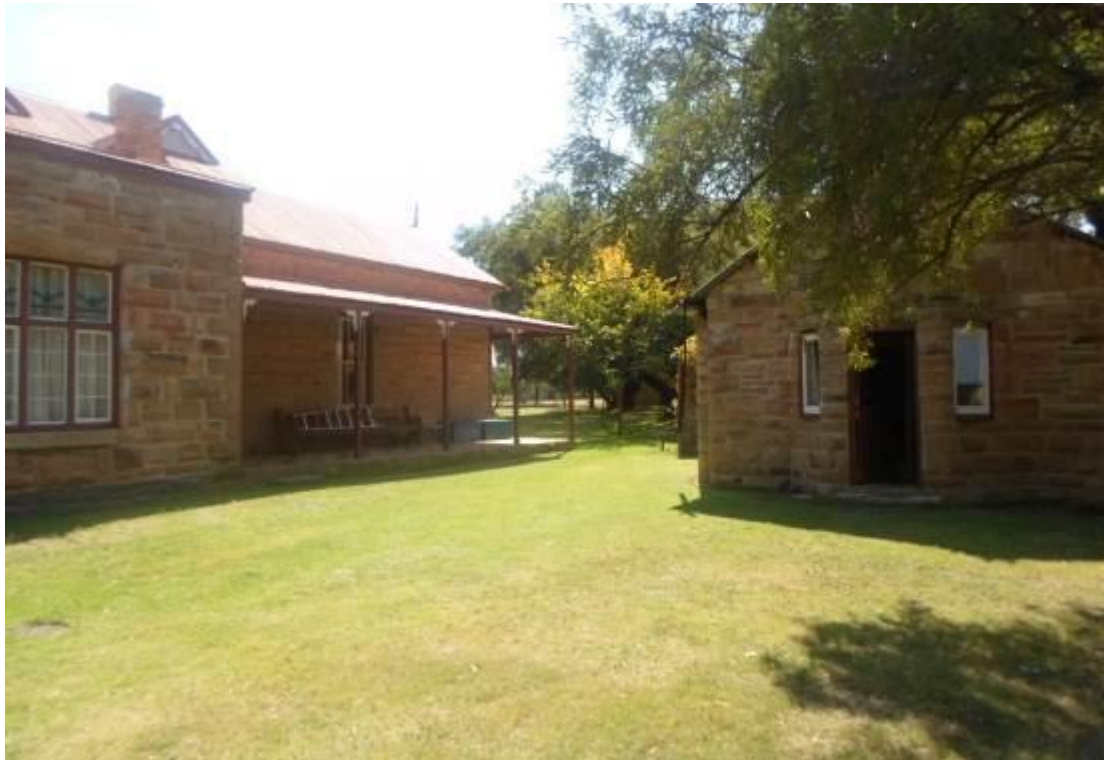
There is a **Farm house** which was built in 1905 and a **Cooler** (S27° 26' 58.6"; E26° 56' 20.5") built before Anglo Boer War on farm Thornvale 147 that is declared as a provincial heritage site in the Free State (See image 14, 15). These heritage resources are occupied by the farm workers. The cooler are used for storage of household goods.

Disturbance of heritage resources during dismantling associated activities on FarmThornvale 147. Legal contravention of the **National Heritage Resources Act 25 of 1999 section 3(2)(a)(National real estate)** might occur if the farm house and cooler are to be damaged or altered on.

Image 14: Provincial heritage site on farm Thornvale 147 (Farm house)

- ❖ Ensure that dismantling of powerline does not destruct the structures of heritage important.
- ❖ Do not disturb the heritage resources during construction activities.

- ❖ **THE FARM HOUSE AND COOLER ON FARM THORNTVALE 147 SHALL NOT BE DISTURBED OR DAMAGED IN ANY WAY POSSIBLE.**

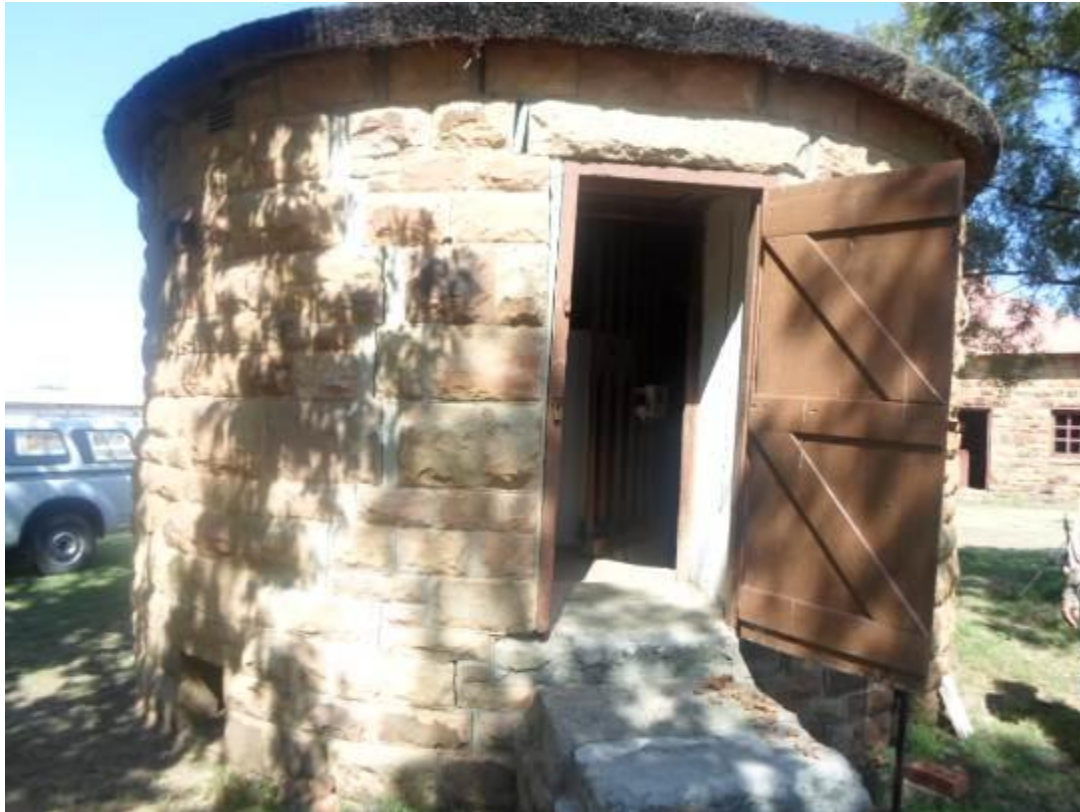
Image 15: Provincial heritage site on farm Thornvale 147 (Cooler)

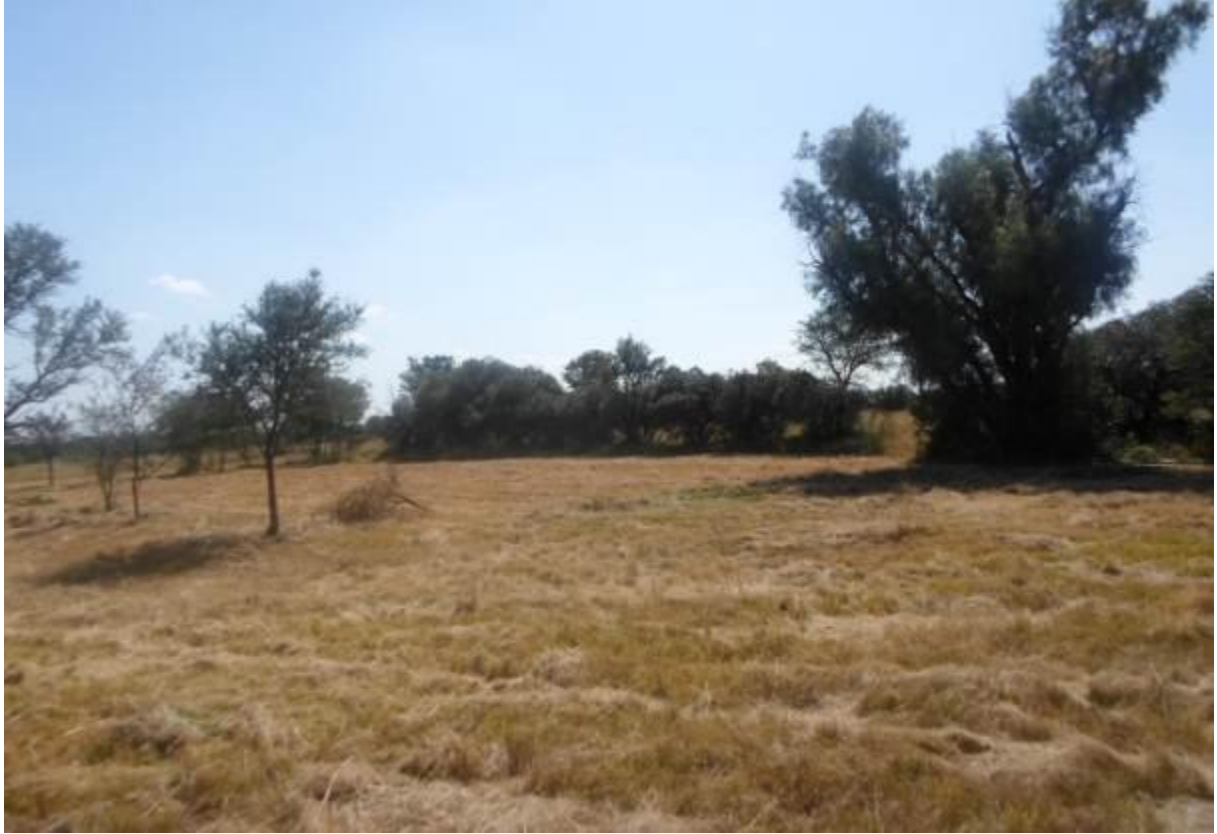
There is grazing land present along the proposed line (See image 16). Game farming practices takes place on farm Thornvale 147 and Doordraai East 235 (See image 17)

Image 16: Grazing land for cattle

- ❖ Minimal removal of grassland should take place.
- ❖ Littering and land pollution must be prevented at all times.
- ❖ Gates should be left as it was found and landowner must be informed when construction is going to take place so he/she can relocate his/her livestock.
- ❖ Livestock should not be disturbed and vehicles must drive at a moderate speed which is 60km/h on gravel roads according to Eskom rules.

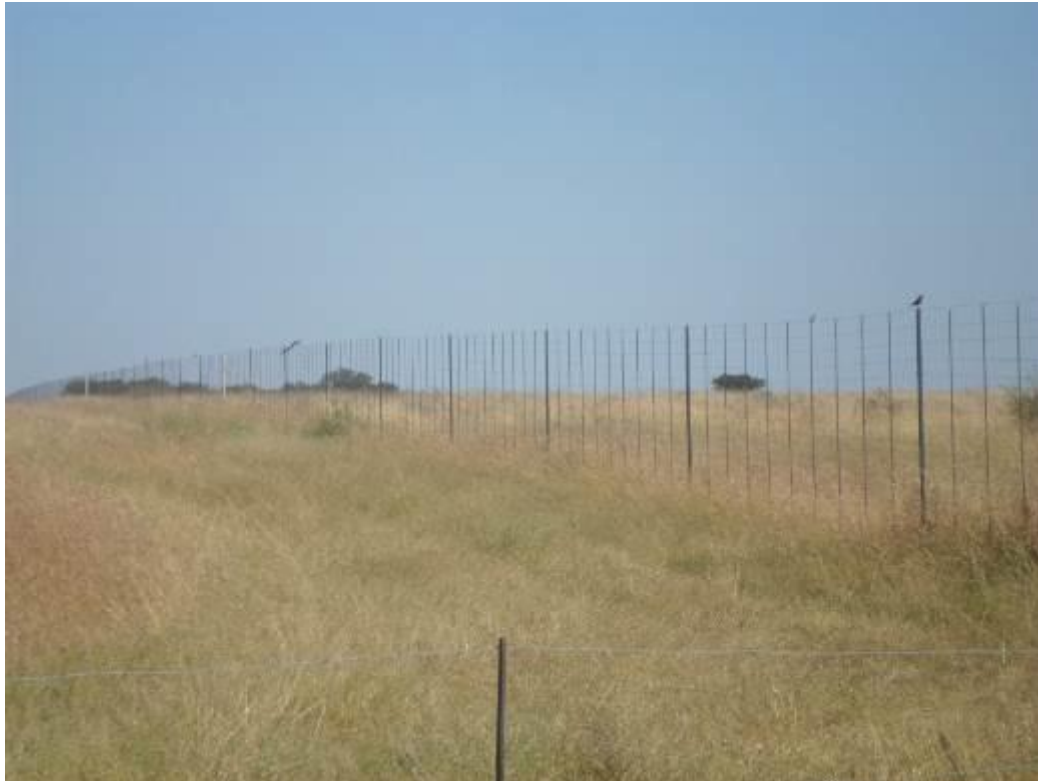
Image 17: Game farming on farm Thornvale 147 and Doorndraai East 235

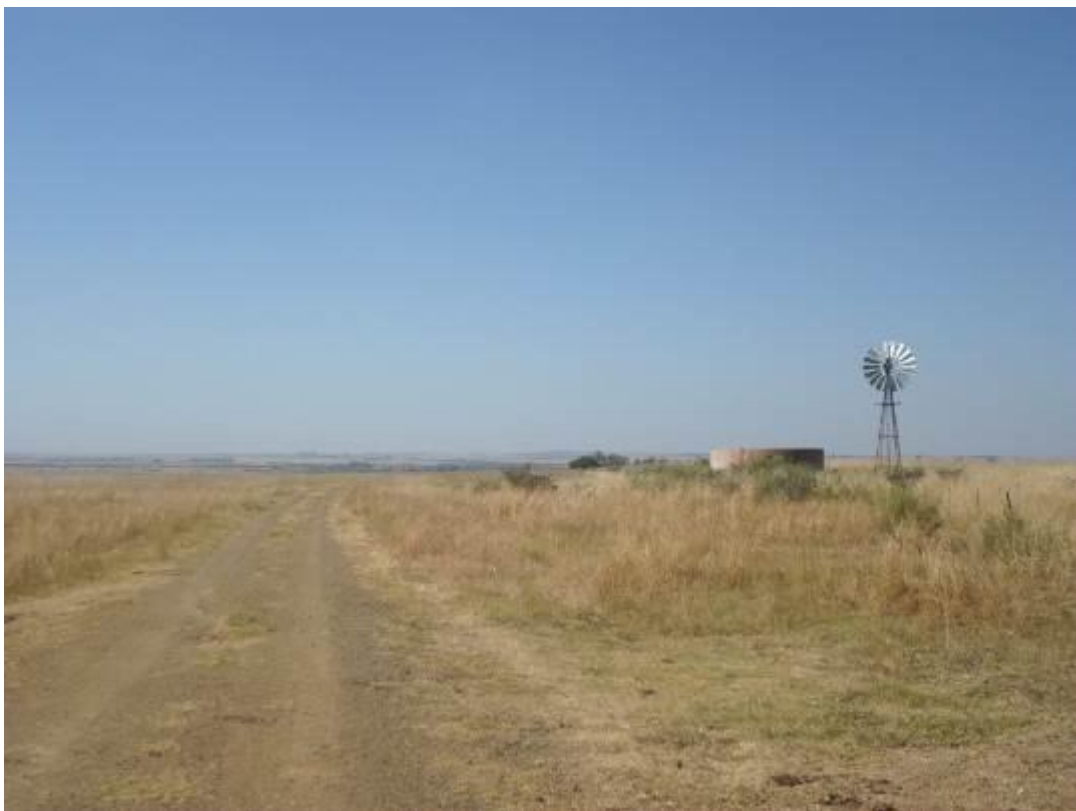
There are portions of the proposed line that crosses existing **gravel roads on farm Doorndraai East 235, Thornvale 147** (See image 18). There are numerous **farm tracks** along the route of the line. There is existing **powerlines** on farm Doorndraai 730 portion 2, Thornvale 147 and Doorndraai East 235 which is going to be dismantled (See image 8). A Telkom **communications line** on farm Doorndraai East 235 is present in close proximity to the proposed powerline. The proposed line is crossing the **R 727 secondary road** at farm Rustpan 1147. There are **water pipelines and a manhole** (S27°26'56.1"; E26°56'22.0") on farm Thornvale in close proximity of the proposed transformer pole (See image 19).

The **encroachment on safety clearances** of roads and communication line servitudes might occur. The excessive driving might accelerate **erosion on the gravel roads**. The earthworks during construction might damage/disturb the drainage system at the manhole and the pipelines.

Image 18: Gravel road along the proposed route of the line in farm Doorndraai East
235

- ❖ Ensure correct clearances clearance from communication- and pipe lines are adhered to.
- ❖ Comply with way leave conditions and landowners requests to promote healthy relationships with customers and stakeholders.
- ❖ Be alert for loose structures, hanging conductors and conductors lying in the veld because it might be live.
- ❖ Keep to safety clearances of roads, manholes, communication lines and pipelines.

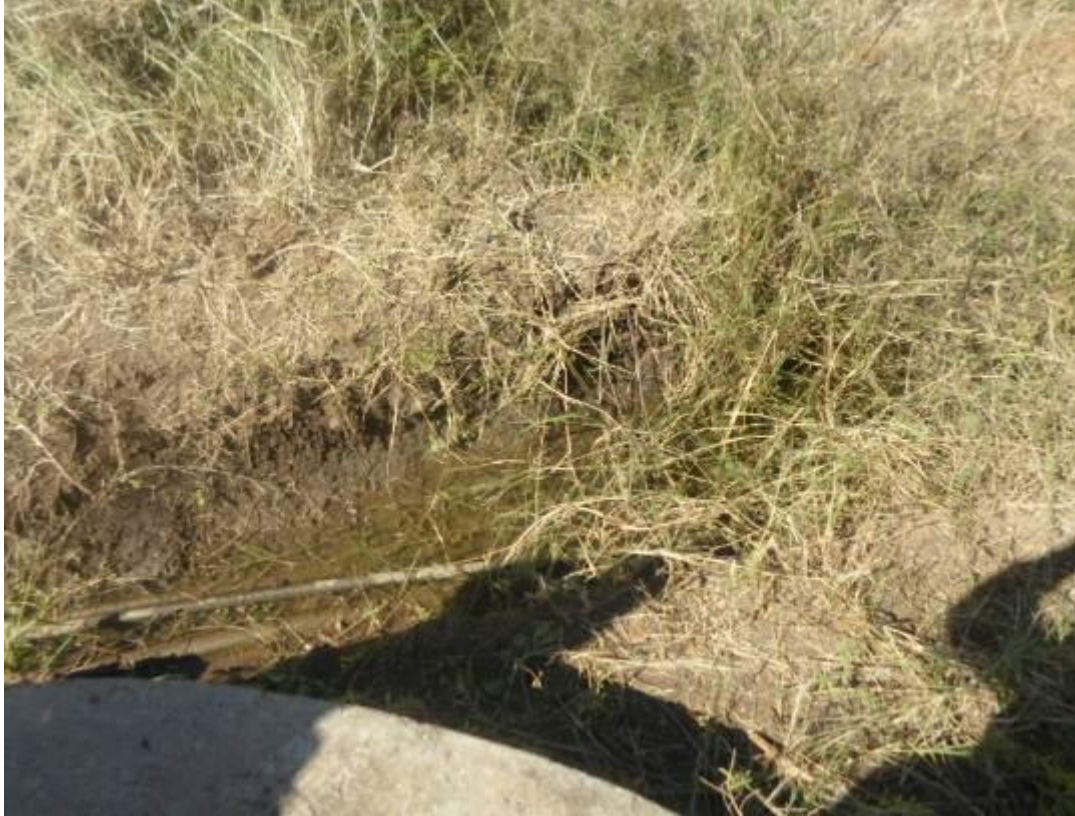
Image 19: Pipeline on farm Thornvale 147 in close proximity of proposed transformer pole number VM88-86-152-44
