VISTA HIGH SCHOOL

DATA SHEET

Report Date:	08 March 2022	Stage 5
Work Type:	2021-22 FCA Preventative maintenance – Heritage schools	
Report Type:	Completion report	
School Name:	Vista High School	DTPW
Location:	1 Military Road, Bo Kaap	
EMIS No.:	0103313416	
Principal:	Mrs C Little	
School Tel:	021-424 7430	
Number of Learners:	624	
Report by:	Danielle Jacobs	021-465-9702
Management Contractor:	Grinaker LTA	
Key person:	Tauriq Mohidin	021-703-1040

1. CLOSE OUT REPORT

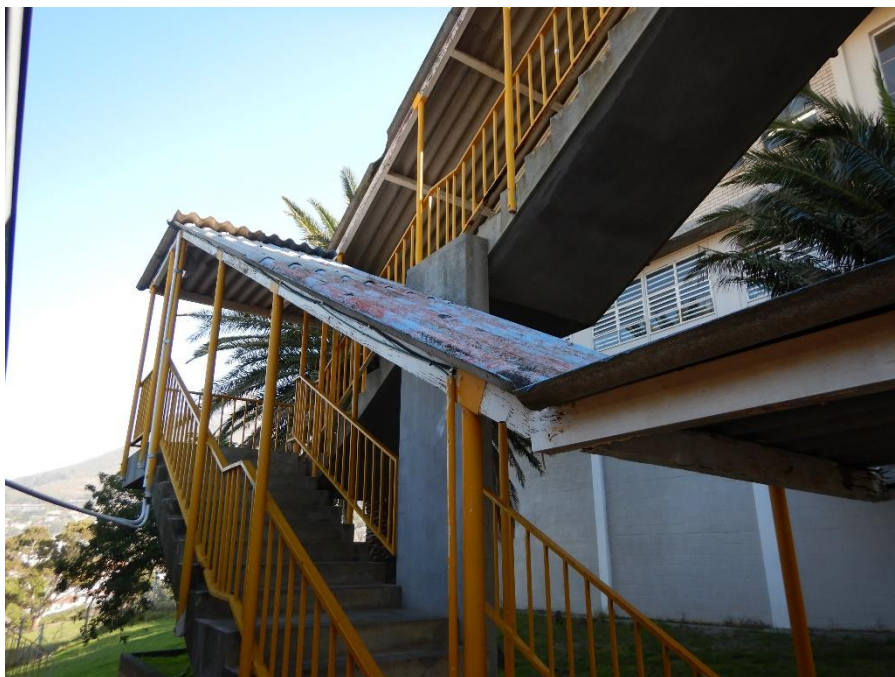
Figure 2A before: Canopy 1. (See site plan)

Asbestos roof replacement on x2 external staircase canopies (before and after)

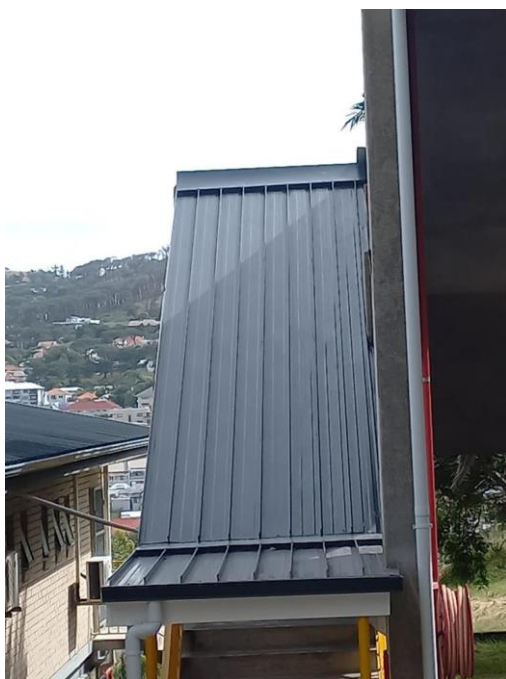
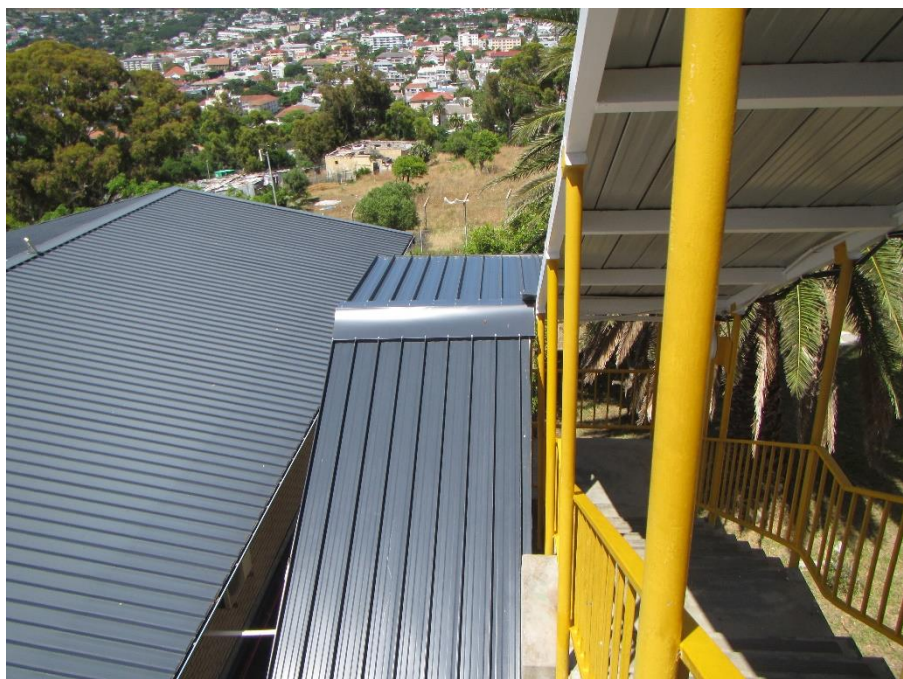
Figure 2B after: Canopy 1.

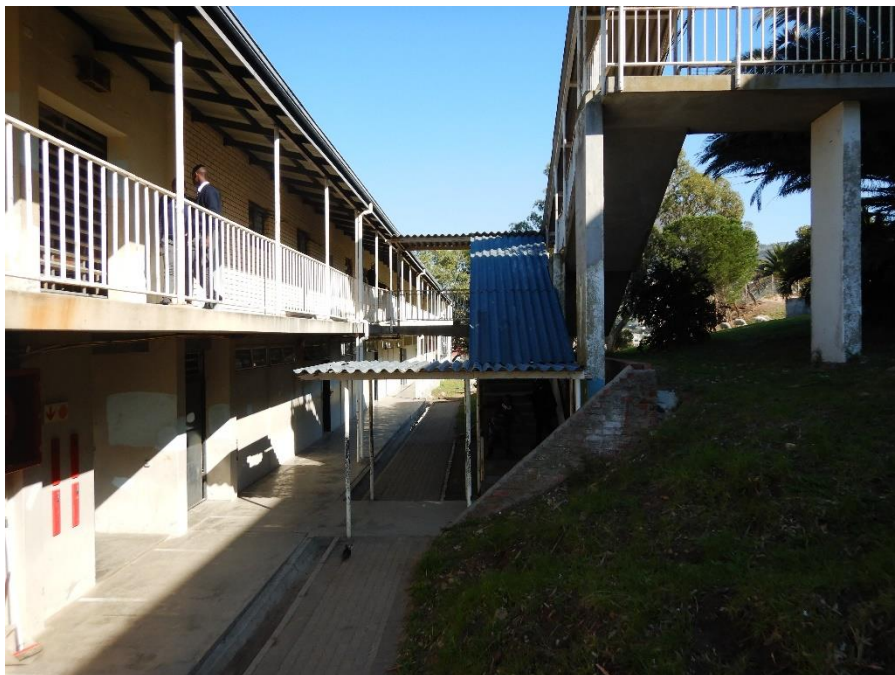
Figure 3A before: Canopy 2. (See site plan)

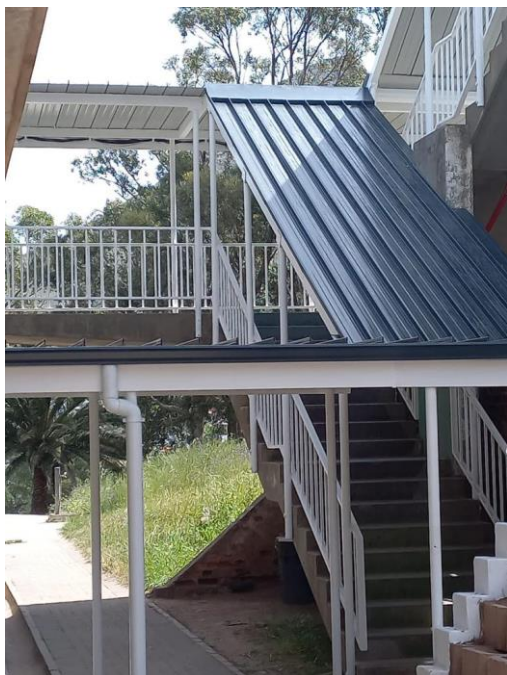
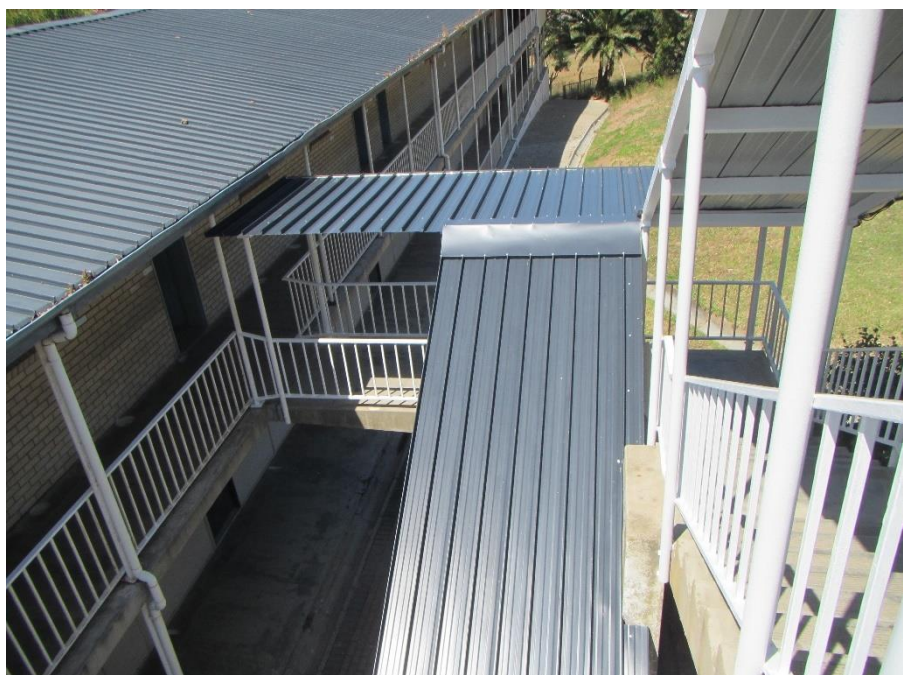
Figure 3B after: Canopy 2.

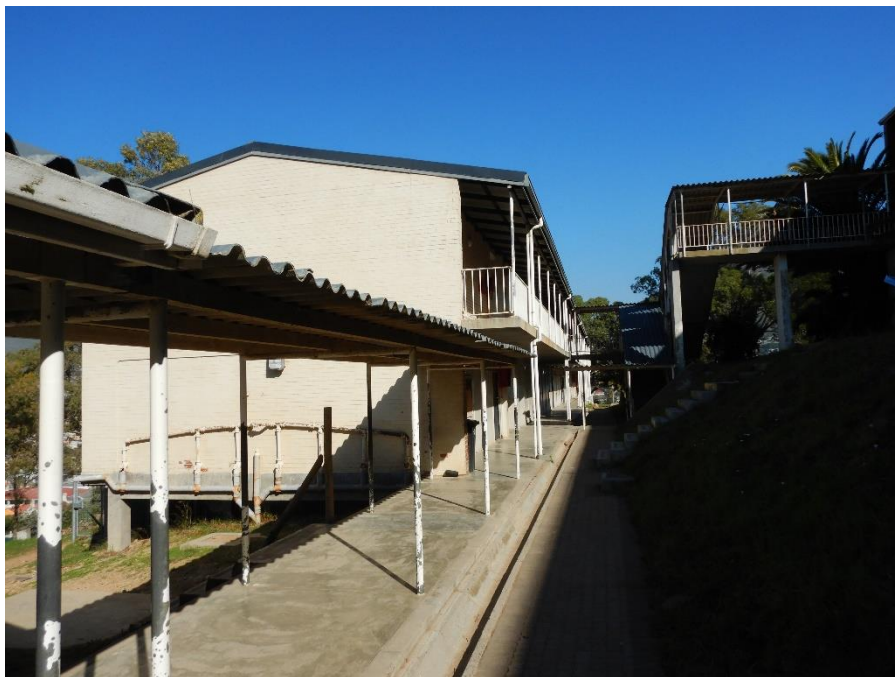
Figure 4A before: Canopy 3. (See site plan)

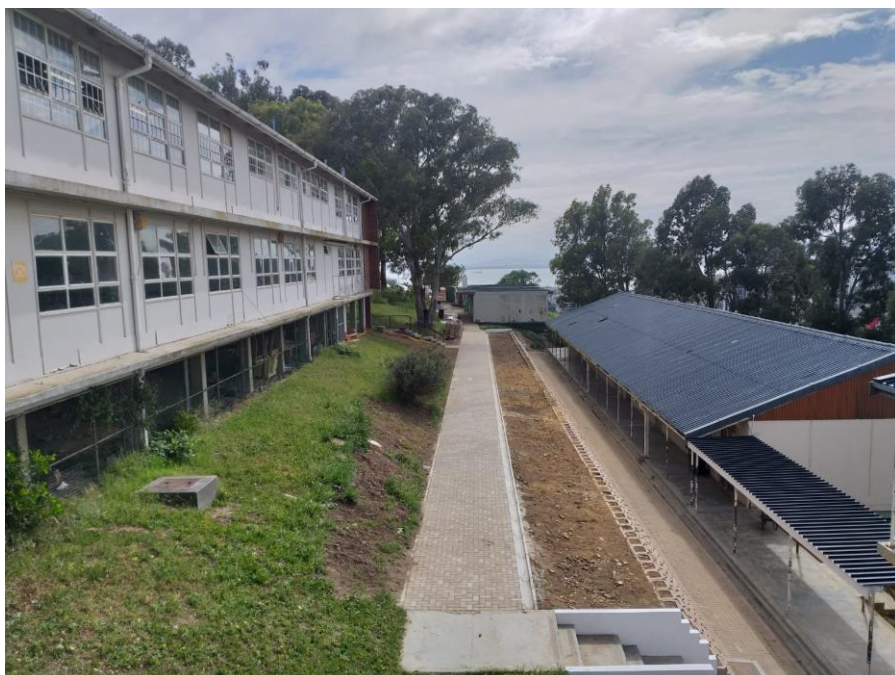
Figure 4B after: Canopy 3.

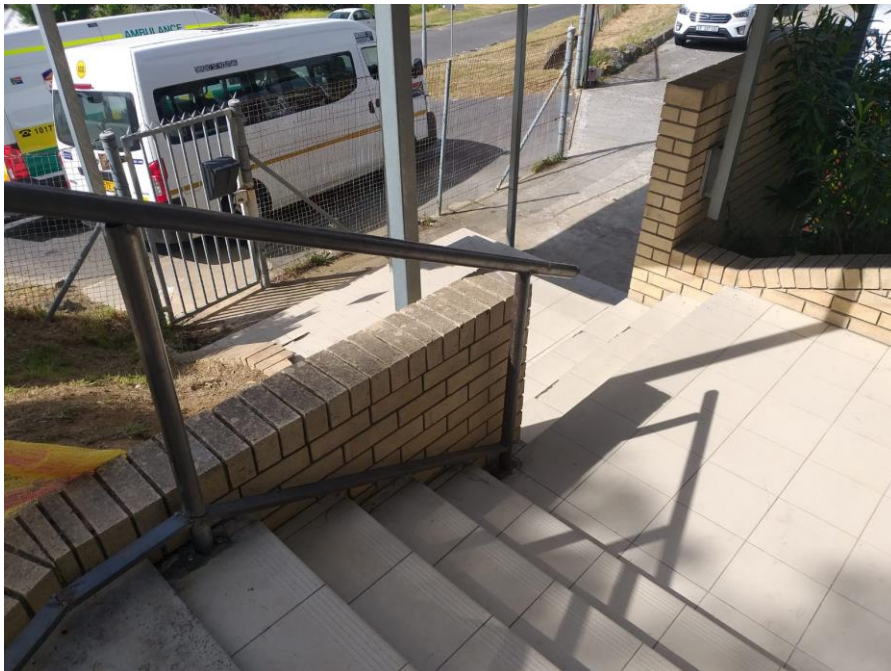
Figure 5A before: (Staircase 1) addition of steel handrails and balustrades on external stairs and walkways.

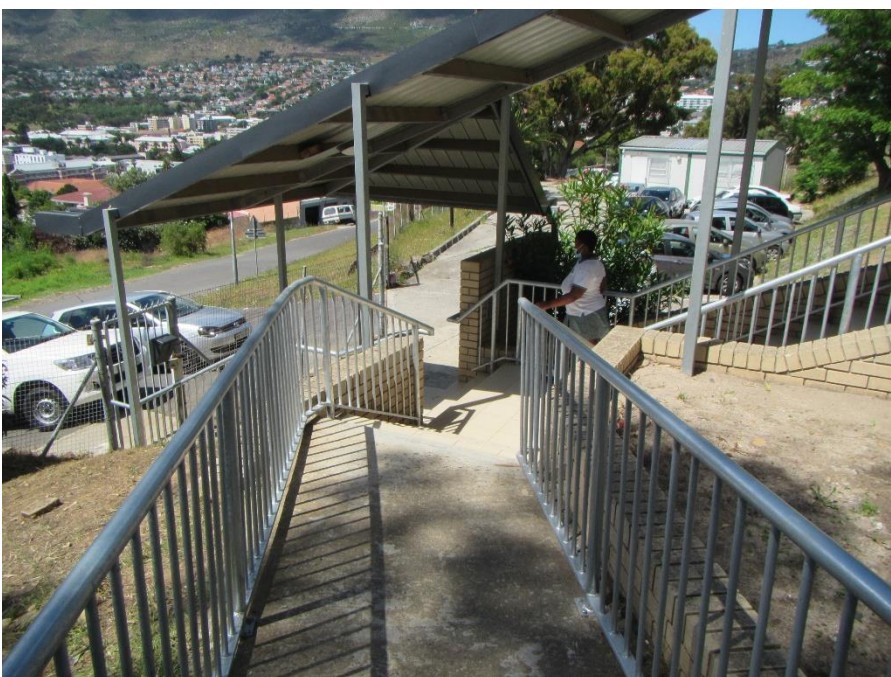
Figure 5B after: (Staircase 1) addition of steel handrails and balustrades on external stairs and walkways.

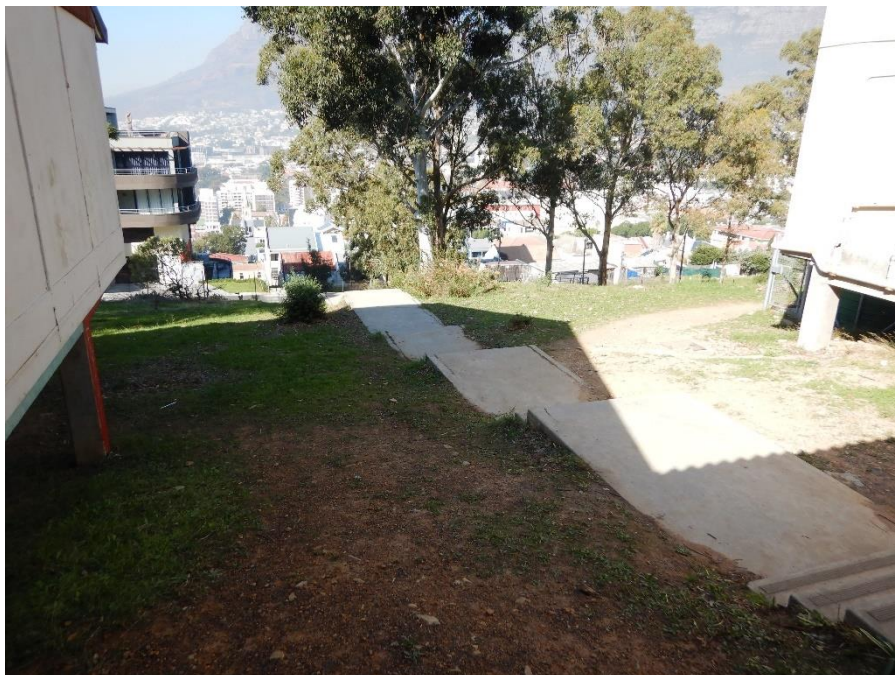
Figure 6A before: (Staircase 2) addition of steel handrails and balustrades on external stairs and walkways.

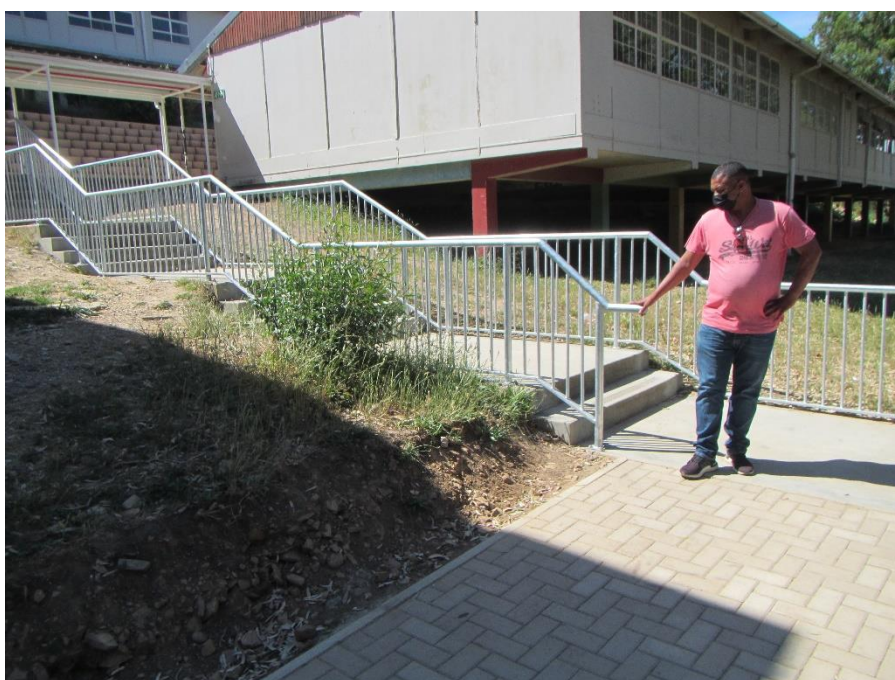
Figure 6B after: (Staircase 2) addition of steel handrails and balustrades on external stairs and walkways.

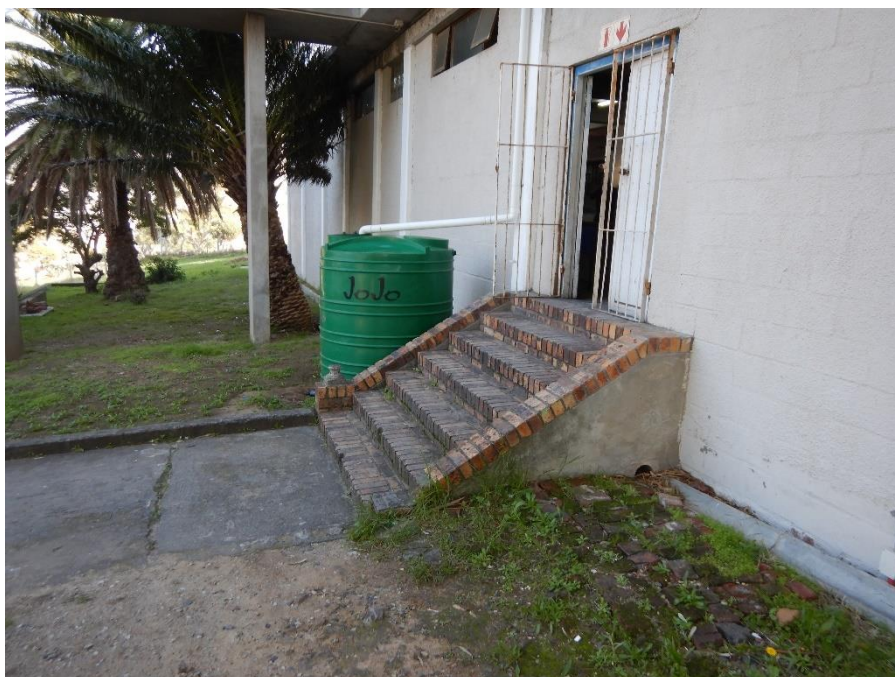
Figure 7A before: (Staircase 3) addition of steel handrails and balustrades on external stairs and walkways.

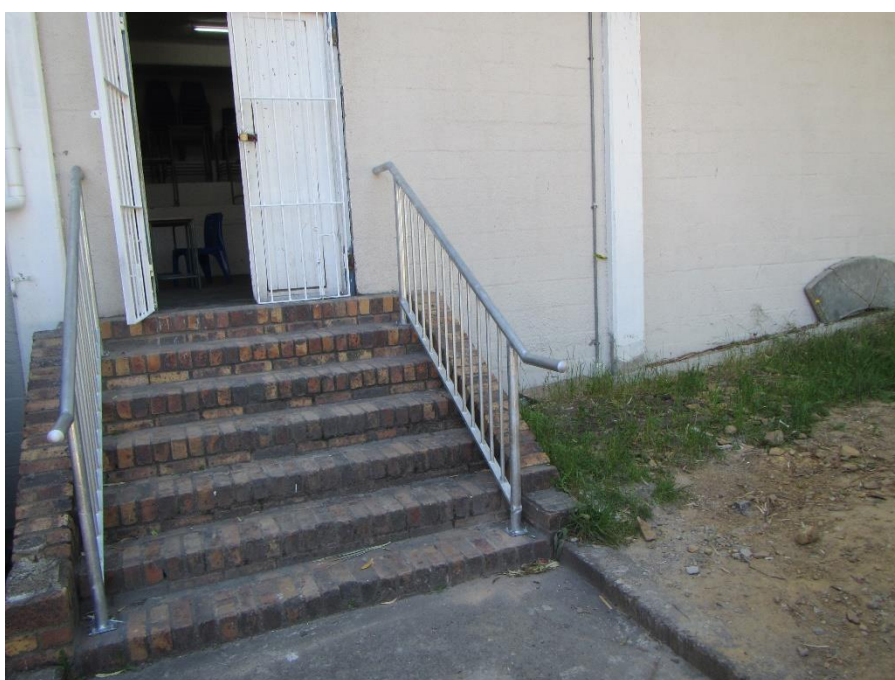
Figure 7B after: (Staircase 3) addition of steel handrails and balustrades on external stairs and walkways.

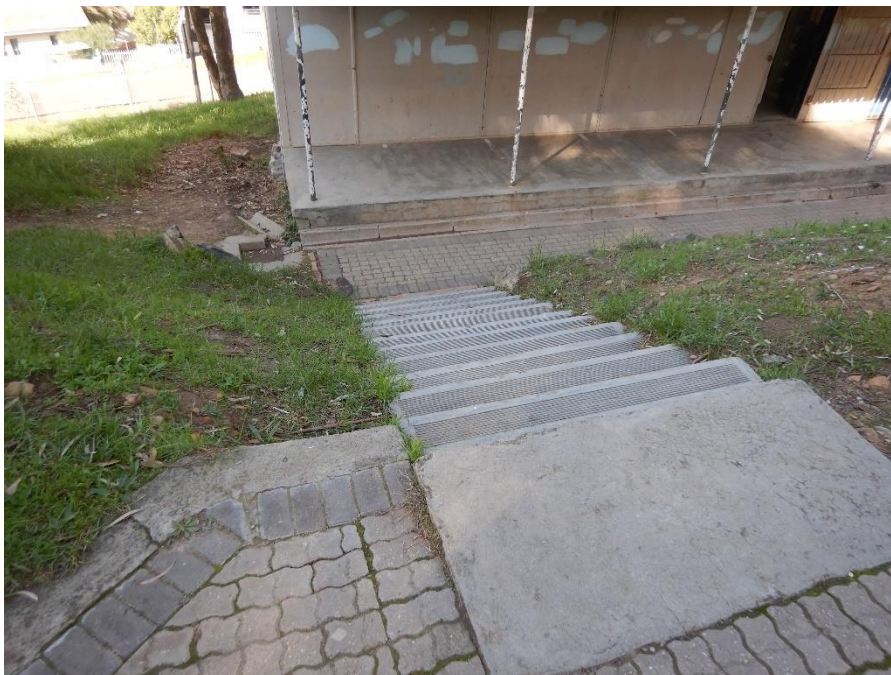
Figure 8A before: (Staircase 4) addition of steel handrails and balustrades on external stairs and walkways.

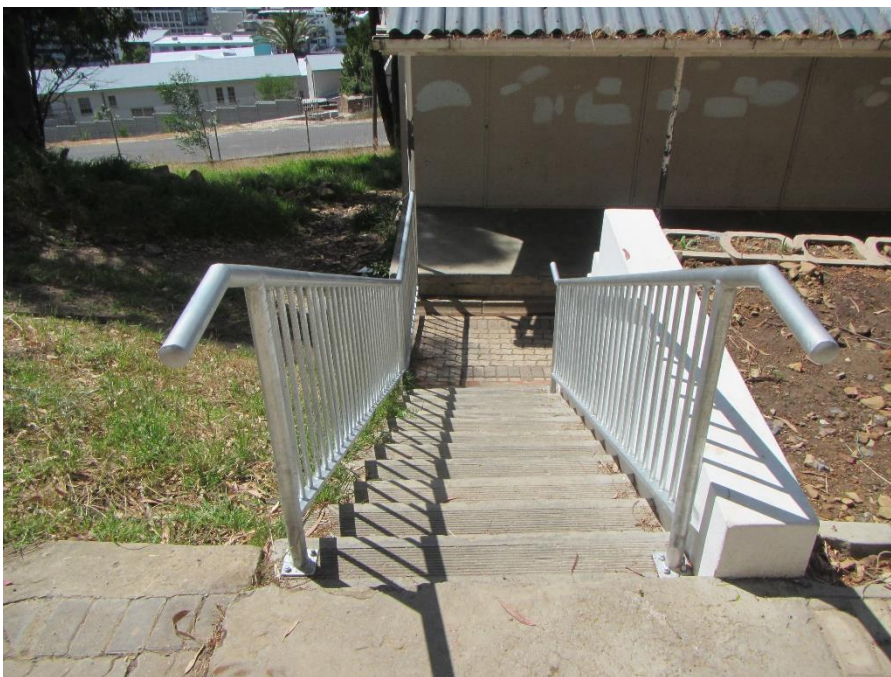
Figure 8B after: (Staircase 4) addition of steel handrails and balustrades on external stairs and walkways.

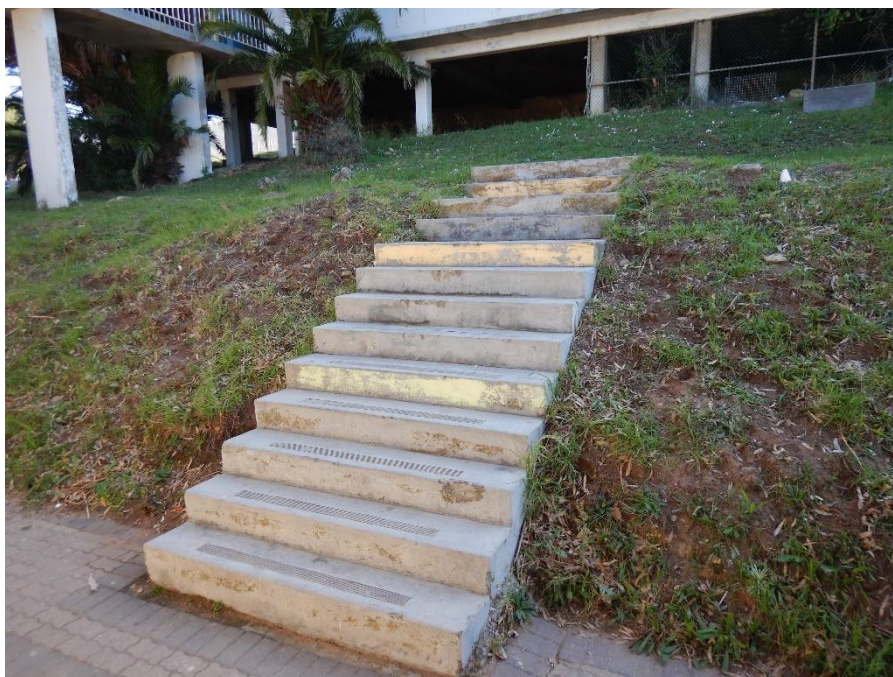
Figure 9A before: (Staircase 5) addition of steel handrails and balustrades on external stairs and walkways.

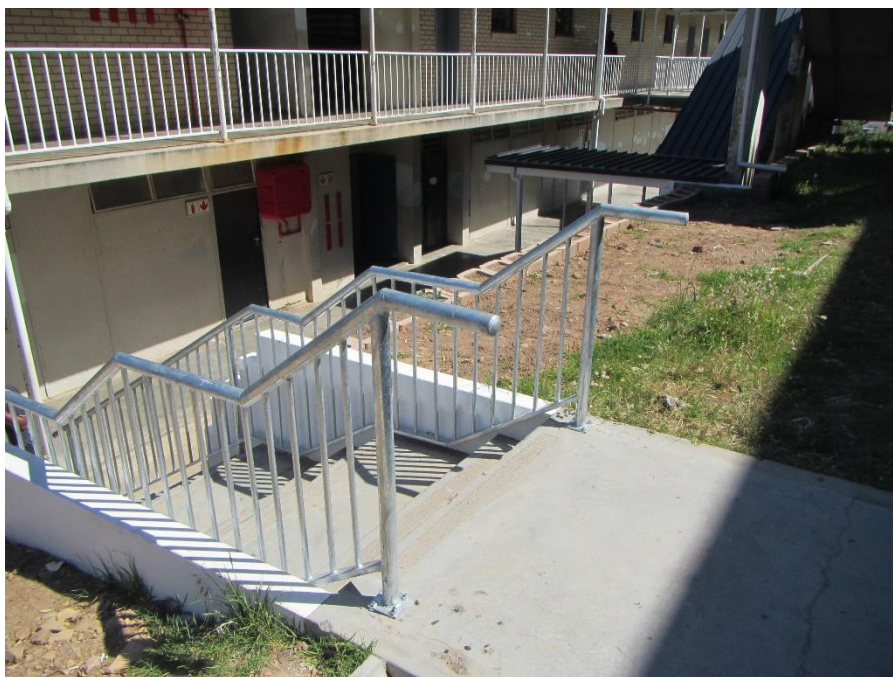
Figure 9B after: (Staircase 5) addition of steel handrails and balustrades on external stairs and walkways.

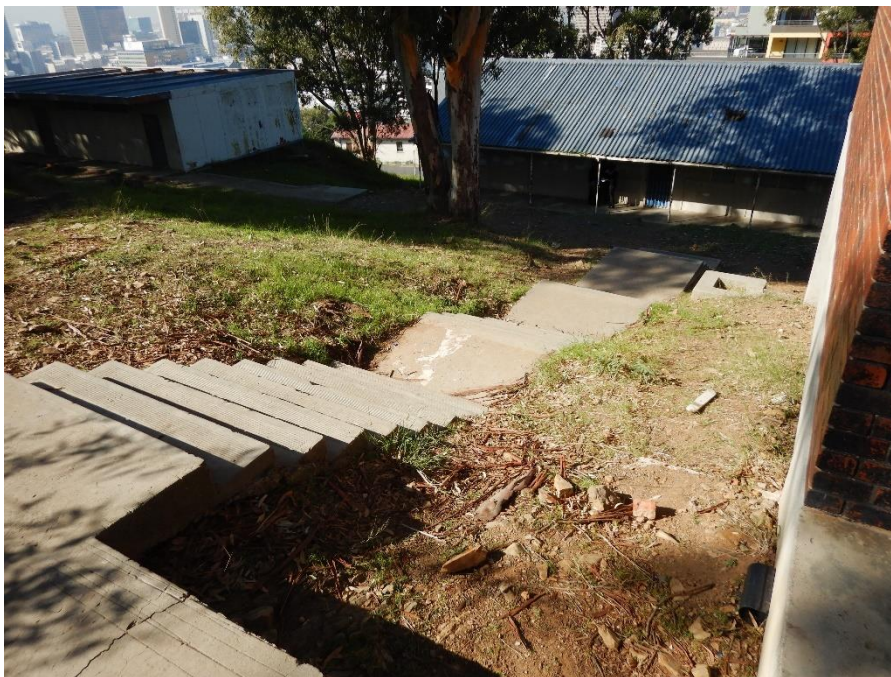
Figure 10A before: (Staircase 6) addition of steel handrails and balustrades on external stairs and walkways.

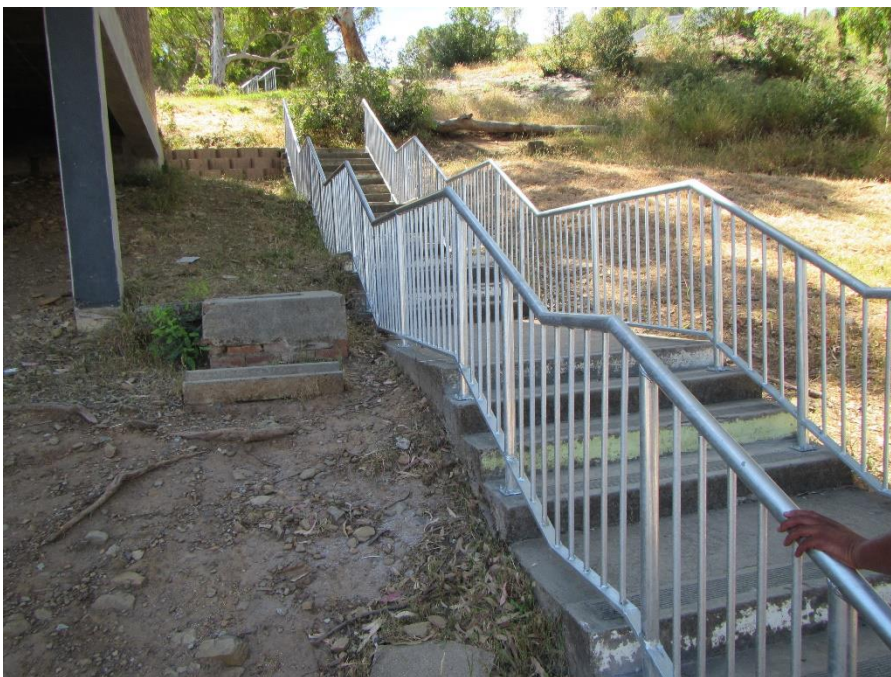
Figure 10B after: (Staircase 6) addition of steel handrails and balustrades on external stairs and walkways.

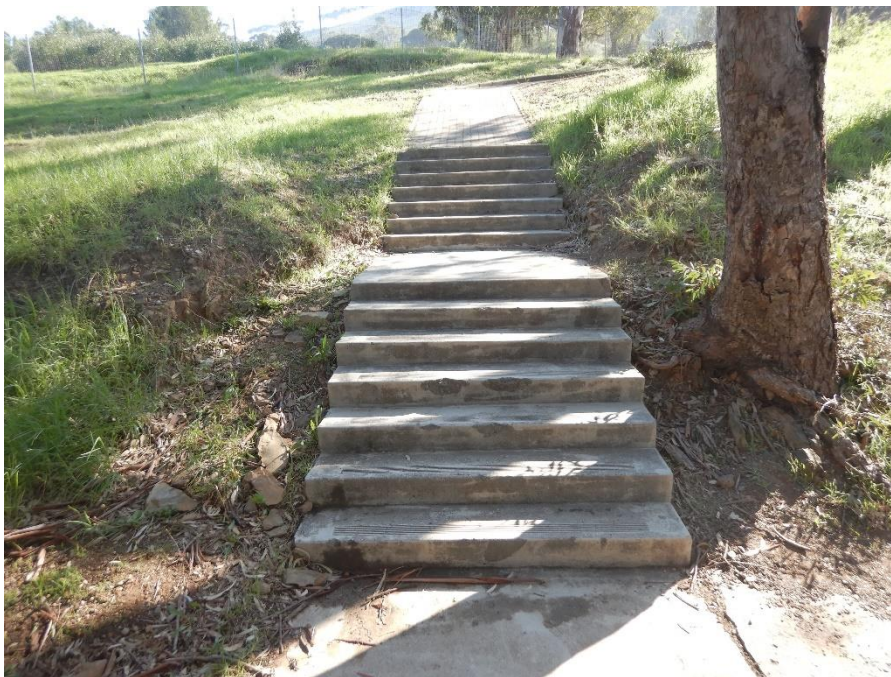
Figure 11A before: (Staircase 7) addition of steel handrails and balustrades on external stairs and walkways.

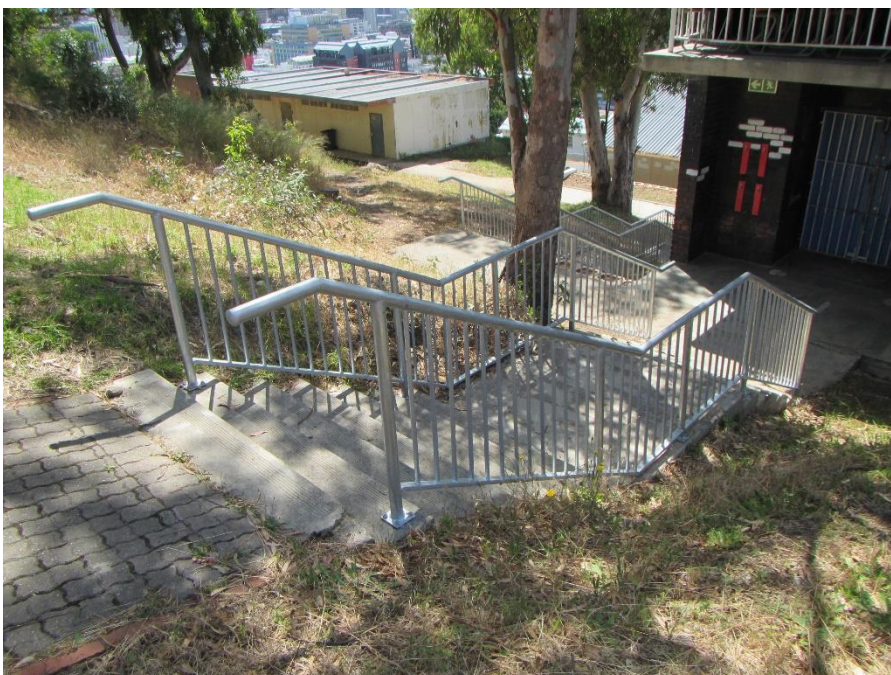
Figure 11B after: (Staircase 7) addition of steel handrails and balustrades on external stairs and walkways.

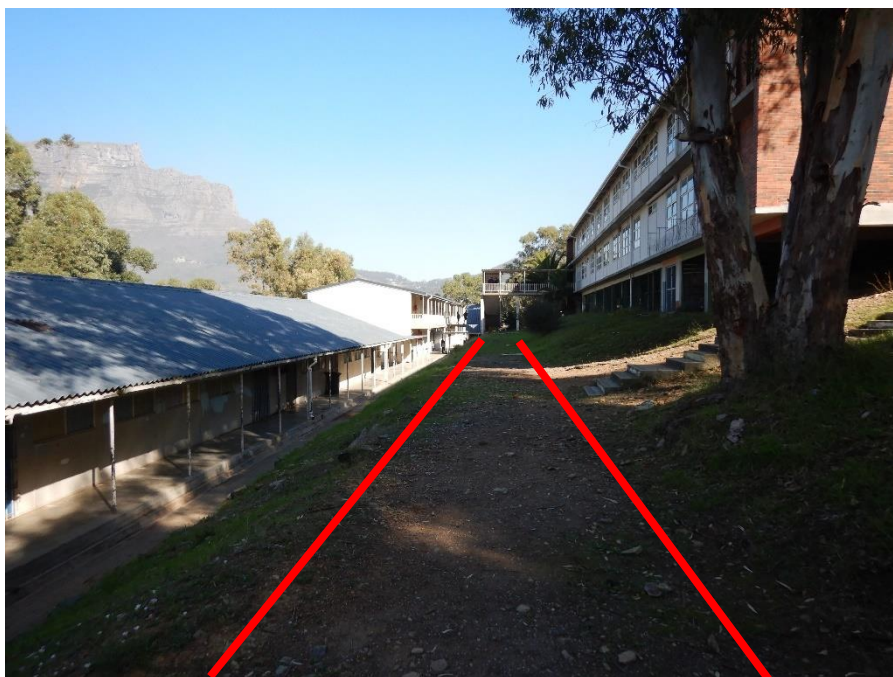
Figure 12A before: Proposed new paving at upper tier.

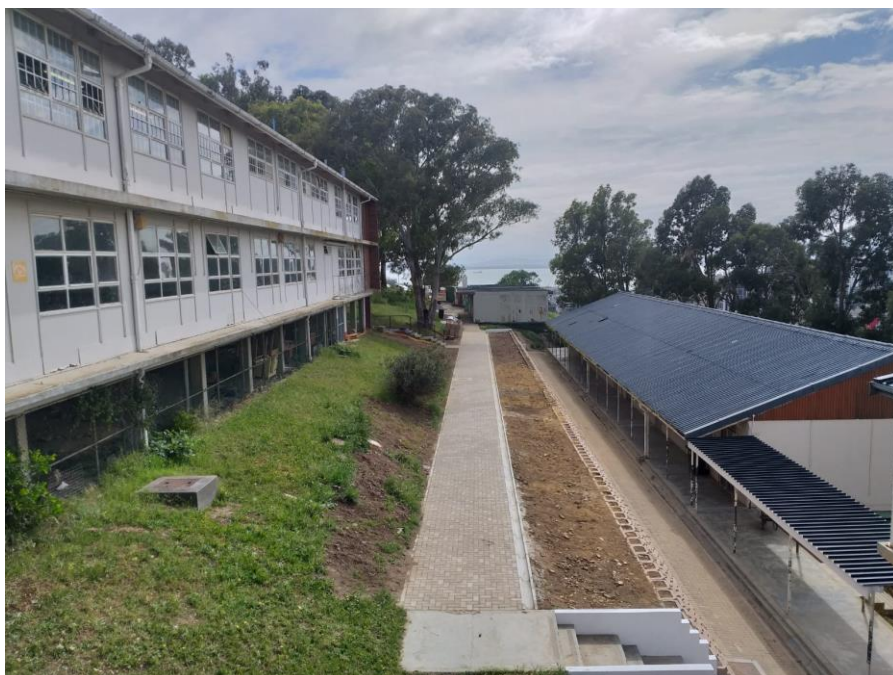
Figure 12B after: new paving at upper tier.

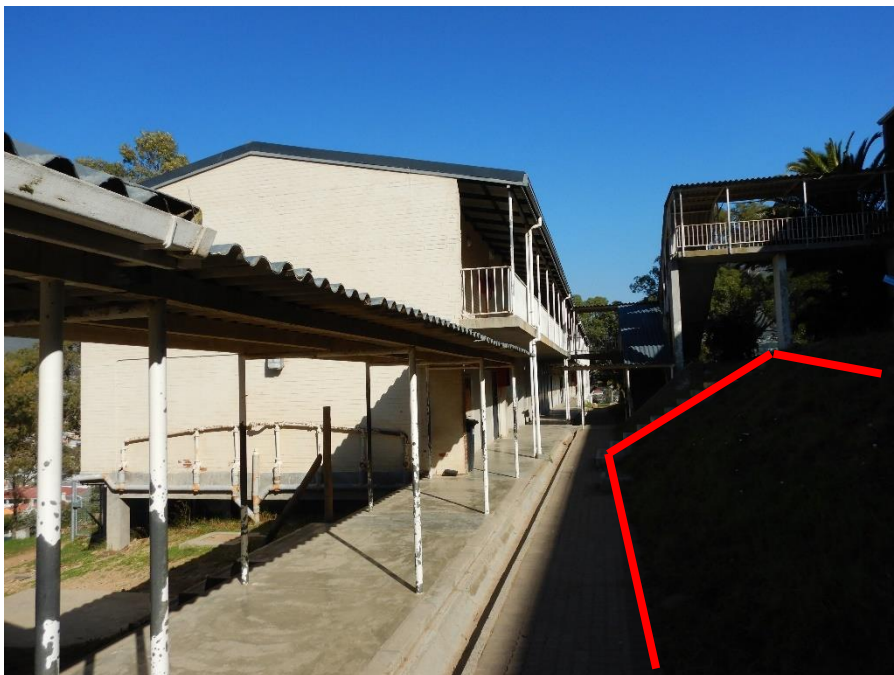
Figure 13A before: Proposed new retaining wall at upper tier.

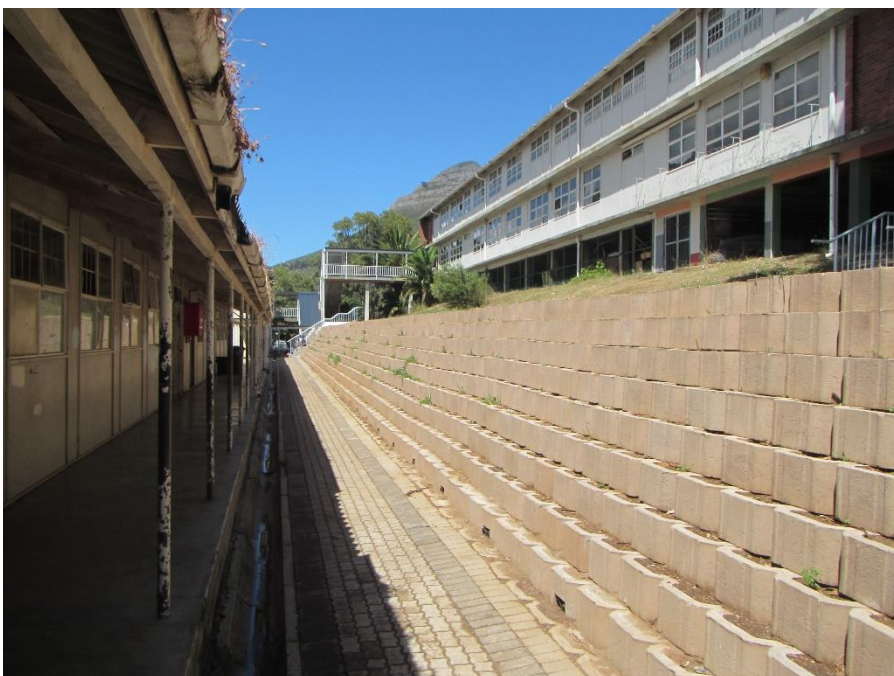
Figure 13B after: new retaining wall at upper tier.

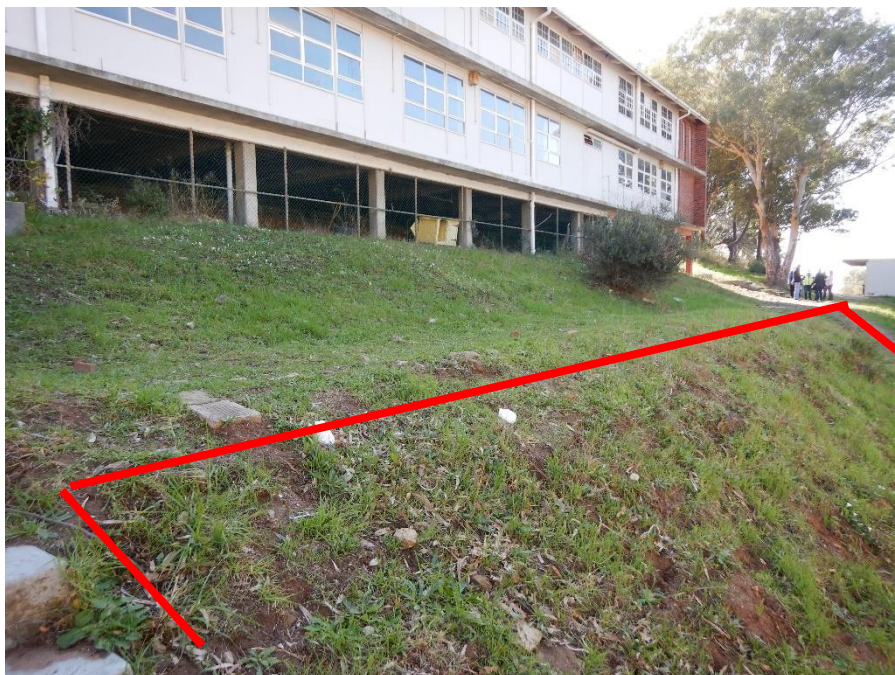
Figure 14A before: Proposed new paving and retaining wall at lower tier.

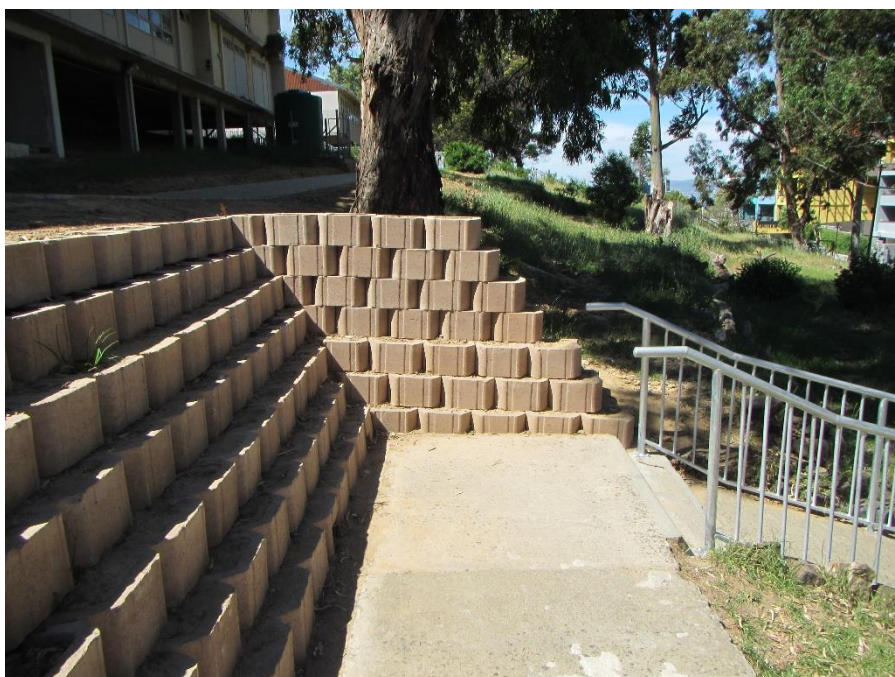
Figure 14B after: new retaining wall at lower tier (entrance walkway).

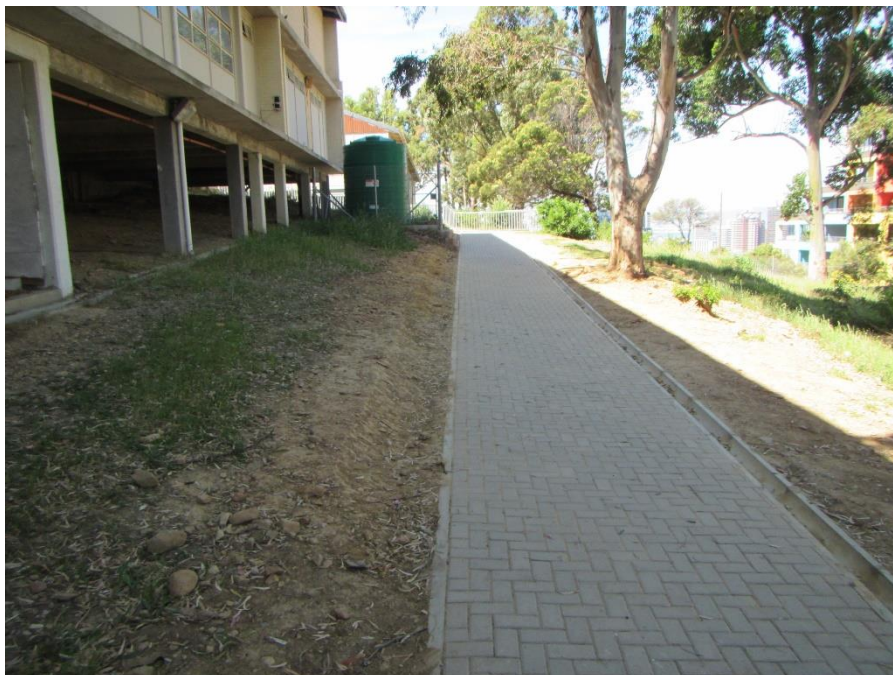
Figure 14C after: new paving/walkway at lower tier

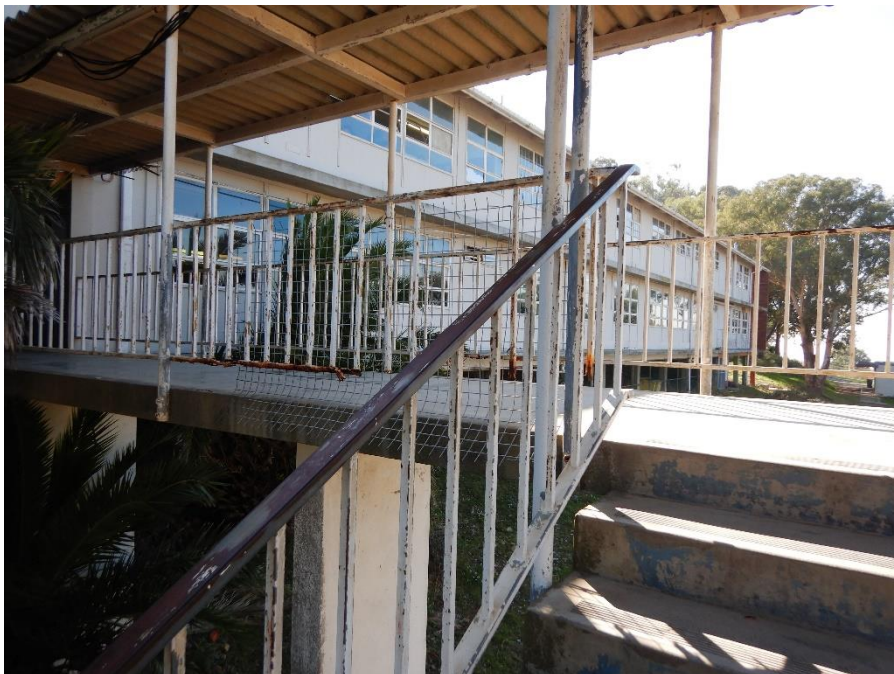
Figure 15A before: Corroded handrails and balustrades.
