## Heritage Application – Vista High School

#### RE: VISTA HIGH SCHOOL – PROPOSED MAINTENANCE – FIRE AND LIFE SAFETY SCHOOL

R&L architects tasked with being the architectural consultants facilitating the public works Scheduled maintenance of Vista High School.

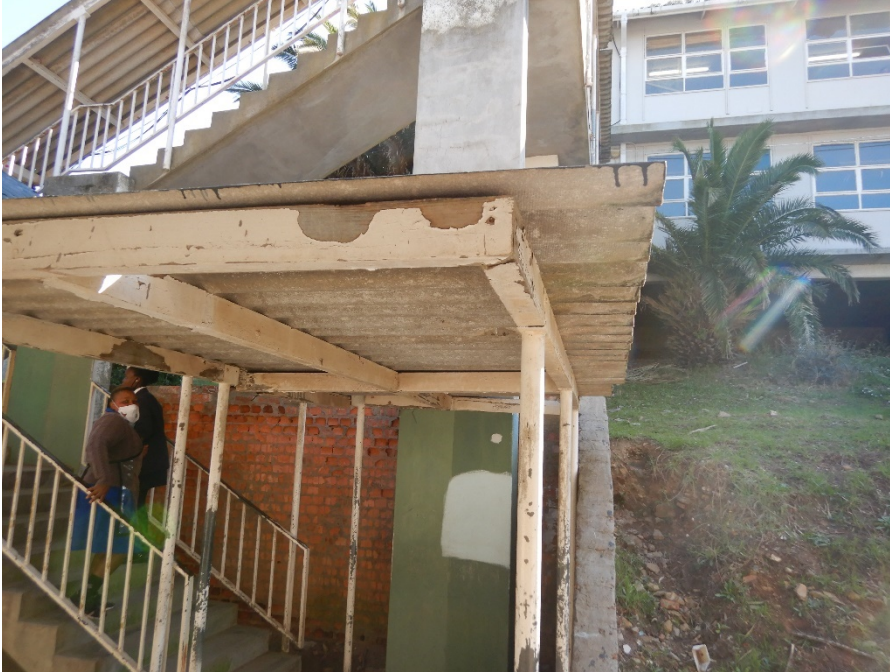
Figure 4: Condition of roof canopy – asbestos sheeting to be replaced.

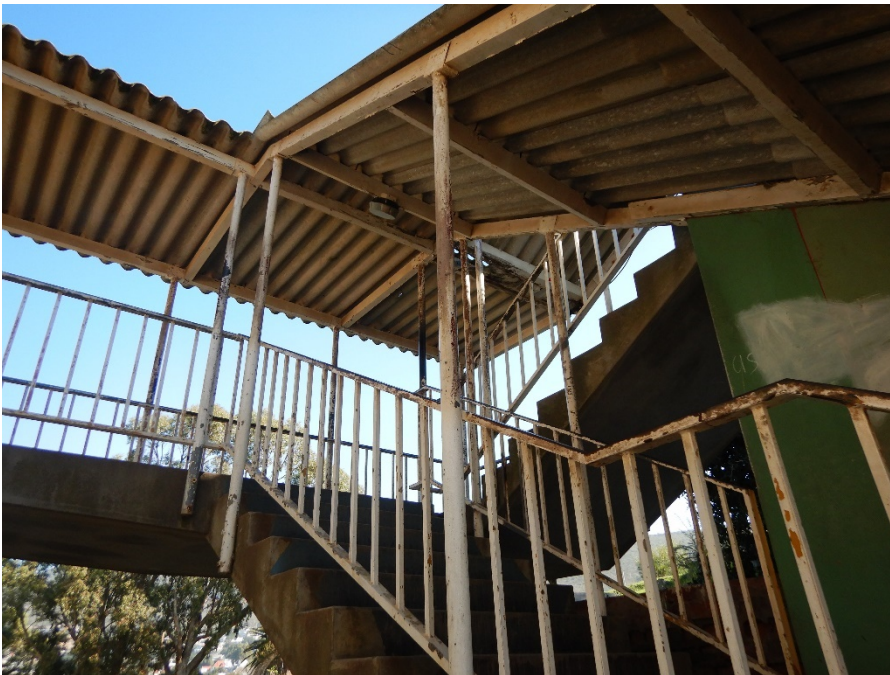
Figure 4.1: Condition of roof canopy – steel posts weathered and corroded.

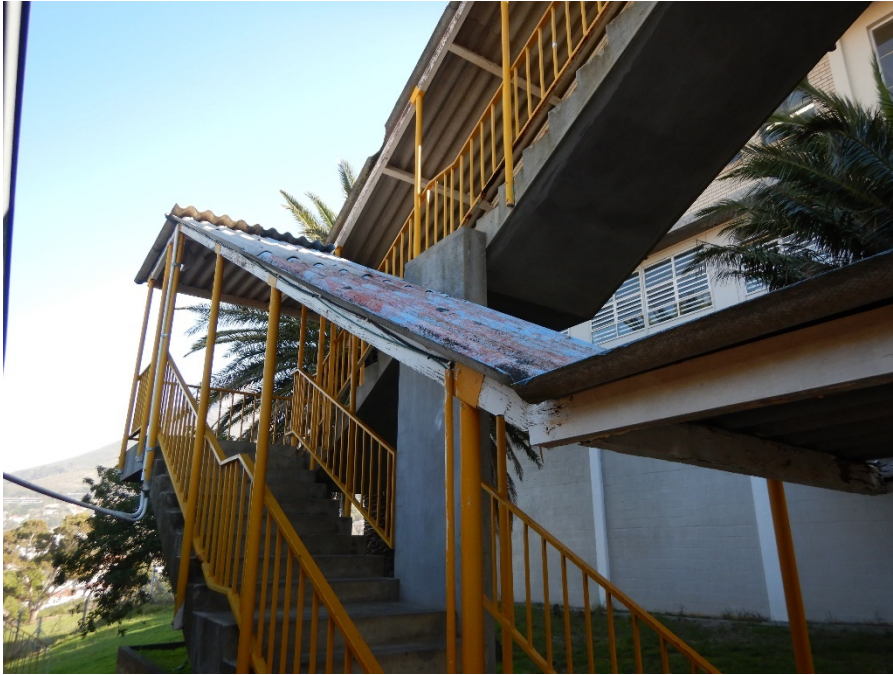
Figure 4.2: Condition of roof canopy 2 - asbestos sheeting unstable, unfit for school use.

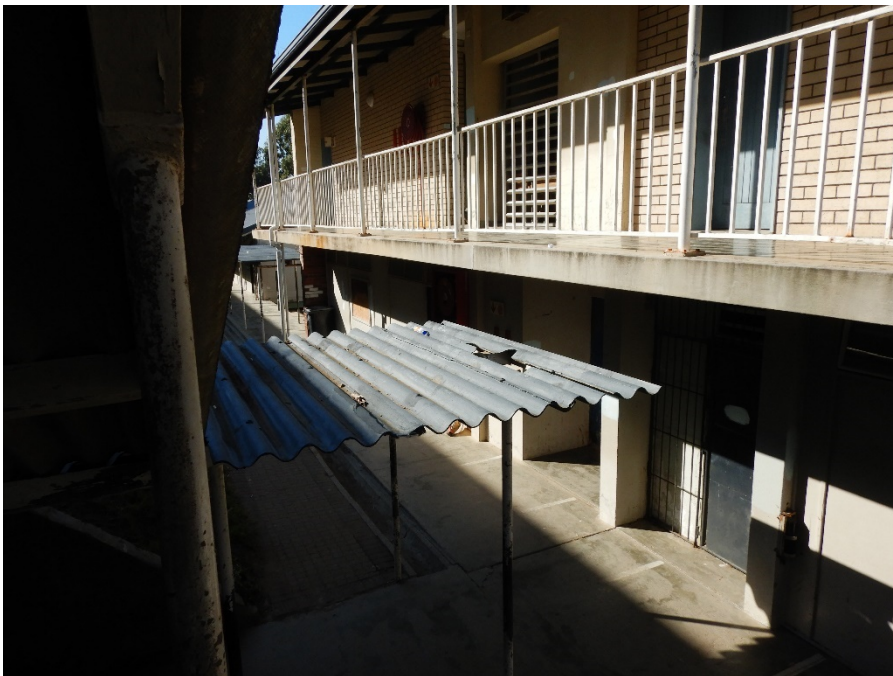
Figure 4.3: Condition of roof canopy – holes causing hazardous conditions for learners.

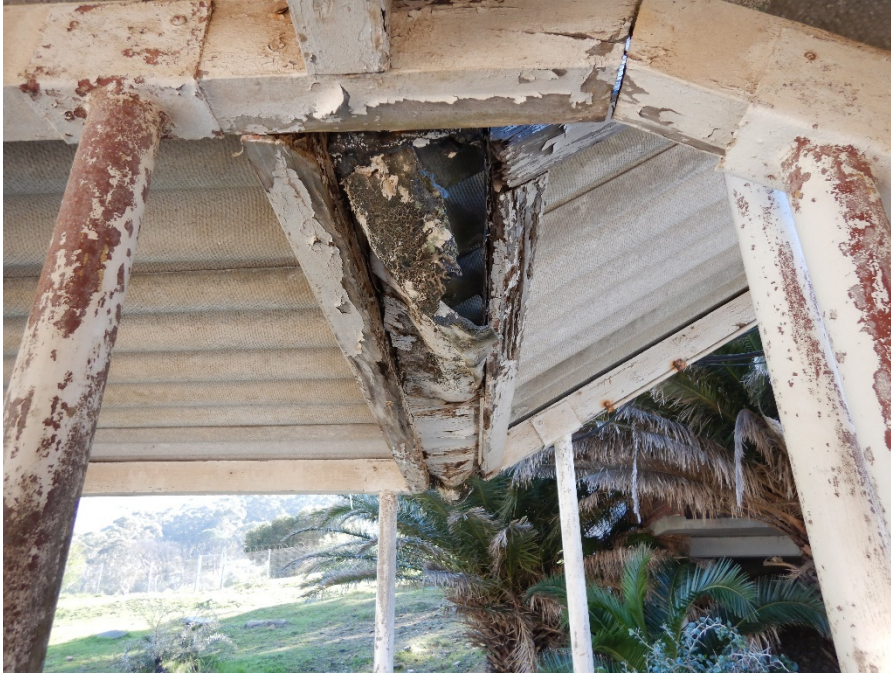
Figure 4.4: Condition of roof canopy – rotting of timber members impacting structural integrity.

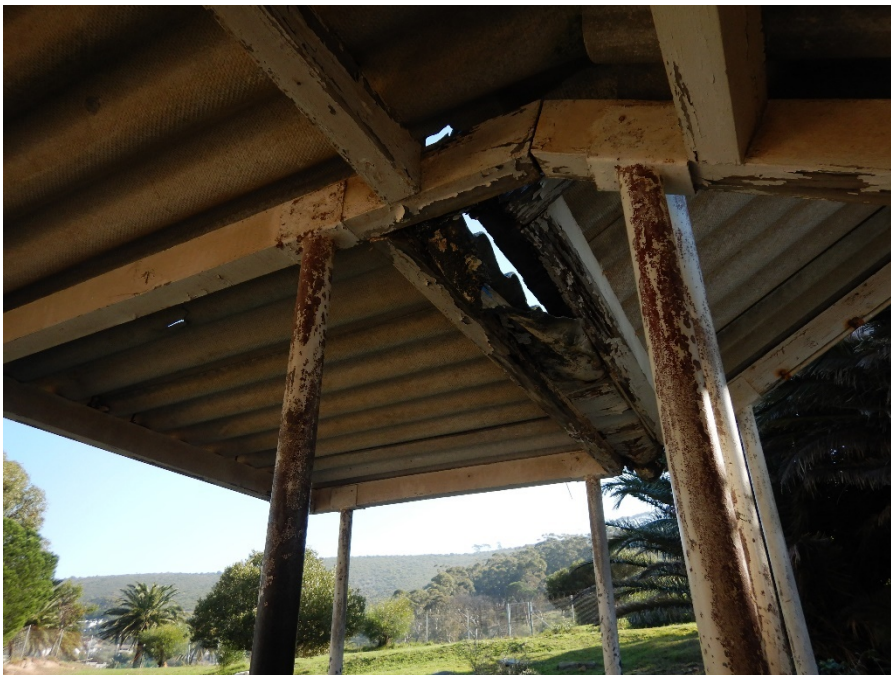
Figure 4.5: Condition of roof canopy – exposed rusted fixing members hazardous for learners.

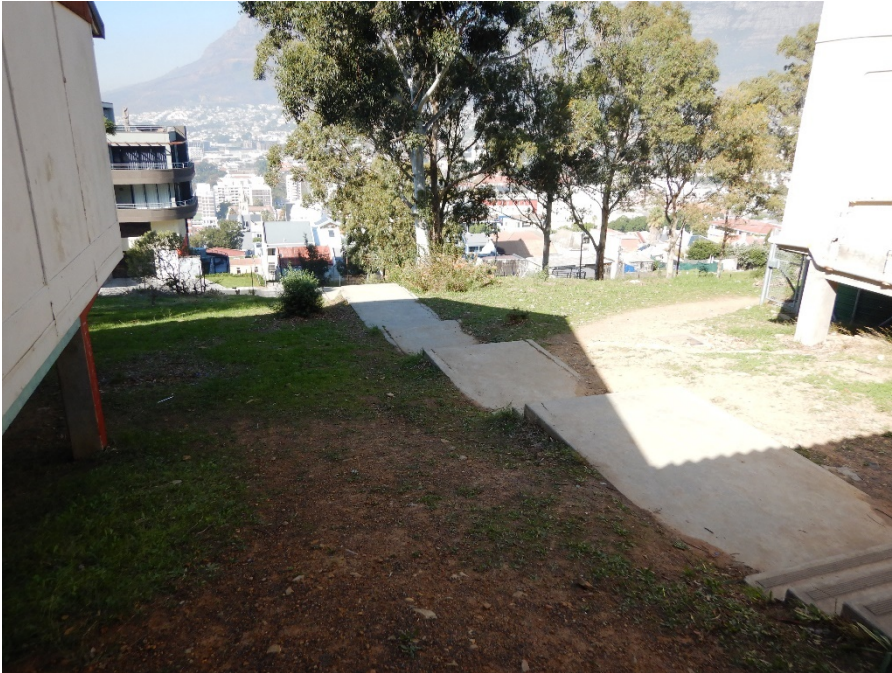
Figure 4.6: Staircase 2 (see site plan) – to receive safety handrails on both sides.

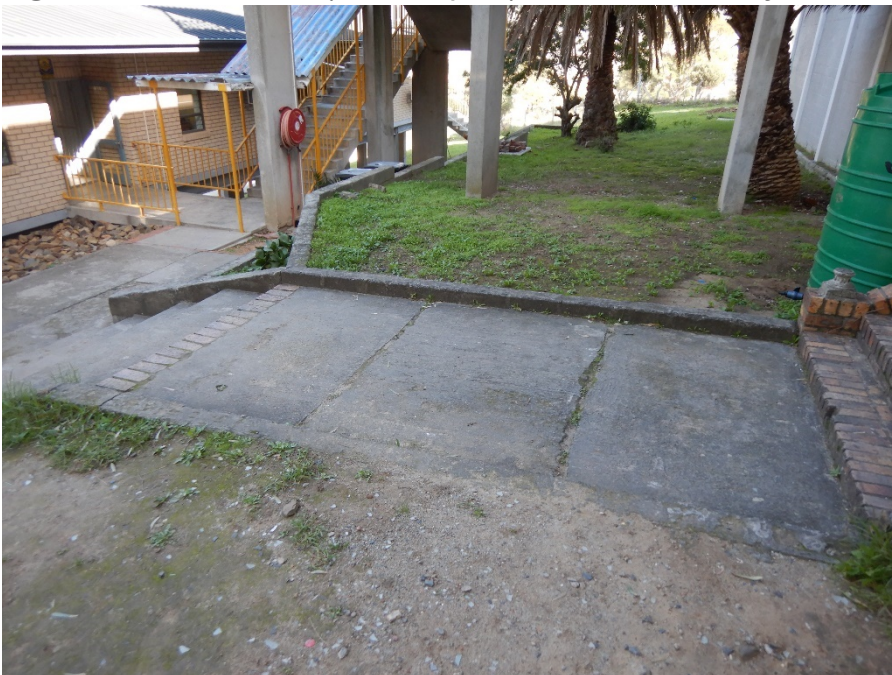
Figure 4.7: Staircase 3 (see site plan) – to receive safety handrails on both sides.

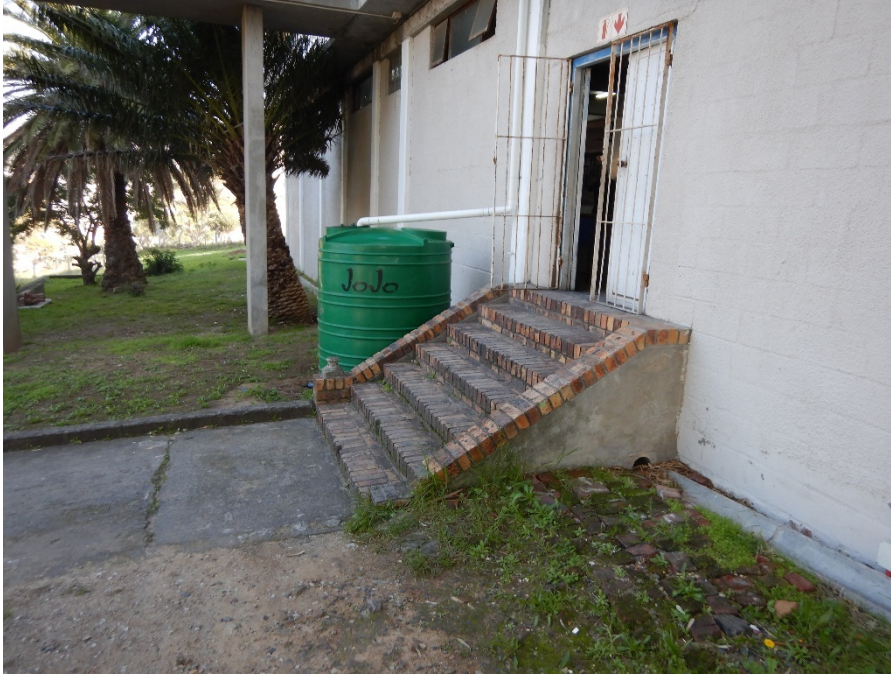
Figure 4.8: Staircase 3 (see site plan) – to receive safety handrails on both sides.

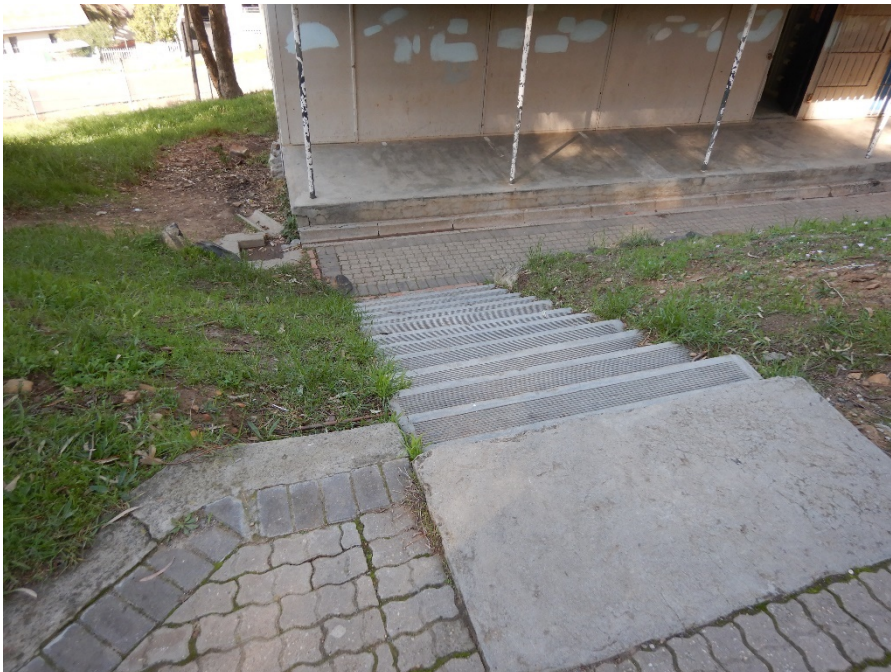
Figure 4.9: Staircase 4 (see site plan) – to receive safety handrails on both sides.

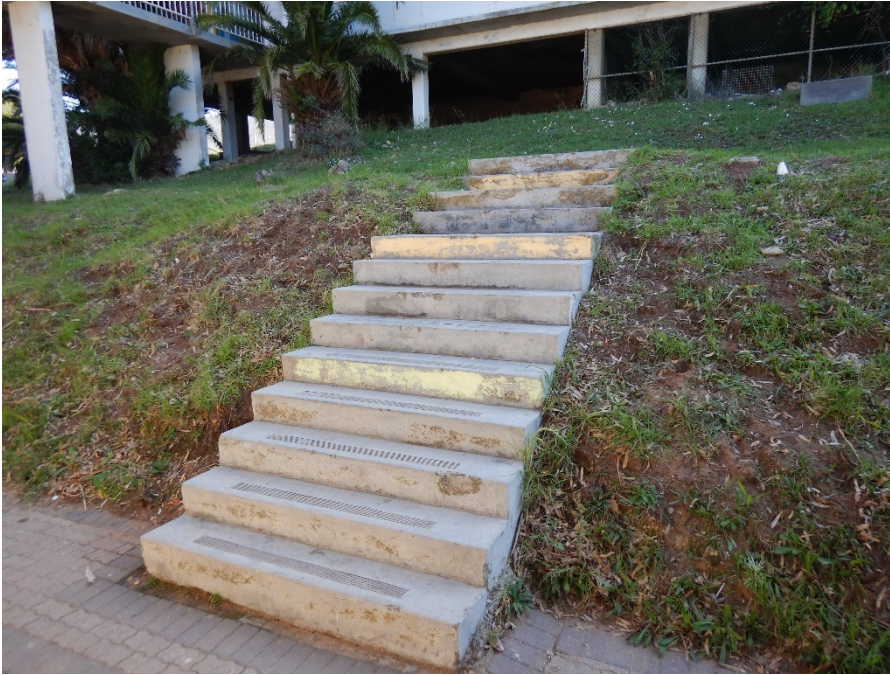
Figure 4.10: Staircase 5 (see site plan) – to receive safety handrails on both sides.

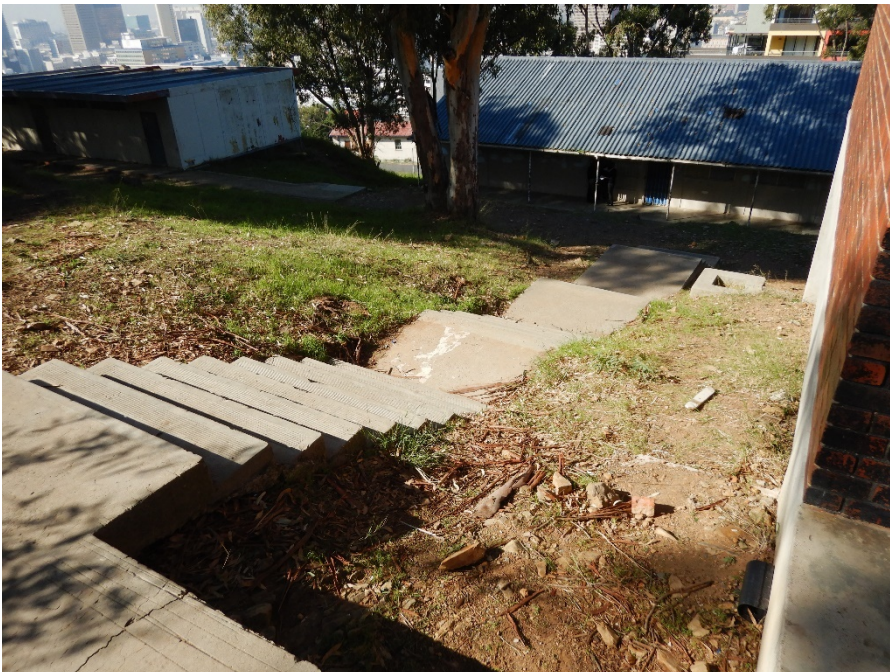
Figure 4.11: Staircase 6 (see site plan) – to receive safety handrails on both sides.

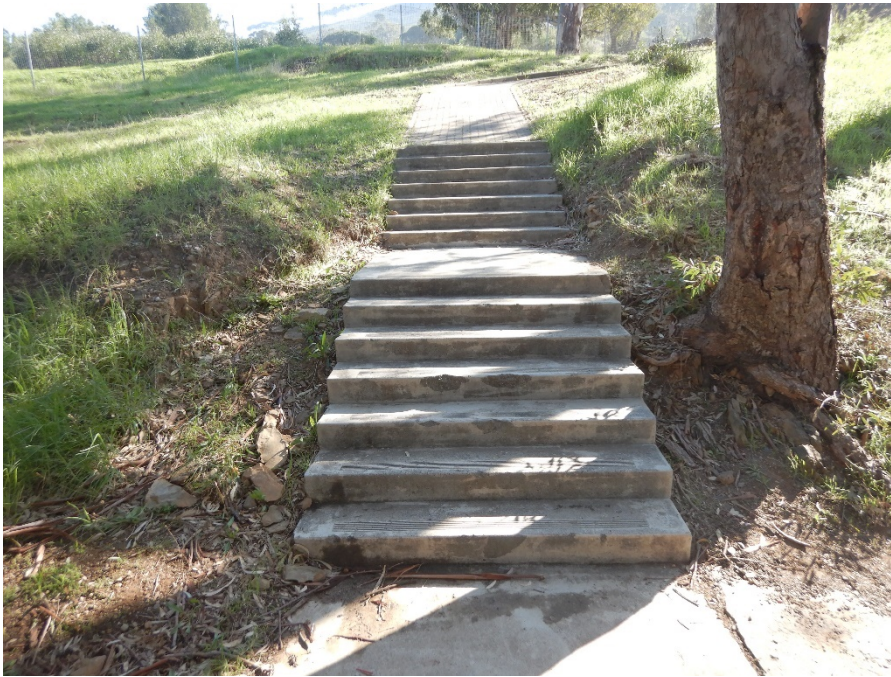
Figure 4.12: Staircase 7 (see site plan) – to receive safety handrails on both sides.

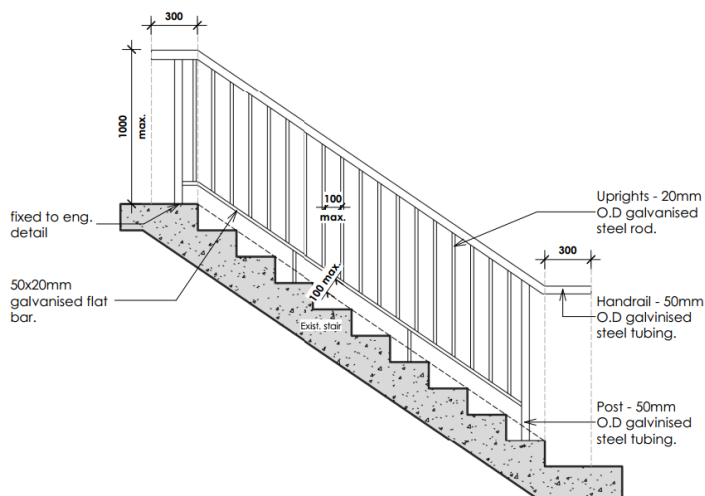
Existing external stairs to be fitted with handrails on both sides as stipulated by SANS 10400-S:2011 and SANS 10400-M:2018.

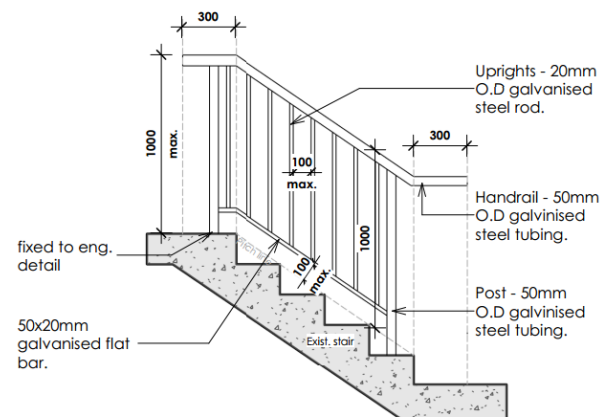
Figure 4.13: Detail of handrail to be installed. To comply with SANS 10400.

**4.3.1** Any flight of steps which contains more than three risers shall have protection on both sides provided by a secure wall, screen, railing or balustrade which shall be not less than 1 m high and so erected that any such wall, screen, railing or balustrade in any occupancy classified as E2, E3, E4, H1, H2, H3, H4 or H5 shall not have any opening above the pitch line that permits the passage of a 100 mm diameter ball; provided that such protection in any occupancy that is not an occupancy classified as E2, E3, E4, H1, H2, H3, H4 or H5 shall consist of at least a handrail and one other rail midway between such handrail and the stair tread.

**4.3.2** Any flight of stairs which contains more than five risers shall be provided with at least one continuous handrail extending the full length of such flight, provided that this requirement shall not apply to any building classified as H4, or within individual dwelling units in an occupancy classified as H3.

**4.3.3** The handrail to any flight of stairs provided in terms of 4.3.2 shall be

- on at least one side of the flight where the width of the flight is less than 1,1 m, and on both sides where the width exceeds 1,1 m,
- securely fixed to such wall, screen, railing or balustrade at a height of not less than 850 mm and not more than 1 m measured vertically from the pitch line to the upper surface of the handrail, and
- of such a design and so fixed that there shall be no obstructions on, above or near to it which might obstruct the movement of a hand moving along it.

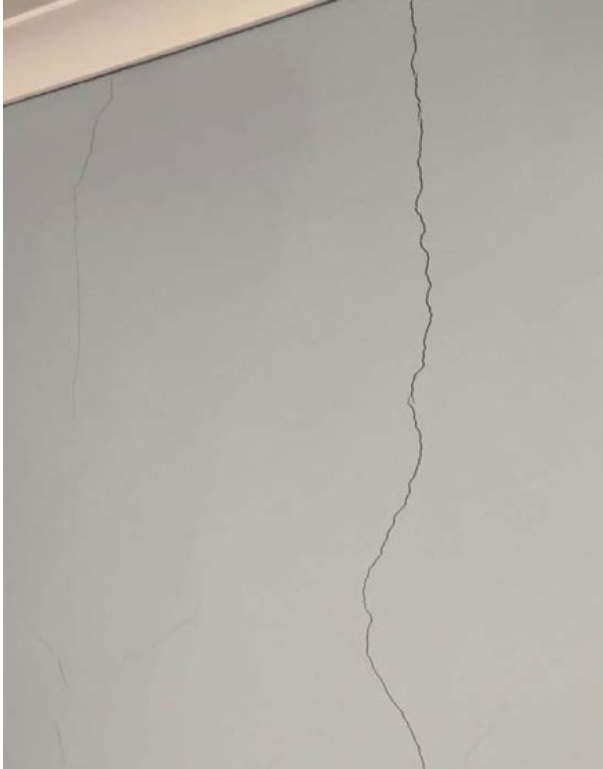
Figure 4.16: cracking in structural brickwork.

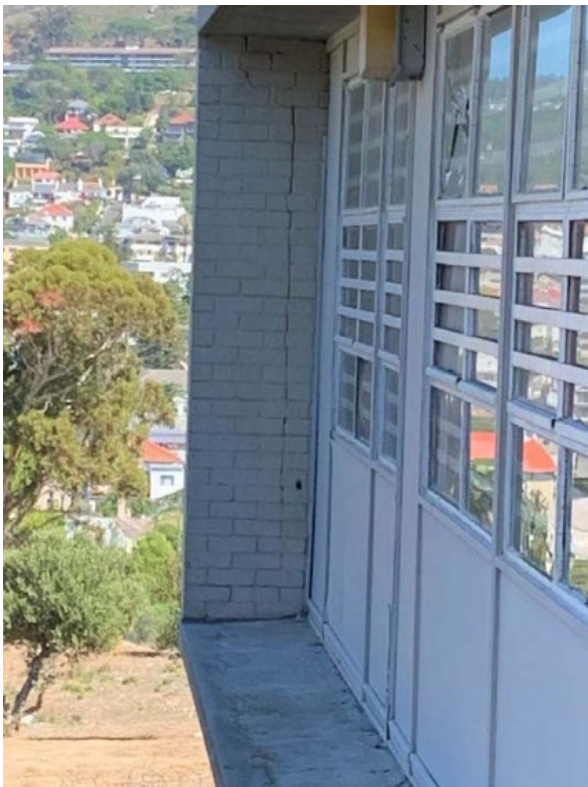
Figure 4.17: cracking in structural brickwork.

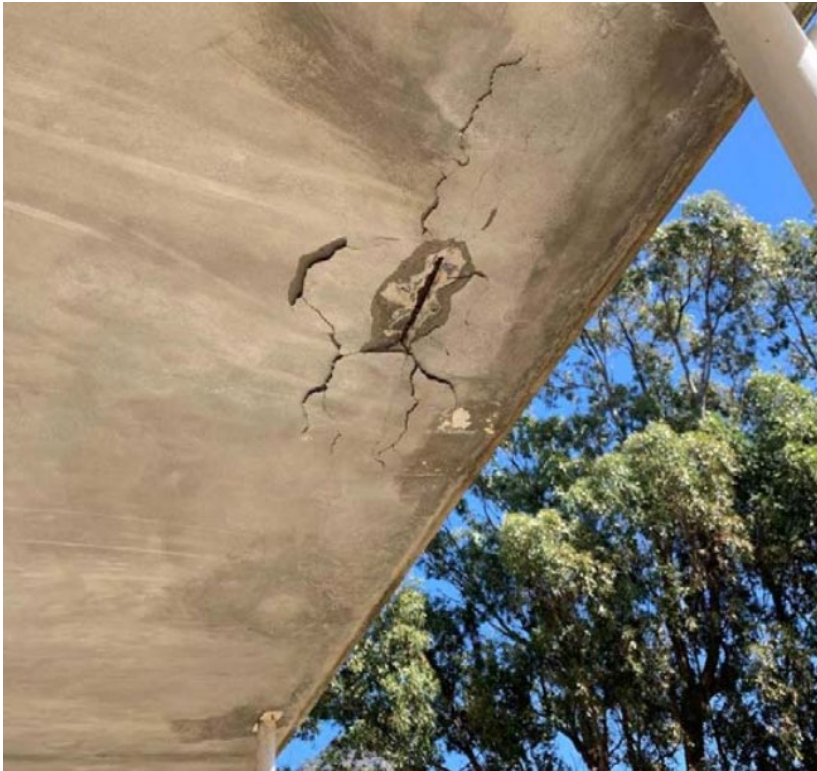
Figure 4.18: concrete spalling and cracking.

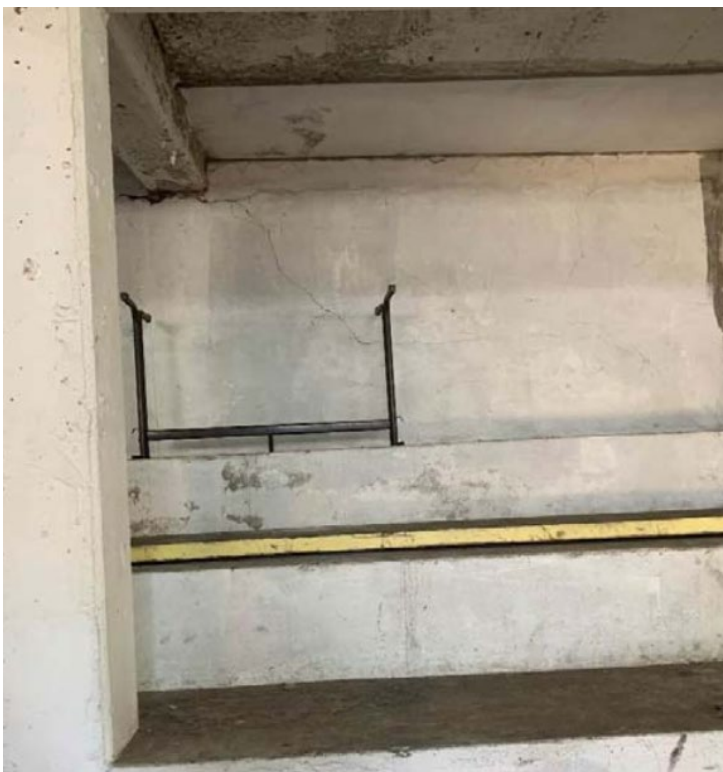
Figure 4.19: concrete spalling and cracking.
