**RECORDING OF HISTORIC BUILDING AT VOORSPOED MINE
(KROONSTAD – FREE STATE PROVINCE)**

**Project: M. Naude
Date: June-August 2013**

PHOTOGRAPHIC RECORDING OF HISTORIC VOORSPOED MINE BUILDING:

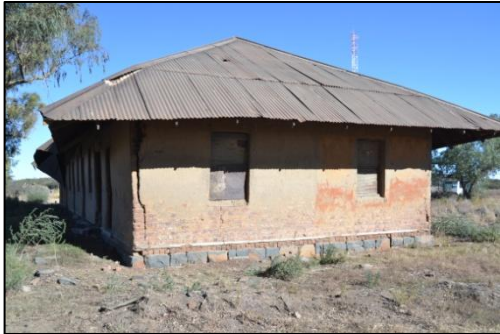
Elevations	
1.	<p>Northern elevation</p> <p>The building is not orientated according to the exact north-south axis but is set slightly off this coordinate. This elevation is the same as the southern elevation.</p>

<p>Figure 1. North, northwest facade (Photograph: M. Naude 2013)</p>
2.	<p>Southern elevation</p> <p>This elevation and façade has been badly damaged with both window frames removed completely and with badly damaged window sills. This is the only elevation where a section of the original roof fascia has remained intact. The clay plaster on the walls have been removed and washed away over time.</p>

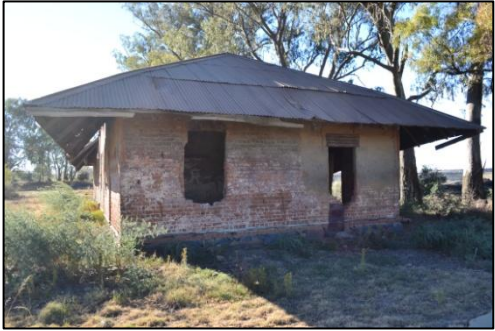
<p>Figure 2. South southwest elevation (photograph: M. Naude 2013)</p>

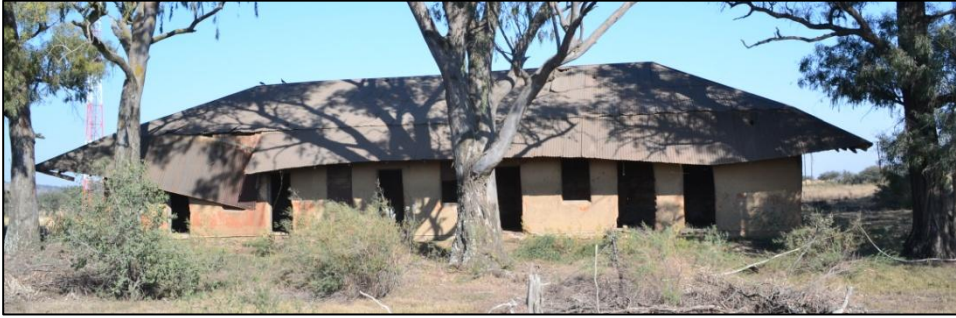
3.	<p>Eastern elevation</p> <p>This elevation faces towards the mine and the open cast activities. A short section of the verandah roof has been damaged due to the removal of the roof timbers supporting the verandah roof.</p>

<p>Figure 3. East northeast elevation (Photograph: M. Naude 2013)</p>	
4.	<p>Western elevation</p> <p>This elevation has been badly damaged with the removal of almost all the door frames and window frames. A large section of the verandah roof has caved-in due to the removal of the supporting timber beams.</p>

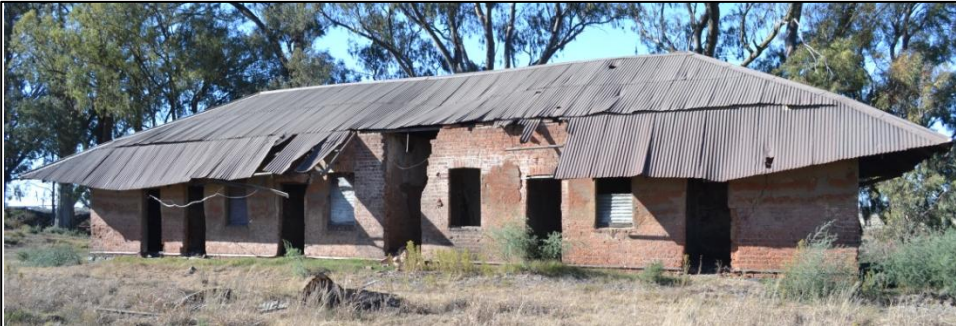
<p>Figure 4. West southwest elevation (Photograph: M. Naude 2013)</p>

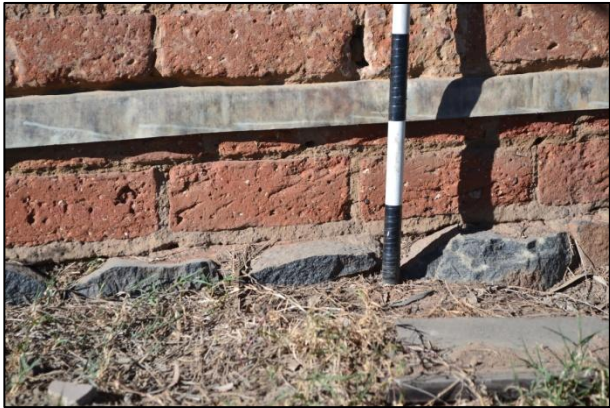
<p>Figure 5. Exposed damp coursing between layers of brick above the granite foundation (Photograph: M. Naude 2013)</p>

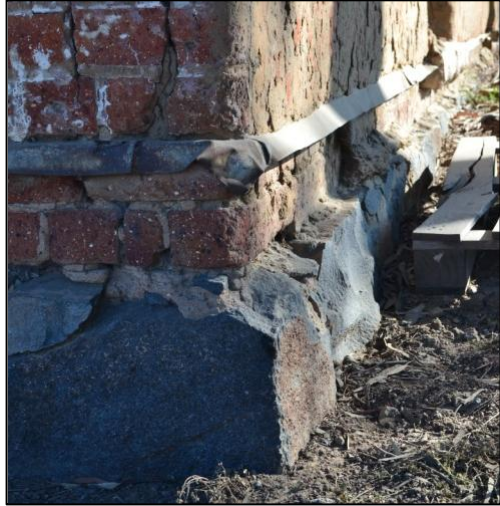
<i>Building elements</i>	<i>Photograph</i>
1.	<p><u>Foundations</u></p> <p>The foundation is one of the unique and very exceptional elements of the building. The entire foundation is intact without structural problems. It was constructed with neatly dressed granite and protrude above the ground to form a plinth. It was left unplastered and was never covered with any material such as paint. The granite stone masonry is topped with two layers of unplastered brick and then covered with a layer of galvanized sheet iron, serving as a damp course. A unique aspect of the damp course is that it extends outwards (not normally done like this) and were then bent downwards almost covering the entire brick directly underneath the damp course.</p> <p>The foundation supports only the building and does not extend outwards (beyond the exterior walls) to define the perimeter of the verandah – even though a row of dressed stones are still in situ indicating the shape and position of the verandah periphery.</p>

<p>Figure 6. Exposed dressed blue granite foundation (Photograph: M. Naude 2013)</p>

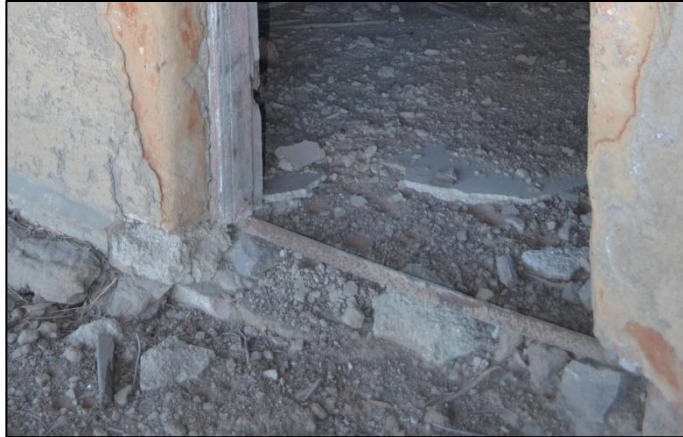
Figure 7. Destroyed floor inside one of the rooms (Photograph: M. Naude 2013)

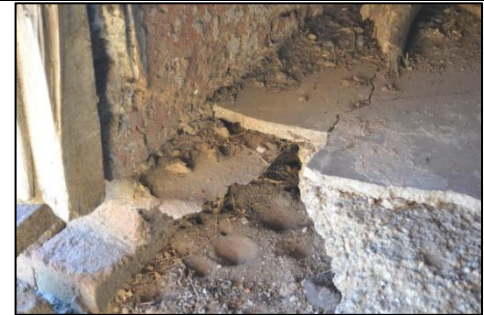
The interior floors were constructed with a thin layer of sand and cement (about 150mm thick), on top of a compacted filling of clay. It could have been ant heap clay but no analysis on the clay type was done. The top of the cement flooring was covered with a red oxide

Figure 8. Exposed cement flooring indicating the thickness of the cement and the underlying compacted clay and lime mixture (photograph: M. Naude 2013)

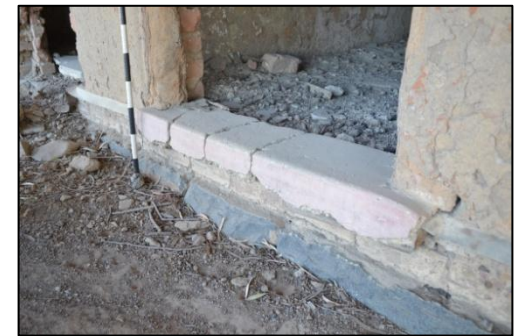
Figure 9. One of the few entrances with a defined threshold that also serves as a step (Photograph: M. Naude 2013)

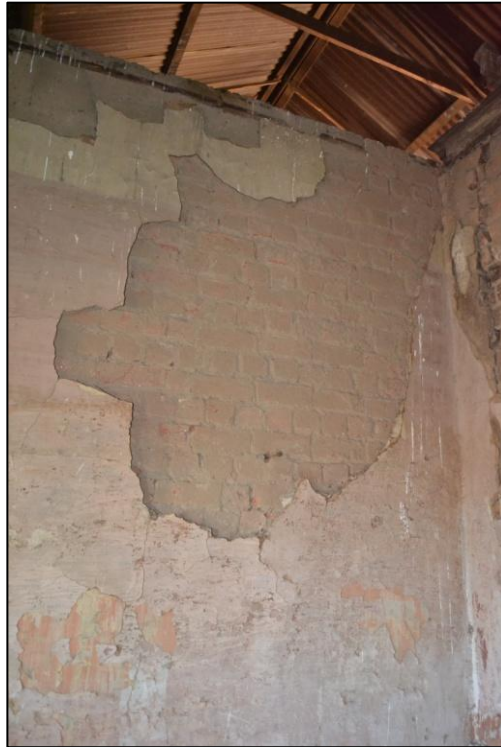
**Figure 10. The building used to be plastered with a clay plaster but large areas have fallen off
(Photograph: M. Naude 2013)**

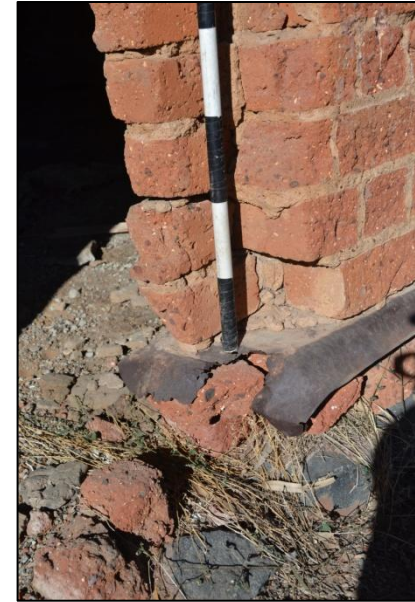
**Figure 11. Entrance where bricks are exposed
indicating the extent of the sheet iron damp course
(Photograph: M. Naude 2013)**

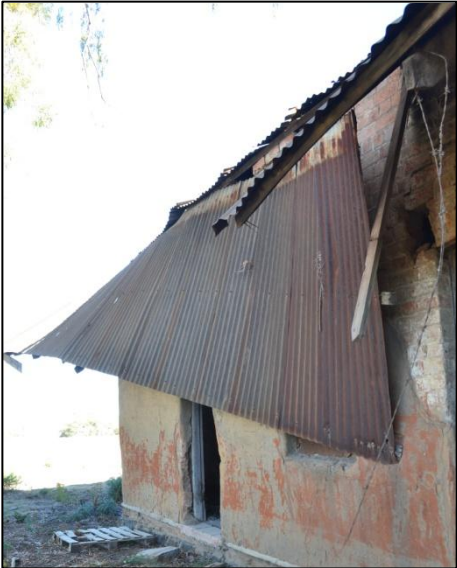
<p>Figure 12. Section of the verandah roof where the roof beams have been removed causing the roof to cave-in (Photograph: M. Naude 2013)</p>

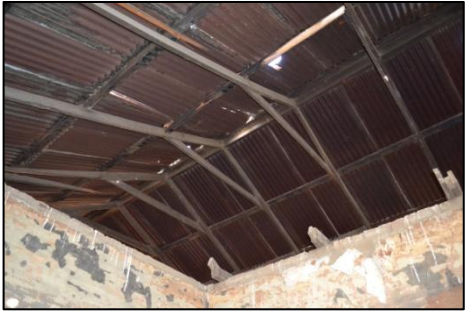
<p>Figure 13. Roof structure exposed due to los of the ceiling boards indicating that the horizontal tie beams have been removed exposing the 'hanebalk' construction at the top (Photograph: M. Naude 2013)</p>

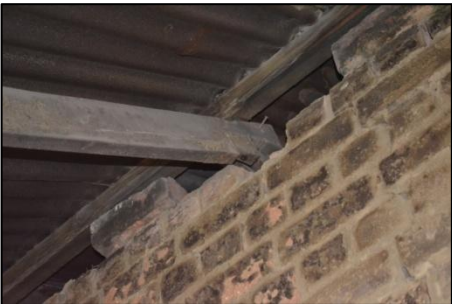
<p>Figure 144. Exposed diagonal truss beams where they exit the building onto the verandah (Photograph: M. Naude 2013)</p>

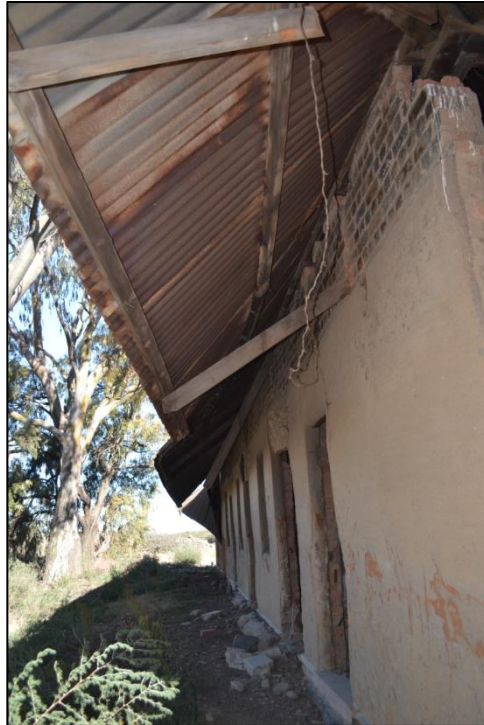
Figure 135. Sections of the remaining diagonal trusses exposed underneath the verandah (Photograph: M. Naude 2013)

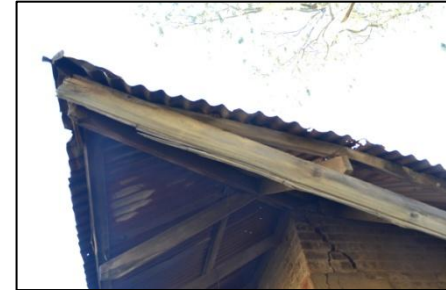
Figure 15. Remaining section of fascia board along the edge of the verandah roof overhang (Photograph: M. Naude 2013)

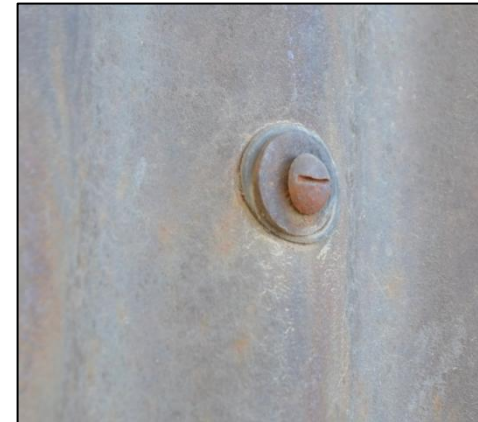
Figure 16. The roof sheeting was screwed to the brundering and not nailed (Photograph: M. Naude 2013)

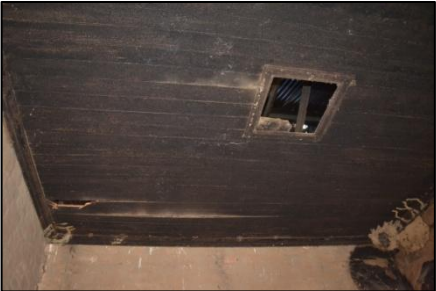
<p>Figure 17. Ceiling boarding with attic entrance (Photograph: M. Naude 2013)</p>

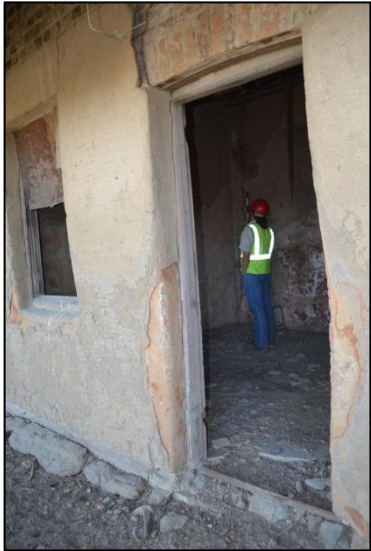
<p>Figure 199. One of the doors that has retained its original door frame (Photograph: M. Naude 2013)</p>

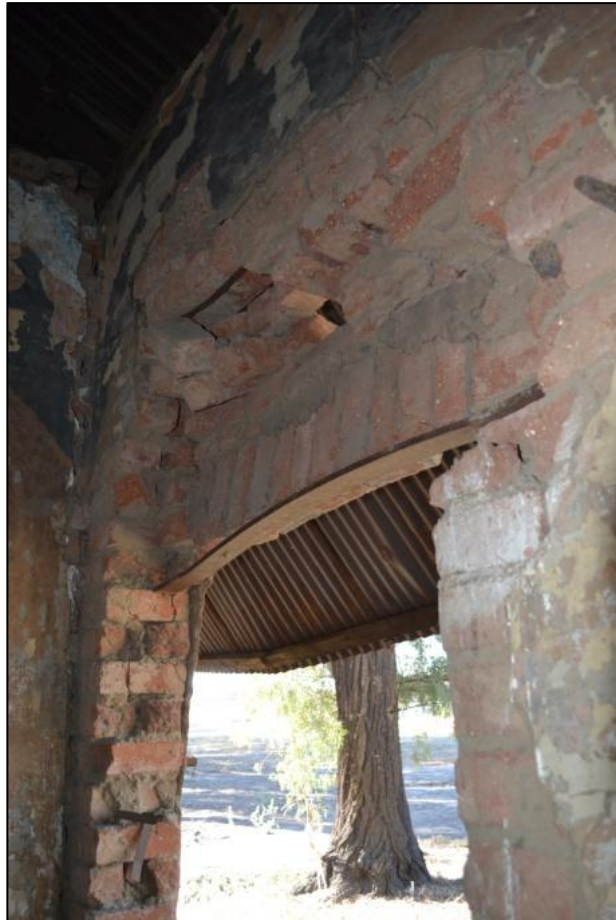
Figure 20. Lost bricks above the entrance of a door exposing the arched lintels (Photograph: M. Naude 2013)

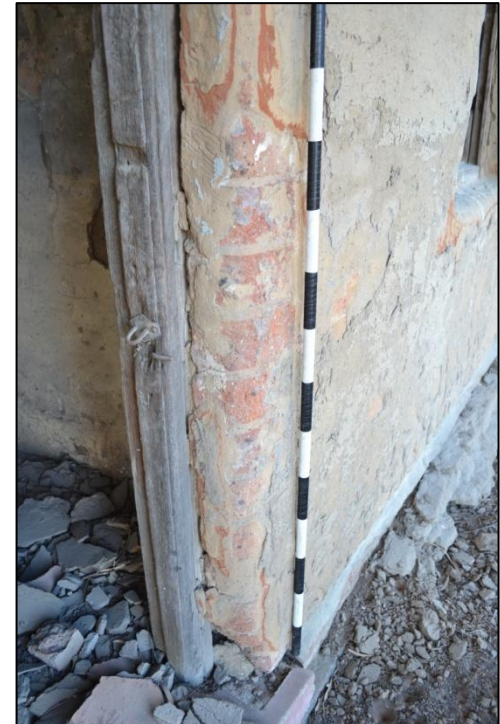
Figure 201. The corners at the doors have been eroded by the movement of cattle and other animals resulting the loss of the original square corners and brick work (Photograph: M. Naude 2013)

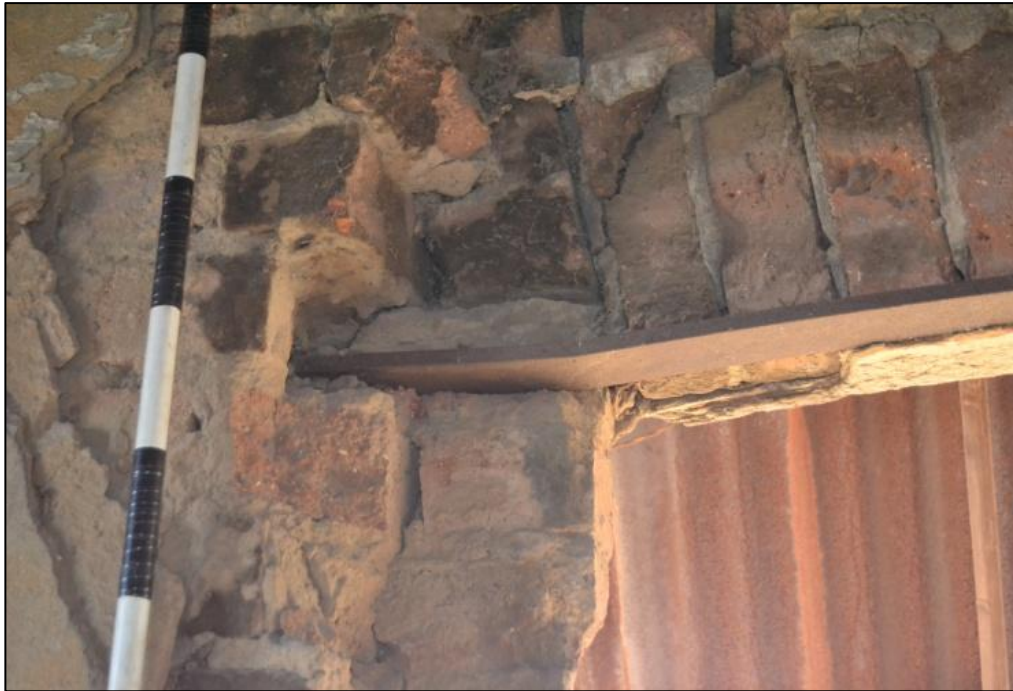
Figure 182. Exposed iron strip used to reinforce the lintel of the door (Photograph: M. Naude 2013)

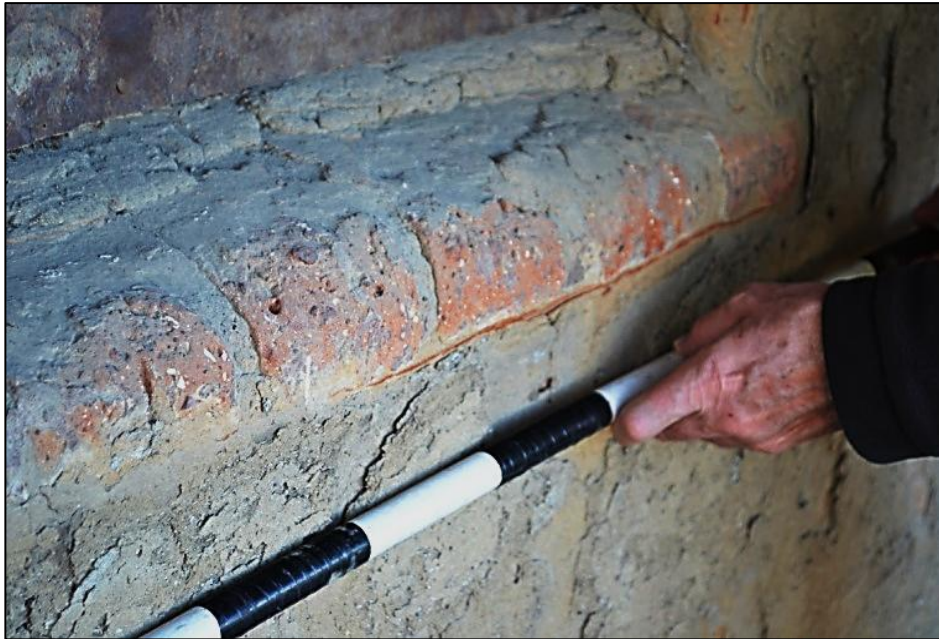
Figure 21. Window sill where the brickwork was exposed and rubbed against causing the loss of the square corner of the sill (photograph: M. Naude 2013)

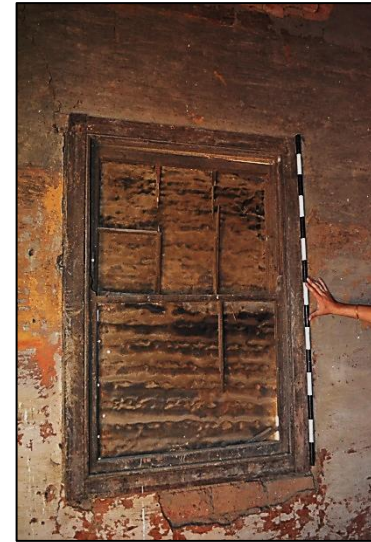
Figure 22. The last remaining window frame and window in the building gives and indication of the style of the sash windows installed (photograph: M. Naude 2013)

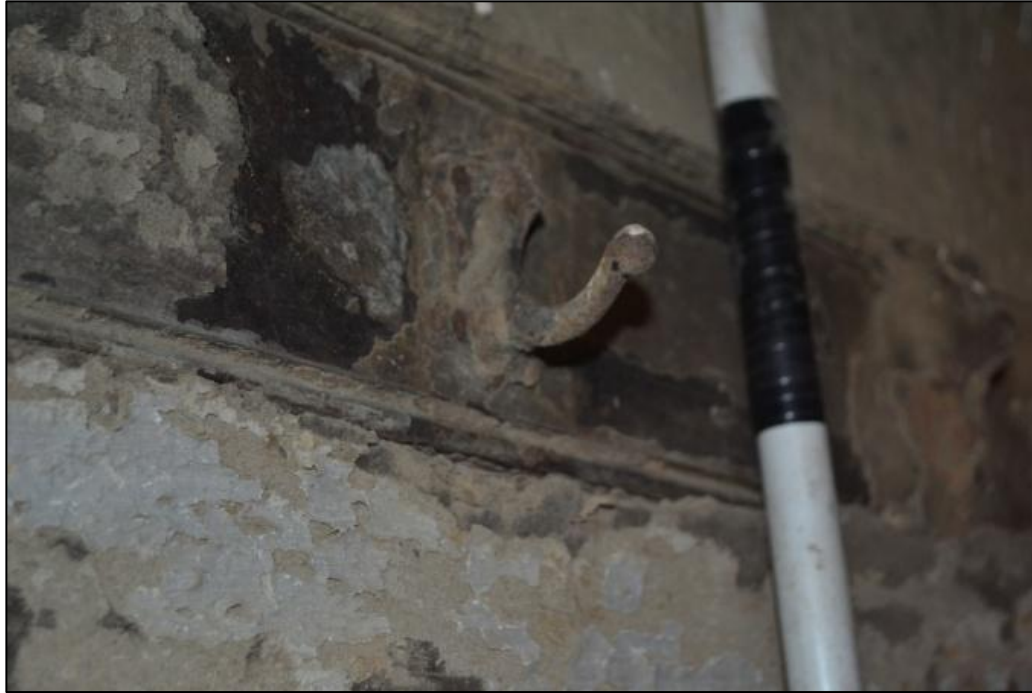
Figure 23. Remains of the last hat and jacket suspension hooks (Photograph M. Naude 2013)

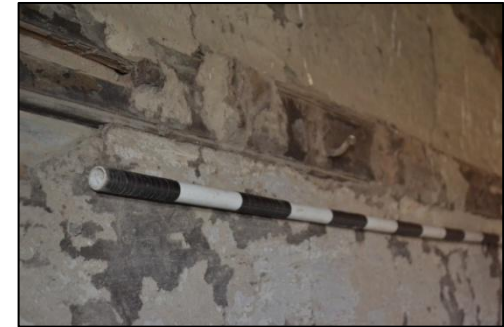
Figure 24. Jacket and hat suspension hooks (Photograph: M. Naude 2013)
