Professional Consultancy Services for Coastal Engineering Infrastructure Activities – Proclaimed Fishing Harbours Western Cape

Project Descriptions: Repairs and upgrades to structures older than 60 years

Hout Bay Harbour

S2042-1-TN-EN-201

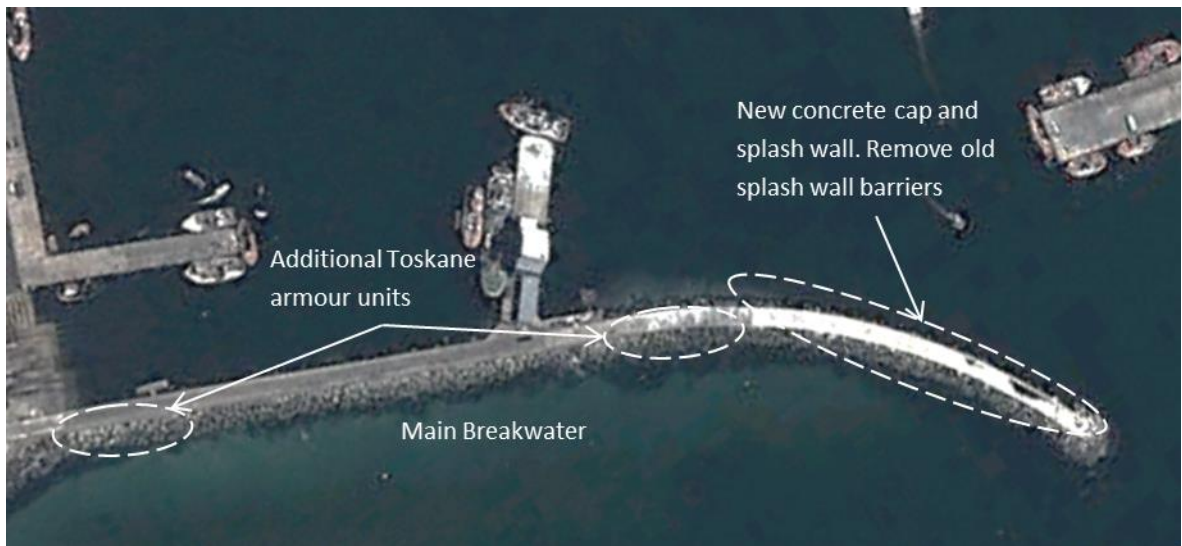
Figure 2-3: Main Breakwater Structure

The main breakwater is a 453 m long rubble mound structure protected with Grobbelaar and Toskane armour units. The following repair work is required:

- Supply and place additional 3.6 tonne Toskane armour units in gaps along the breakwater;
- Cast a new concrete cap along the last 150m of the breakwater. This includes a wave wall, and steel reinforcing; and
- Removal of corroded and damaged existing precast wave wall units at the end of the breakwater.

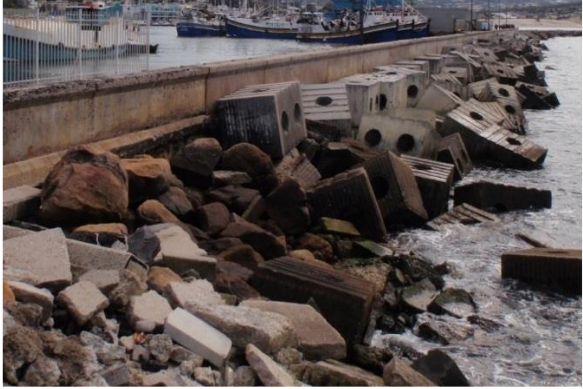
<p><u>Main Breakwater – Armour units</u></p> <p>A few additional concrete armour units are required to fill a few gaps that have formed along the breakwater. (Approx. 20 additional units)</p>

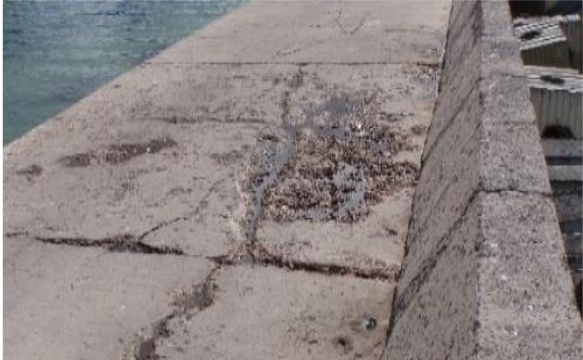
<p><u>Main Breakwater – Concrete capping</u></p> <p>The concrete cap at the end of the main breakwater is in poor condition and needs to be repaired by casting a new concrete cap along the existing surface.</p>

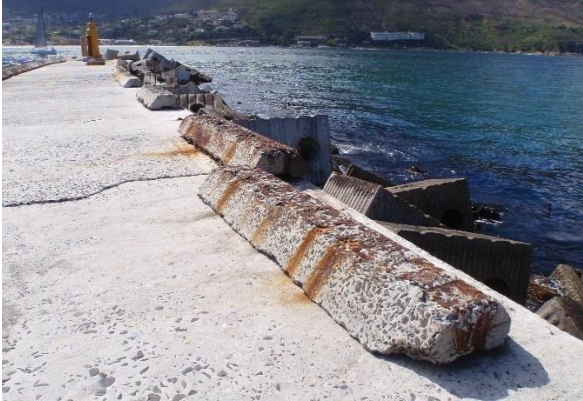
<p><u>Main Breakwater – Splash barrier removal</u></p> <p>The splash wall barrier along the end of Hout Bay has become a safety hazard and must be removed.</p>

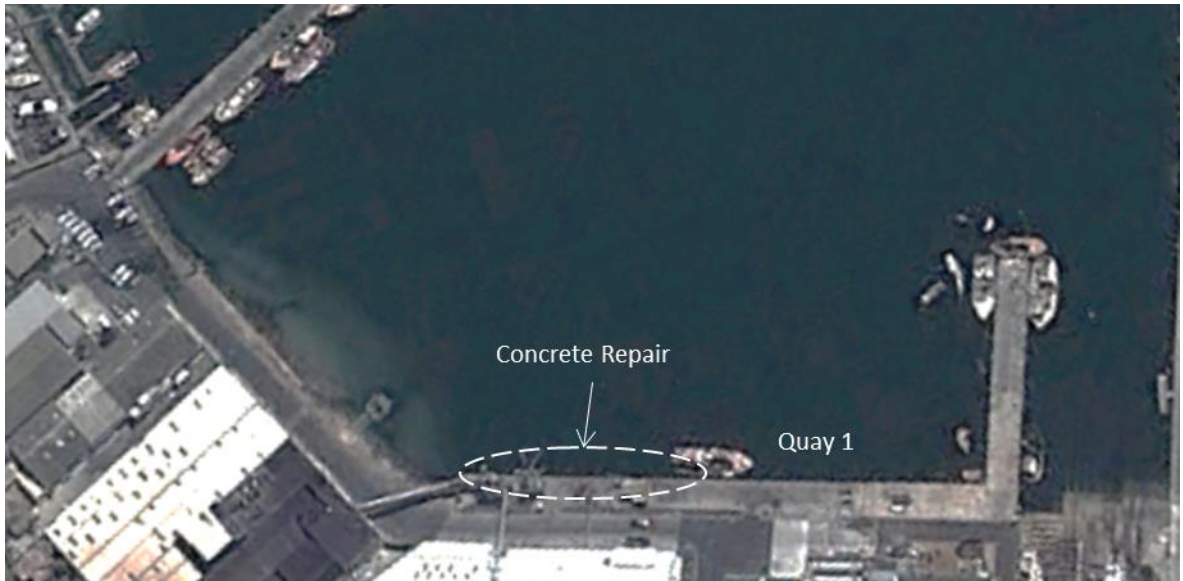
Figure 2-4: Quay 1 Structure

A 145 m long concrete deck-on-pile structure used for offloading fish and servicing of trawlers. The following repair work is required:

- Concrete repair of 2 No. contraction joints;
- Minor concrete repair along the cope edge of quay 1;
- Repair, clean and paint bollards;
- Replace corroded and missing fender fixings;

- Replace damaged and missing fenders; and

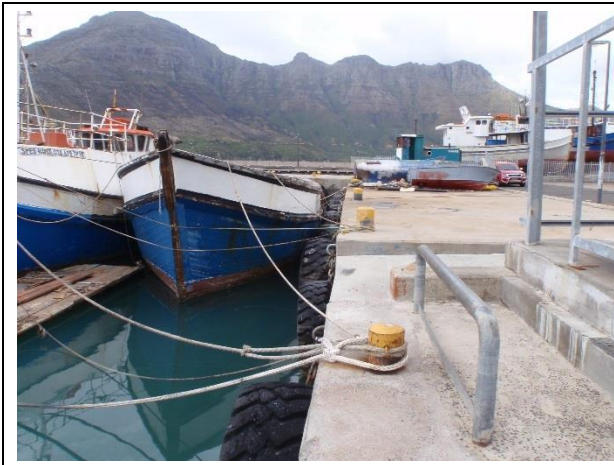
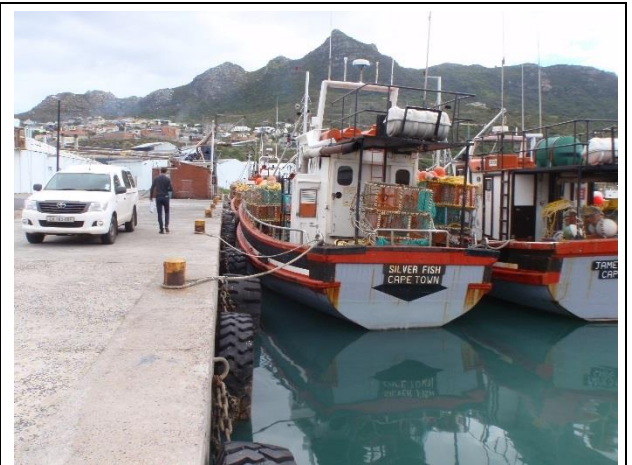
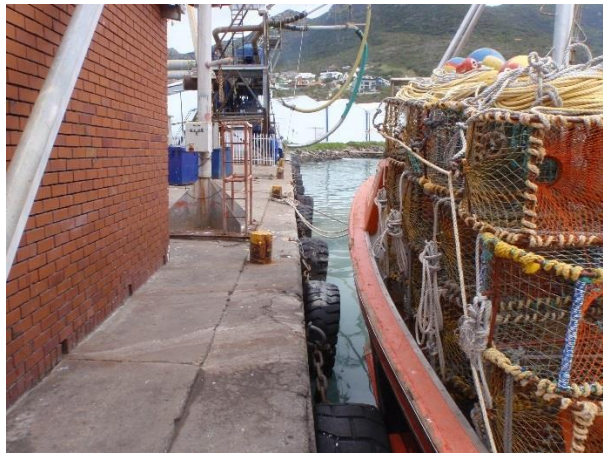
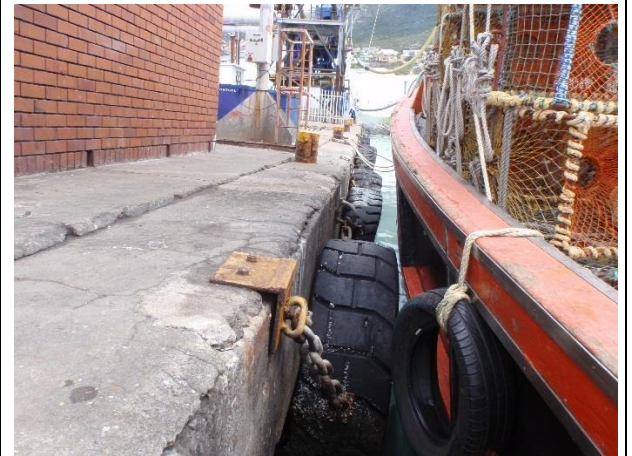
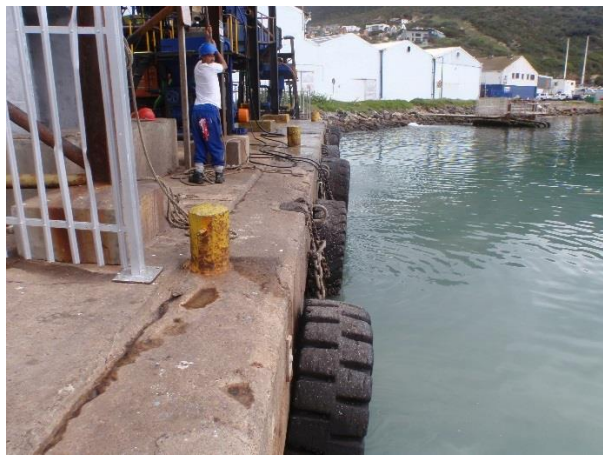
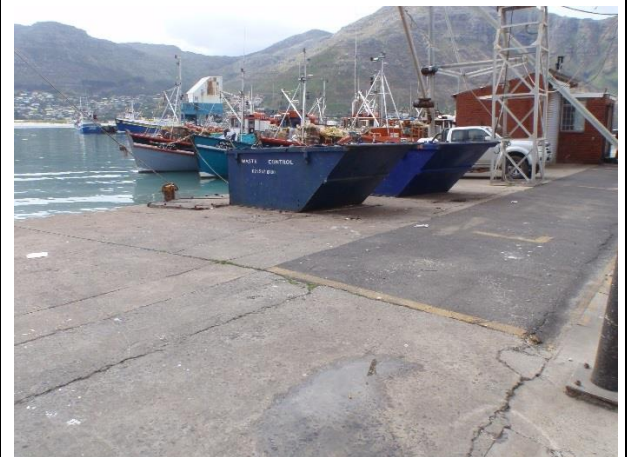
ANNEXURE B | QUAY 1 – ADDITIONAL FIGURES

<p><u>Quay 1</u> Concrete repair along the cope edge and construction joints of quay 1.</p>	
---	--
