**2019-11-25**

Reference: **APAC019/121**

**RE: FINAL REPORT ON THE MONITORING OF PROTECTED ARCHAEOLOGICAL SITES RELATED TO THE CHMP IMPLEMENTATION FOR THE PROPOSED 75MW ZEERUST PHOTOVOLTAIC SOLAR FACILITY ON PORTIONS OF THE FARMS KAMEELDOORN 271JP & KRUISRIVIER 270JP, INCLUDING THE NEW ALTERNATIVE EXPANSION AREAS, ZEERUST, NORTHWEST PROVINCE**

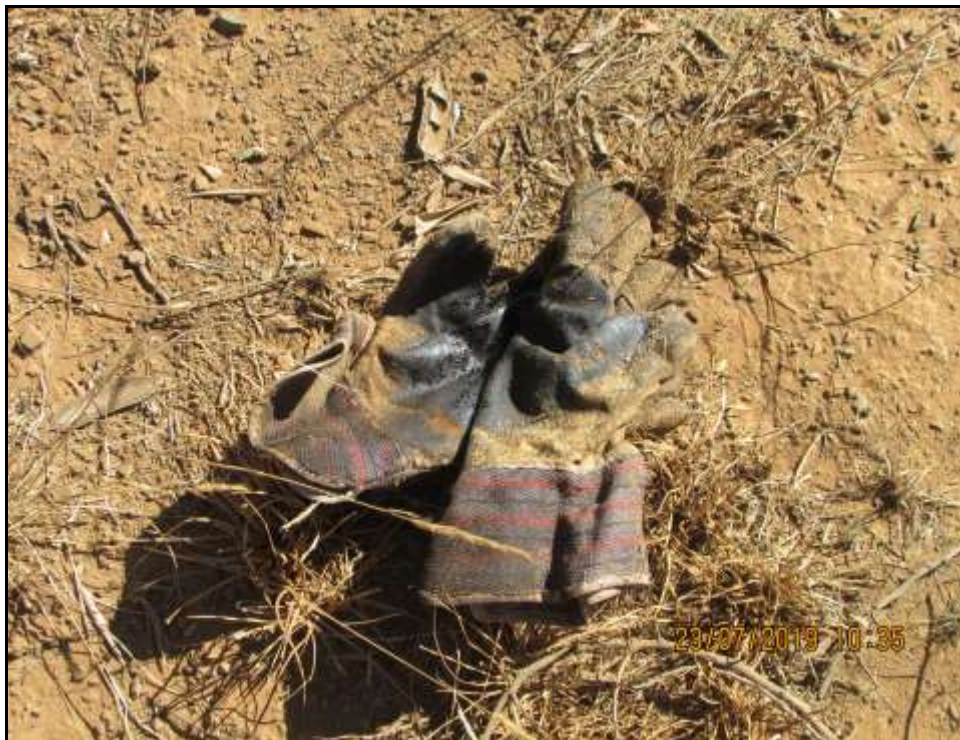
1. The sites were in fairly good condition, although some recent bush-clearing and resultant vehicle tracks had impacted on some portions
2. Some dumping of refuse and other material occurred in some sections
3. The Site Signage/Notices erected at these sites were not in a good condition, with some notices torn, completely removed and/or invisible from the outside of the sites

Figure 16: Old work gloves in one of the fenced-in sites.

- A. The site signage needed to be replaced by more permanent markers (chromadek) and should be placed on the perimeter of the fenced-in sites, facing outwards so that contractors/workers/visitors can see them clearly.
- B. Refuse removal should be undertaken as a matter of course and contractors/workers need to be encouraged to not litter in or on these heritage sites.
- C. No vehicles should be allowed inside the fenced-in areas in order to avoid damage to the sites and the stone-walled features on them.

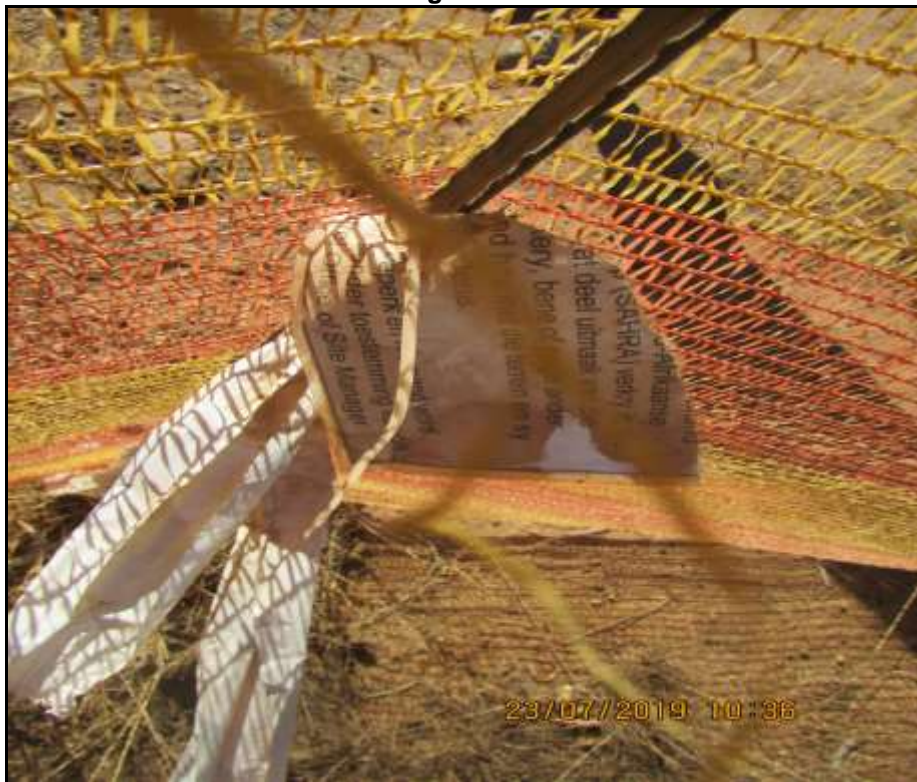
Figure 20: Some of the Site Notices have been torn.

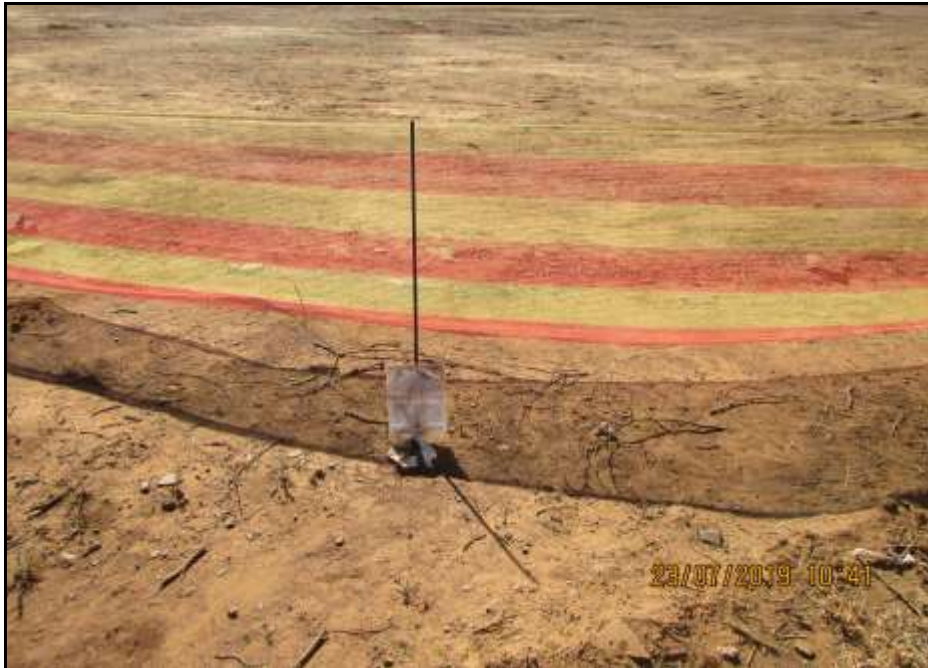
**Figure 21: Most of the remaining Site Notices were placed on the inside of the sites & was not visible to contractors/workers.**

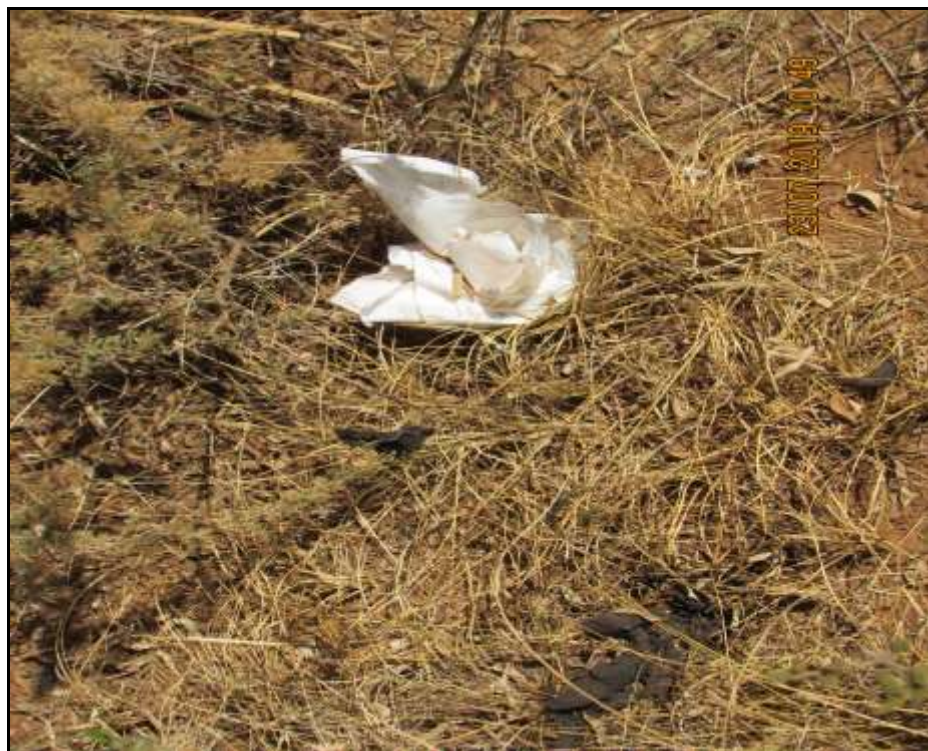
**Figure 22: Someone used a part of the archaeological site as a toilet.**

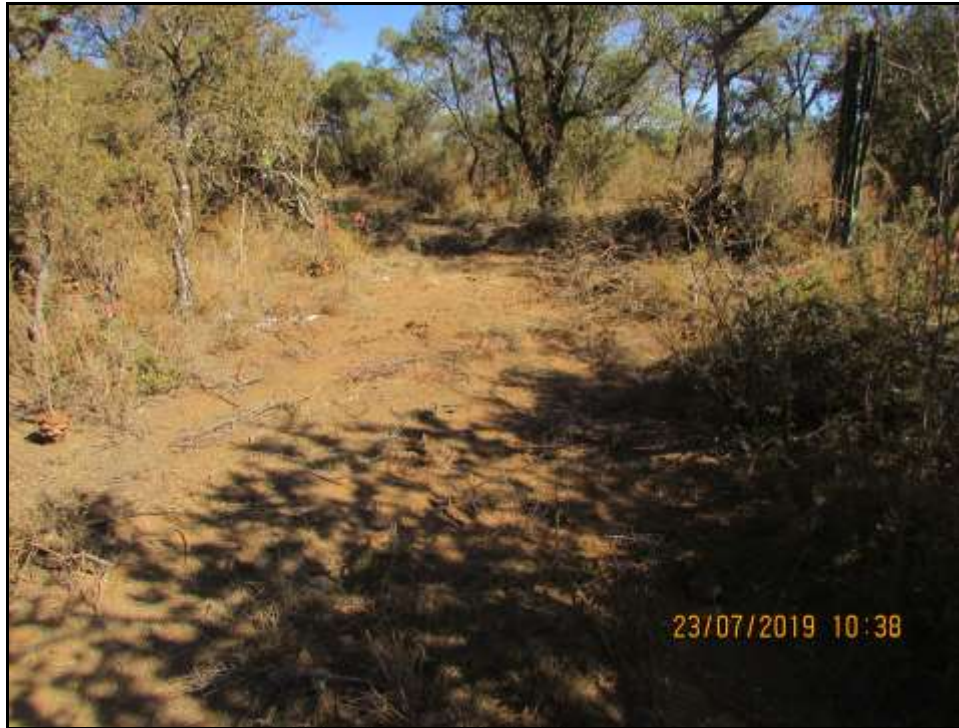
**Figure 23: A recent vehicle track in a part of the fenced-in site.**

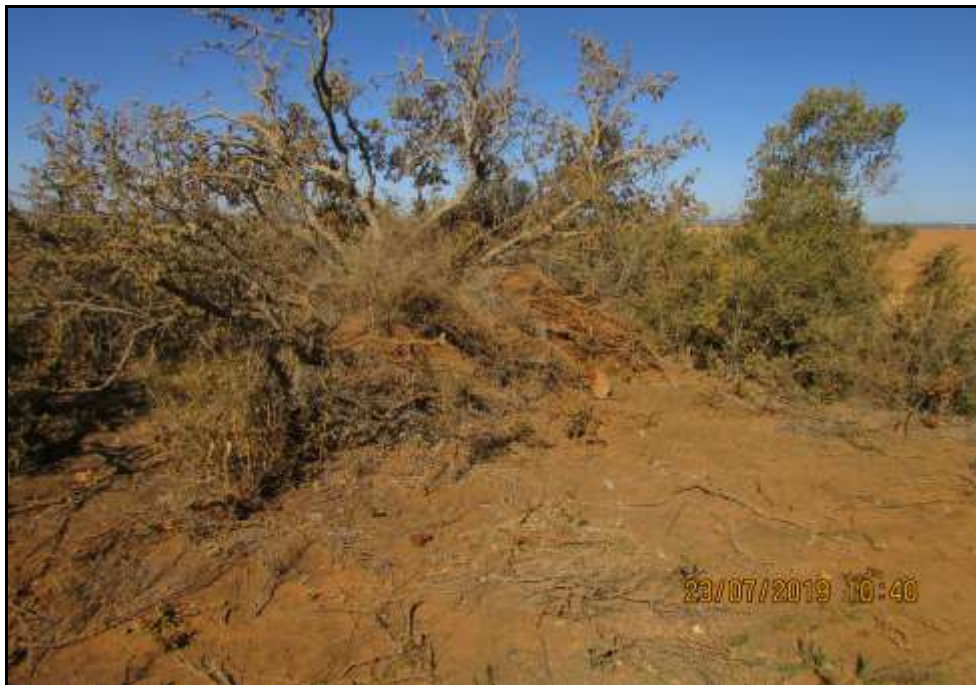
**Figure 24: Recent bush clearance in a section of the site.**

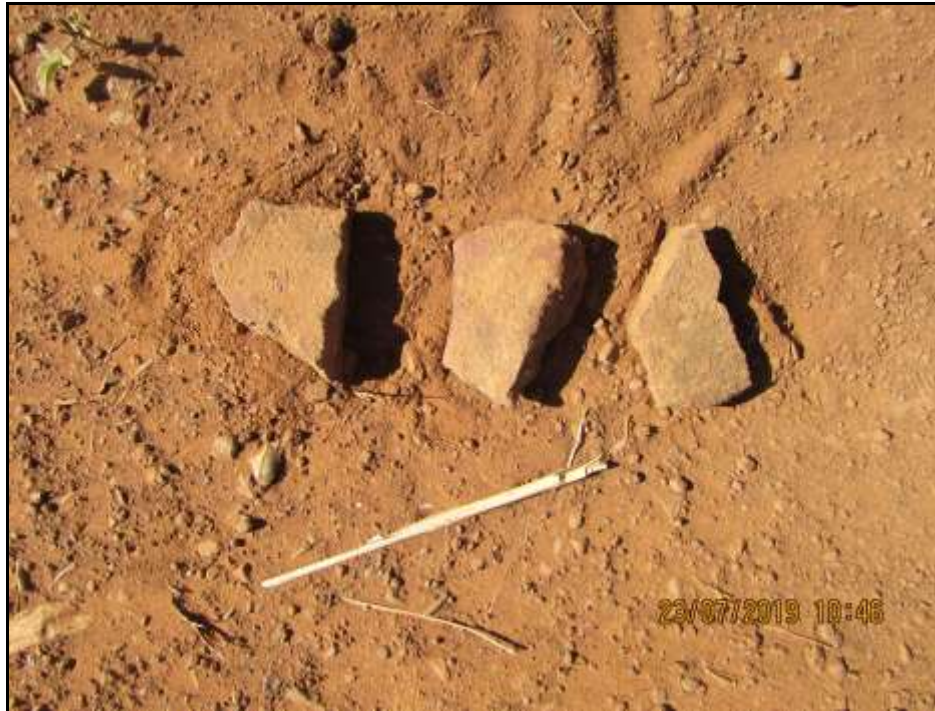
It was also evident from the 2<sup>nd</sup> site visit that the archaeological sites were not that rich in terms of cultural material deposits. Very few scatters of material (which are typical of these sites) were visible on the surface of the sites, and only small numbers of objects were seen in the scraped/cleared areas outside of the fenced-in sites. A few fragments of undecorated pottery pieces were found just outside in one or two spots.

**Figure 25: Fragments of Iron Age pottery found outside of the fenced-in sites in a cleared area.**

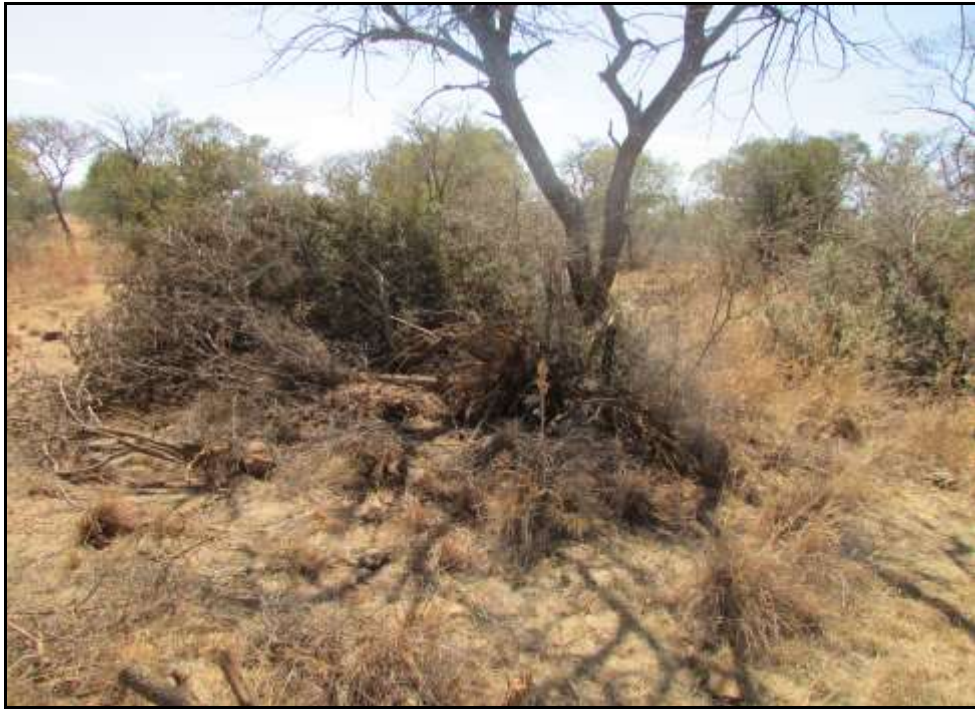
**Figure 29: Trees and vegetation removed and dumped on site. These and others should be removed.**

- ii. All cut and trimmed branches and trunks had to be removed from the site once the work had been completed.

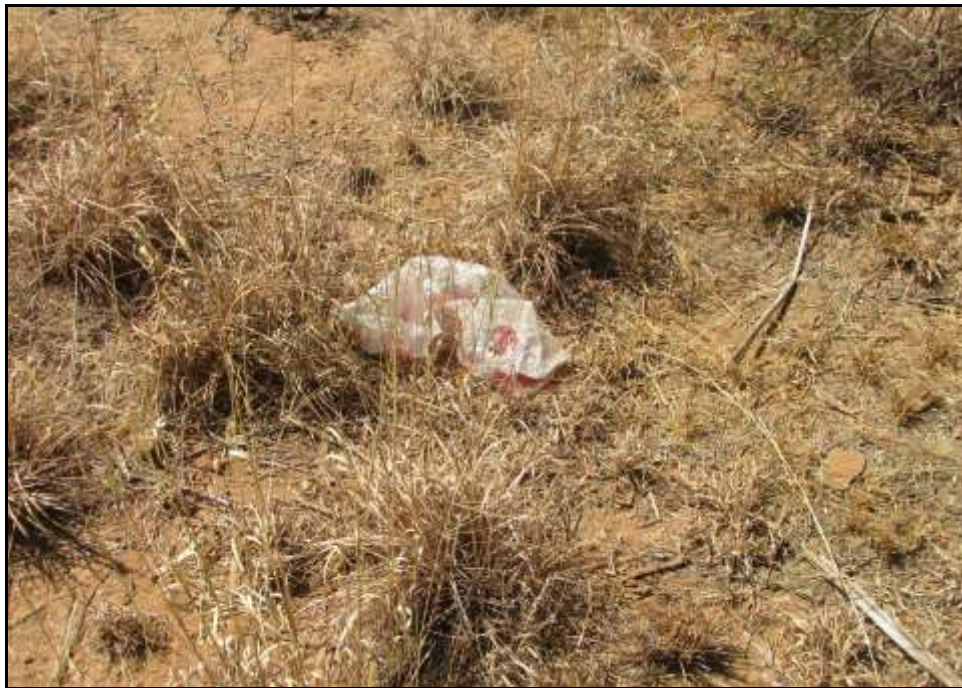
Refuse removal since the 2<sup>nd</sup> Site Visit had clearly taken place. There were however still some remaining rubbish while some areas with “new” litter were also identified. Refuse removal should be undertaken as a matter of course and contractors/workers needs to be encouraged to not litter in or on these heritage sites.

**Figure 30: Refuse found on the site.**

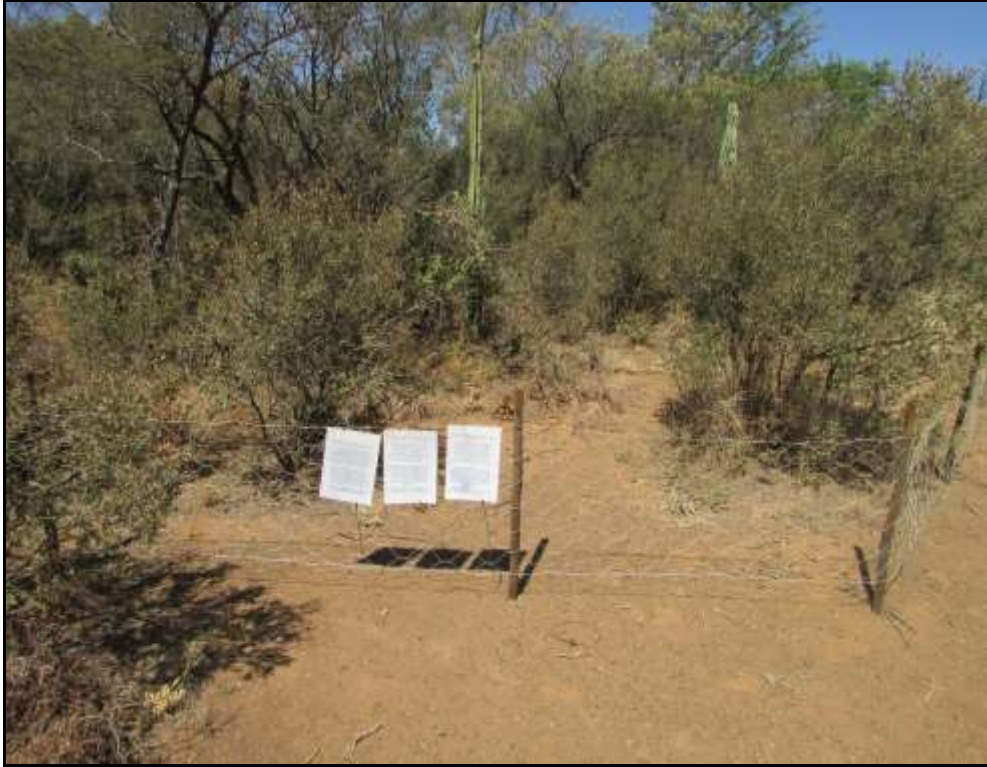
Although the Site Signage had been updated since the last visit, only Site Signage in English, Spanish and Afrikaans were visible on site. The Tswana ones (according to a Zeerust Solar PV Plant representative that escorted the team during the visit) were erected but had been removed for some reason. Also, the signs are still non-permanent (paper-based, laminated only). Although this is a relatively cheap option they have to be constantly replaced as the wind and other weather factors (sun) tear and bleach them. It was recommended that the Chromadek-type signs recommended earlier needs to be considered as a permanent solution. It was also deemed of high importance that Site Signage in Tswana had to be erected in the same locations as the English, Spanish and Afrikaans ones.

**Figure 31: More new Site Signage. Only English, Spanish and Afrikaans remained on site.**

2. the recommended Site Signage at the sites needs to be changed to the more permanent Chromadek-type material and the Tswana-worded notices needs to be erected as well as a matter of urgency.

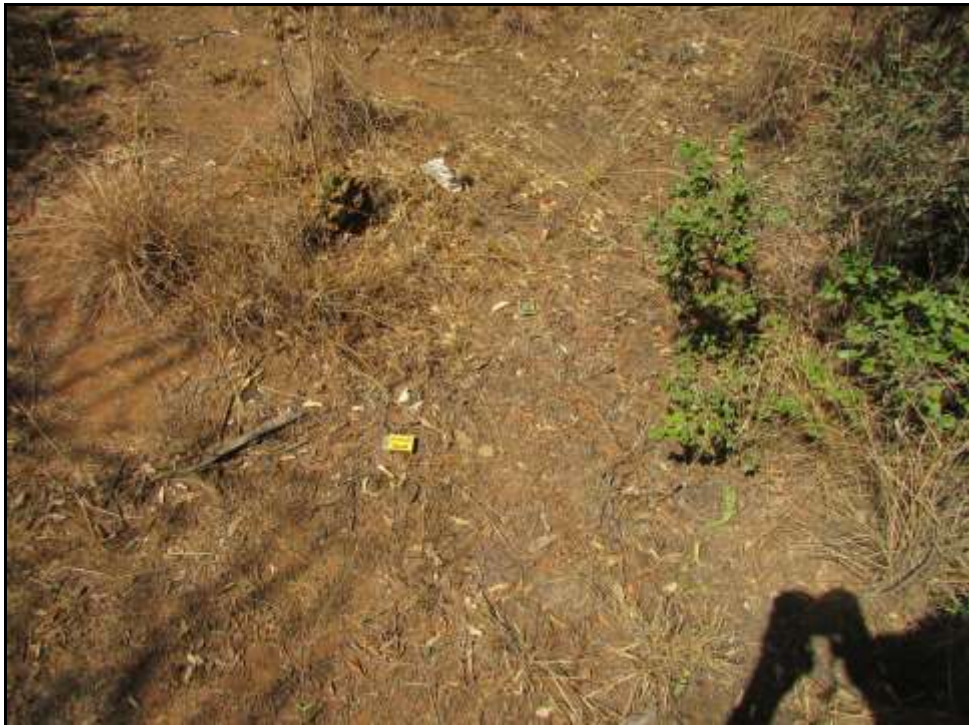
**Figure 32: More rubbish on site.**

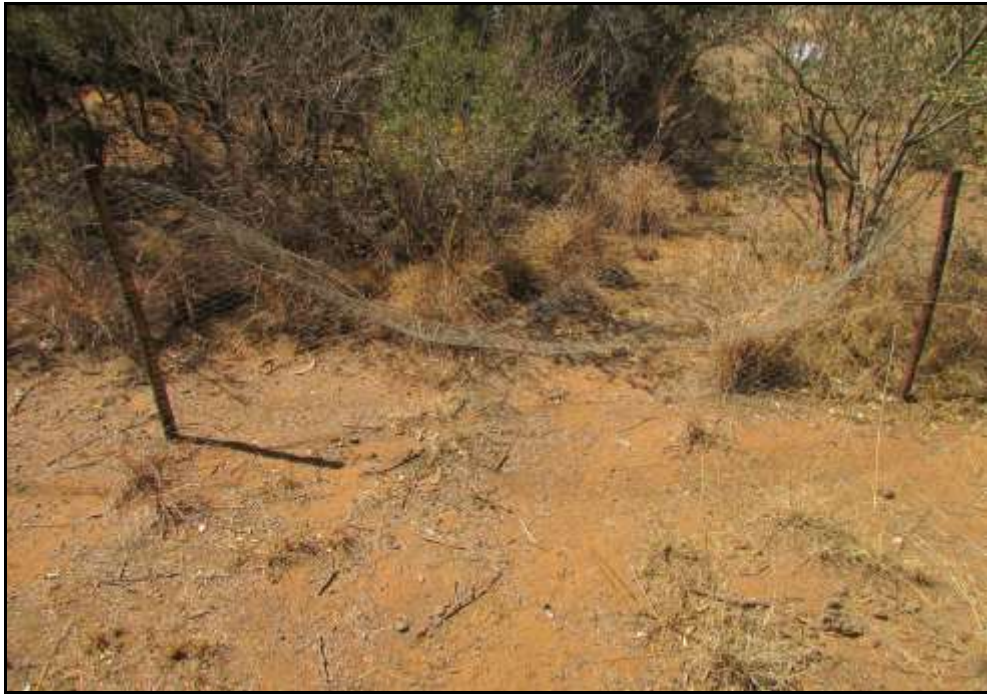
**Figure 33: A section of fencing around Site 12 that had been broken and needed to be fixed.**

1. the fenced-in Archaeological Sites needs to be protected in situ in perpetuity as indicated in the Cultural Heritage Management Plan for the Development. This CHMP needs to be updated once every five years. No development work on these sites are allowed and the fences around them needs to be maintained and fixed should they be damaged

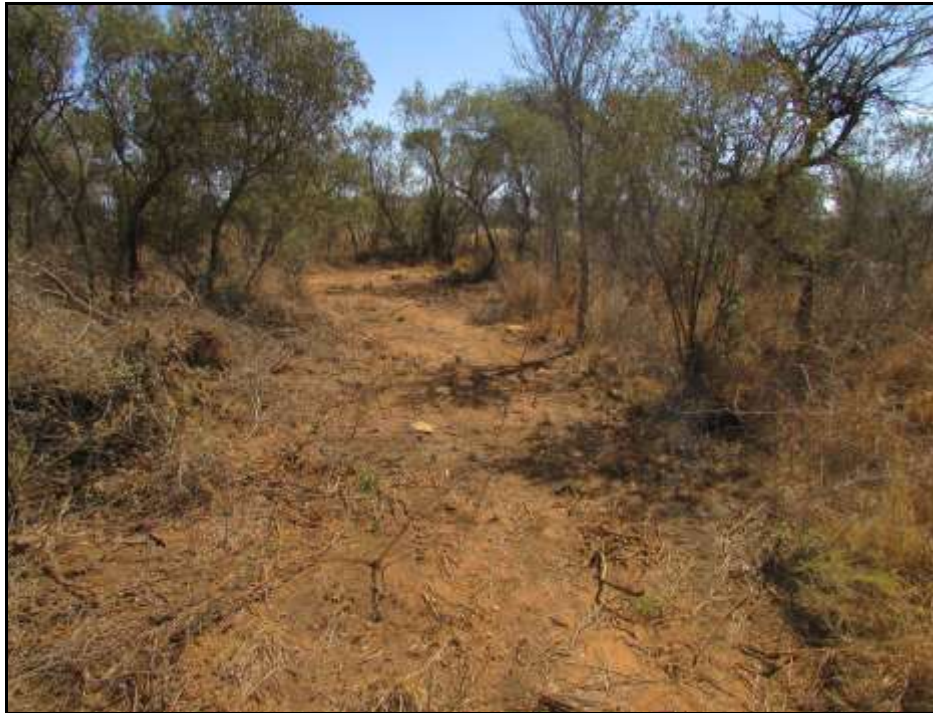
**Figure 35: Vegetation removed but left on site. A vehicular track is also visible.  
No vehicles should be allowed on site.**

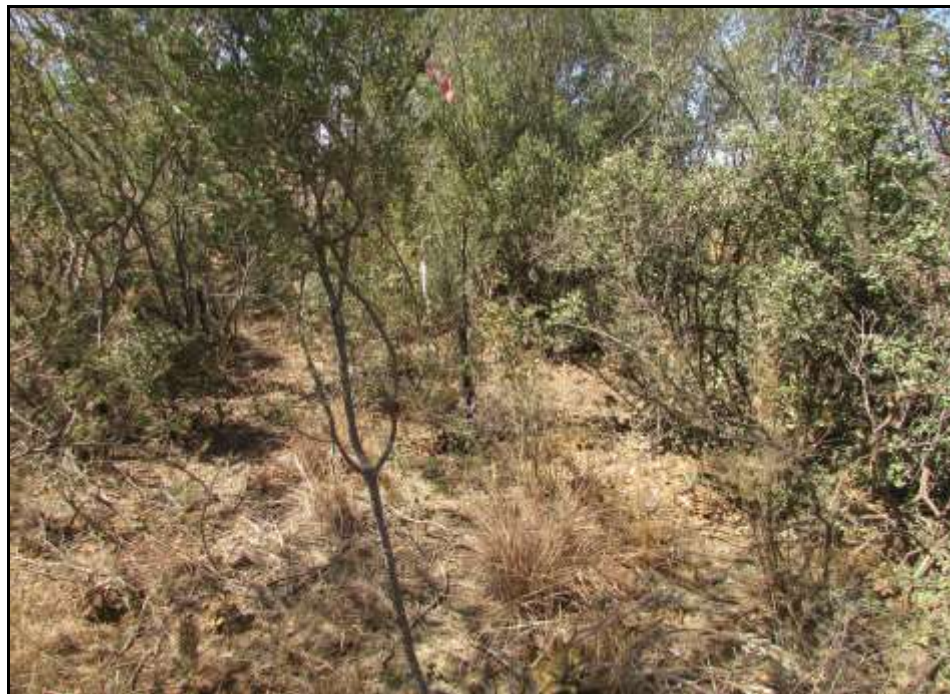
During the 3<sup>rd</sup> visit the team was also asked to give advice on the development of the Solar Panels that will be close to the fenced-in archaeological sites. The positioning of these panels were fixed a long time ago before the fencing of the sites and the final buffer zone (of 30m) determination. As a result this section of panelling cannot be moved or changed and a small section will encroach into the larger fenced-in area (not the fenced-in archaeological sites). As part of this some further vegetation will have to be removed.

**Figure 36: The section of vegetation that has to be removed to make way for the Solar Panels**

1. The trees should be cut down at the stump level and not be uprooted physically to avoid accidental exposure of archaeological deposits
2. All cut down vegetation should be removed from inside of the fenced-in area
3. If possible the work should be done under supervision of the Heritage Specialist to ensure that no archaeological heritage features or material are damaged or exposed
