Recording of stone walling on the farm Zwartkoppies (Pretoria): mitigation of proposed Rand Water pipeline development.

(Date: 2013/03/20)

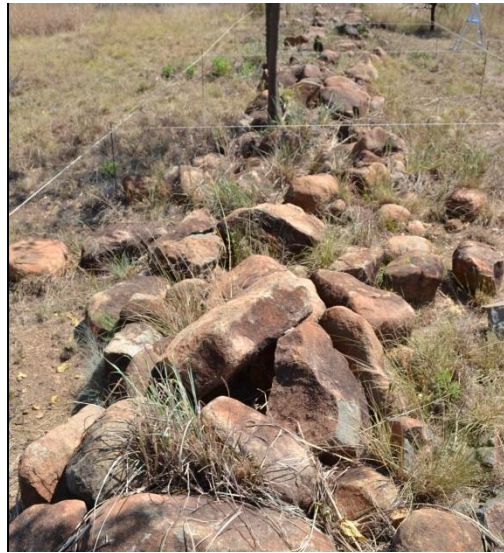
Figure 1. Recorded section of stone wall - view from southeast to the northwest (Photograph: M. Naude 2013)

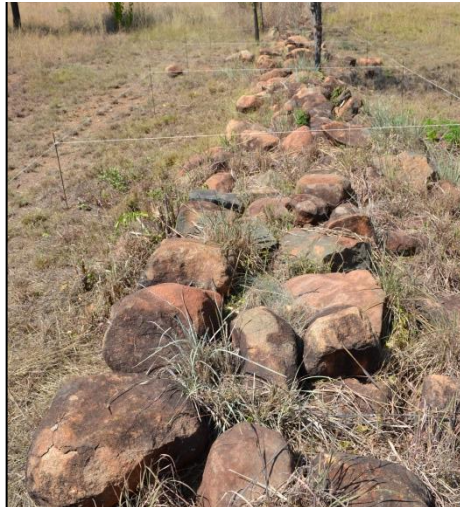
Figure 2. Section of the recorded wall - view from northwest to southeast (photograph: M. Naude 2013)

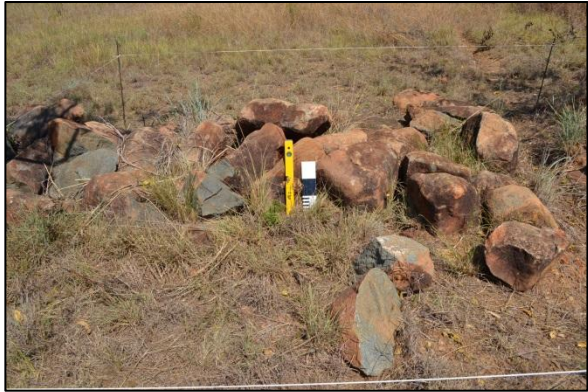
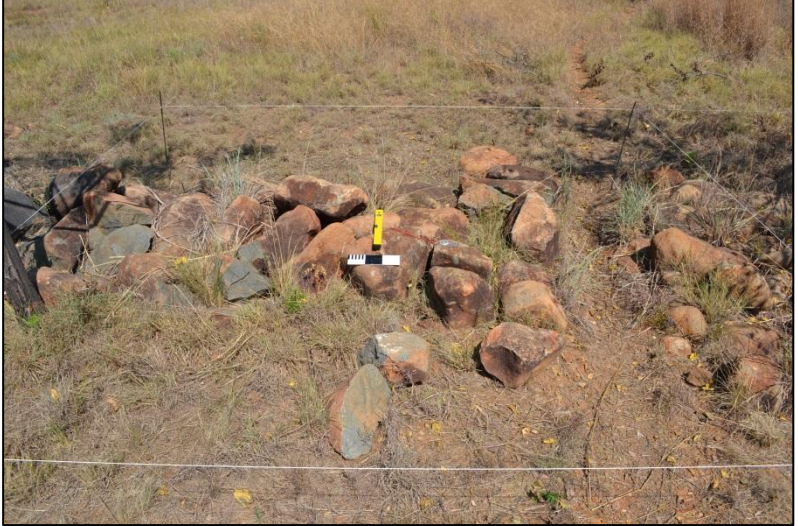
Site name	Site description	Site photographs
<p data-bbox="178 297 296 321">Site ZW 1</p>	<p data-bbox="380 326 1010 472">The feature forms part of the remains of an old stone wall which has been vandalized and stripped of most of its original stone to be used elsewhere. No coursework is visible and the wall consists of random stacking without mortar.</p> <p data-bbox="380 509 1010 591">A narrow foot path has been created through this section of the wall and large stones have been removed to make passing through the barrier easier.</p> <p data-bbox="380 628 1010 688">[Scale bar – 300mm] [red line – indicates magnetic north to the right]</p>

<p data-bbox="1010 886 1923 946">Figure 3. Northern elevation of the remains of stone wall feature with footpath cutting through the wall on the right (Photograph: M. Naude 2013)</p>

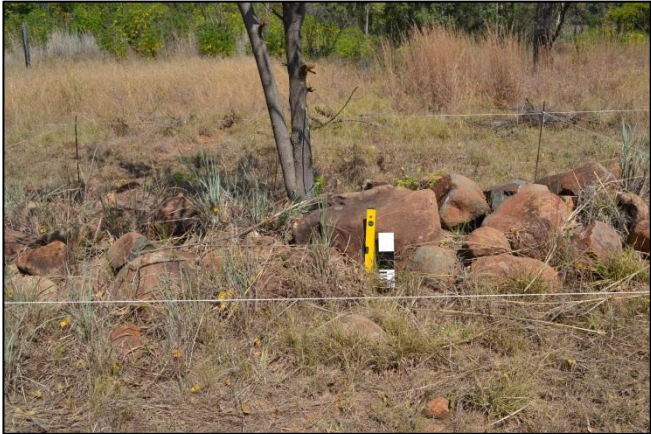
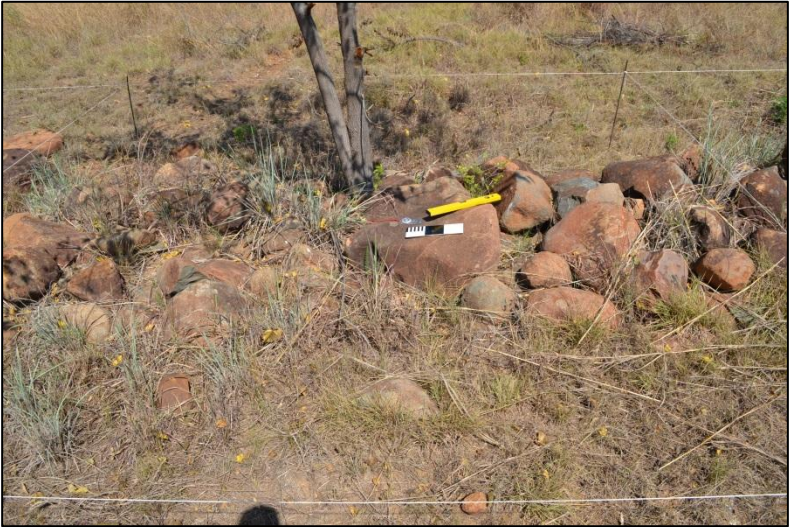
Site name	Site description	Site photographs
Site ZW 2	<p>The feature forms part of the remains of an old stone wall which has been vandalized and stripped of most of its original stone to be used elsewhere. No coursework is visible and the wall consists of random stacking without mortar.</p> <p>[Scale bar – 300mm] [red line – indicates magnetic north to the right]</p>

<p>Figure 4. Northern elevation of the remains of stone wall without course work (Photograph: M. Naude 2013)</p>

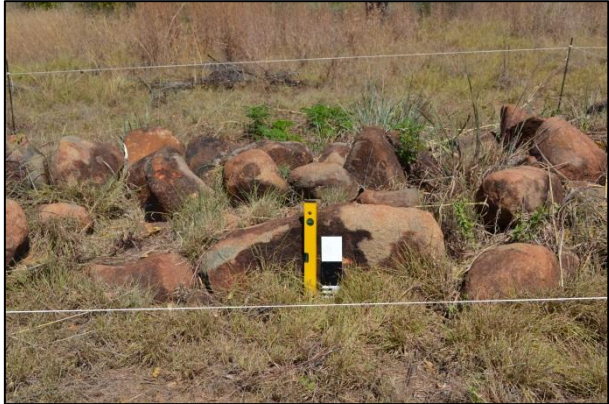
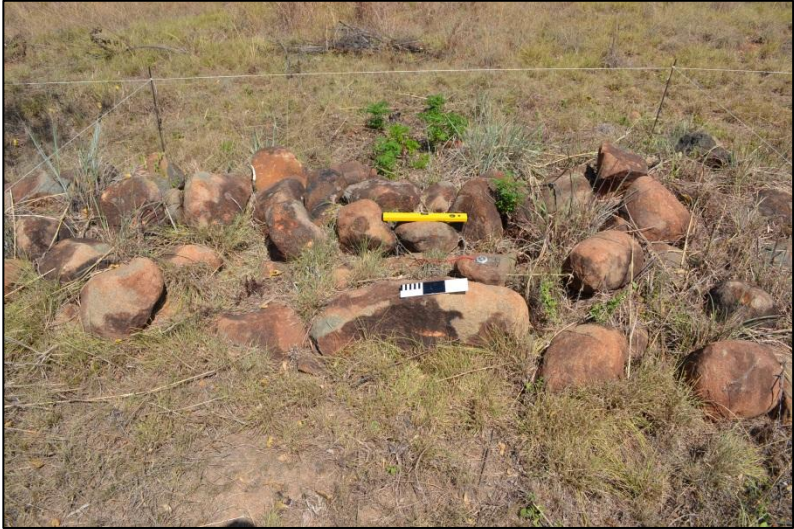
Site name	Site description	Site photographs
Site ZW 3	<p>The feature forms part of the remains of an old stone wall which has been vandalized and stripped of most of its original stone to be used elsewhere. No coursework is visible and the wall consists of random stacking without mortar. Large stone in front has been placed in such a way that it defines the side and width of the wall and could be used as base for second layering.</p> <p>[Scale bar – 300mm] [red line – indicates magnetic north to the right]</p>

<p>Figure 5. Northern elevation of the remains of stone wall without coursework (M. Naude 2013)</p>

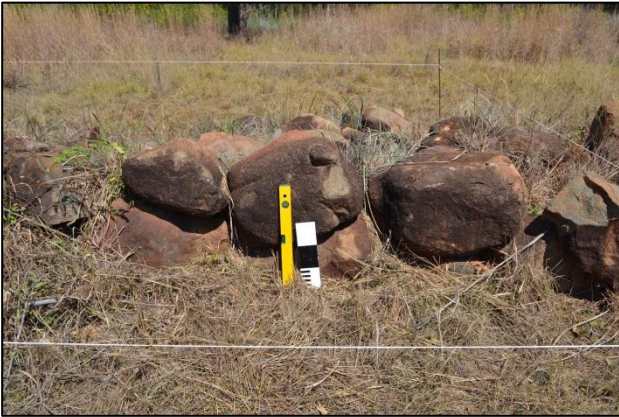
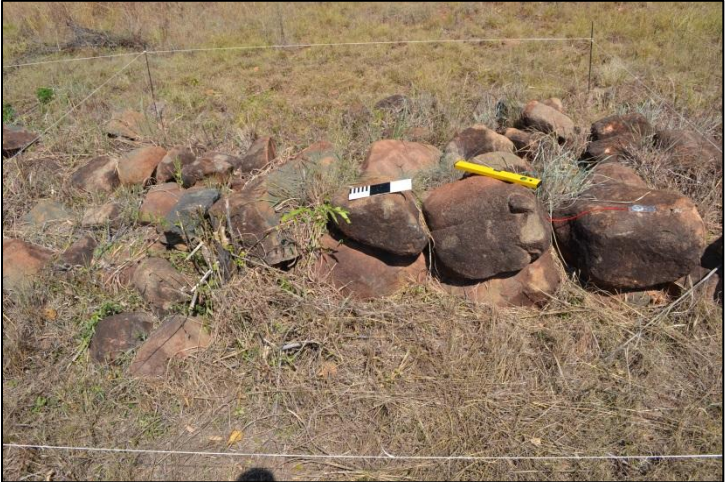
Site name	Site description	Site photographs
Site ZW 4	<p>The feature forms part of the remains of an old stone wall which has been vandalized and stripped of most of its original stone to be used elsewhere. Some coursework is visible where the largest stones have been placed on top of each other defining a second row in the coursework. Otherwise the wall consists of random stacking without mortar similar to the other sections that were recorded.</p> <p>[Scale bar – 300mm] [red line – indicates magnetic north to the right]</p>

<p>Figure 6. Northern elevation of the remains of stone wall with an indication of primitive coursework where the largest stones are stacked on top of each other (Photograph: M. Naude 2013)</p>

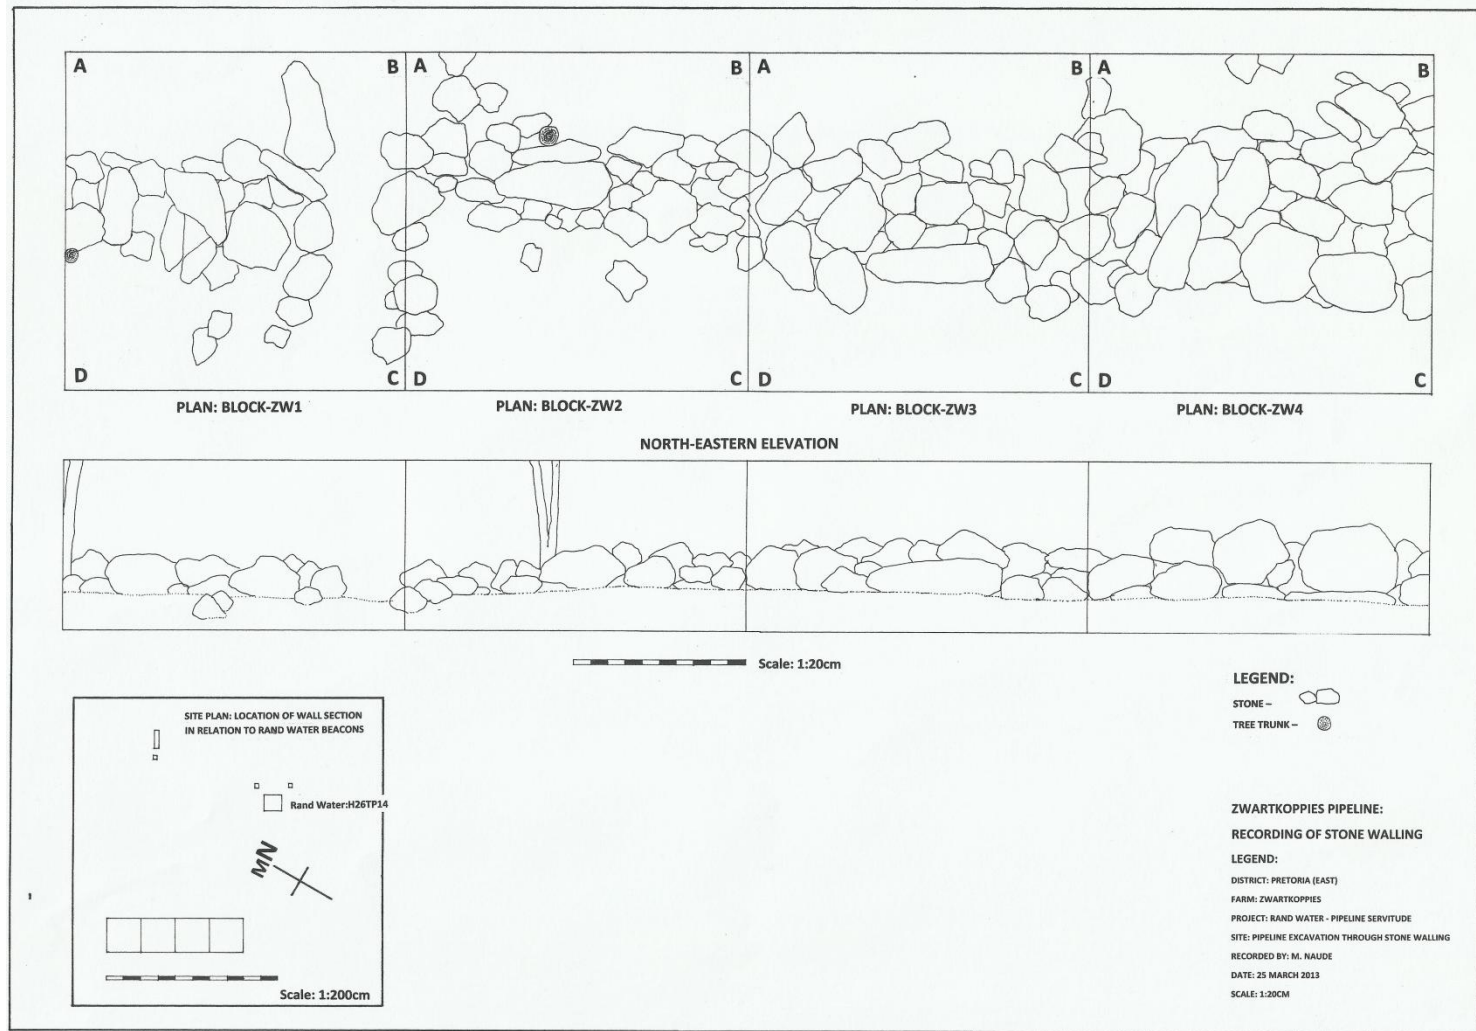
Figure 7. Plan and elevation of a section of the remains of a stone wall to be impacted on by the proposed new pipeline installation on the farm Zwartkoppies (Drawing: M. Naude 2013)
