EXTERIOR FACADE

93 MANOR VIEW ROAD, BELLAIR

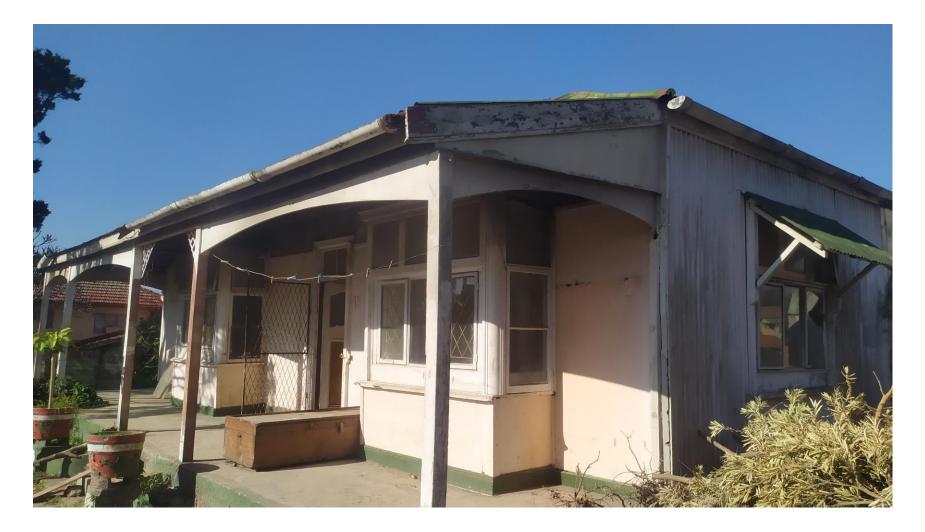
EXTERIOR FAÇADE- ILLUSTRATING TIN WALL STRUCTURE AND BROKEN AWNINGS

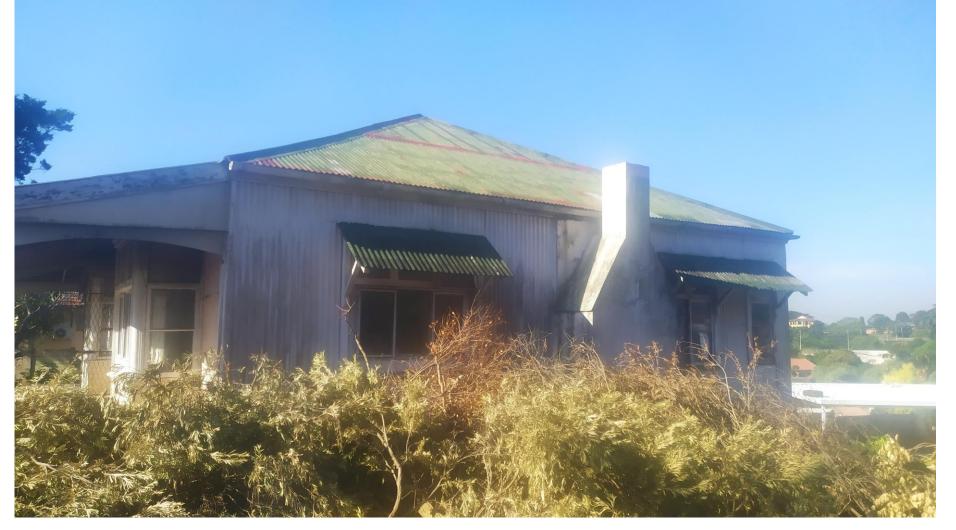
EXTERIOR FAÇADE- ILLUSTRATING TIN ROOF AND BROKEN GUTTERS

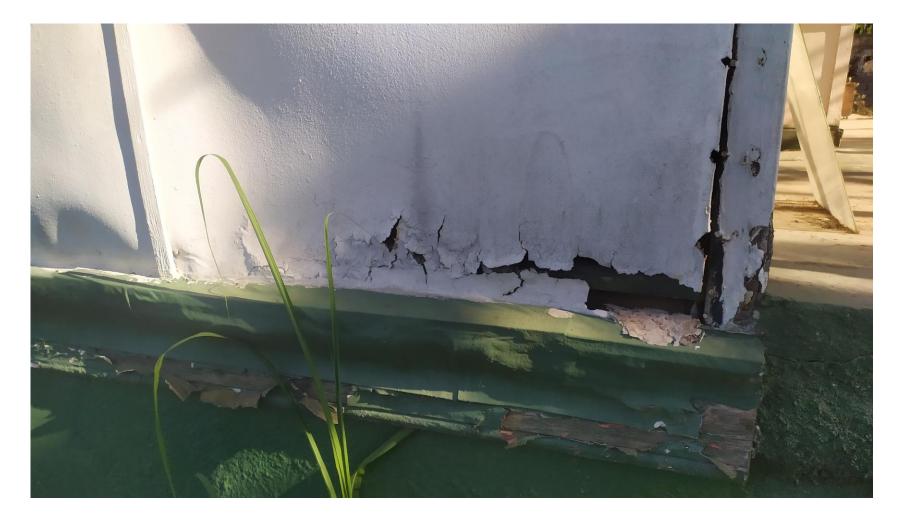
EXTERIOR FAÇADE- ILLUSTRATING TIN WALL STRUCTURE THAT IS ERODED AND TIMBER WALL SUPPORTS INFESTED WITH WOOD BORERS

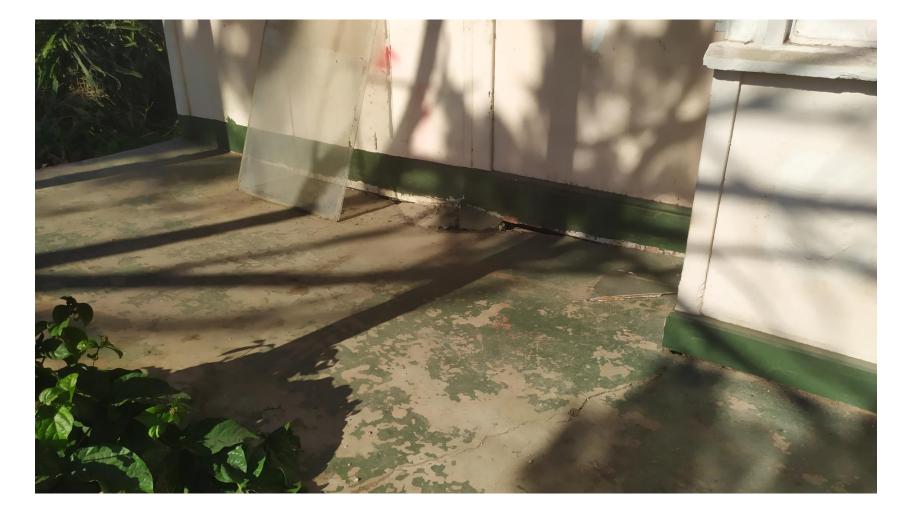
EXTERIOR FAÇADE- ILLUSTRATING TIN WALL STRUCTURE THAT IS ERODED AND TIMBER WALL SUPPORTS INFESTED WITH WOOD BORERS

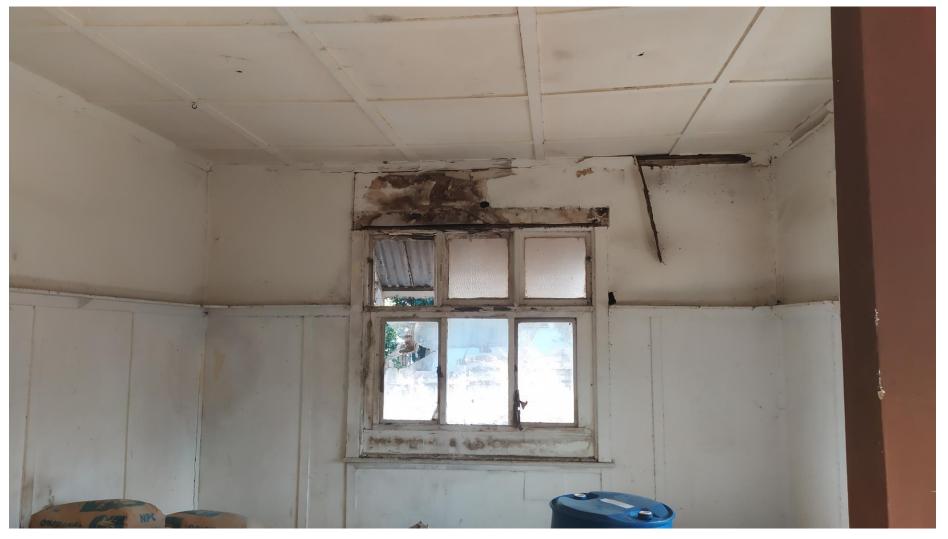
DAMPNESS FROM THE ROOF HAS ENTERED THE HOUSE AFFECTING THE HEALTH AND SAFETY OF THE HABITANTS

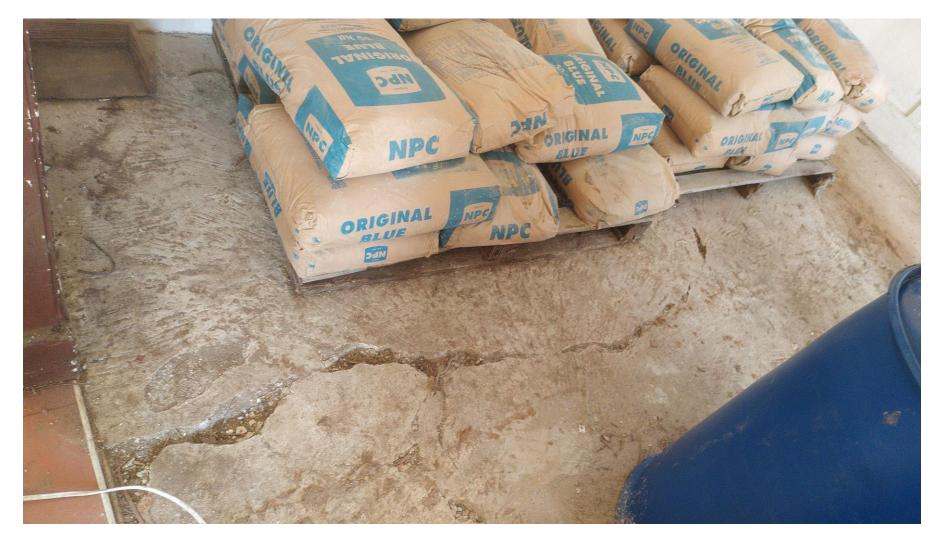
CRACKED CONCRETE FLOOR SLABS

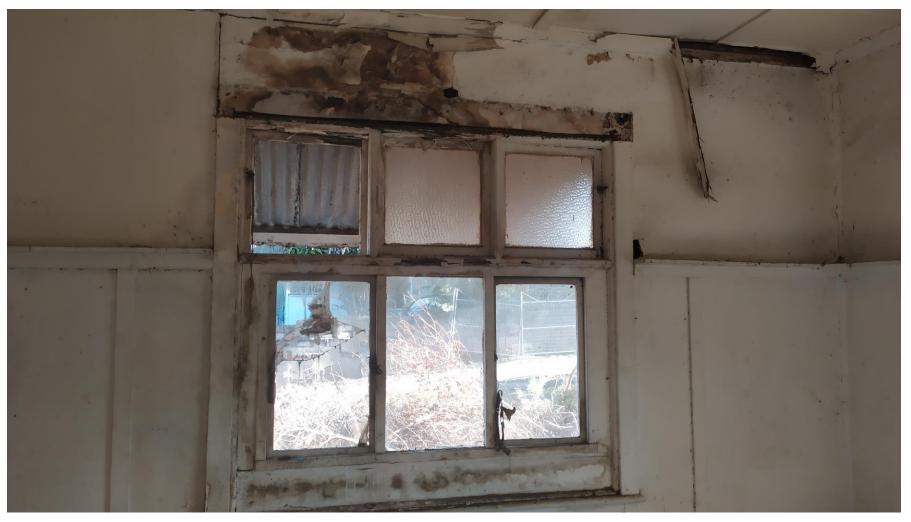
DAMPNESS FROM THE ROOF HAS ENTERED THE HOUSE AFFECTING THE HEALTH AND SAFETY OF THE HABITANTS

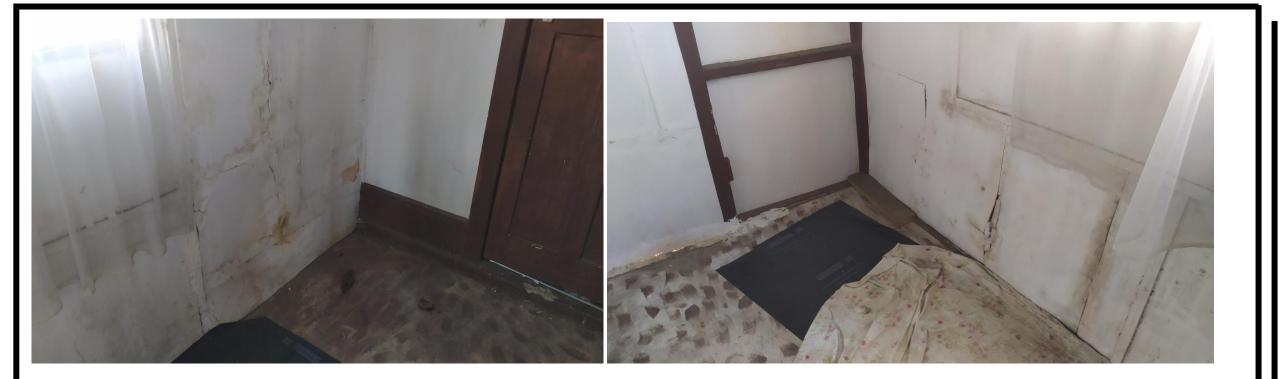
DAMPNESS FROM THE ROOF HAS ENTERED THE HOUSE AND HAS AFFETED THE STRUTUAL INTEGRITY OF THE TIMBER WALL STUDS

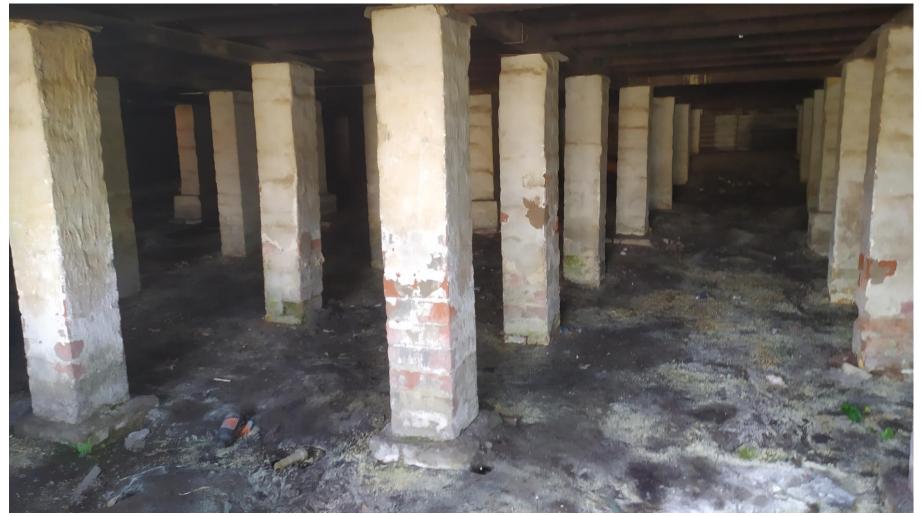
THE DAMPNESS IN THE CRAWL SPACE HAS FOSTED MOULD GROWTH WHICH IS A HEALTH AND SAFTEY CONCERN FOR THE HABITATS

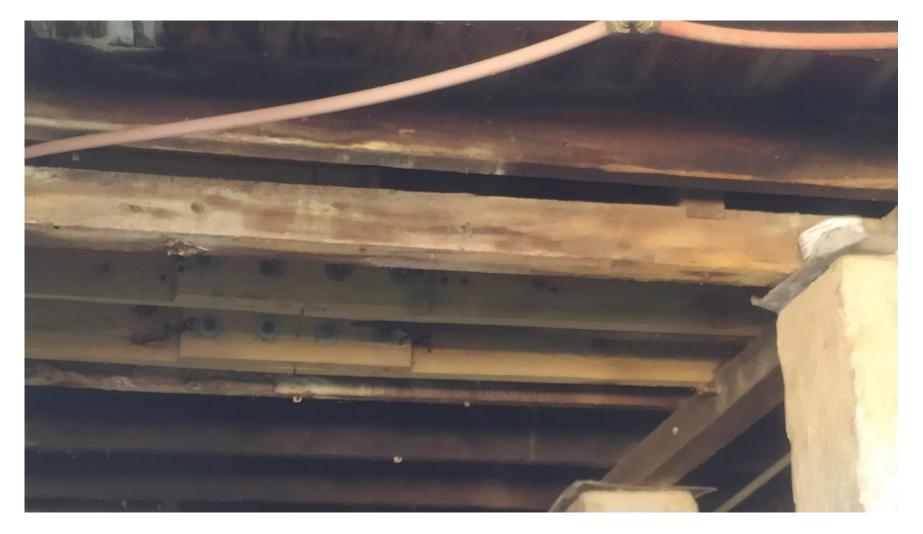
THE DAMPNESS IN THE CRAWL SPACE HAS STRUTURALLY AFFECTED THE TIMBER SUPPORTS FOR THE FLOOR AND THE TIMBER IS AFFECTED WITH WOOD BORERS
