THE TEACHER'S HOUSE (33/34)

Site Management Plan

Hidaya Jaffar Ali

Postgraduate Diploma Museum and Heritage Studies 2013

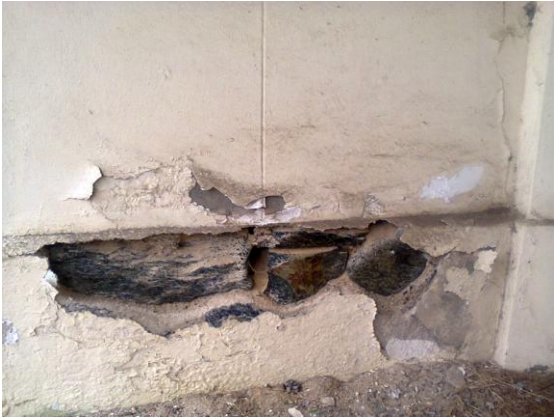
house. Most of the windows glasses are broken and allow birds to enter and deteriorate some of the rooms and dropping are found in side, corrosion of reinforcements due to the structural failures which mostly on the door and windows of outside kitchen and the area where by the upper water tank is located. Generally the houses are surrounded by vegetation cover or growth that courses the path ways not seen properly. On the Southern side of the building which has un plastered wall the mortars are detached because of the rain water which come straight to the wall, also the plinth of the house is deteriorate and plaster are also removed which can cause the

Condition of plinth

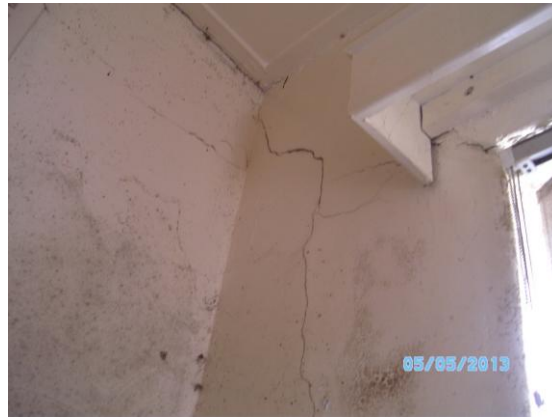
The investigation analyzed that the condition of the building general is not good, and facing some challenges in conservation that include lack of maintenance and neglected. Cracks are evident on walls and mostly on the western side of the

Crack on the wall inside

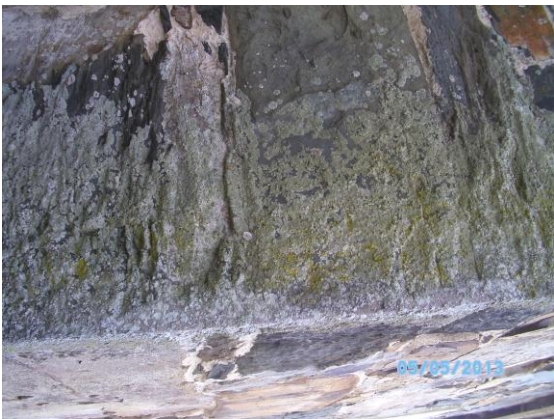
Fungus on the Southern wall (un plastered)

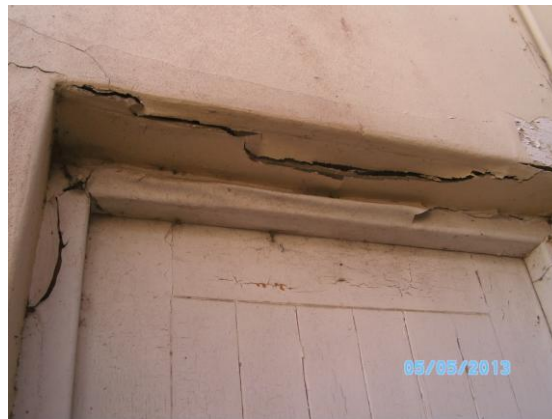
Structural failure on the door

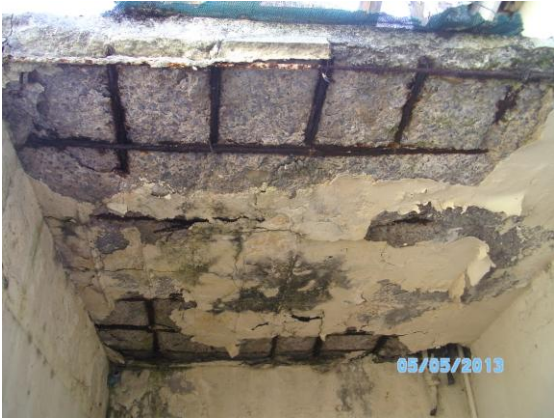
Corrosion of Reinforcement on the slab

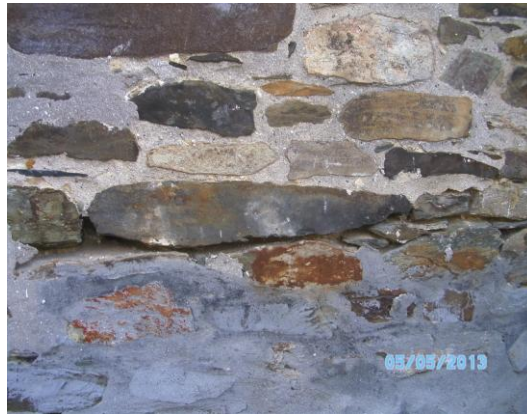
Mortar detached on un plastered wall

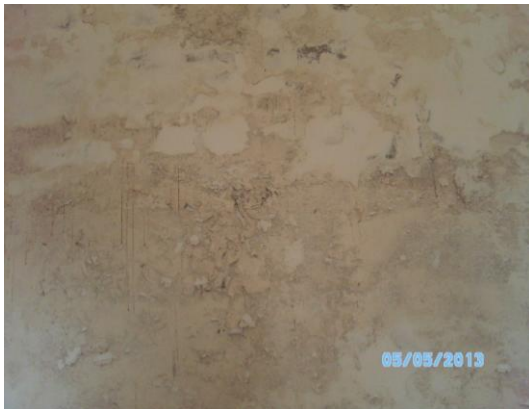
water to penetrate to the foundation and walls. The front wall of the fence shows cracks which probably caused by the vibration of traffic, and the wired one is already lay down. Plasters in some parts inside the building and fire places are crumbled because of the moisture.

Condition of the plaster in side (Crumble)

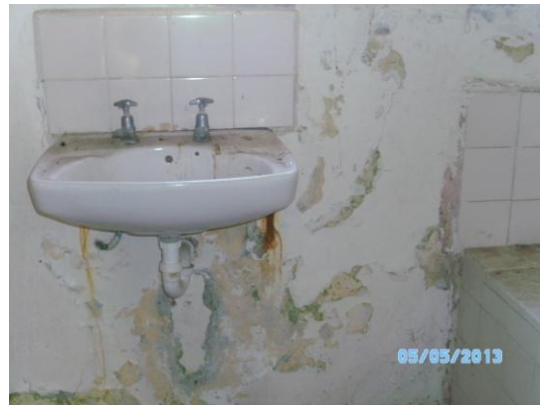
Effect of moisture on the wall

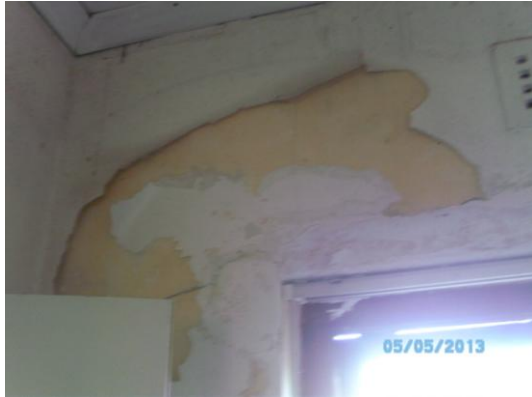
Oil white paint on lime plaster wall

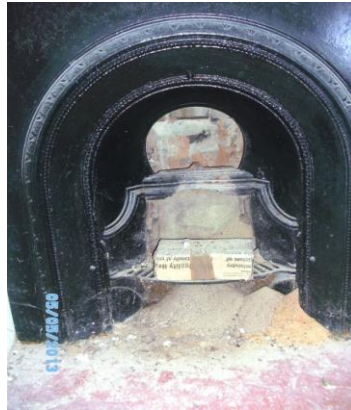
Rust of the metal and crumbling wall

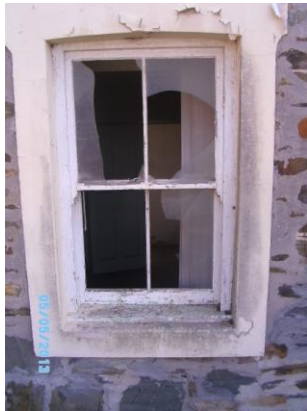
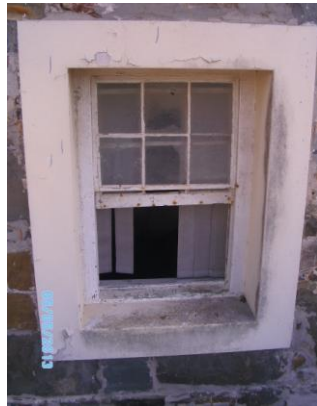
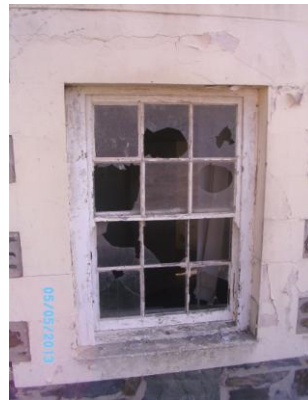
Window with broken glasses

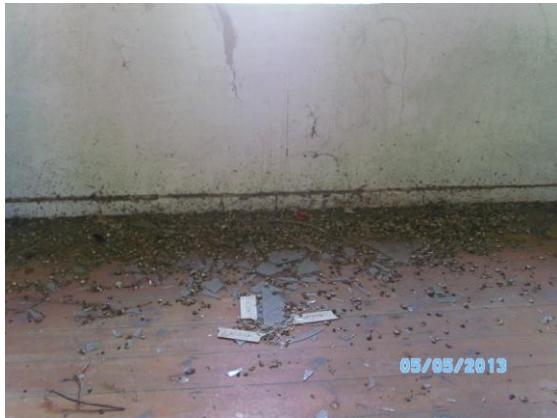
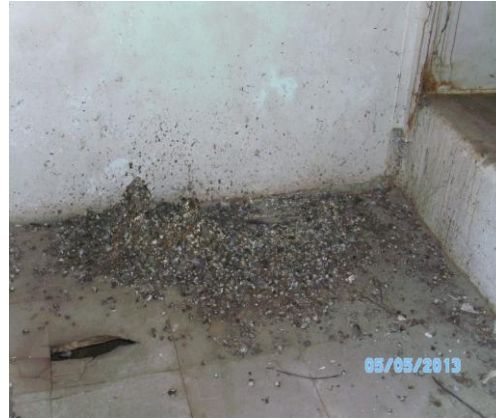
Birds dropping in side the house

According to the condition of the building, most of the windows are open and glasses are broken, the birds are properly entered to the building through those open windows. The evidence of the situation is found in side where by a lot of birds dropping are every where inside the house, which cause the building to loose its integrity.

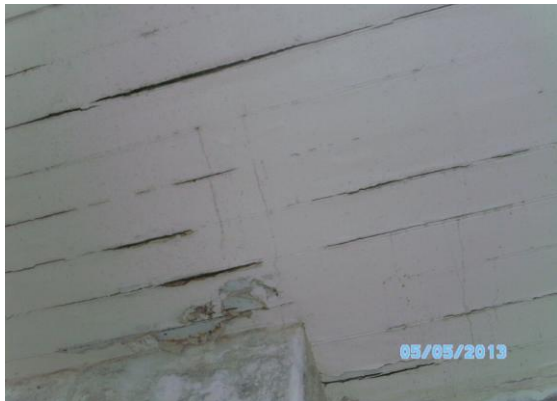
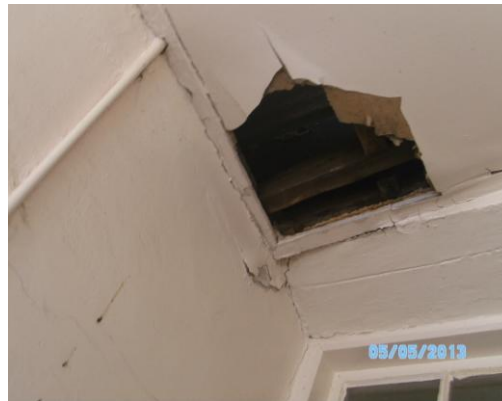
Condition of the ceiling

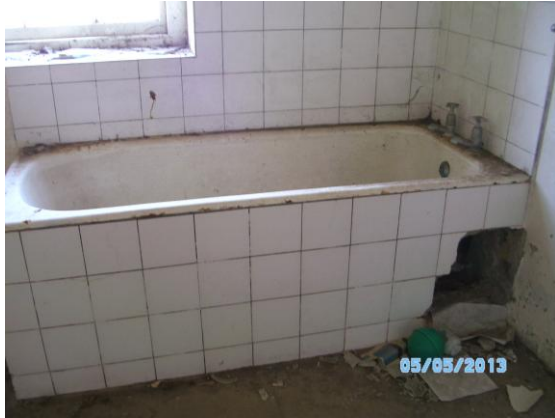
Condition of the showed basin

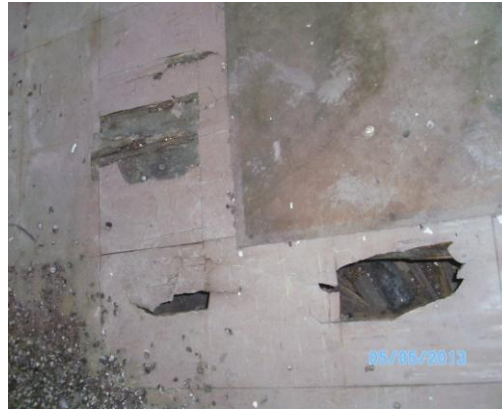
Tiles floor with holes and bird droppings

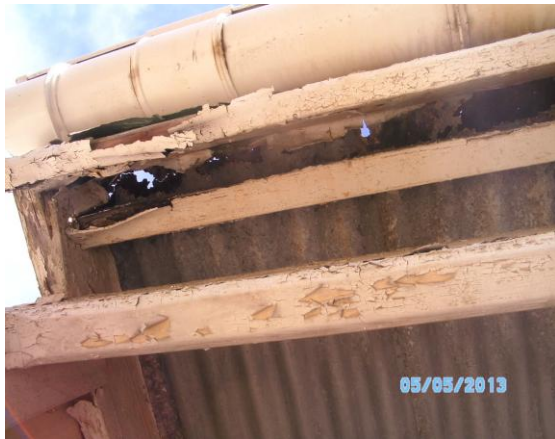
Rusting Corrugated iron sheets

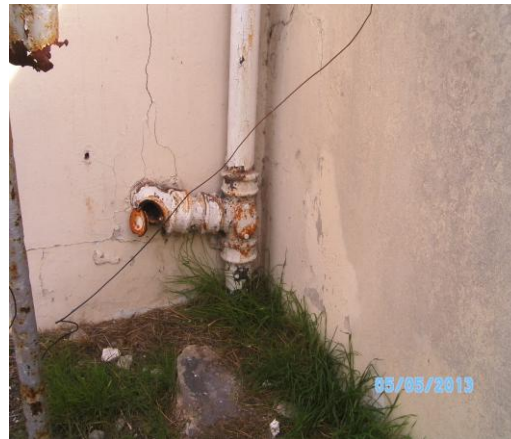
rusting of drainage pipe

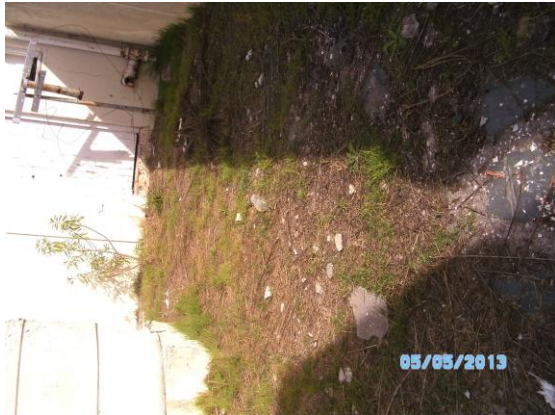
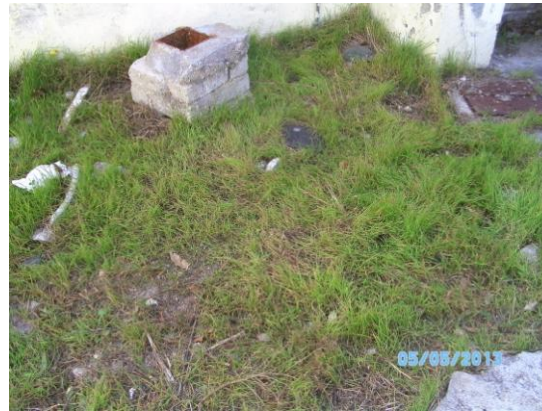
Condition of path ways

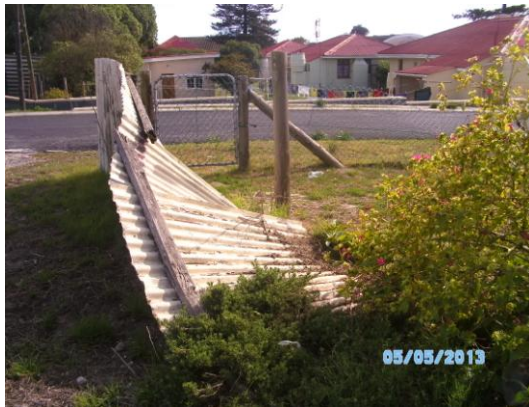
Part of fence laying down

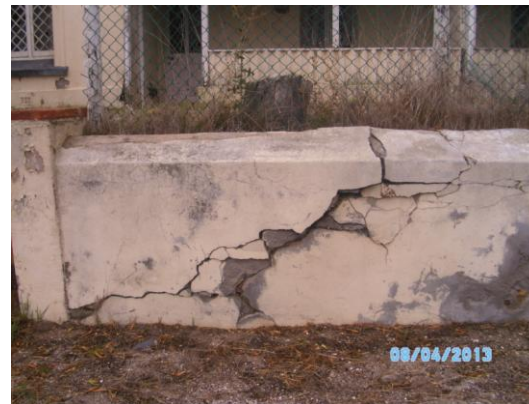
Fence wall has cracks caused by traffic vibration

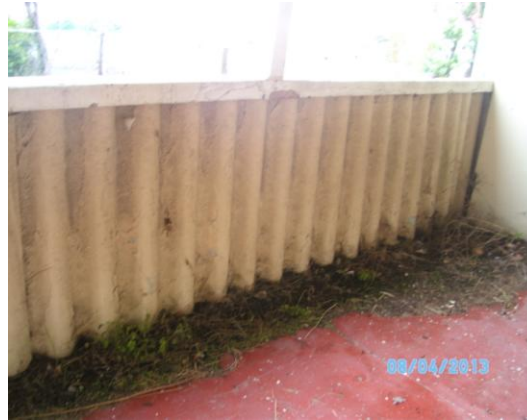
Condition of the porch
