26 June 2023

**198-202 GORDON RD, Morningside, Durban**

**HERITAGE IMPACT ASSESSMENT : ILLEGAL WORK AND PROPOSED CHANGES TO EXISTING  
TOWNHOUSES (AND CONVERSION TO BUSINESS)**

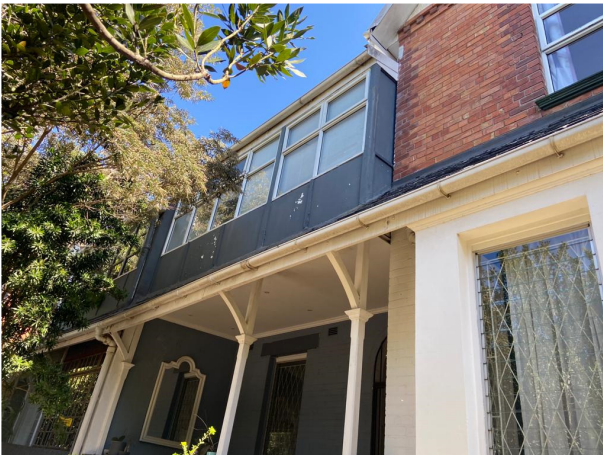
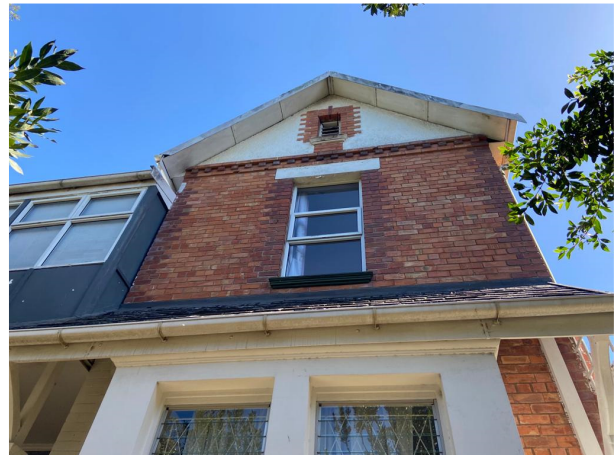
Over time, the first floor balconies were enclosed (date unknown) for additional bedrooms and bathrooms added on the balcony – a common alteration to houses in the area. Sash windows were changed to louvre windows and aluminium top-hung windows. Internal alterations had been made over many years to keep up with modern living standards. Sadly, this has weakened the historical integrity of the building.

By the early 2000’s, the town houses were mostly screened from the road by ugly walls, fences and trees. Veranda walls and parts of the facebrick gable had been painted to suit the taste of various owners.
