Application submitted to the South African Heritage Resources Agency (SAHRA) in terms Section 34 and Section 38 of the National Heritage Resources Act (No 25 of 1999) for the demolition of an Old Railway Building on the Farm Driehoekspan 435 near Glosam in the Tsantsabane Local Municipality, Northern cape

Thursday, 14 July 2022

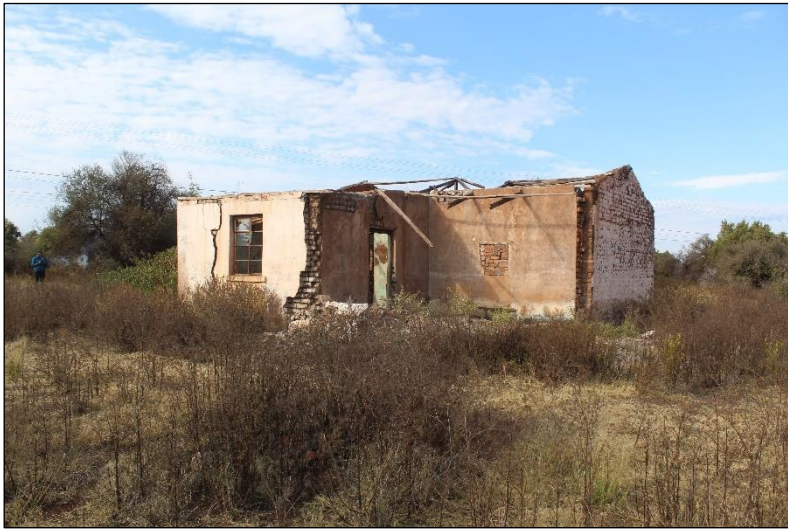
Figure 2: View of the east and north elevation of the building shows a room with two walls which have collapsed

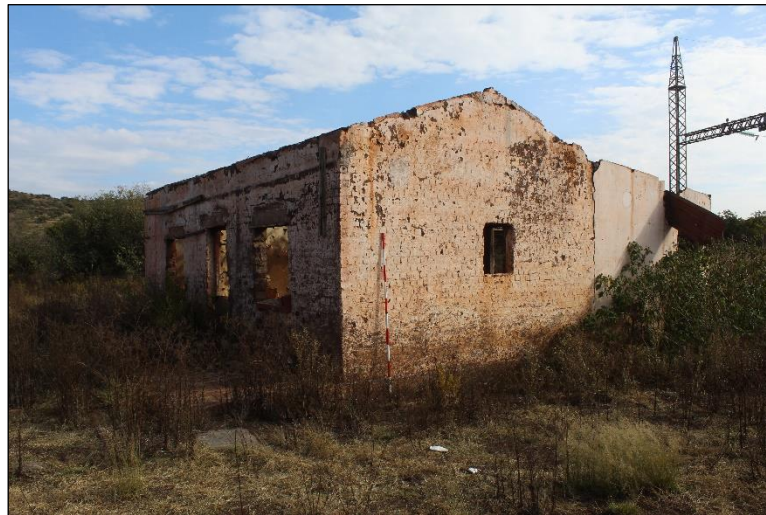
Figure 4: The Old Railway Building, view from the southeast shows the south and east elevation

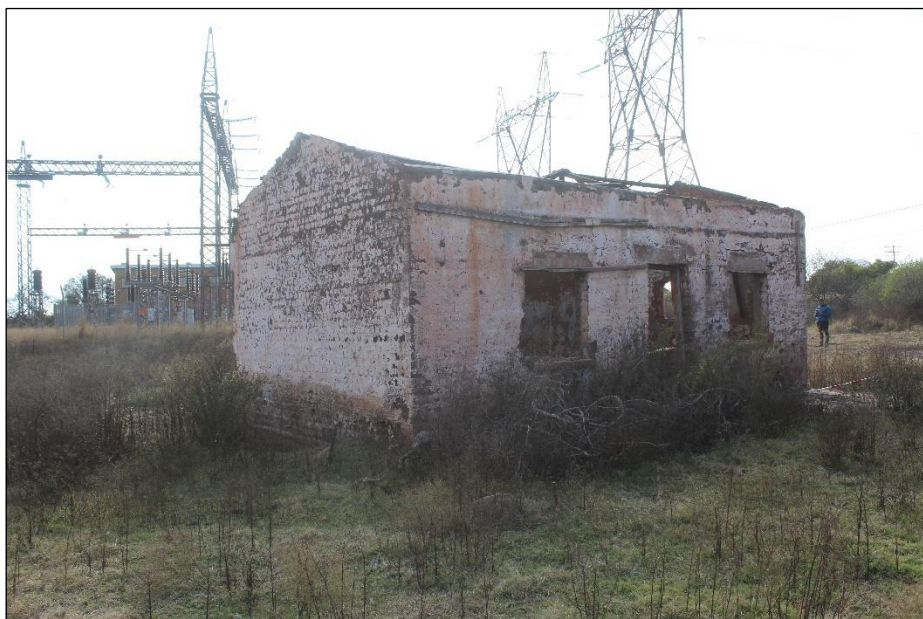
Figure 5: Another view shows the west and south elevation of the building

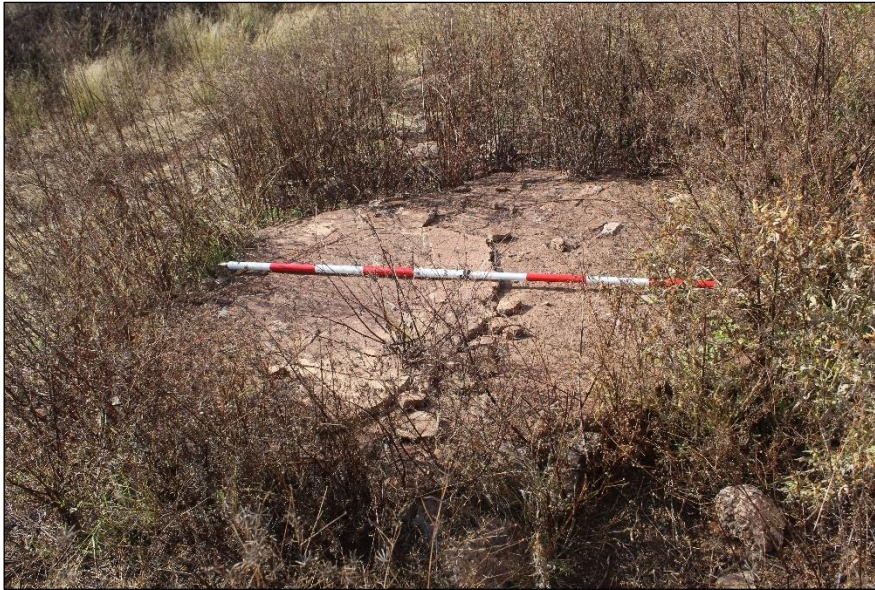
Figure 6: Cement floor located close to the east corner of the building is possible the remains of a kitchen

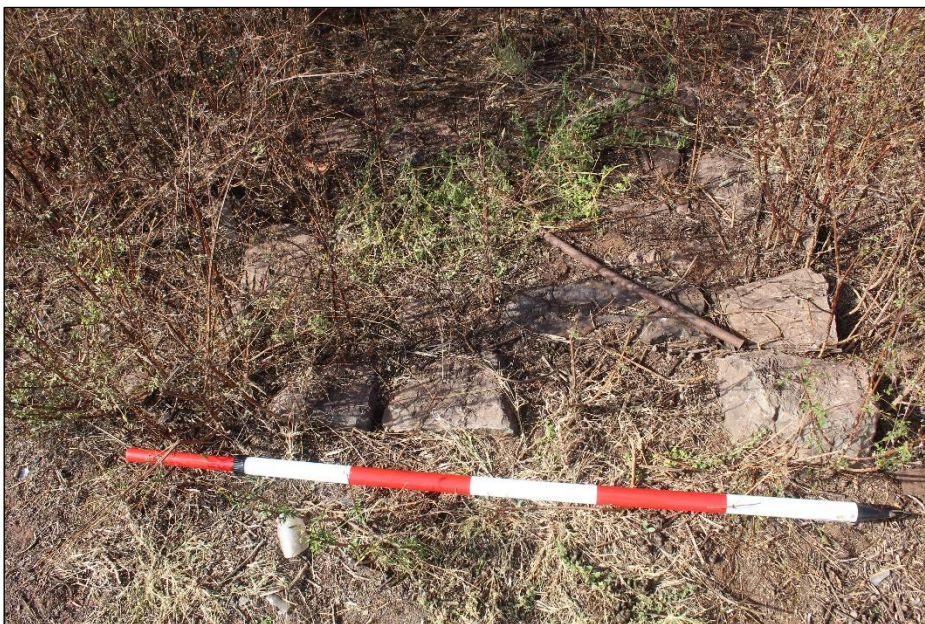
Figure 7: A 1 m x 1m square pavement of stones located at the southern boundary of the yard

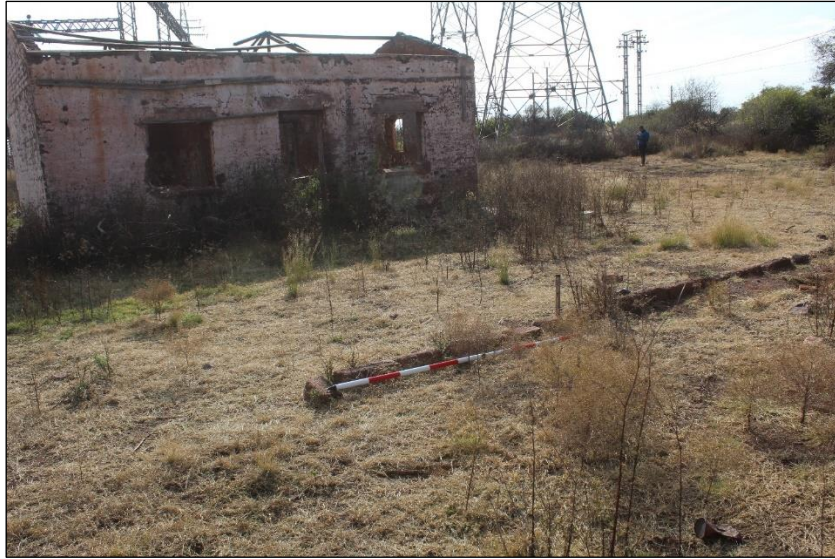
setting of bricks 10 m south of the building was probably a screening wall marking the boundary of the domestic area around the house (Figure 8).

Figure 8. A straight arrangement of bricks probably marks the western boundary of the domestic area

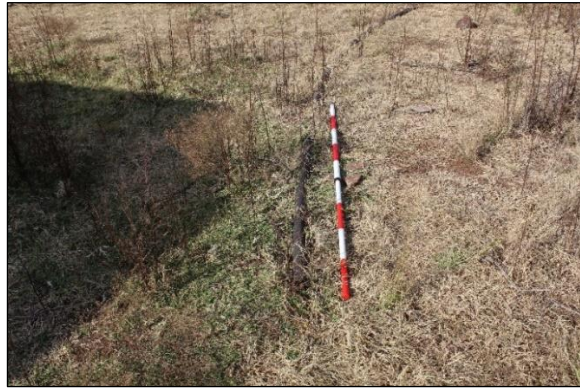
Figure 14: Polythene pipe for transportation of water

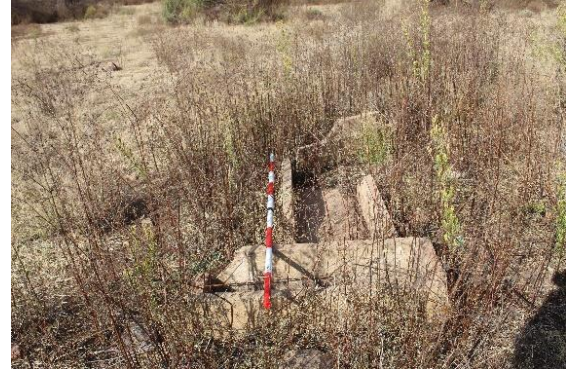
Figure 15: Broken concrete used for watering livestock
