APPENDIX A: ARCHITECTURAL ASSESSMENT REPORT

**Project name: Old Railway Building on the Farm Driehoekspan 435 near Glosam in
the Tsantsabane Local Municipality, Northern Cape**

Architectural Assessment by Gershon Manana. Pr. Arch

11 July 2022

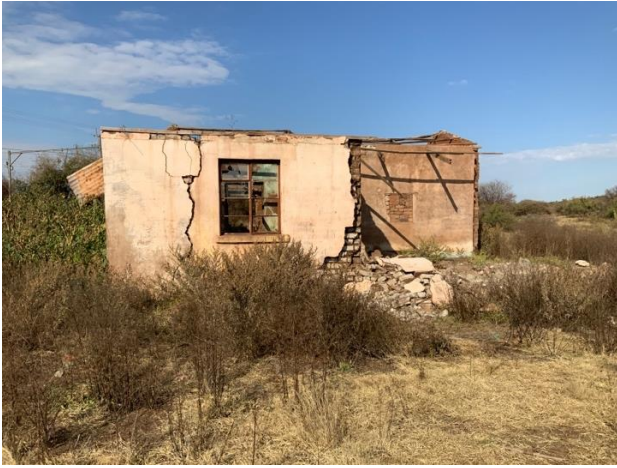
Figure 3. Eastern elevation

Figure 3 shows the eastern elevation with the low-pitched added section. The kitchen part is still intact with the steel cottage pane window on the left and the crumbled section on the right which may have been a veranda. The structure shows progressive collapse of all the elements.

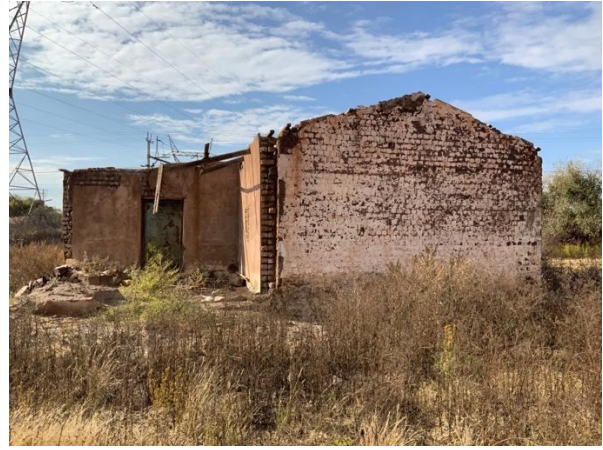
Figure 4. Northern elevation

Figure 4 shows the northern elevation with the double pitched old section to the left and the low pitched lean-to section on the right. The collapse of the building elements and erosion of some is clearly visible.

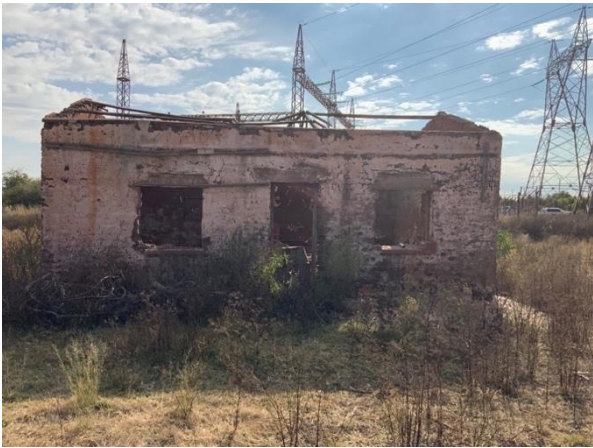
Figure 5. Western elevation

Figure 5 shows the western elevation with the veranda located across the full length of the building. What is left of the veranda is the floor and the timber bearer that fixed to the face of the building, where the veranda was attached. The door and windows are indicated with timber frames and concrete lintels and window sills. The roof is missing and only the damaged truss is visible.

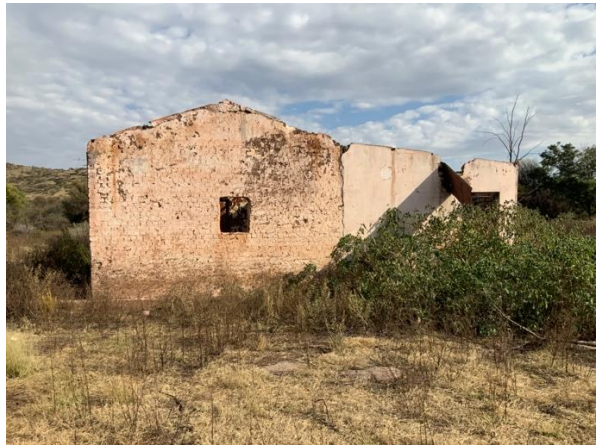
Figure 6. Southern elevation

Figure 6 shows the southern elevation with the different architectural treatment of the original and added building. The original building with the wash and paint and the added building with plaster and paint finish.

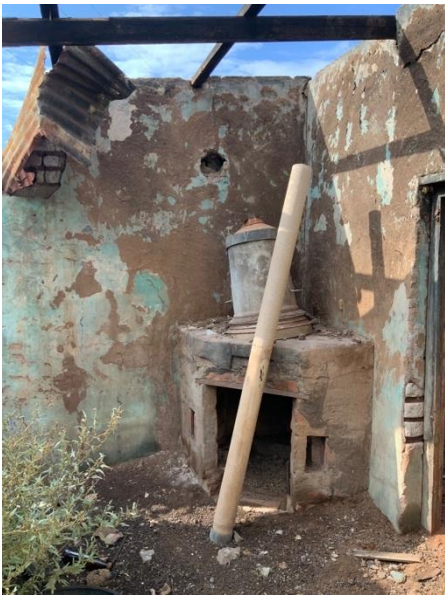
Figure 7. Detail of the kitchen

Figure 7 shows the detail of the stove in the kitchen area that was added latter.

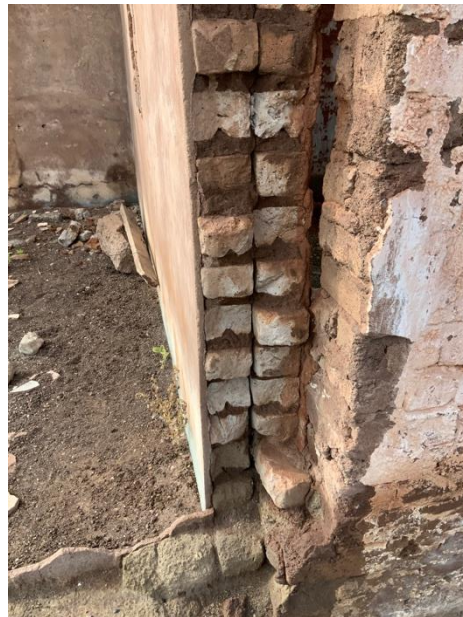
Figure 8 shows the detail of the brickwork junction between original and added part and depicts the mix of cement and lime stock bricks.

Figure 8. Detail of the brickwork junction between the original section and added section

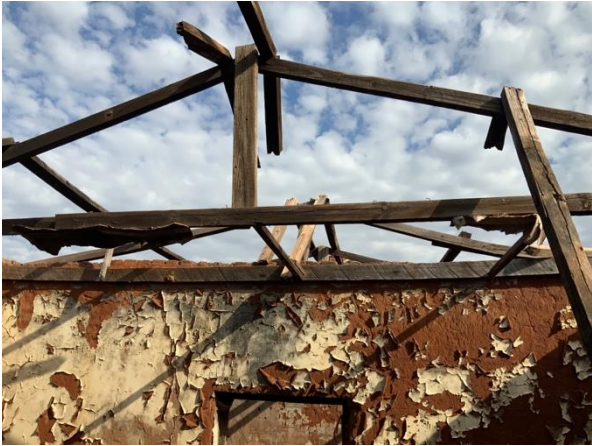
Figure 9 shows the detail of the truss system with nails where ceilings would be fixed, however the ceilings have since been removed. Also indicated is the internal wall clay mix and white paint finish that is peeling off.

Figure 9. Detail of the truss structure and weathering internal wall paint

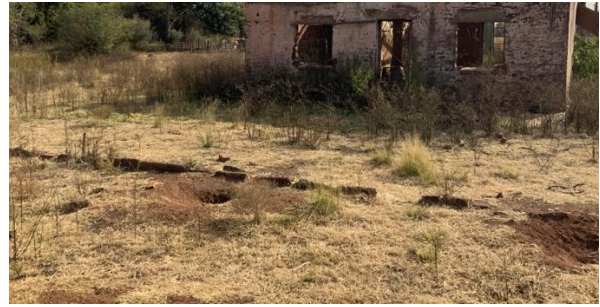
Figure 10. Screening wall brickwork

Immediately in the vicinity of the building are a screen wall and water tank concrete plinth. The screen wall is located in front of the western side veranda and is demolished and only the foundation brickwork, of rammed earth, is left. The 2m diameter water tank concrete plinth is located on the south-eastern corner of the kitchen indicating that there would have been some gutter for rain water harvesting. Both the tank and gutter and downpipes are missing from the building and immediate surrounds.

Figure 10 shows the detail of the remaining portion of the screen wall constructed of rammed brickwork.

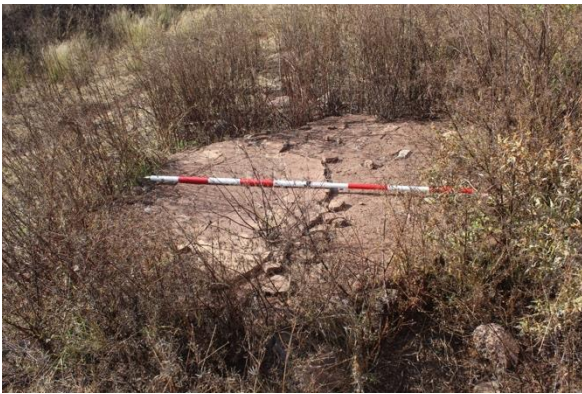
Figure 11 shows the detail of the concrete water tank plinth, where the water tank would have been located. The water tank would have been fed through a gutter and downpipe system which has since disappeared from the build and immediate surrounds.

Figure 11. Cement floor, remnants of a water tank
