Heritage Statement
**Application for demolition in terms of Section 34 of
the National Heritage Resources Act (Act 25 of 1999)**
Section 34 application and heritage statement Erf 10192, Helliger Lane, BoKaap
submitted to Heritage Western Cape in terms of the
National Heritage Resources Act

**INVESTIGATION & REPORT ON
STATE OF STRUCTURES ADJOINING
ERF 10192, HELLIGER LANE
REGARDING IMPLICATIONS OF THE
PROPOSED DEMOLITION**

DATE	MARCH 2014
REF.	0454R001 rev 02

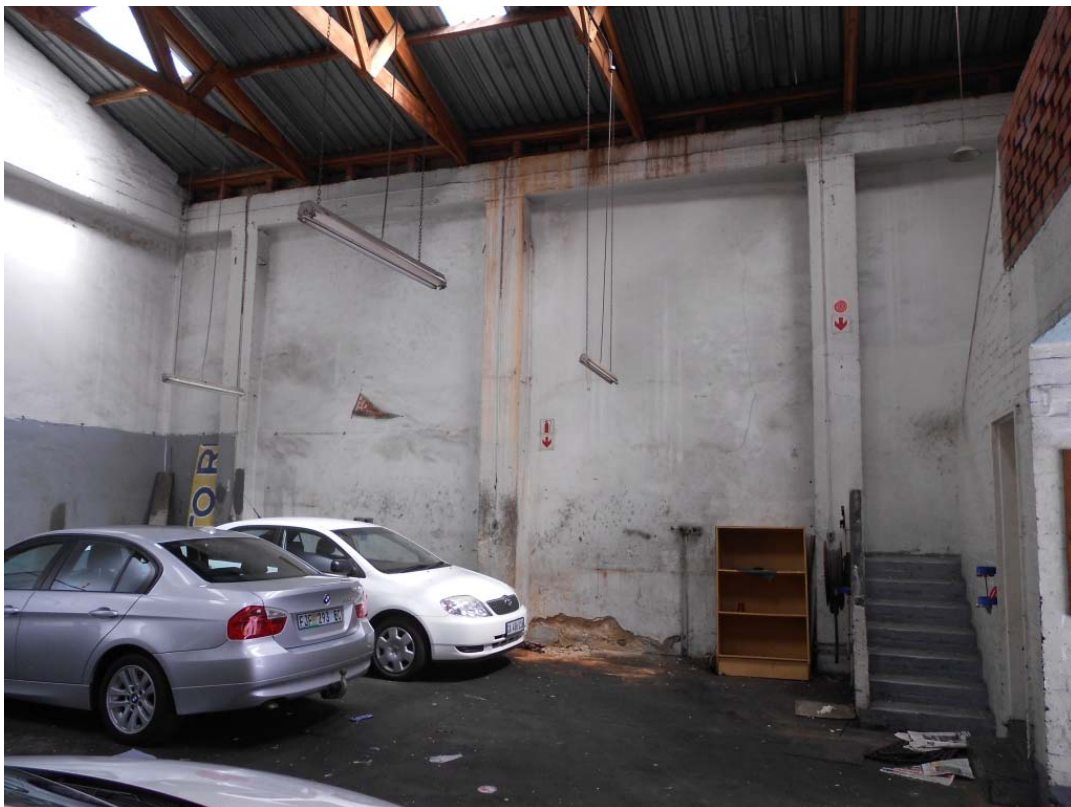
Photo 6: Internal wall of Danny's Auto being supported laterally by the concrete frame.

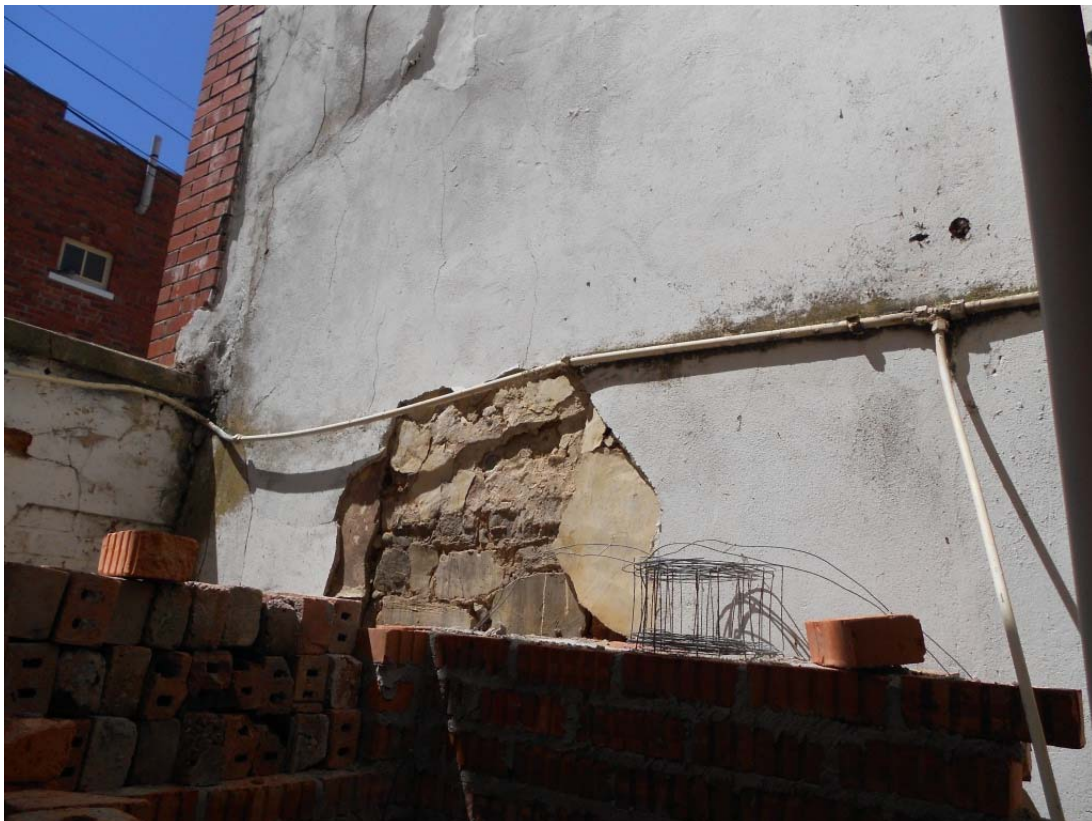
As can be seen on the survey drawing (Appendix B), the existing boundary wall between between erf 10192 and the Mohidiens is positioned on erf 10192. The wall is a stone wall, that is leaning at the top and is structurally unsound.

Photo 8: View inside Mohidien courtyard of new brickwork as well as existing plastered stone wall.

There has been a double storey structure constructed in the alleyway between the primary house and the boundary wall, making use of the existing boundary wall. The Mohidiens are currently renovating this structure to incorporate a new loadbearing wall on their site, acknowledging that the boundary wall is unsafe.

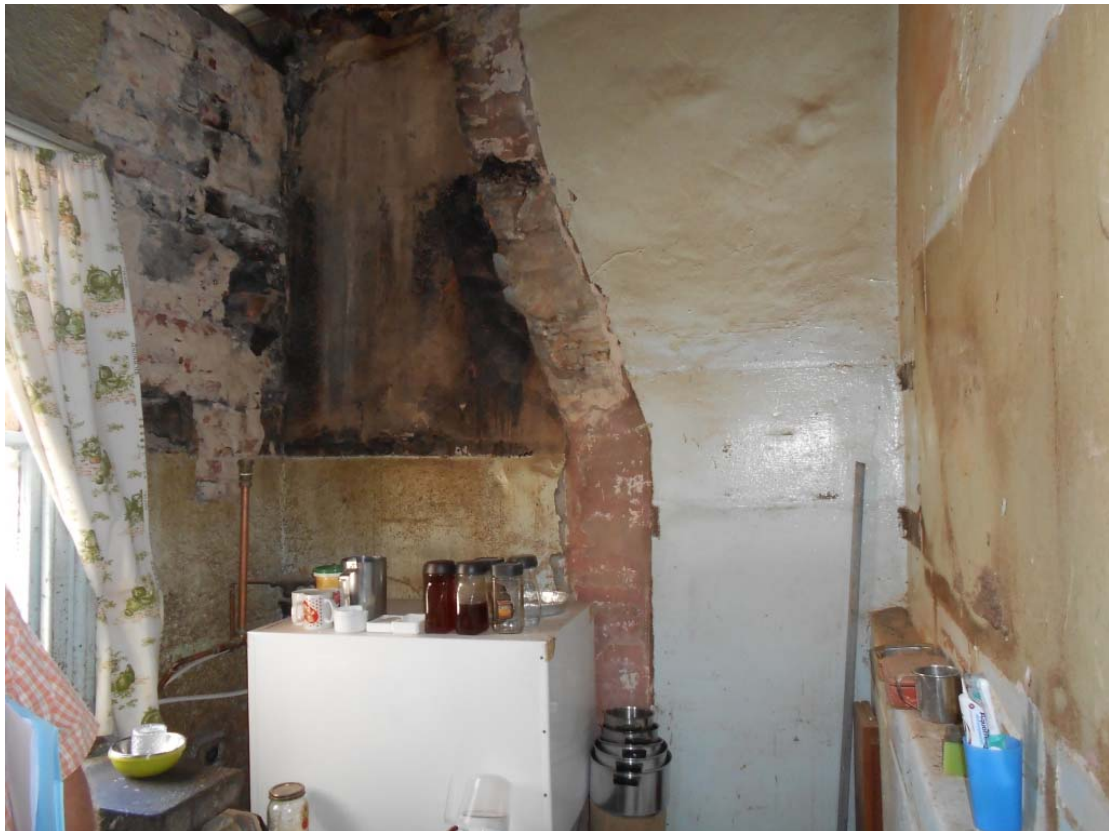
Photo 9: View inside Mohidien upstairs kitchen. Back wall of kitchen is boundary wall.

Should this construction not be complete at the time of demolition of the boundary wall, a new wall will be built for the Mohidiens on their site. The same applies for the upstairs kitchen. (see photo 9 in Appendix C).

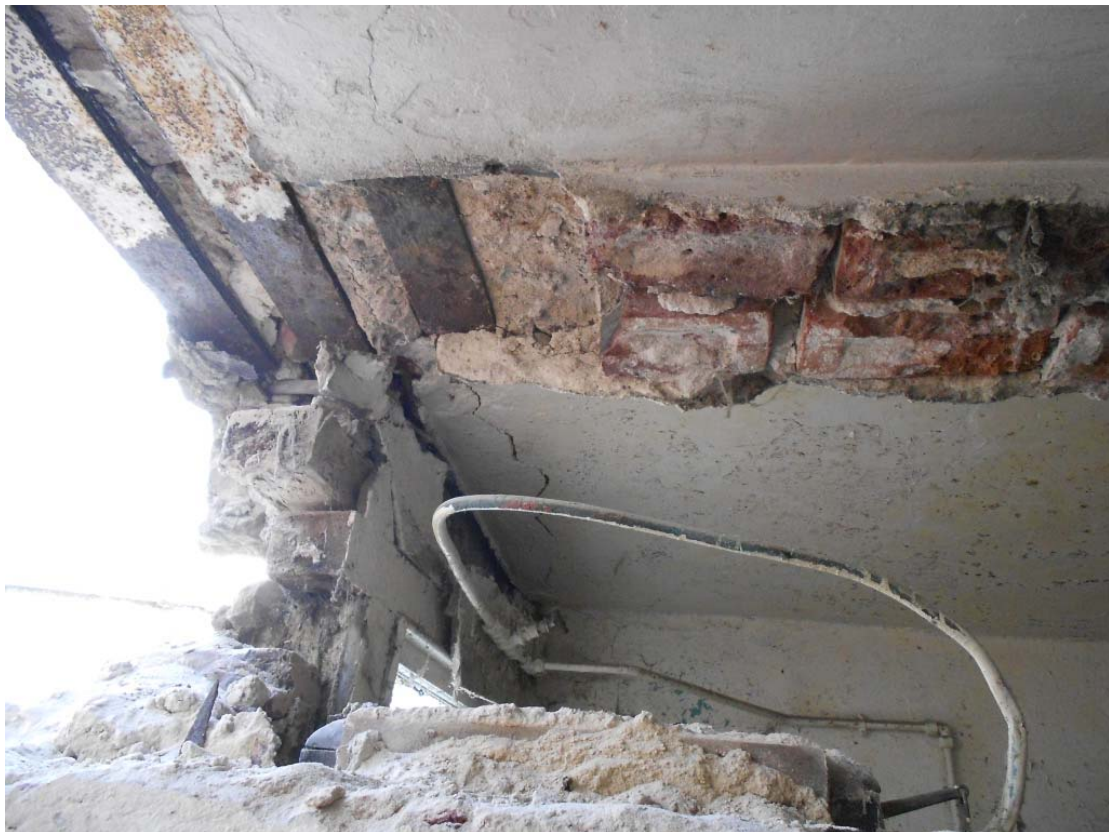
Photo 10: View of slab under kitchen. In a state of disrepair, currently being rebuilt by the Mohidiens.

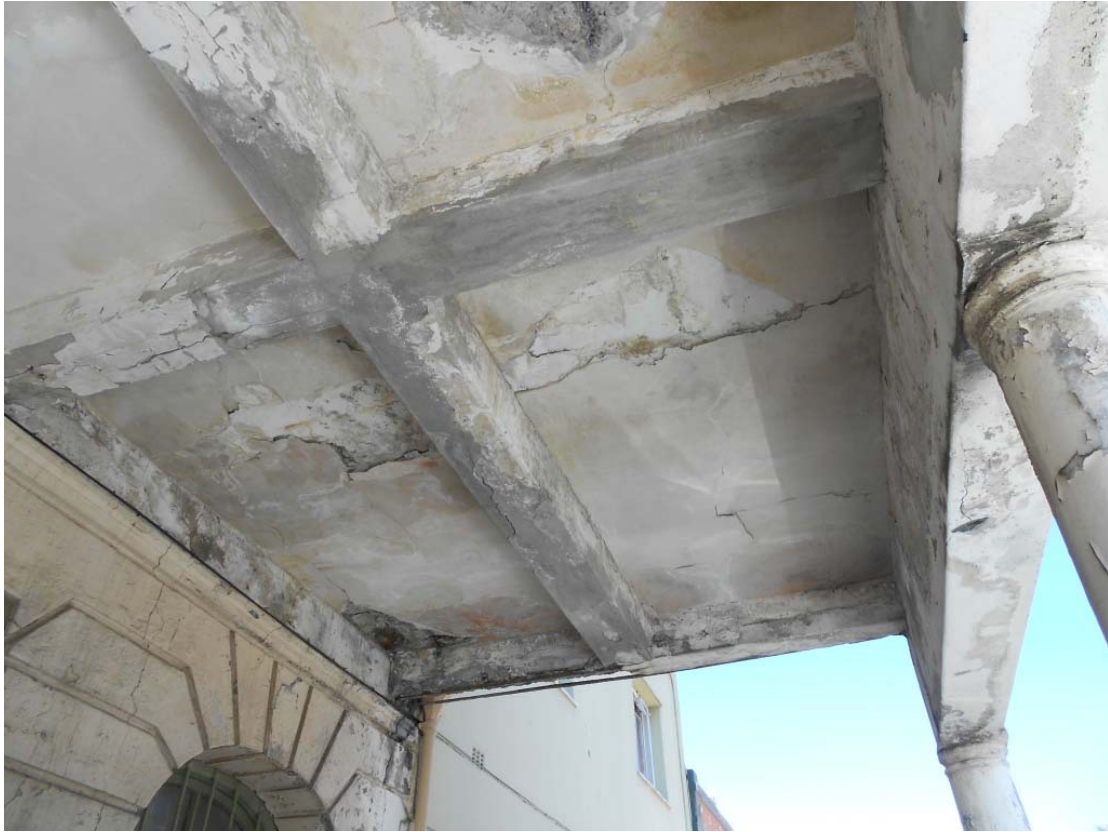
The primary residence is to some extent in a state of disrepair. Externally, there is significant spalling of the concrete on the balcony on Rose Street. Internally, the house is showing signs of age, and lack of maintenance.

Photo 11: Balcony slab over the butchery entrance in Rose Street. Significant spalling and corroded reinforcement.

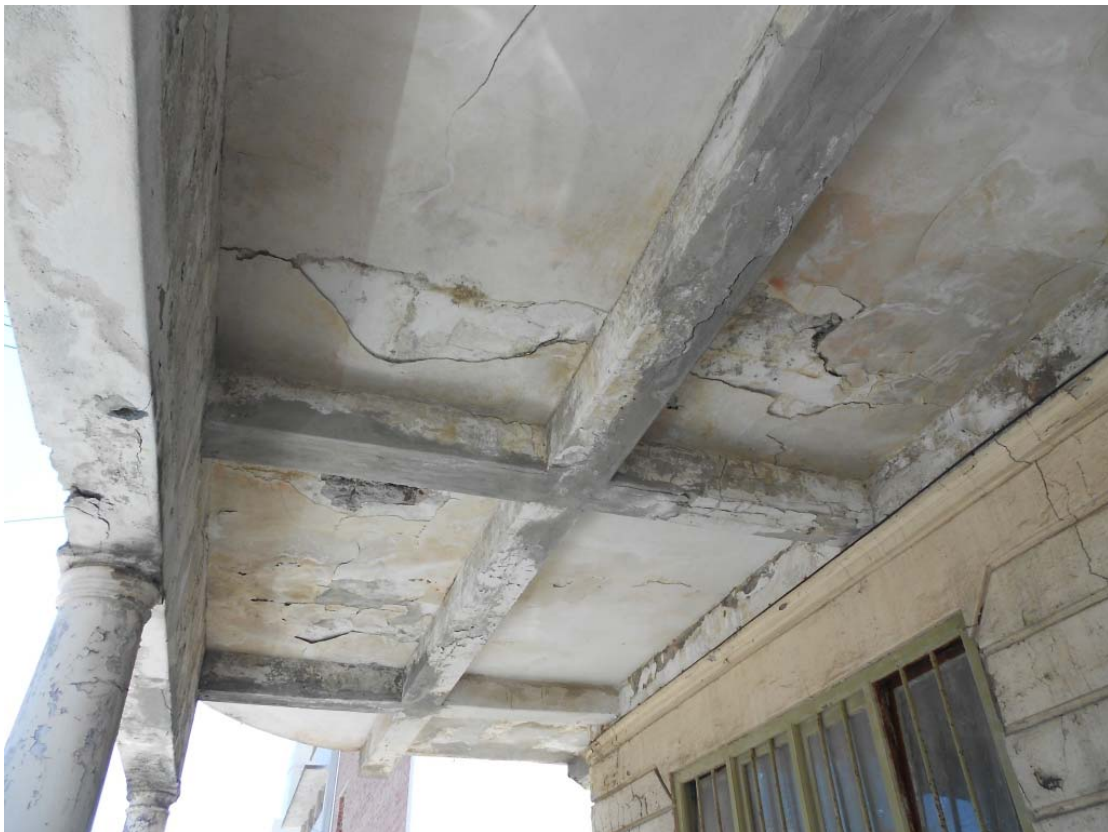
Photo 12: As above.

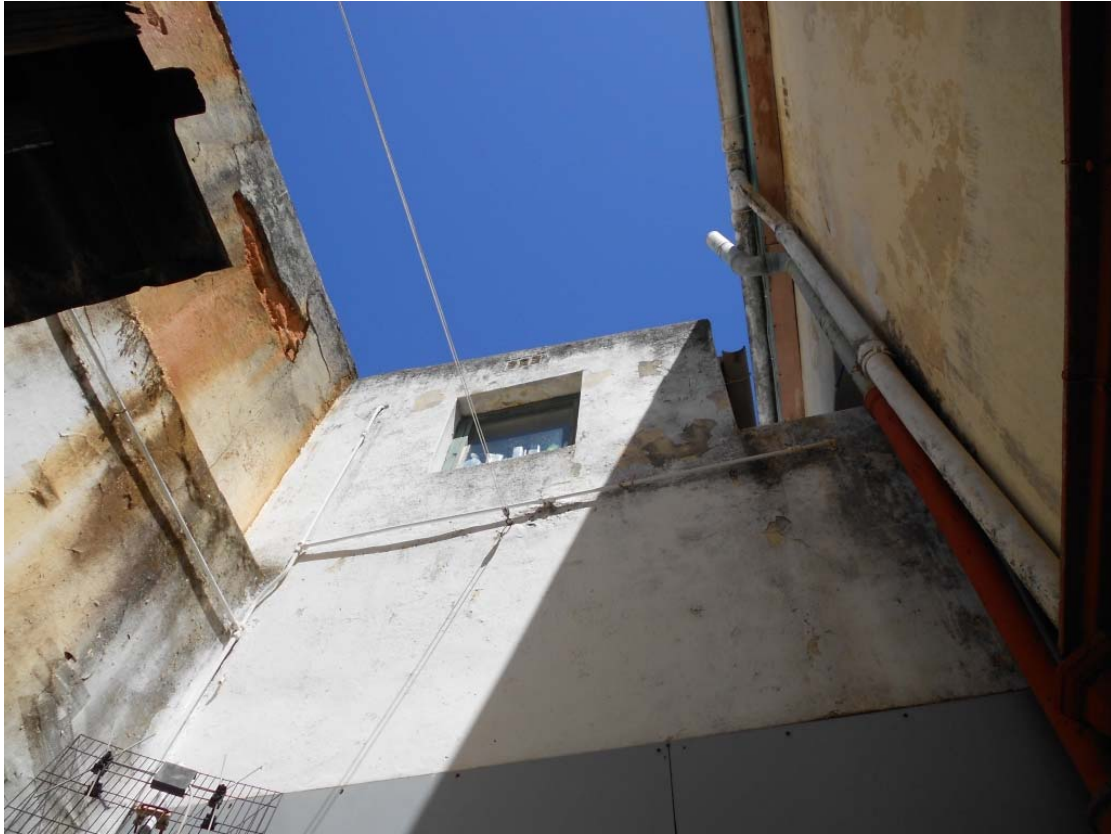
There has been a double storey structure constructed in the alleyway between the primary structure and the boundary wall, abutting the existing boundary wall. (see photos 13 to 16 in Appendix C) From the photographs it is also evident that there is another wall independent of the boundary wall.

It is unclear if this wall continues through into the out-building. If this wall is found to continue through both storeys of the out-building, demolition of the boundary wall will have no impact on the Barber Shop. If however, the wall does not continue through into the outbuilding, a wall will need to be built by the owner of erf 10192 for the Barber prior to demolition of the boundary wall.

Photo 13: View inside back yard of barber shop. Note new independent wall adjacent stone wall.

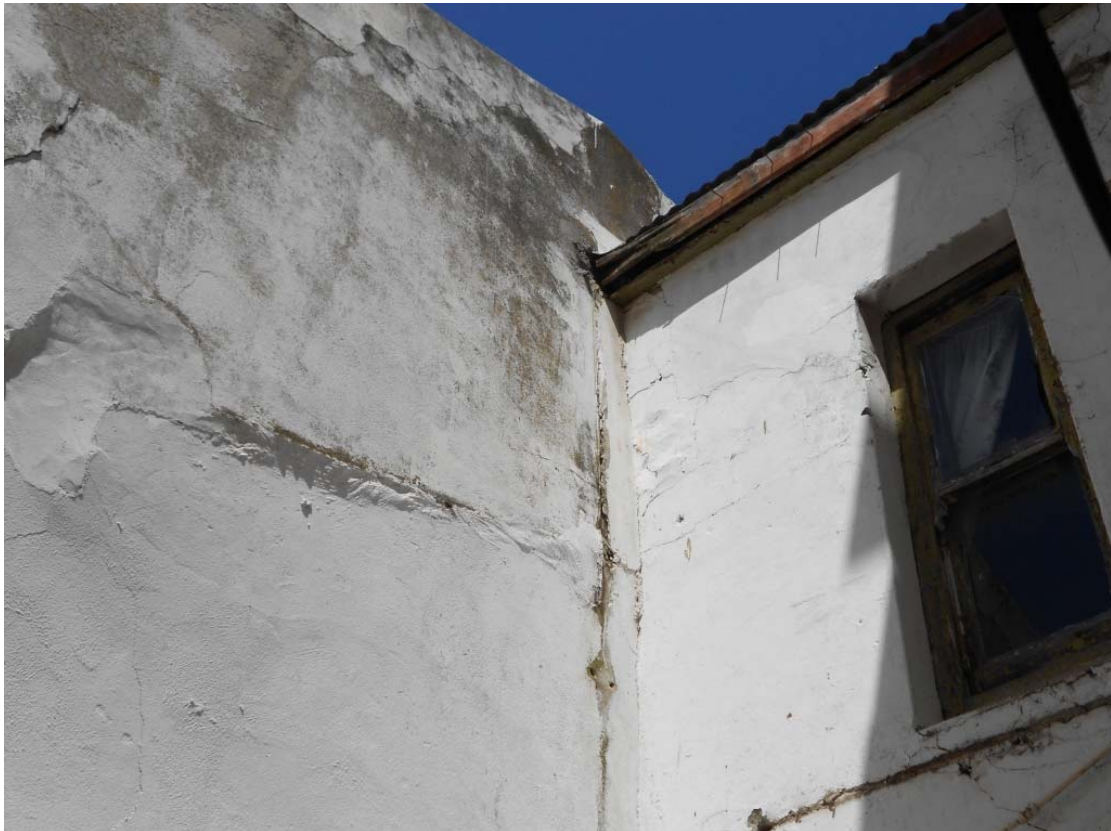
As can be seen on the survey drawing (Appendix B), the existing boundary wall between between erf 10192 and the Barber Shop is positioned on erf 10192. The wall is a stone wall, that is cracked and leaning at the top and is structurally unsound.

Photo 14: View inside back yard of barber shop. Note bad state of boundary wall.

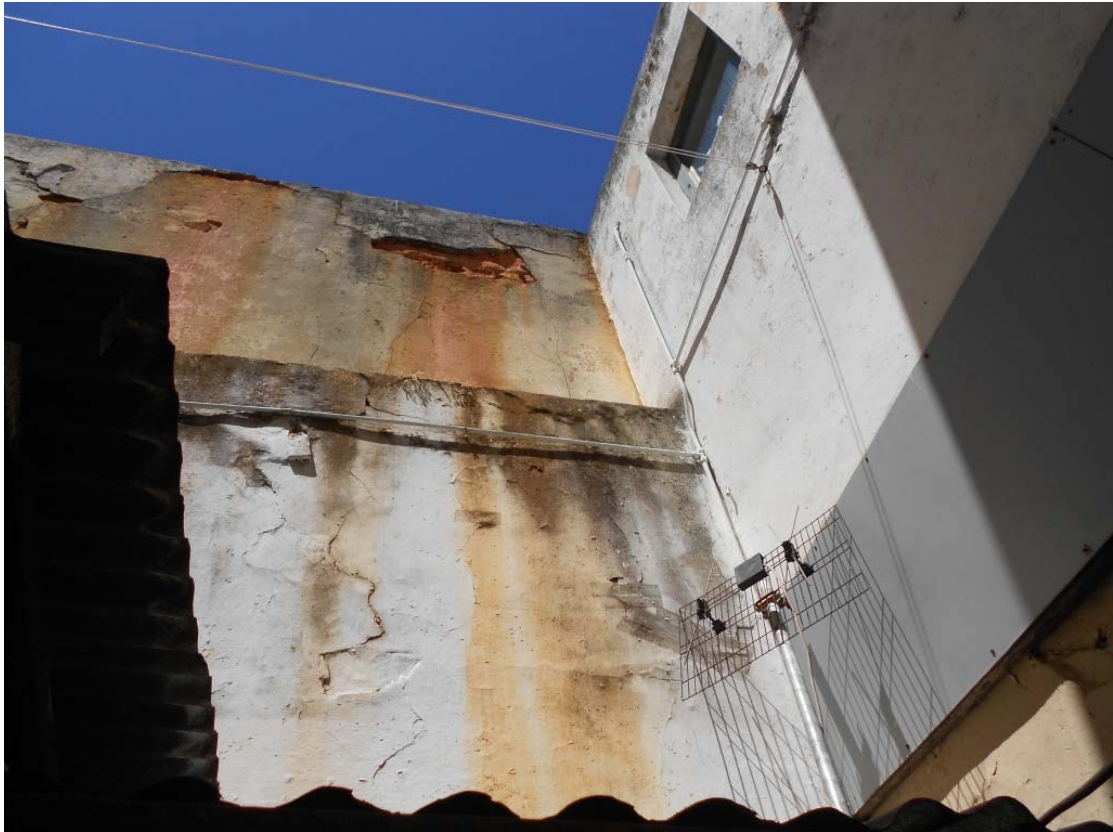
Photo 15: View inside back yard of barber shop. Notes as above.

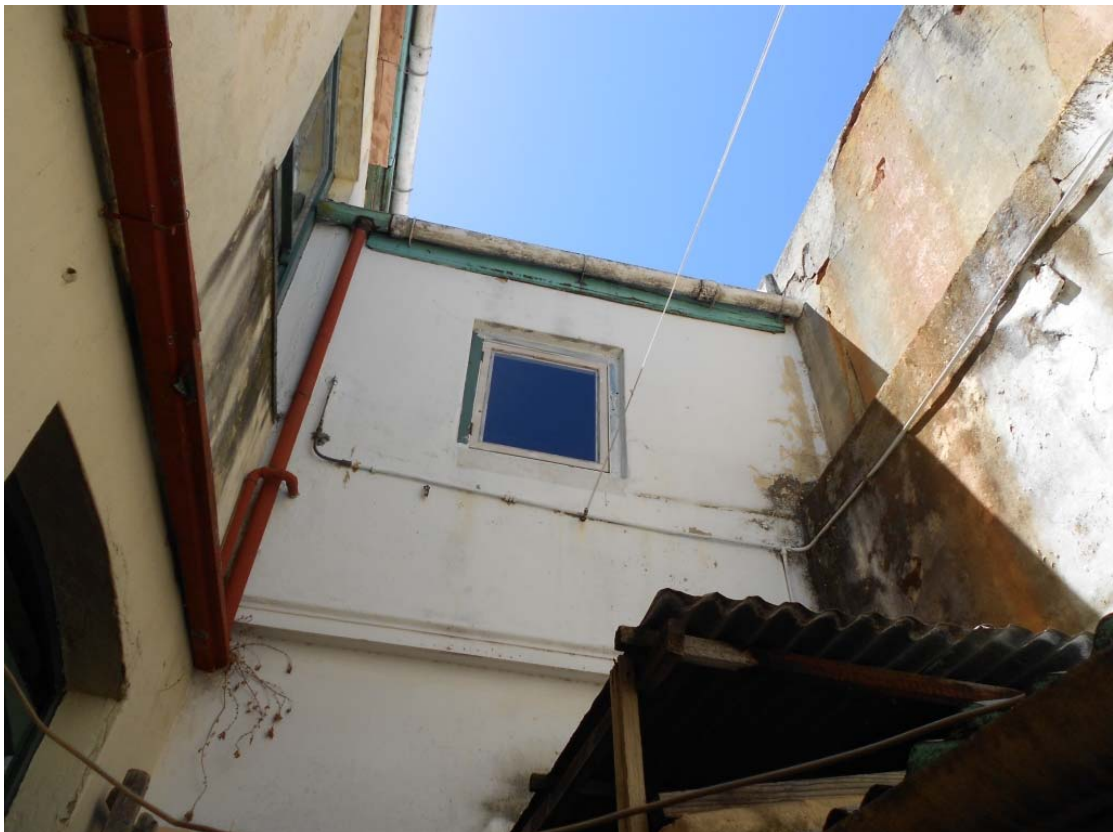
Photo 16: View inside back yard of barber shop. Notes as above.

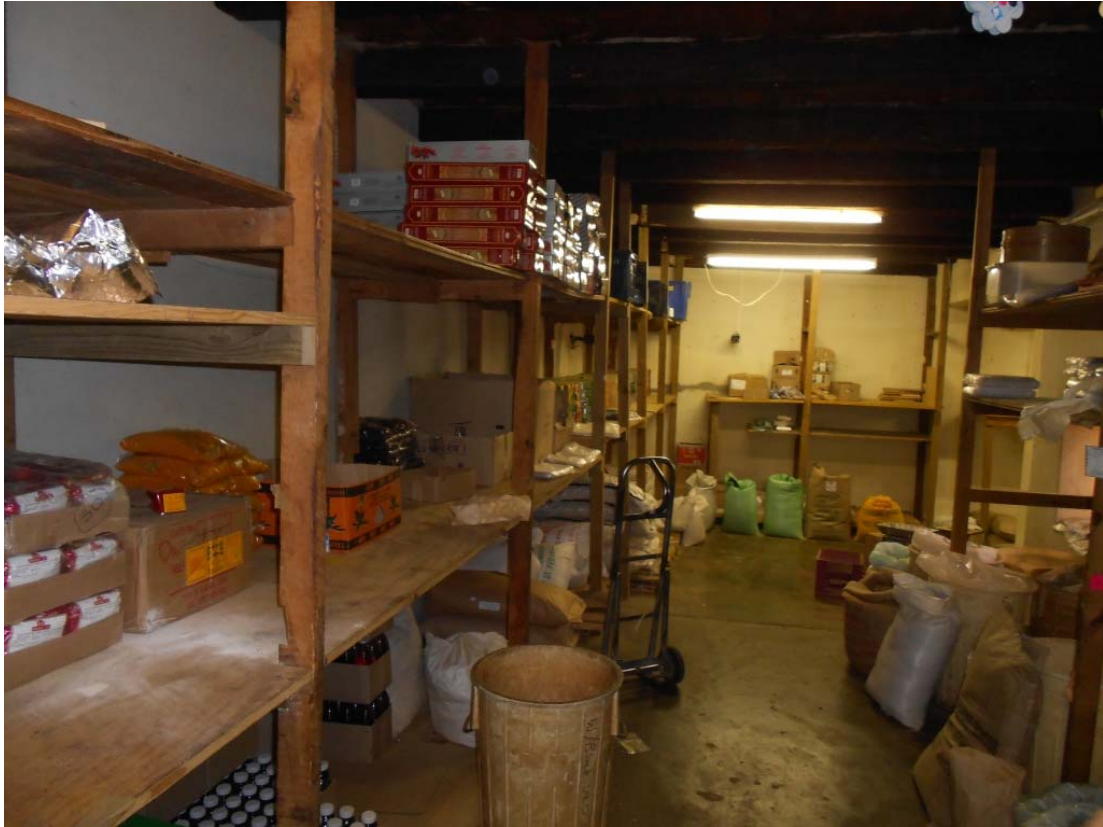
Atlas Trading comprises a double storey concrete frame structure, built approximately 35 years ago after a fire destroyed the original structure, and a double storey out-building where most of the bulk materials (spices) are stored. The suspended floor and the roof of the outbuilding comprise timber beams supported by the boundary wall.

Photo 19: View inside ground level storeroom behind Atlas Trading looking towards existing hotel. Left-hand wall backs onto Danny's Auto.

In order to allow the demolition of the boundary wall, a new independent structure will need to first be built to suspend the first floor and the roof of the store, and make them independent of the boundary wall. This structure could be constructed from brickwork or steel. Detail will be agreed with Mr Ahmed so as to ensure minimum disruption to his trade. During demolition Atlas Trading will be kept informed of critical activities and will be accommodated in terms of their requirements.

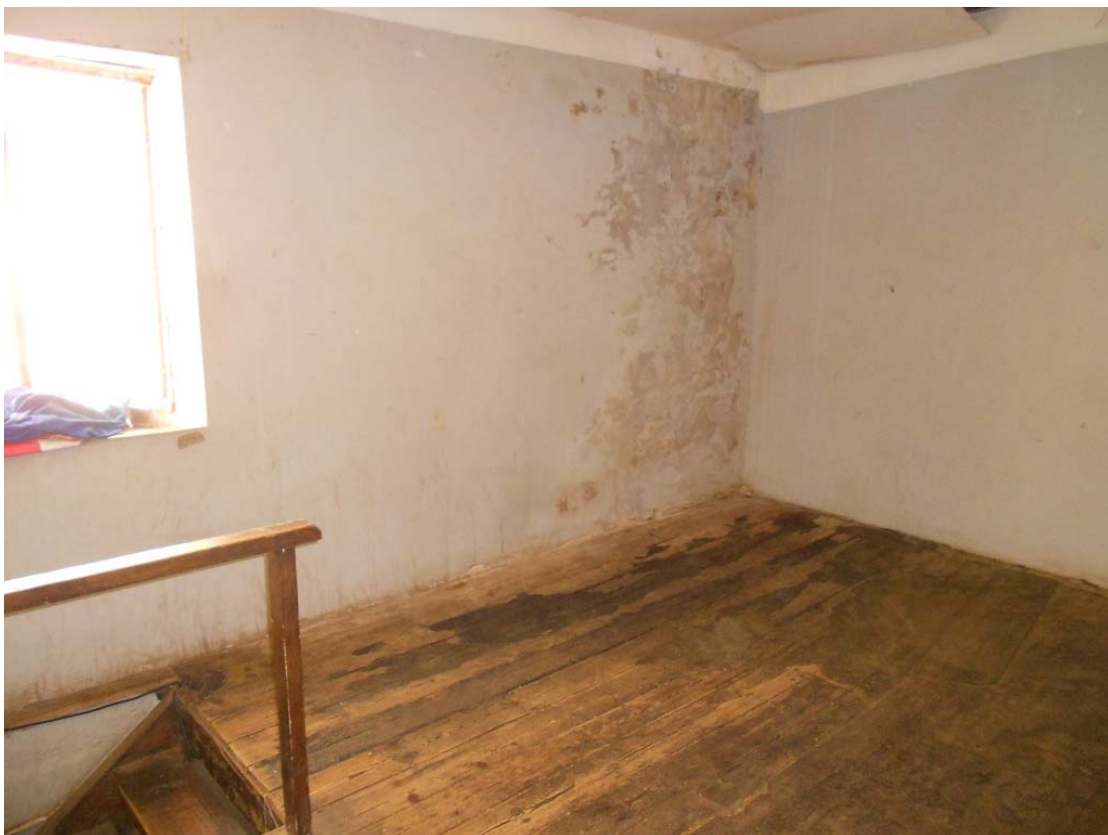
Photo 20: View inside first level storeroom behind Atlas Trading looking away from existing hotel.

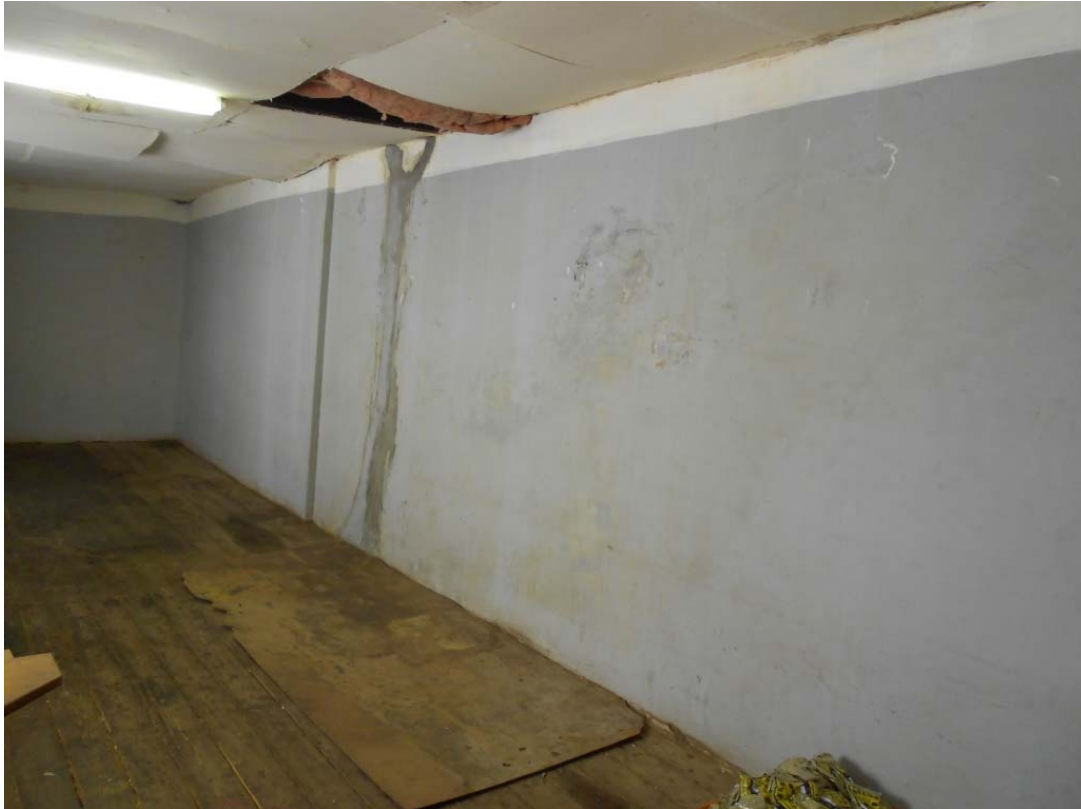
Photo 21: View inside upper level storeroom behind Atlas Trading. Right-hand wall backs onto Danny's Auto

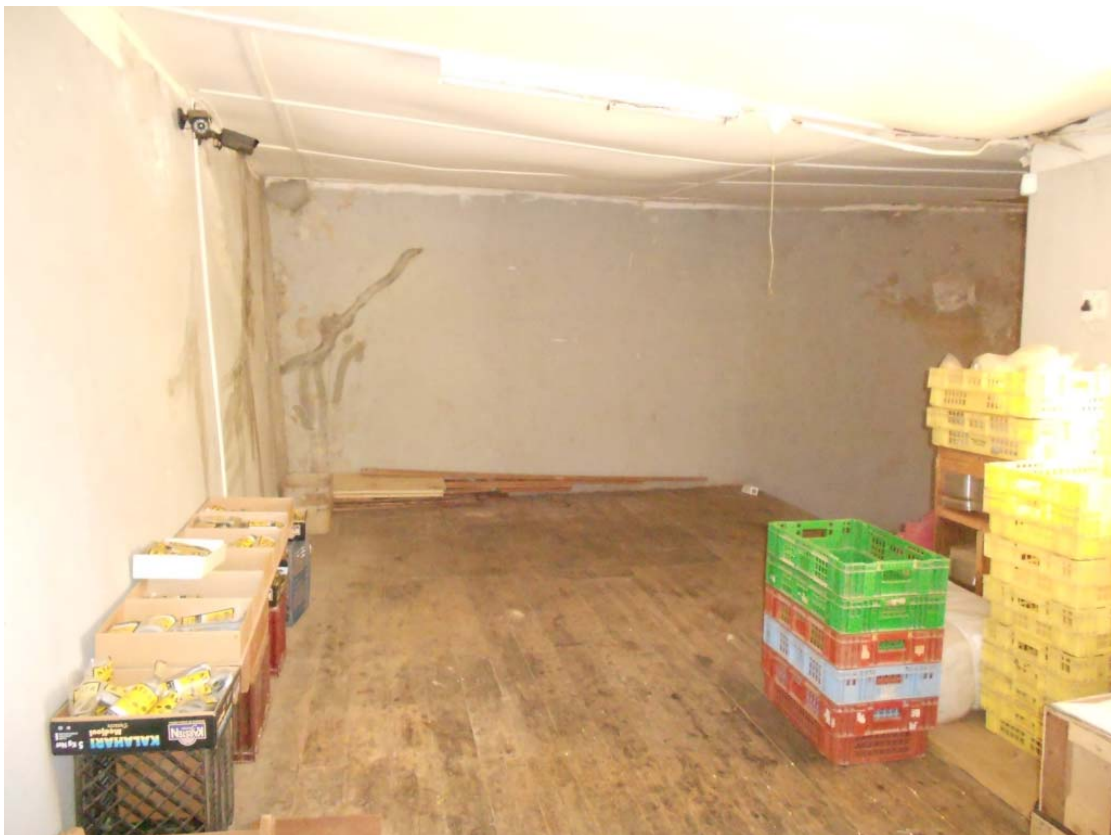
At the outset Mr Ahmed expressed displeasure with the lack of response from the Hilton Hotel, who he says caused cracking to his storeroom during construction on the adjacent site. The project manager in charge of the construction of the Hilton has been contacted, and has in turn contacted the owner, both of whom confirm this to be the first time that they have been notified of this outstanding issue. Contact will be made with Mr Ahmed in this regard to rectify any and all such items.

The concrete framed structure, housing the trading floor and some changing areas and office space upstairs is in a good state and has been well maintained. Being “back-of-house”, the out-building has undergone far less maintenance, but is nevertheless structurally sound. Cracks in the wall, originate from the construction of the Hilton, and are addressed above (see photo 22 in Appendix C).

Photo 22: View inside upper level storeroom behind Atlas Trading looking towards existing hotel. Left-hand wall backs onto Danny's Auto.
