CONGELLA POWER STATION ("THE OLD SMOKEY")

110 SOUTH COAST ROAD ON:

Report by: G. S Bester (EPA)

**Revamped JLR Premises
110 South Coast Road
Umbilo Industrial Durban 4075**

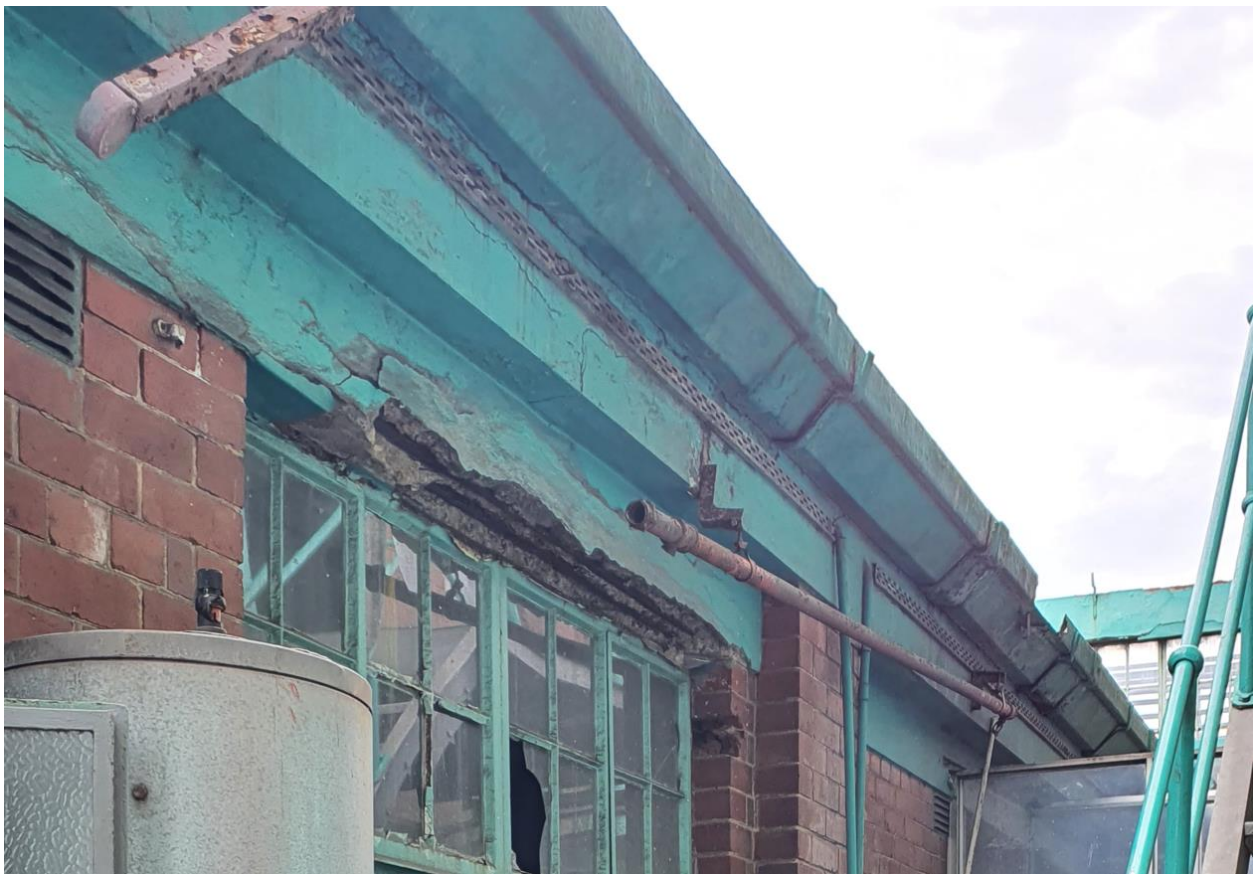
A decorative concrete ring beam have been constructed for structural stability as well as acting as a lintel above all the external windows and doors. Over the years the steel rebar within the ring main has eroded to a point where the Spalding has compromised the structural stability of the beams and roof structure.

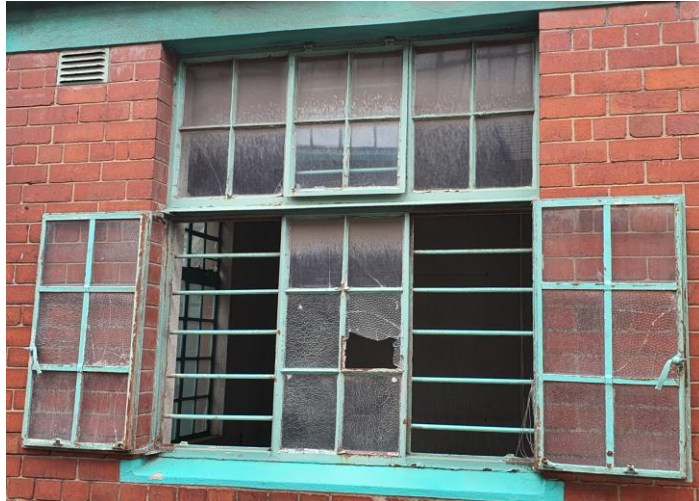
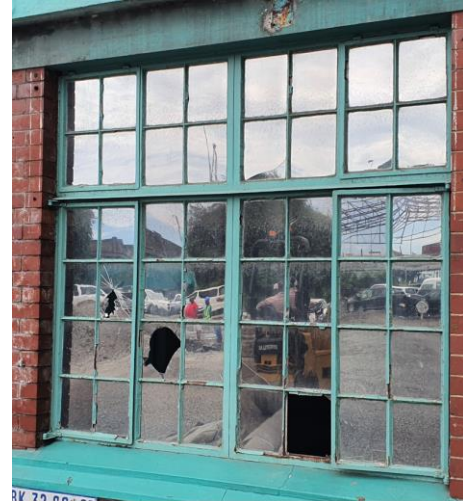
Some of the original steel windows has remarkably survived the relentless onslaught of the Durban corrosive air over the decades. Although still present, much of its functionality is lost due

to rust corrosion. Most of the glass have been broken or cracked, possibly due to vandalism during its vacant period. Various types of glass are evident, most of which appears to be obscured glass.

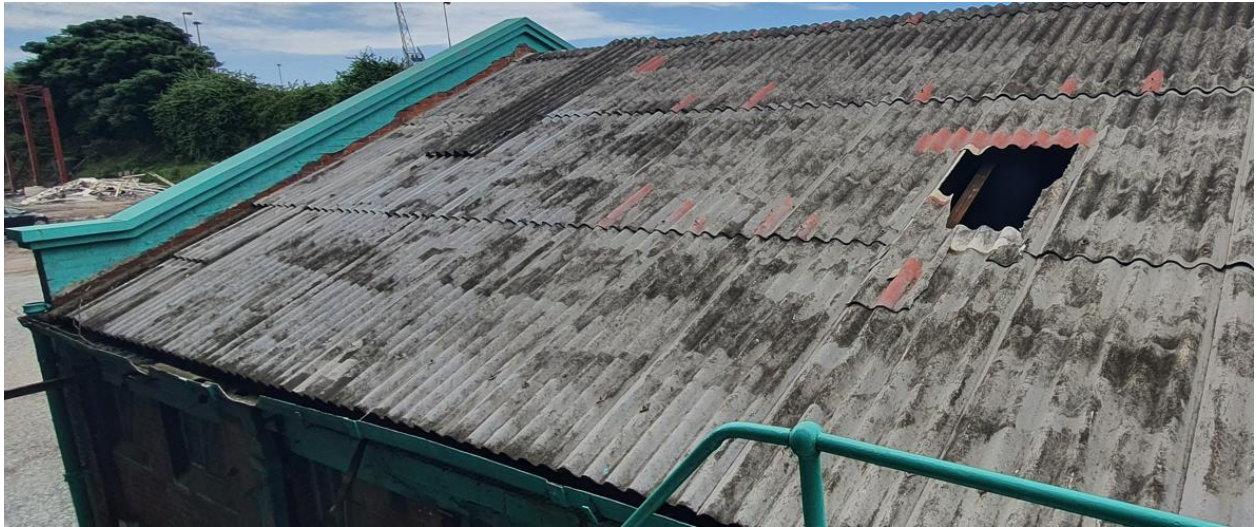
The existing roof sheeting are believed to be made from Asbestos. Asbestos was aggressively mined even before the construction of the Congella Power Station in 1928. Asbestos mining has only ceased as recently as 2002 and has been the leading cause of mesothelioma of which South

Africa having the largest cases in the world. The existing roof in building A has been damaged before and repairing the roof is not optional due to the high risk associated with Asbestos.⁶

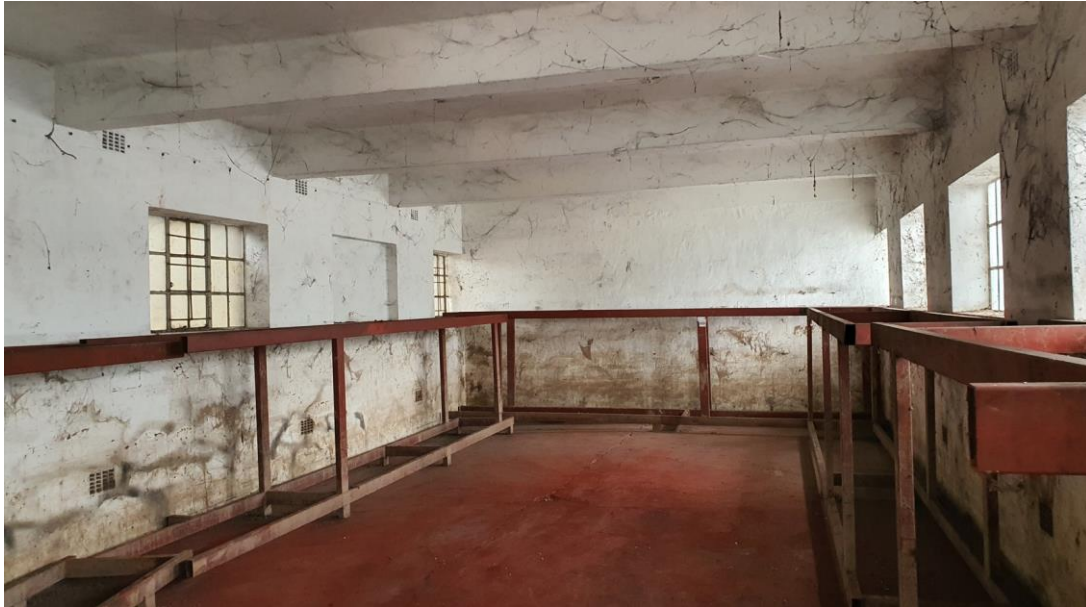
The lower ground floor has been used as storage in the past and after the 2022 floods, the building has been left derelict. The flood waters have reached a depth up to 1.2m at some places and has caused extensive damage to the building's infrastructure.

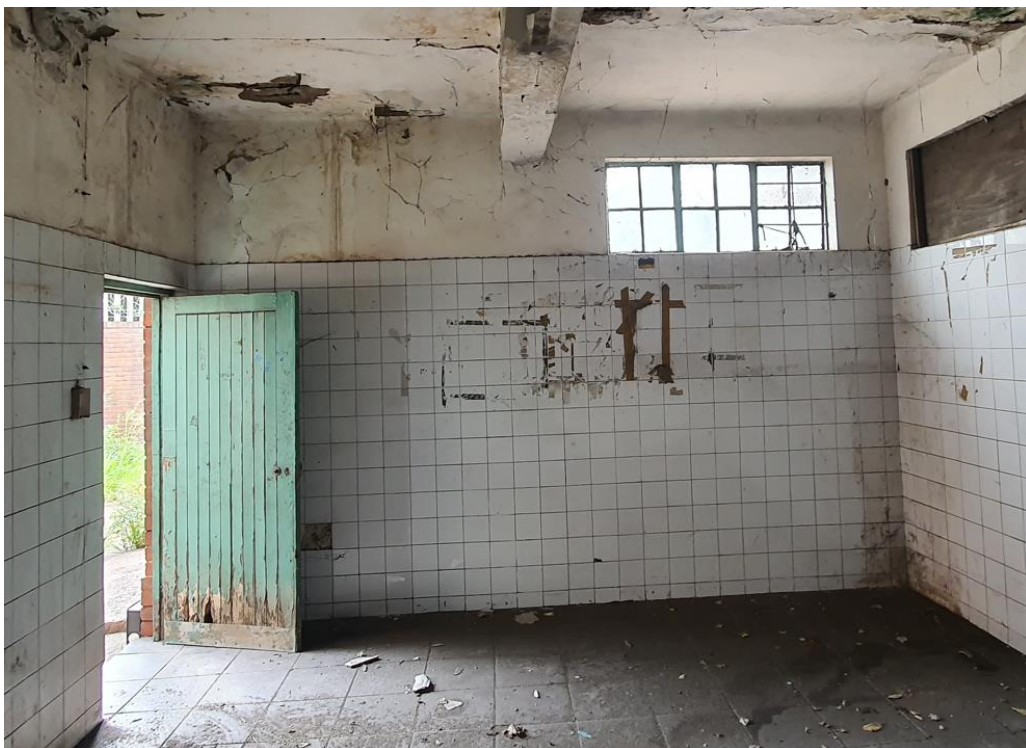
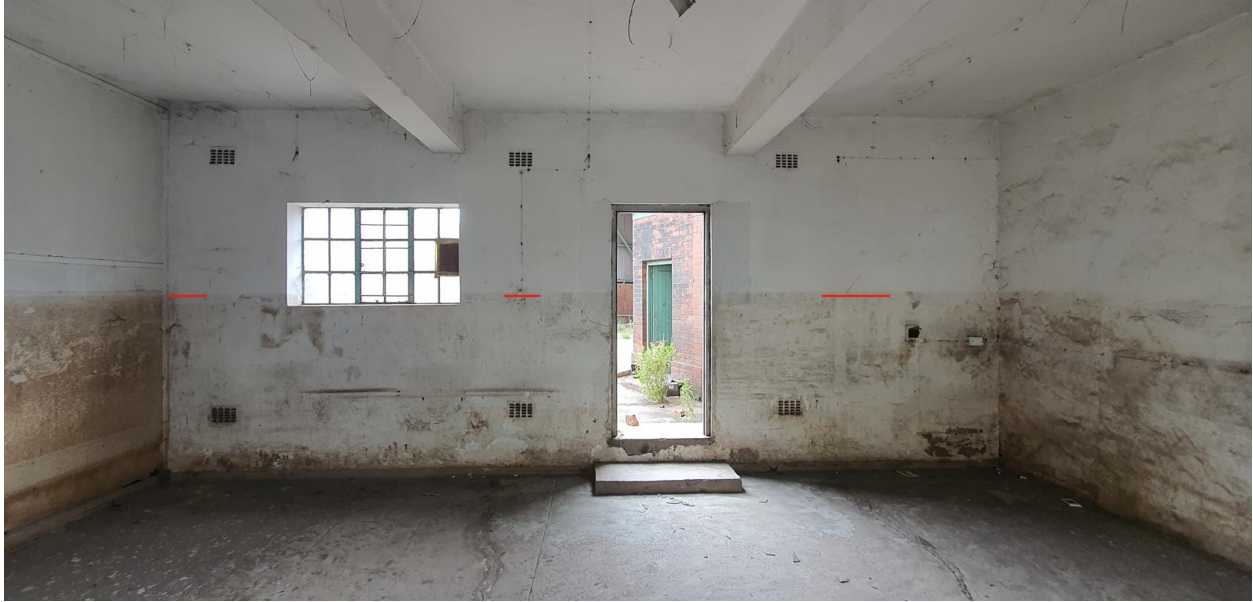
Most of the existing electrical fixtures and plumbing items has been vandalized and stolen from the property during the past year rendering the building unusable.

Important services such as fire hose reels and fire hydrants have been stolen and even some of the plumbing have been removed. Leaving the rest of the services to corrode under the Durban environment.

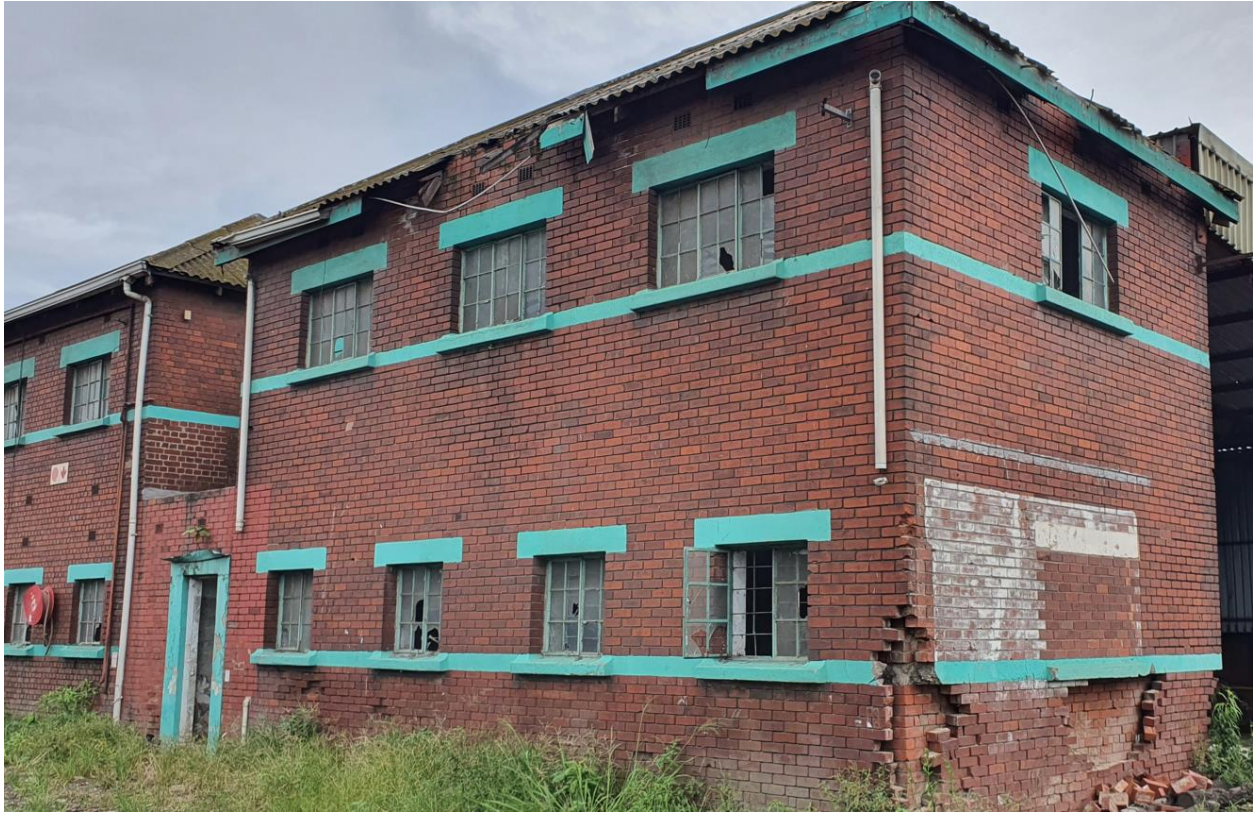
Building C and D have also experience extensive damage from the floods and subsequent vandalism and theft.

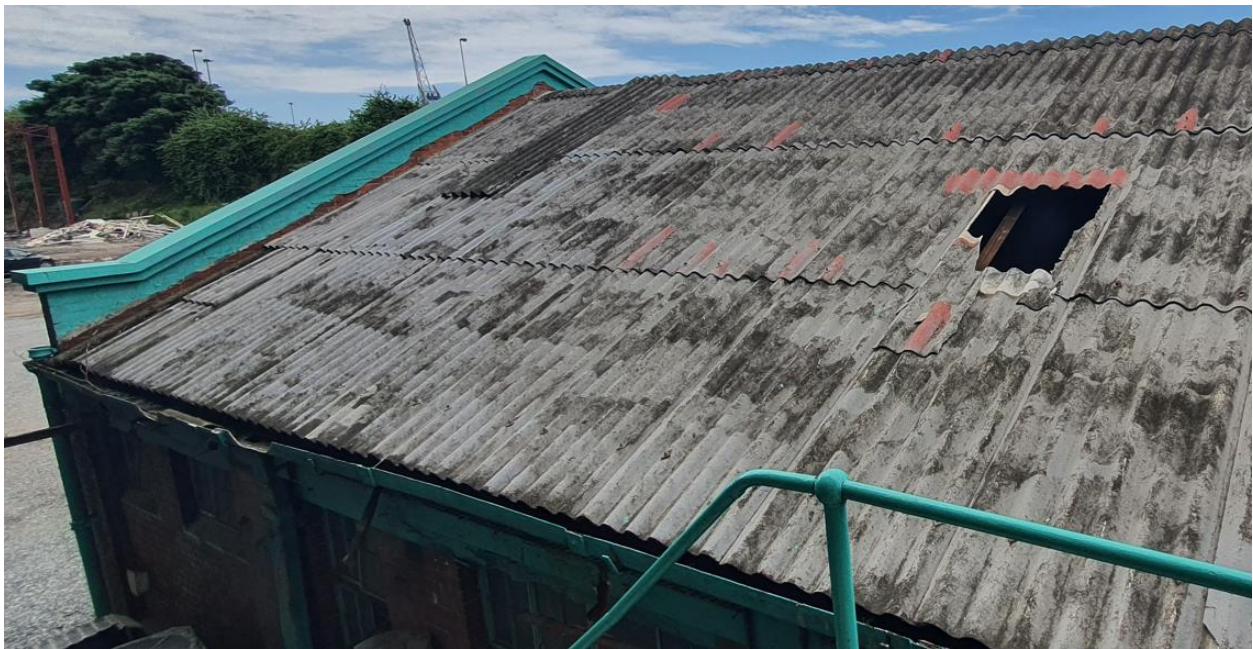
Roof damage to Building A

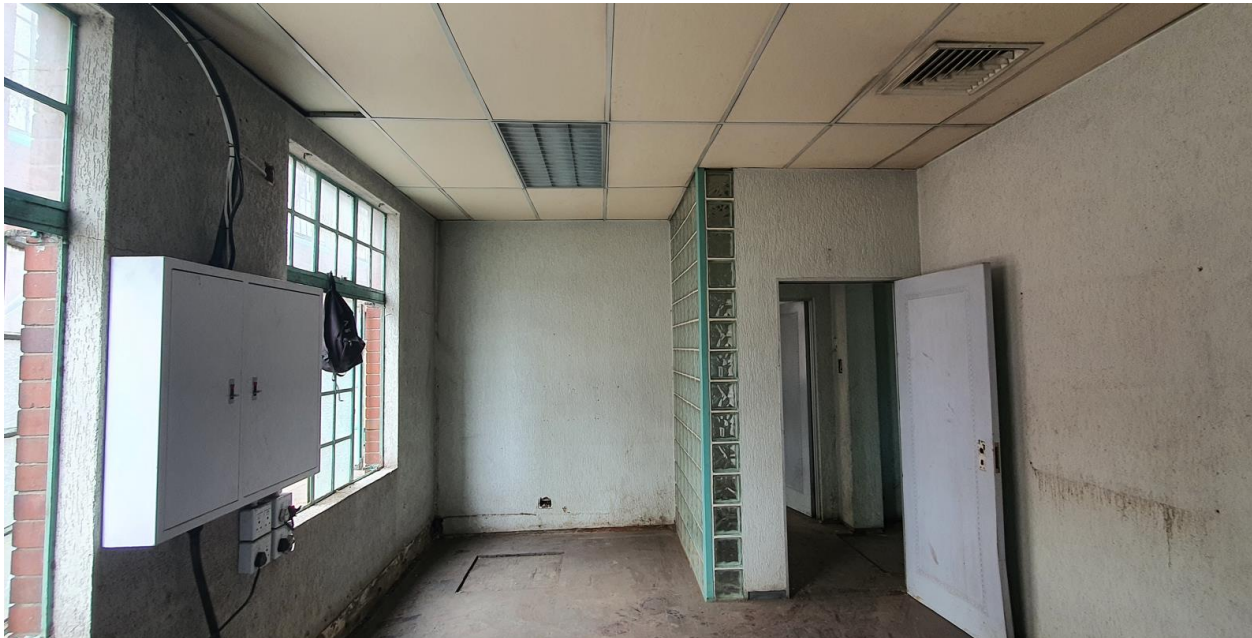
Typical Wall finishes in Building A. Note the modern glass blocks being used as well as the absence of timber skirtings. All doors were damaged during the floods. For more pictures, please see attached folder.

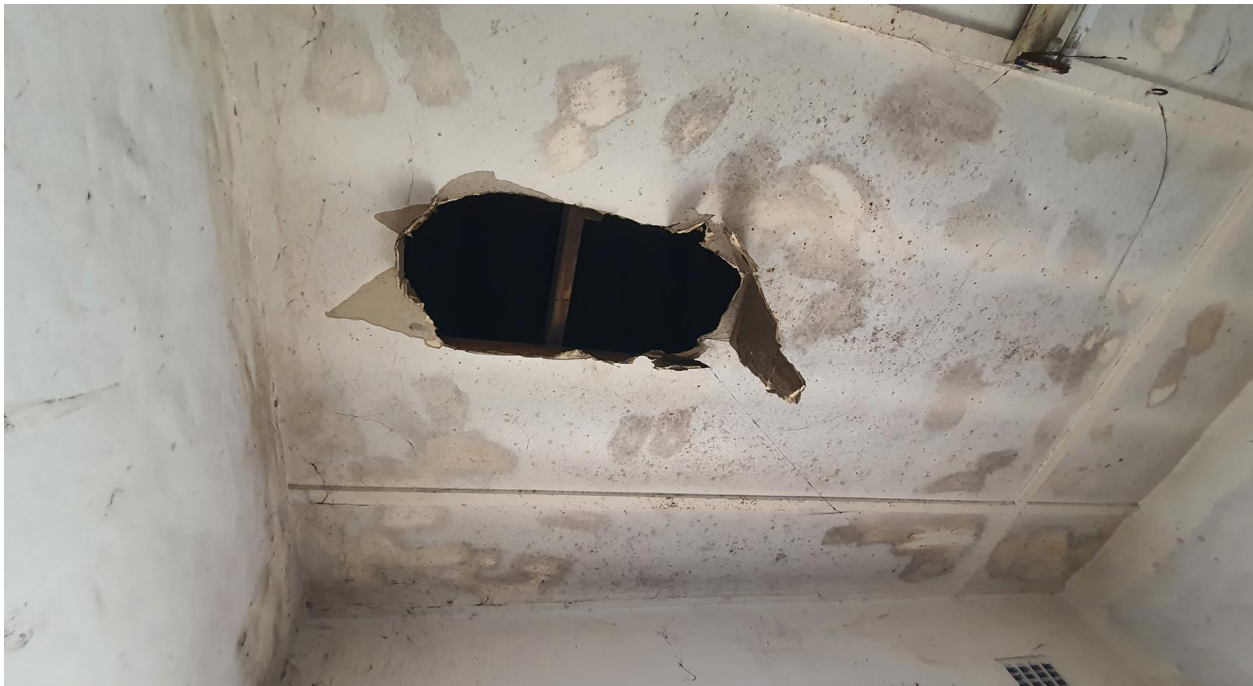
General Ceiling Damage

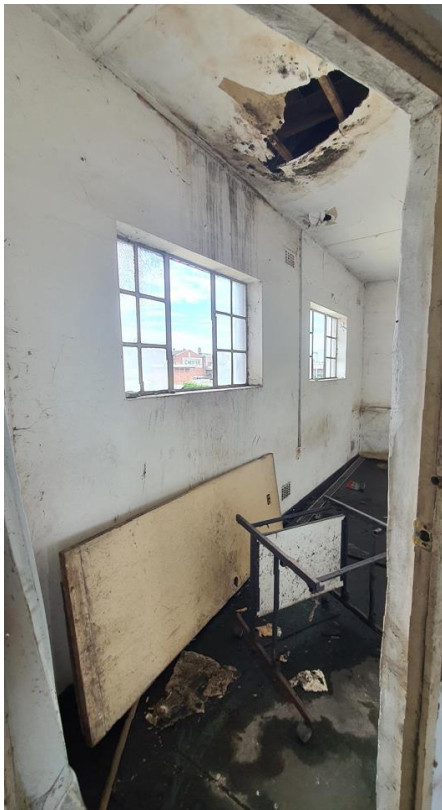
Third Floor water damage

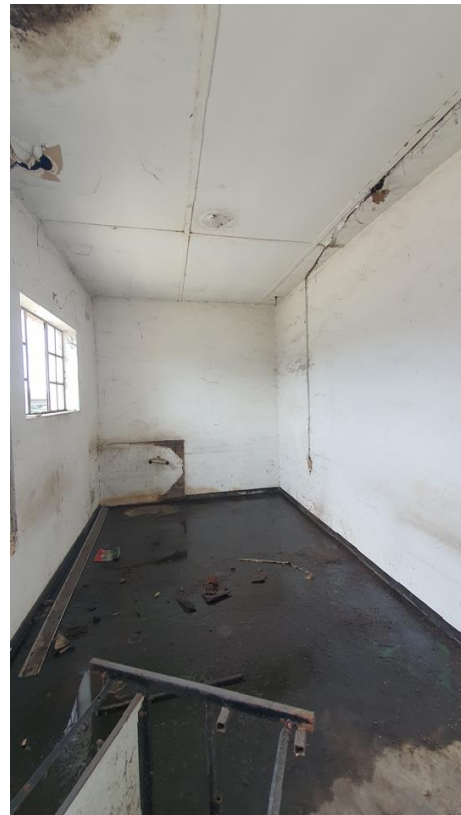
Third Floor water damage

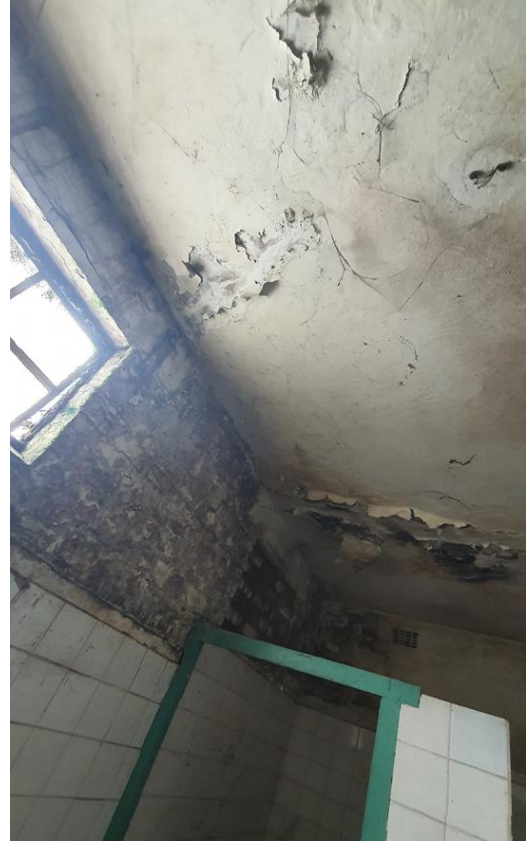
First Floor Ablution. Note water damage.

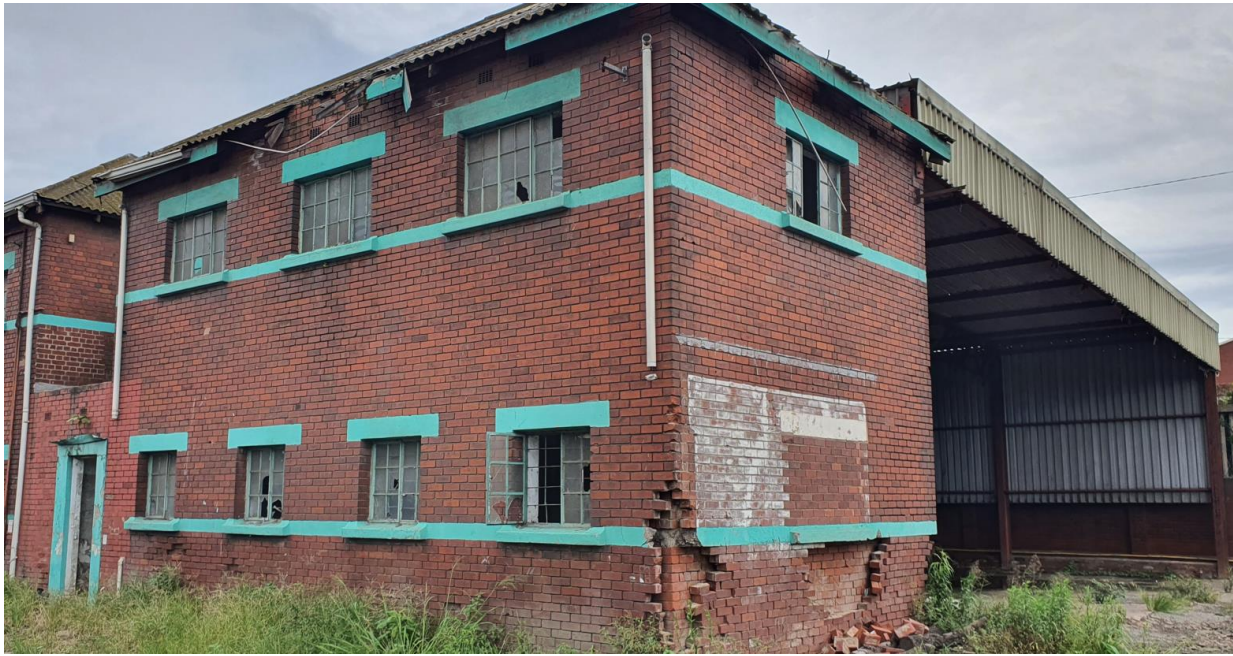
Structural Damage are evident to Building D to the North.

Damage to the North East corner
