## Appendix 3: Photographs

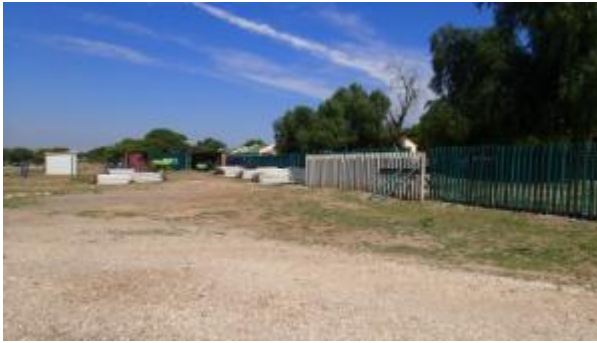
**Photograph 1:** Component 1 - Concrete Pole Fence around Core Area under construction.

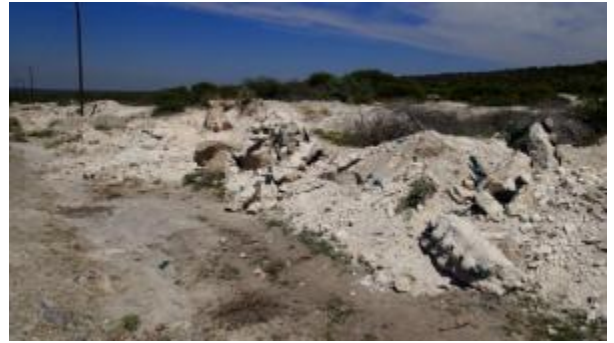
**Photograph 2:** Component 1 - Previous fence needs to be disposed of appropriately.

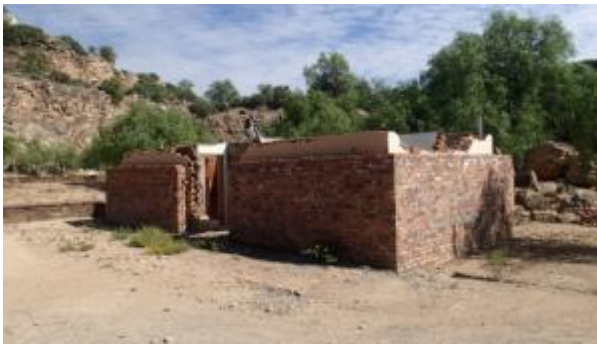
**Photograph 3:** Component 2 - The ablation facility at the Blue Pools picnic site is under construction.

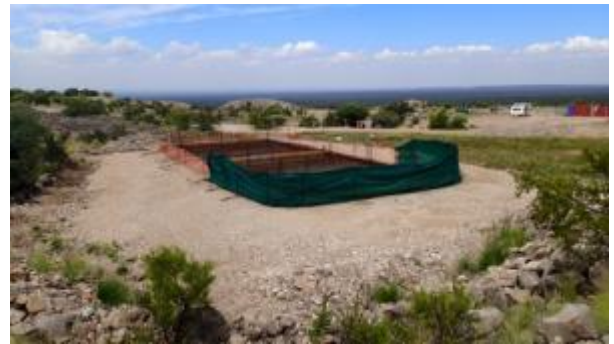
**Photograph 4:** Component 3 - The ablation facility at Thomeng Falls is under construction.

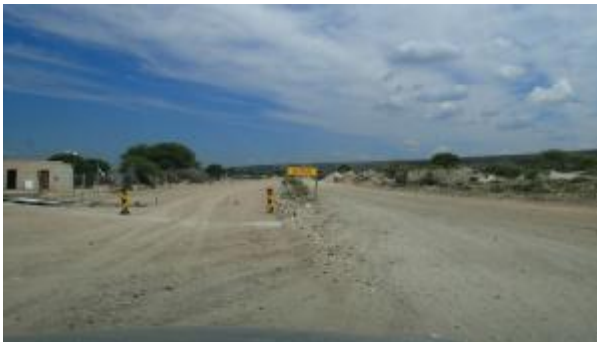
**Photograph 5:** Component 4 - Road to Thomeng is under construction.

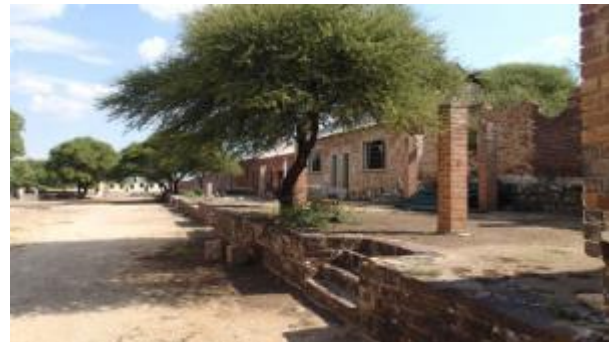
**Photograph 6:** Component 5 - Mine Workers Compound is to be restored.

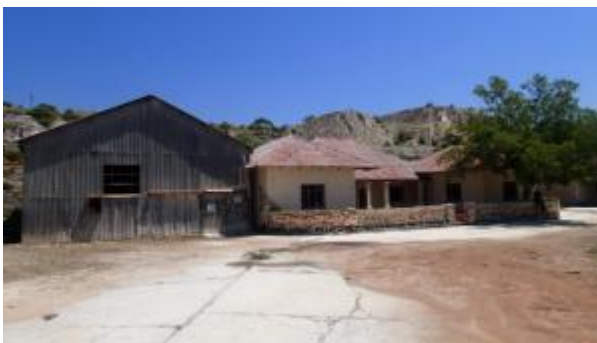
**Photograph 7:** Component 6 - Mine Manager's Office to be restored.

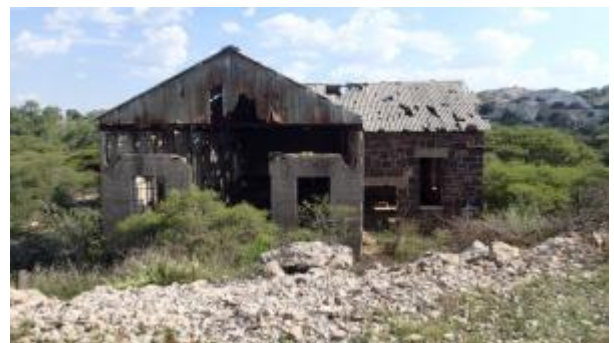
**Photograph 8:** Component 7 - Power House to be restored.

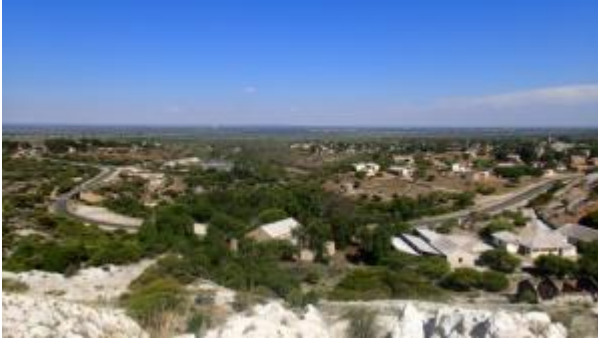
**Photograph 9:** Component 8 - The improvement of the proposed entrance area and parking area can be done so as to screen parking

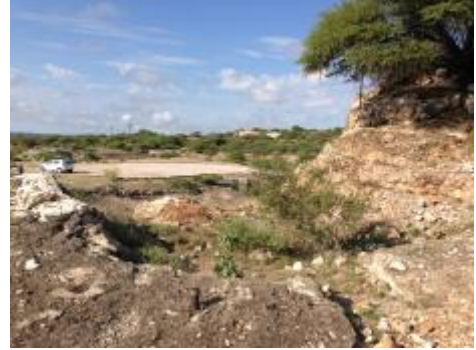
**Photograph 10:** Component 9a - Hrdlička's, a sensitive heritage site requiring conservation

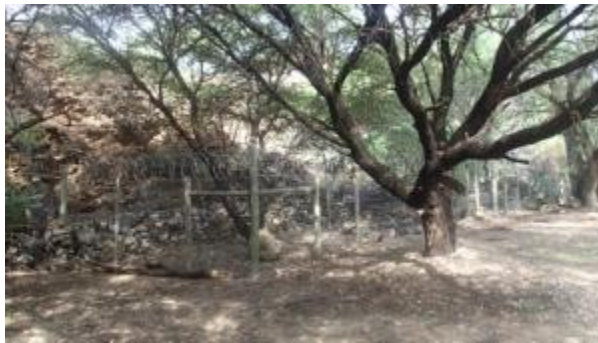
**Photograph 11:** Component 9b - Equus Cave, a sensitive heritage site requiring conservation measures.

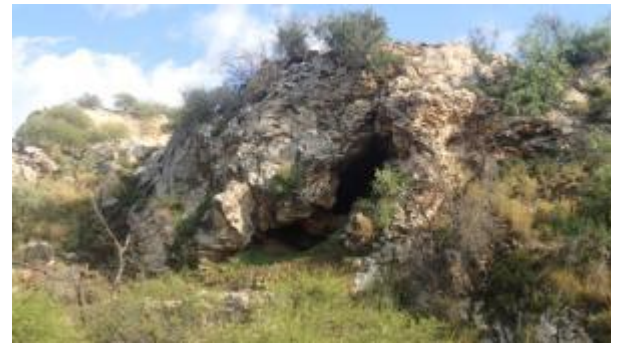
**Photograph 12:** Component 9c - Black Earth Cave, a sensitive heritage site requiring conservation measures.

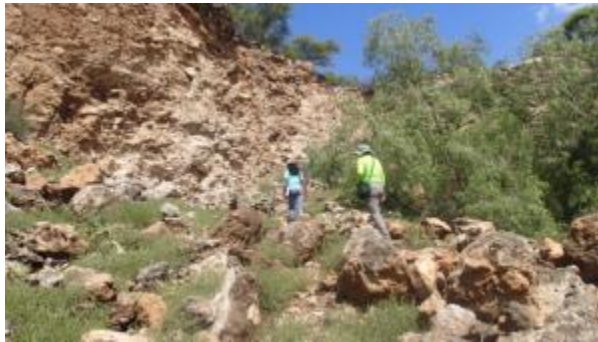
**Photograph 13:** Component 9d - Oxland Large Mammal Fossil Site, a sensitive heritage site requiring conservation measures.

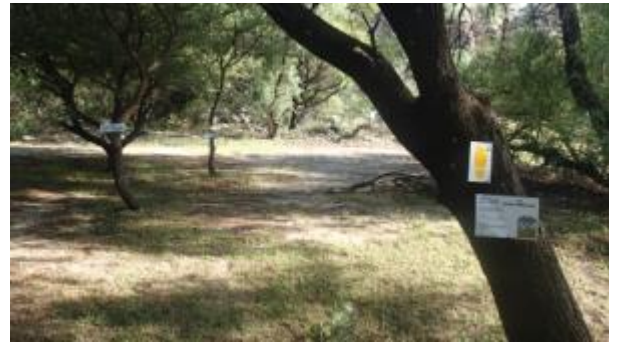
**Photograph 14:** Component 10 - Signage along existing trails.

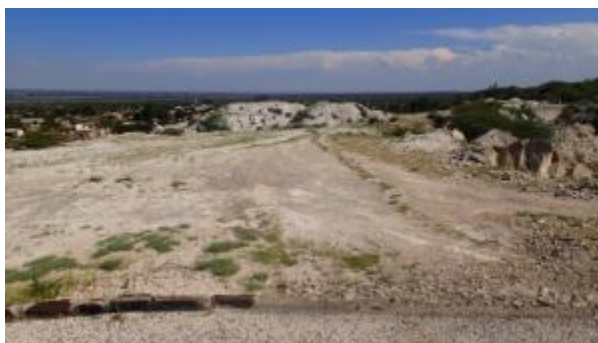
**Photograph 15:** Component 11 - Memorial site and proposed pavilion site.

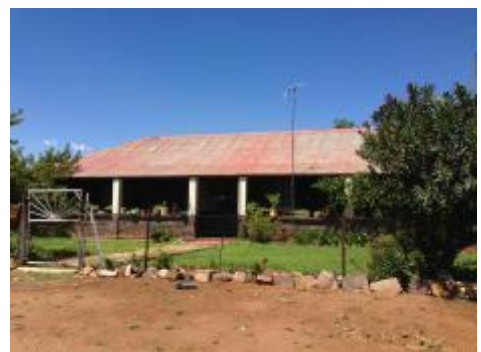
**Photograph 16:** Component 13 - Historic building in Buffer Zone.
