TAUNG SKULL WORLD HERITAGE SITE: BUILT LANDSCAPE INVENTORY OF SELECTED BUILDINGS AND STRUCTURES

The HIA, which is in the process of being conducted on the TSWHS, provides an opportunity to showcase the value of such an approach and output. The Built Landscape Inventory is a catalogue of buildings falling within both the Core and Buffer Zones and attempts to provide a very simplistic vantage point and baseline, from where the assessment and planning process can unfold. The purpose of the Built Landscape Inventory is to provide a list of key buildings, an assessment of the condition and the possible repurposing of the facilities into functional entities. This provides an initial recording of baseline data on the built landscape that can be further developed into a management [development and maintenance] plan for the built landscape at TSWHS.

The Built Landscape Inventory is compiled for the following Preliminary Zones and Sites on the TSWHS:

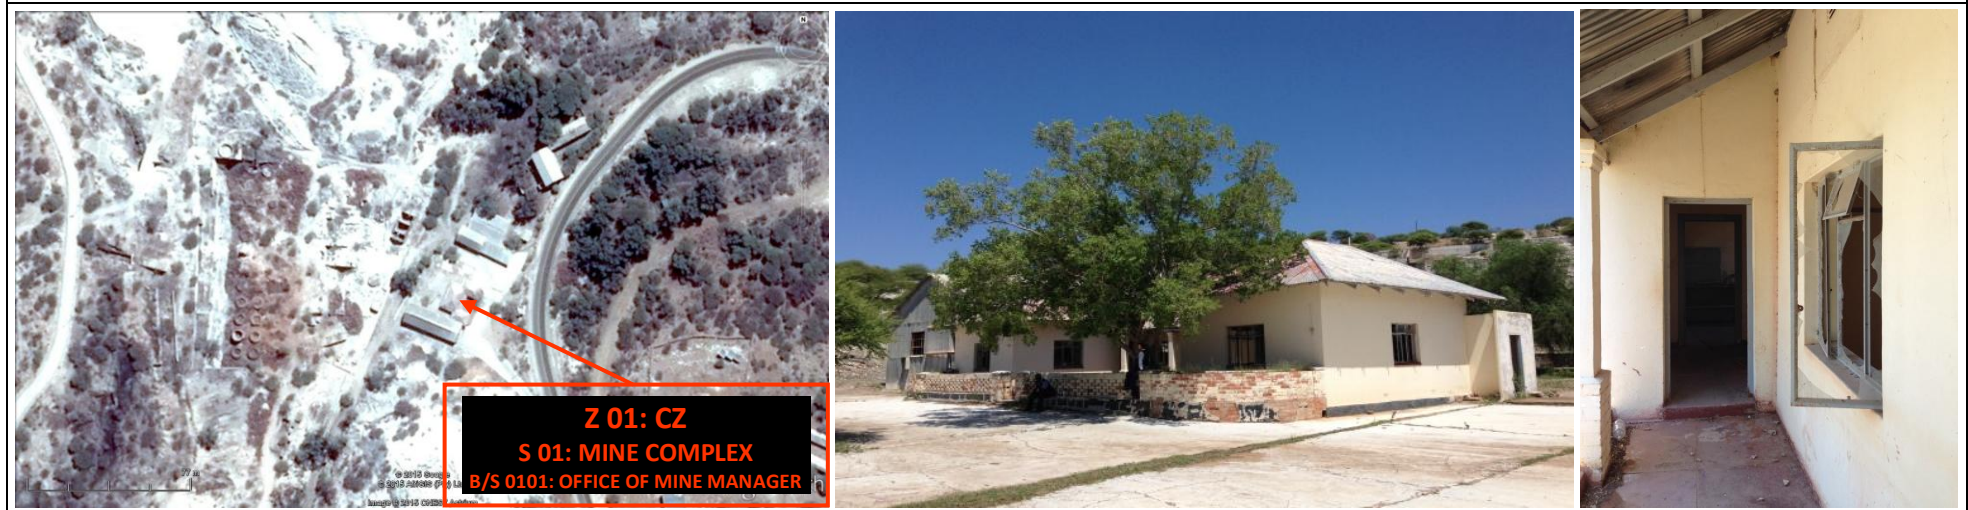
FIGURE 01 • PHOTOGRAPH 01 • Zone 01 [Z 01]: Core Zone [CZ] • Site 01 [S 01]: Mine Complex • Building/Structure 0101 [B/S 0101]: Office of Mine Manager • Date: 24 February 2015

SITE & RELATIVE LOCALITY	BUILDING/STRUCTURE & RELATIVE POSITION	CONSTRUCTION MATERIALS & METHODS	HISTORICAL & CURRENT USES	CURRENT STATE & CONDITION	RESTORATION POTENTIAL & PRIORITY	PROPOSED FUTURE USES
<ul style="list-style-type: none"> ● Site 01: Mine Complex ● Relative Locality: Approaching from the North, Site 01 is situated on the Western Side of the Main Entrance Road to the Norlim/Buxton Mine Town, just after passing over the Road Bridge and just before reaching the Trading Store [refer to Figure 01] 	<ul style="list-style-type: none"> ● Building/Structure 0101: Office of Mine Manager [refer to Photograph 01] ● Relative Position: Central Building on Mine Complex Site [refer to Figure 01] 	<ul style="list-style-type: none"> ● Construction Materials: Bricks, cement, steel, glass, wood and corrugated iron ● Construction Methods: Brick and plaster structure, covered by wooden roof trusses, clad with corrugated iron roof sheets 	<ul style="list-style-type: none"> ● Historical Use: Office of Mine Manager ● Current Use: Not in use 	<ul style="list-style-type: none"> ● State: Vandalised ● Condition: Good <ul style="list-style-type: none"> ○ Basic structure in good condition, but should be restored ○ Fenestration and doors [steel and wood] partly removed, but should be restored and replaced, where necessary ○ Floor covering [wood planks] partly removed in some passages and rooms, but should be restored and replaced, where necessary ○ Roof support structure [wood trusses] present, but should be checked for structural integrity and should be restored and replaced, where necessary ○ Roof covering [corrugated iron roof sheets] present, but should be restored and replaced, where necessary ○ All interior installations have been removed and should be replaced with authentic items ○ Basic services should be installed and connected 	<ul style="list-style-type: none"> ● Restoration potential: Good ● Restoration priority: High 	<p>Site Office of the Taung Skull World Heritage Site</p>

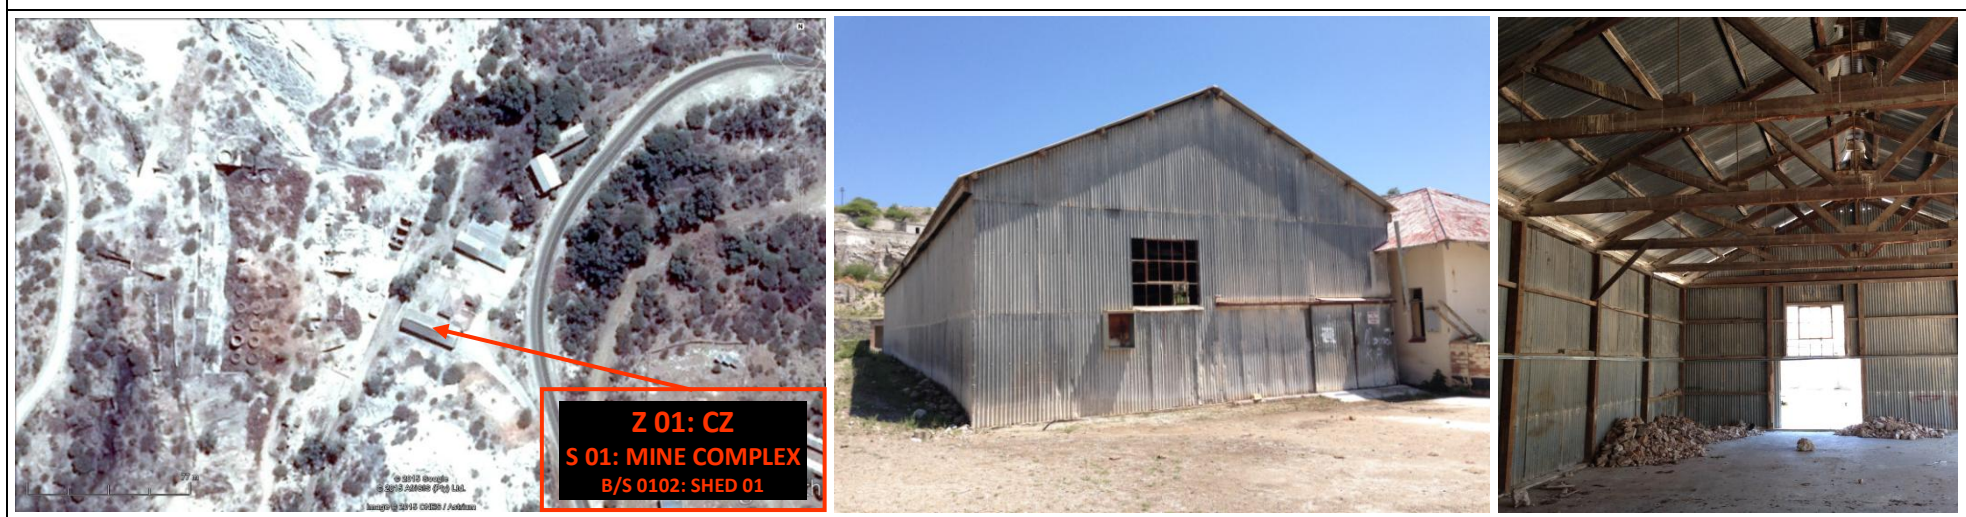
FIGURE 02 • PHOTOGRAPH 02 • Zone 01 [Z 01]: Core Zone [CZ] • Site 01 [S 01]: Mine Complex • Building/Structure 0102 [B/S 0102]: Shed 01 • Date: 24 February 2015

SITE & RELATIVE LOCALITY	BUILDING/STRUCTURE & RELATIVE POSITION	CONSTRUCTION MATERIALS & METHODS	HISTORICAL & CURRENT USES	CURRENT STATE & CONDITION	RESTORATION POTENTIAL & PRIORITY	PROPOSED FUTURE USES
<ul style="list-style-type: none"> ● Site 01: Mine Complex ● Relative Locality: Approaching from the North, Site 01 is situated on the Western Side of the Main Entrance Road to the Norlim/Buxton Mine Town, just after passing over the Road Bridge and just before reaching the Trading Store [refer to Figure 02] 	<ul style="list-style-type: none"> ● Building/Structure 0102: Shed 01 [refer to Photograph 02] ● Relative Position: Building adjoining and just South-East of the Office of Mine Manager [refer to Figure 02] 	<ul style="list-style-type: none"> ● Construction Materials: Steel, glass, wood and corrugated iron ● Construction Methods: Steel and wood structure with a concrete slab floor, clad with corrugated iron sheets and covered with wood roof trusses, clad with corrugated iron roof sheets 	<ul style="list-style-type: none"> ● Historical Use: Storage ● Current Use: Not in use 	<ul style="list-style-type: none"> ● State: Vandalised ● Condition: Good <ul style="list-style-type: none"> ○ Basic structure in good condition, but should be restored ○ Fenestration and doors [steel] partly removed, but should be restored and replaced, where necessary ○ Floor covering [concrete slabs] present, but should be replaced and restored, where necessary ○ Roof support structure [wood trusses] present, but should be checked for structural integrity and should be restored and replaced, where necessary ○ Roof covering [corrugated iron roof sheets] present, but should be restored and replaced, where necessary ○ All interior installations have been removed and should be replaced with authentic items ○ Basic services should be installed and connected 	<ul style="list-style-type: none"> ● Restoration potential: Good ● Restoration priority: High 	Recycled Use, complementing the Site Office of the Taung Skull World Heritage Site

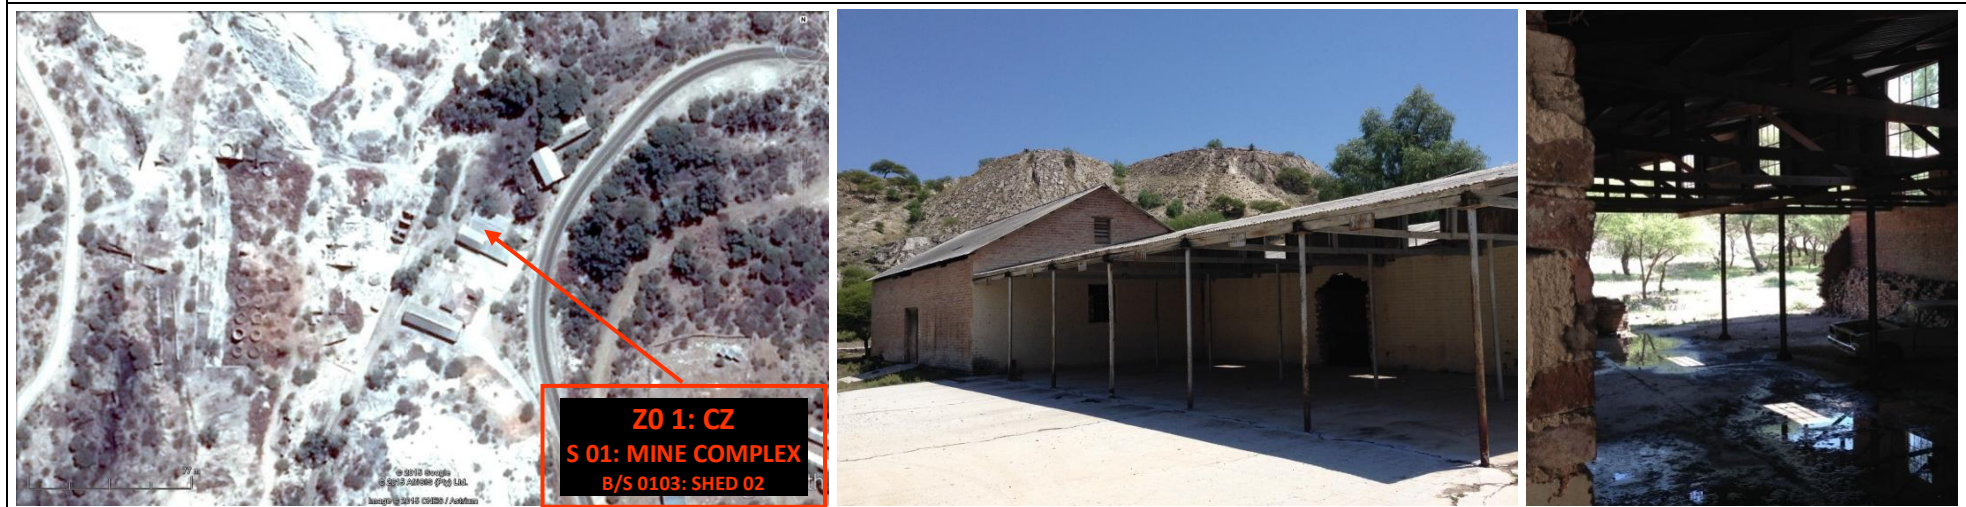
FIGURE 03 • PHOTOGRAPH 03 • Zone 01 [Z 01]: Core Zone [CZ] • Site 01 [S 01]: Mine Complex • Building/Structure 0103 [B/S 0103]: Shed 02 • Date: 24 February 2015

SITE & RELATIVE LOCALITY	BUILDING/STRUCTURE & RELATIVE POSITION	CONSTRUCTION MATERIALS & METHODS	HISTORICAL & CURRENT USES	CURRENT STATE & CONDITION	RESTORATION POTENTIAL & PRIORITY	PROPOSED FUTURE USES
<ul style="list-style-type: none"> ● Site 01: Mine Complex ● Relative Locality: Approaching from the North, Site 01 is situated on the Western Side of the Main Entrance Road to the Norlim/Buxton Mine Town, just after passing over the Road Bridge and just before reaching the Trading Store [refer to Figure 03] 	<ul style="list-style-type: none"> ● Building/Structure 0103: Shed 02 [refer to Photograph 03] ● Relative Position: Building just North-East of the Office of Mine Manager [refer to Figure 03] 	<ul style="list-style-type: none"> ● Construction Materials: Bricks, cement, steel, glass, wood and corrugated iron ● Construction Methods: Brick and plaster structure with a concrete slab floor, covered by wooden roof trusses, clad with corrugated iron roof sheets 	<ul style="list-style-type: none"> ● Historical Use: Parking for Mine Management and Storage ● Current Use: Not in use 	<ul style="list-style-type: none"> ● State: Vandalised ● Condition: Fair <ul style="list-style-type: none"> ○ Basic structure in good condition, but should be restored ○ Fenestration and doors [steel and wood] partly removed, but should be restored and replaced, where necessary ○ Floor covering [concrete slabs] present, but should be restored and replaced, where necessary ○ Roof support structure [wood trusses] present, but should be checked for structural integrity and should be restored and replaced, where necessary ○ Roof covering [corrugated iron roof sheets] present, but should be restored and replaced, where necessary ○ All interior installations have been removed and should be replaced with authentic items ○ Basic services should be installed and connected 	<ul style="list-style-type: none"> ● Restoration potential: Fair ● Restoration priority: High 	Recycled Use, complementing the Site Office of the Taung Skull World Heritage Site

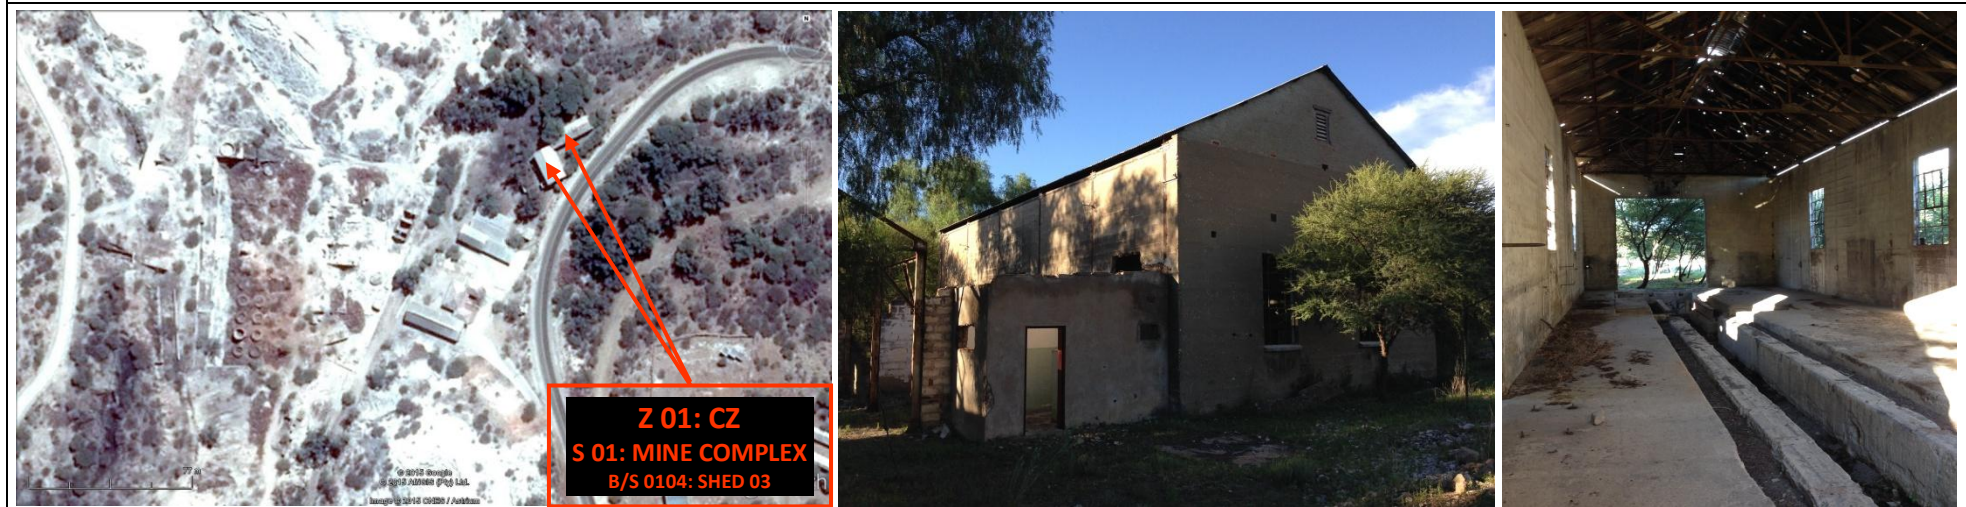
FIGURE 04 • PHOTOGRAPH 04 • Zone 01 [Z 01]: Core Zone [CZ] • Site 01 [S 01]: Mine Complex • Building/Structure 0104 [B/S 0104]: Shed 03 • Date: 24 February 2015

SITE & RELATIVE LOCALITY	BUILDING/STRUCTURE & RELATIVE POSITION	CONSTRUCTION MATERIALS & METHODS	HISTORICAL & CURRENT USES	CURRENT STATE & CONDITION	RESTORATION POTENTIAL & PRIORITY	PROPOSED FUTURE USES
<ul style="list-style-type: none"> ● Site 01: Mine Complex ● Relative Locality: Approaching from the North, Site 01 is situated on the Western Side of the Main Entrance Road to the Norlim/Buxton Mine Town, just after passing over the Road Bridge and just before reaching the Trading Store [refer to Figure 04] 	<ul style="list-style-type: none"> ● Building/Structure 0104: Shed 03 [refer to Photograph 04] ● Relative Position: Building North-East of the Office of Mine Manager [refer to Figure 04] 	<ul style="list-style-type: none"> ● Construction Materials: Bricks, cement, steel, glass, wood and corrugated iron ● Construction Methods: Brick and plaster structure with a concrete slab floor, covered by wooden roof trusses, clad with corrugated iron roof sheets 	<ul style="list-style-type: none"> ● Historical Use: Locomotive Maintenance Workshop and Storage ● Current Use: Not in use 	<ul style="list-style-type: none"> ● State: Vandalised ● Condition: Fair <ul style="list-style-type: none"> ○ Basic structure in good condition, but should be restored ○ Fenestration and doors [steel and wood] partly removed, but should be restored and replaced, where necessary ○ Floor covering [concrete slabs] present, but should be restored and replaced, where necessary ○ Roof support structure [wood trusses] present, but should be checked for structural integrity and should be restored and replaced, where necessary ○ Roof covering [corrugated iron roof sheets] present, but should be restored and replaced, where necessary ○ All interior installations have been removed and should be replaced with authentic items ○ Basic services should be installed and connected 	<ul style="list-style-type: none"> ● Restoration potential: Fair ● Restoration priority: High 	<p>Recycled Use, complementing the Site Office of the Taung Skull World Heritage Site</p>

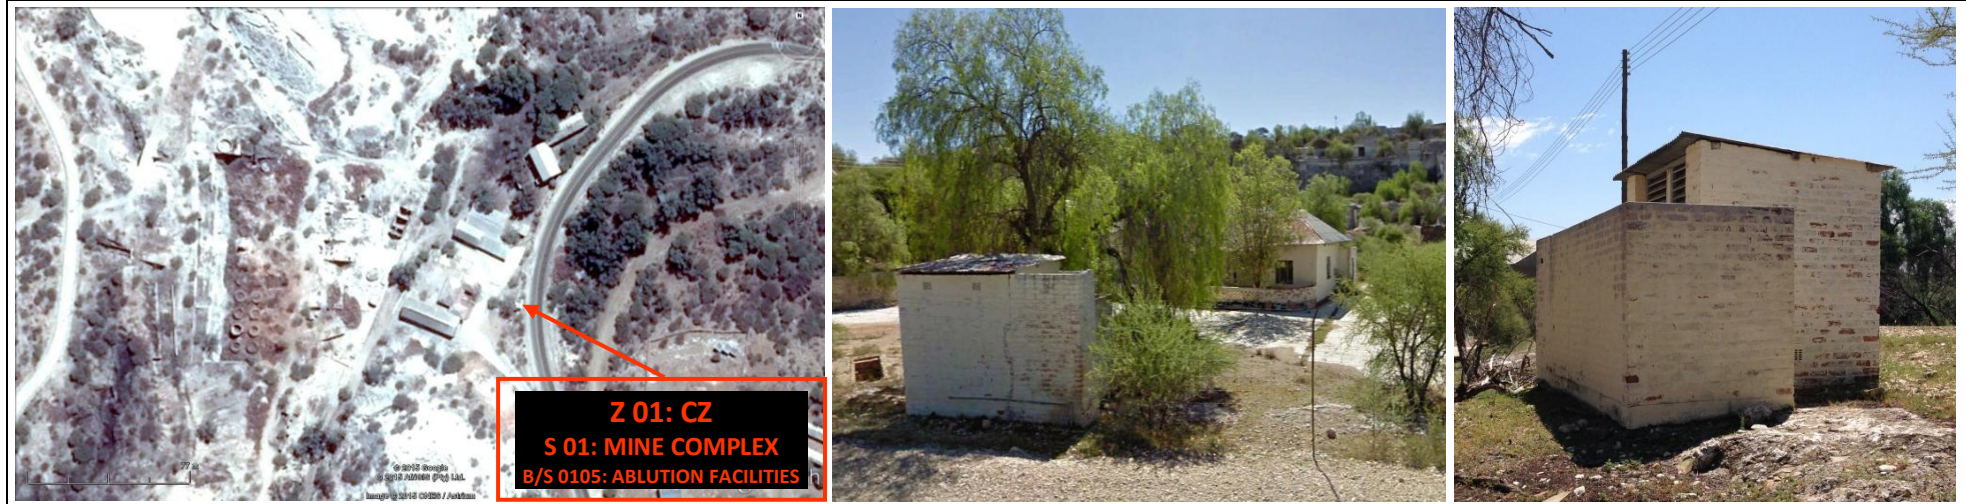
FIGURE 05 • PHOTOGRAPH 05 • Zone 01 [Z 01]: Core Zone [CZ] • Site 01 [S 01]: Mine Complex • Building/Structure 0105 [B/S 0105]: Ablution Facilities • Date: 24 February 2015

SITE & RELATIVE LOCALITY	BUILDING/STRUCTURE & RELATIVE POSITION	CONSTRUCTION MATERIALS & METHODS	HISTORICAL & CURRENT USES	CURRENT STATE & CONDITION	RESTORATION POTENTIAL & PRIORITY	PROPOSED FUTURE USES
<ul style="list-style-type: none"> ● Site 01: Mine Complex ● Relative Locality: Approaching from the North, Site 01 is situated on the Western Side of the Main Entrance Road to the Norlim/Buxton Mine Town, just after passing over the Road Bridge and just before reaching the Trading Store [refer to Figure 05] 	<ul style="list-style-type: none"> ● Building/Structure 0105: Ablution Facilities [refer to Photograph 05] ● Relative Position: Building in front, and just East, of the Office of Mine Manager [refer to Figure 05] 	<ul style="list-style-type: none"> ● Construction Materials: Bricks, cement, wood and corrugated iron ● Construction Methods: Brick and plaster structure with a concrete slab floor, covered by wooden roof trusses, clad with corrugated iron roof sheets 	<ul style="list-style-type: none"> ● Historical Use: Ablution Facilities ● Current Use: Not in use 	<ul style="list-style-type: none"> ● State: Vandalised ● Condition: Fair <ul style="list-style-type: none"> ○ Basic structure in poor condition, but should be restored ○ Fenestration and doors [steel and wood] removed, but should be restored and replaced, where necessary ○ Floor covering [cement slabs] present, but should be restored and replaced, where necessary ○ Roof support structure [wood trusses] present, but should be restored and replaced, where necessary ○ Roof covering [corrugated iron roof sheets] present, but should be restored and replaced, where necessary ○ All interior installations have been removed and should be replaced with authentic items ○ Basic services should be installed and connected 	<ul style="list-style-type: none"> ● Restoration potential: Fair ● Restoration priority: High 	<p>Recycled Use, complementing the Site Office of the Taung Skull World Heritage Site</p>

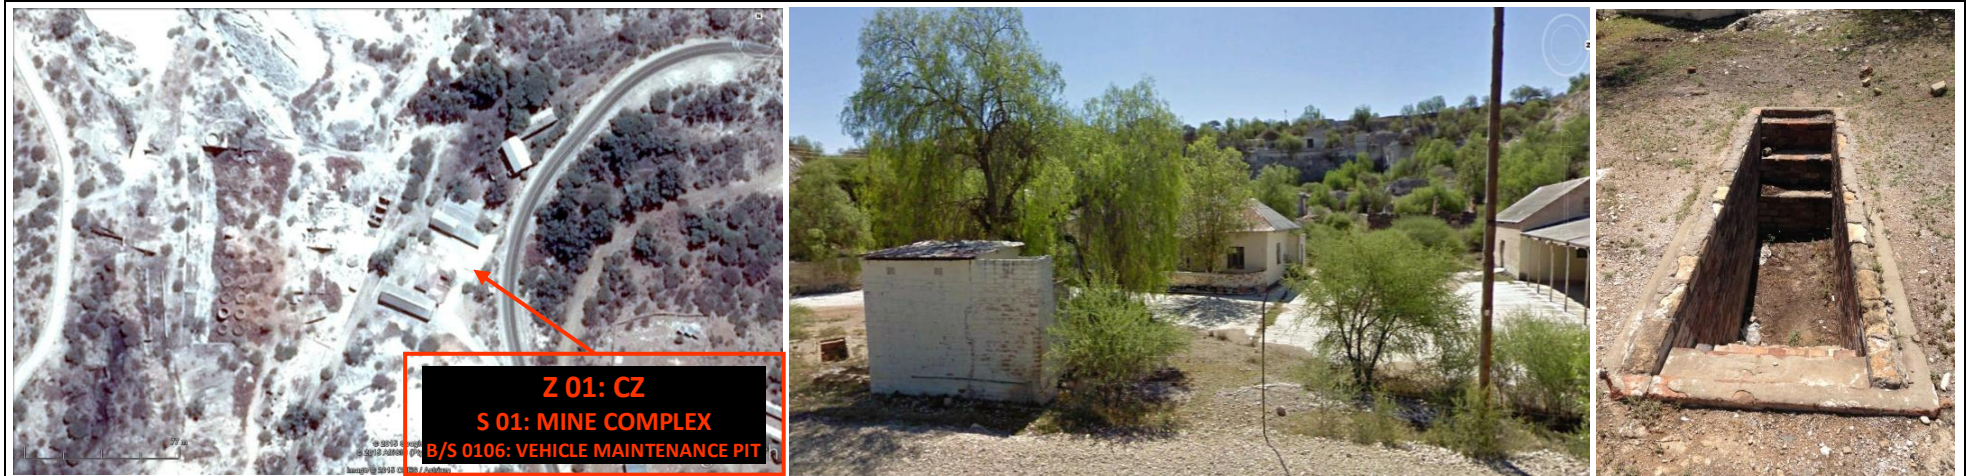
FIGURE 06 • PHOTOGRAPH 06 • Zone 01 [Z 01]: Core Zone [CZ] • Site 01 [S 01]: Mine Complex • Building/Structure 0106 [B/S 0106]: Vehicle Maintenance Pit • Date: 24 February 2015

SITE & RELATIVE LOCALITY	BUILDING/STRUCTURE & RELATIVE POSITION	CONSTRUCTION MATERIALS & METHODS	HISTORICAL & CURRENT USES	CURRENT STATE & CONDITION	RESTORATION POTENTIAL & PRIORITY	PROPOSED FUTURE USES
<ul style="list-style-type: none"> ● Site 01: Mine Complex ● Relative Locality: Approaching from the North, Site 01 is situated on the Western Side of the Main Entrance Road to the Norlim/Buxton Mine Town, just after passing over the Road Bridge and just before reaching the Trading Store [refer to Figure 06] 	<ul style="list-style-type: none"> ● Building/Structure 0106: Vehicle Maintenance Pit [refer to Photograph 06] ● Relative Position: Structure in front, and just East, of the Office of Mine Manager [refer to Figure 06] 	<ul style="list-style-type: none"> ● Construction Materials: Bricks and cement ● Construction Methods: Brick and plaster structure with a concrete slab floor 	<ul style="list-style-type: none"> ● Historical Use: Vehicle Maintenance Pit ● Current Use: Not in use 	<ul style="list-style-type: none"> ● State: Not vandalised ● Condition: Poor <ul style="list-style-type: none"> ○ Basic structure in good condition, but should be restored ○ Floor covering [concrete slab] present, but should be restored and replaced, where necessary 	<ul style="list-style-type: none"> ● Restoration potential: Fair ● Restoration priority: High 	<p>Historical Structure Exhibit</p>

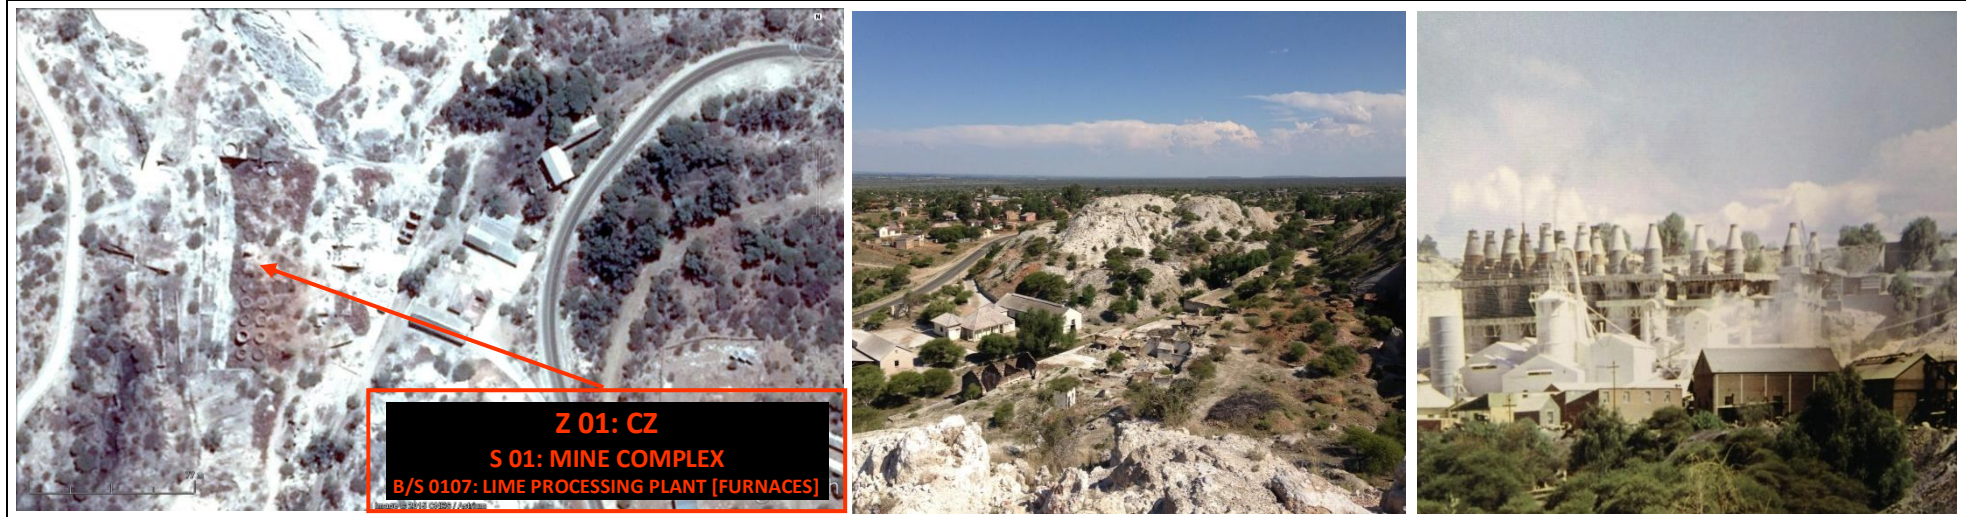
FIGURE 07 • PHOTOGRAPH 07 • Zone 01 [Z 01]: Core Zone [CZ] • Site 01 [S 01]: Mine Complex • Building/Structure 0107 [B/S 0107]: Lime Processing Plant [Furnaces] • Date: 24 February 2015

SITE & RELATIVE LOCALITY	BUILDING/STRUCTURE & RELATIVE POSITION	CONSTRUCTION MATERIALS & METHODS	HISTORICAL & CURRENT USES	CURRENT STATE & CONDITION	RESTORATION POTENTIAL & PRIORITY	PROPOSED FUTURE USES
<ul style="list-style-type: none"> ● Site 01: Mine Complex ● Relative Locality: Approaching from the North, Site 01 is situated on the Western Side of the Main Entrance Road to the Norlim/Buxton Mine Town, just after passing over the Road Bridge and just before reaching the Trading Store [refer to Figure 07] 	<ul style="list-style-type: none"> ● Building/Structure 0107: Lime Processing Plant [Furnaces] [refer to Photograph 07] ● Relative Position: Structures [ruins] just West of the Office of the Mine Manager [refer to Figure 07] 	<ul style="list-style-type: none"> ● Construction Materials: Steel, concrete, bricks, cement, stone, wood and corrugated iron ● Construction Methods: Steel and concrete structures with concrete slab floors covered by steel chimneys, and steel, brick/stone and plaster structures with concrete slab floor, covered by wood trusses, clad by corrugated iron roof sheets 	<ul style="list-style-type: none"> ● Historical Use: Lime Processing Plant [Furnaces] ● Current Use: Not in use 	<ul style="list-style-type: none"> ● State: Deconstructed ● Condition: Poor <ul style="list-style-type: none"> ○ Basic structures removed, but should be reconstructed ○ Base platforms [concrete slabs] partly present, but should be checked for structural integrity and should be restored ○ Roof support structure [steel and wood trusses] removed, but should be replaced ○ Roof covering [steel chimneys and corrugated iron roof sheets] removed, but should be replaced ○ All the installations have been removed and should be replaced with authentic items ○ Basic services should be installed and connected 	<ul style="list-style-type: none"> ● Restoration potential: Poor ● Restoration priority: Low 	<p>Historical Structure Exhibit</p>

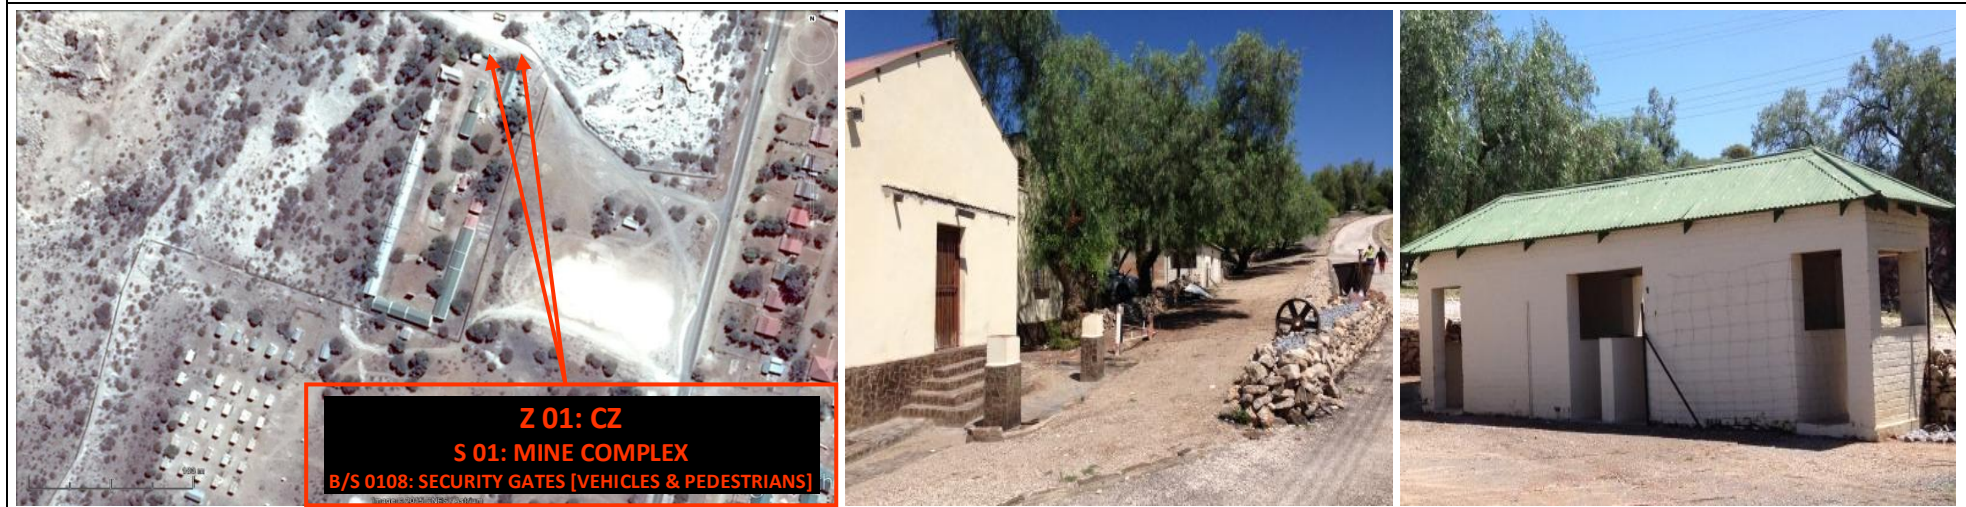
FIGURE 08 • PHOTOGRAPH 08 • Zone 01 [Z 01]: Core Zone [CZ] • Site 01 [S 01]: Mine Compound Complex • Building/Structure 0108 [B/S 0108]: Security Gates [Vehicles & Pedestrians] • Date: 24 February 2015

SITE & RELATIVE LOCALITY	BUILDING/STRUCTURE & RELATIVE POSITION	CONSTRUCTION MATERIALS & METHODS	HISTORICAL & CURRENT USES	CURRENT STATE & CONDITION	RESTORATION POTENTIAL & PRIORITY	PROPOSED FUTURE USES
<ul style="list-style-type: none"> ● Site 02: Mine Compound Complex ● Relative Locality: Approaching from the North, Site 02 is situated on the Western Side of the Main Entrance Road to the Norlim/Buxton Mine Town, after passing over the Road Bridge and just past the Trading Store on the right, just before reaching the Soccer Field [refer to Figure 08] 	<ul style="list-style-type: none"> ● Building/Structure 0108: Security Gates [Vehicles and Pedestrians] [refer to Photograph 08] ● Relative Position: Building on Mine Compound Complex Site [refer to Figure 08] 	<ul style="list-style-type: none"> ● Construction Materials: Bricks, cement, wood and corrugated iron ● Construction Methods: Brick and plaster structure, concrete slab floors, covered by wooden roof trusses, clad with corrugated iron roof sheets 	<ul style="list-style-type: none"> ● Historical Use: Security Gates for Vehicles and Pedestrians ● Current Use: Vacant 	<ul style="list-style-type: none"> ● State: Revamped ● Condition: Good <ul style="list-style-type: none"> ○ Basic structure in good condition, but should be restored ○ Floor covering [concrete slabs] present, but should be restored and replaced, where necessary ○ Roof support structure [wood trusses] present, but should be checked for structural integrity and should be restored and replaced, where necessary ○ Roof covering [corrugated iron roof sheets] present, but should be restored and replaced, where necessary ○ All interior installations have been removed and should be replaced with authentic items ○ Basic services should be installed and connected 	<ul style="list-style-type: none"> ● Restoration potential: Good ● Restoration priority: Medium 	To be determined

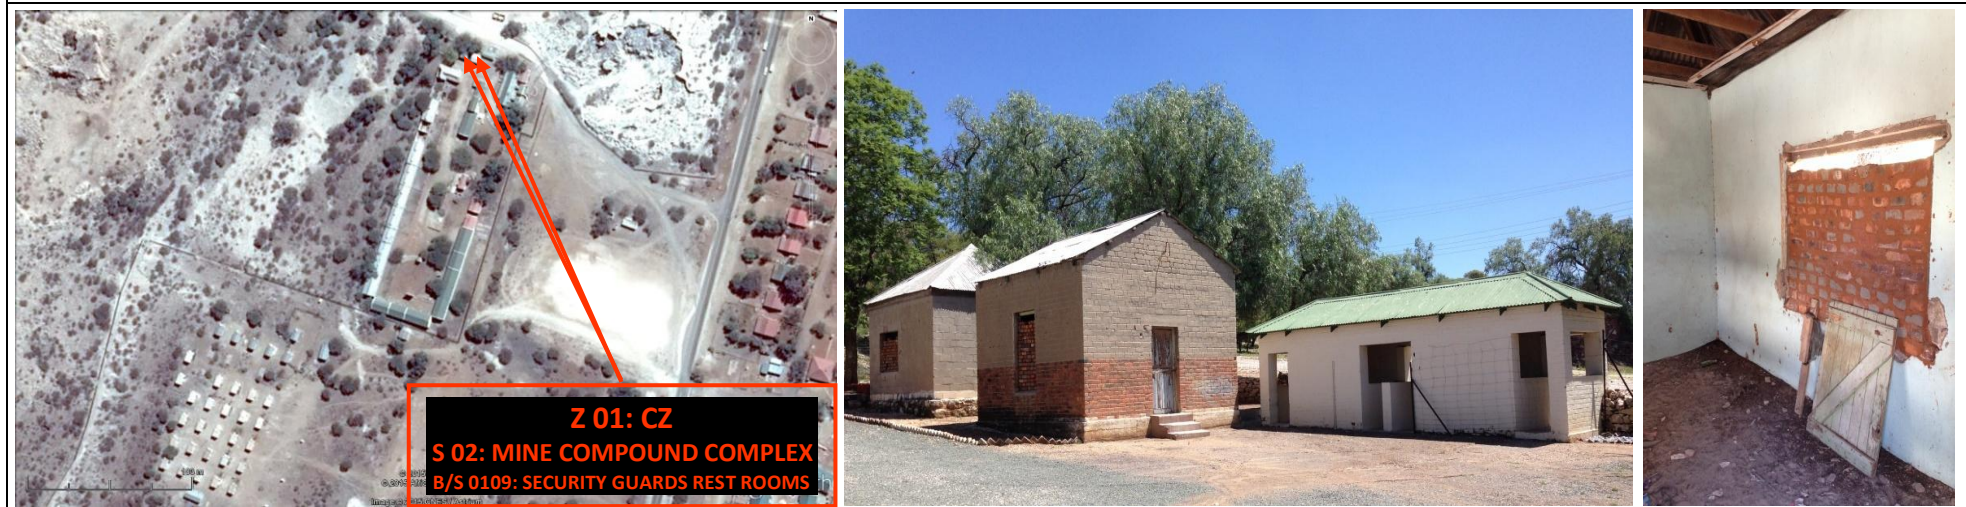
FIGURE 09 • PHOTOGRAPH 09 • Zone 01 [Z 01]: Core Zone [CZ] • Site 02 [S 02]: Mine Compound Complex • Building/Structure 0109 [B/S 0109]: Security Guards Rest Rooms • Date: 24 February 2015

SITE & RELATIVE LOCALITY	BUILDING/STRUCTURE & RELATIVE POSITION	CONSTRUCTION MATERIALS & METHODS	HISTORICAL & CURRENT USES	CURRENT STATE & CONDITION	RESTORATION POTENTIAL & PRIORITY	PROPOSED FUTURE USES
<ul style="list-style-type: none"> ● Site 02: Mine Compound Complex ● Relative Locality: Approaching from the North, Site 02 is situated on the Western Side of the Main Entrance Road to the Norlim/ Buxton Mine Town, after passing over the Road Bridge and just past the Trading Store on the right, just before reaching the Soccer Field [refer to Figure 09] 	<ul style="list-style-type: none"> ● Building/Structure 0109: Security Guards Rest Rooms [refer to Photograph 09] ● Relative Position: Building on Mine Compound Complex Site [refer to Figure 09] 	<ul style="list-style-type: none"> ● Construction Materials: Bricks, cement, steel, glass, wood and corrugated iron ● Construction Methods: Brick and plaster structure, covered by wooden roof trusses, clad with corrugated iron roof sheets 	<ul style="list-style-type: none"> ● Historical Use: Security Guards Rest Rooms ● Current Use: Not in use 	<ul style="list-style-type: none"> ● State: Vandalised ● Condition: Good <ul style="list-style-type: none"> ○ Basic structure in good condition, but should be restored ○ Fenestration and doors [steel and wood] partly removed, but should be restored and replaced, where necessary ○ Floor covering [wood planks] partly removed, but should be restored and replaced, where necessary ○ Roof support structure [wood trusses] present, but should be checked for structural integrity and should be restored and replaced, where necessary ○ Roof covering [corrugated iron roof sheets] present, but should be restored and replaced, where necessary ○ All interior installations have been removed and should be replaced with authentic items ○ Basic services should be installed and connected 	<ul style="list-style-type: none"> ● Restoration potential: Good ● Restoration priority: Medium 	To be determined

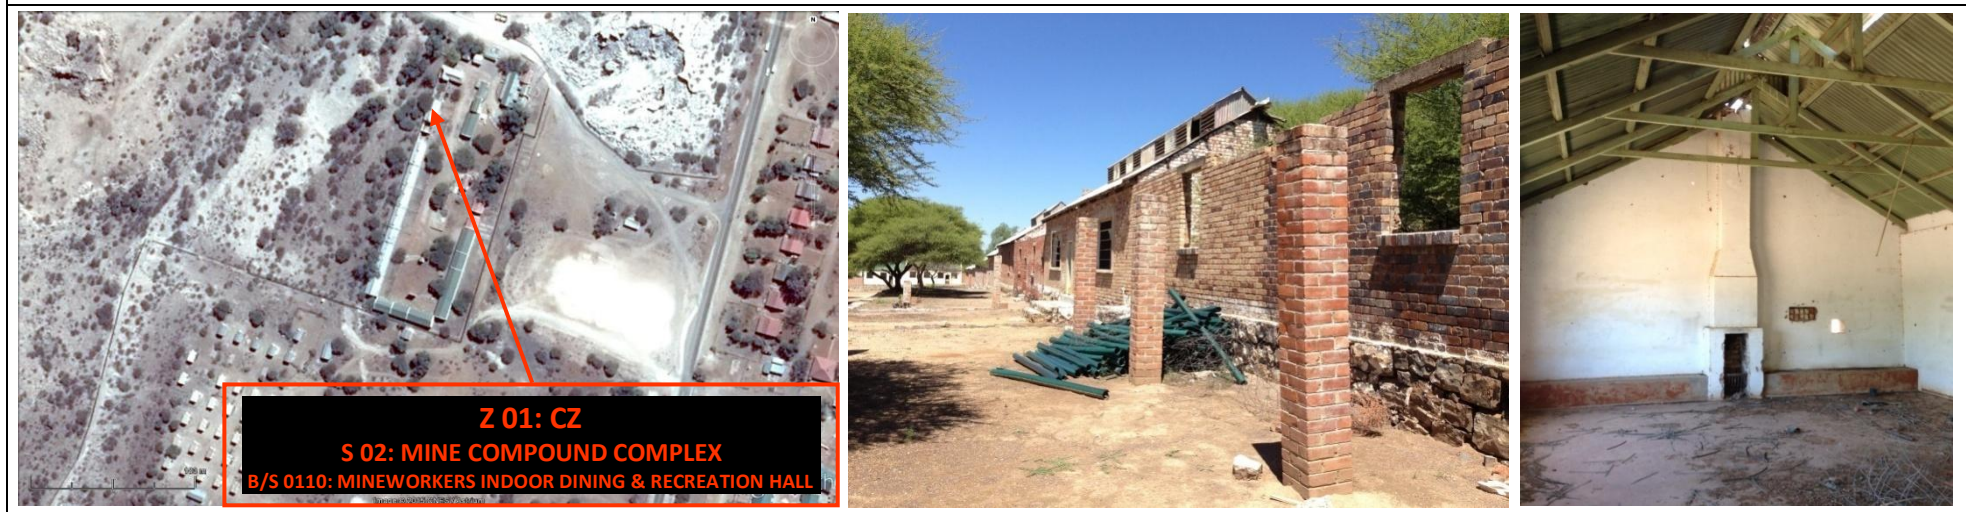
FIGURE 10 • PHOTOGRAPH 10 • Zone 01 [Z 01]: Core Zone [CZ] • Site 02 [S 02]: Mine Compound Complex • Building/Structure 0110 [B/S 0110]: Mineworkers Indoor Dining & Recreation Hall • Date: 24 February 2015

SITE & RELATIVE LOCALITY	BUILDING/STRUCTURE & RELATIVE POSITION	CONSTRUCTION MATERIALS & METHODS	HISTORICAL & CURRENT USES	CURRENT STATE & CONDITION	RESTORATION POTENTIAL & PRIORITY	PROPOSED FUTURE USES
<ul style="list-style-type: none"> ● Site 02: Mine Compound Complex ● Relative Locality: Approaching from the North, Site 02 is situated on the Western Side of the Main Entrance Road to the Norlim/Buxton Mine Town, after passing over the Road Bridge and just past the Trading Store on the right, and just before reaching the Soccer Field [refer to Figure 10] 	<ul style="list-style-type: none"> ● Building/Structure 0110: Mine Workers Indoor Dining and Recreational Hall [refer to Photograph 10] ● Relative Position: Building on Mine Compound Complex Site [refer to Figure 10] 	<ul style="list-style-type: none"> ● Construction Materials: Bricks, cement, steel, glass, wood and corrugated iron ● Construction Methods: Brick and plaster structure, covered by wooden roof trusses, clad with corrugated iron roof sheets 	<ul style="list-style-type: none"> ● Historical Use: Mine Workers Indoor Dining and Recreational Hall ● Current Use: Vacant 	<ul style="list-style-type: none"> ● State: Vandalised ● Condition: Poor <ul style="list-style-type: none"> ○ Basic structure in poor condition, but should be restored ○ Fenestration and doors [steel and wood] removed, but should be restored and replaced, where necessary ○ Floor covering [concrete slabs] present, but should be restored and replaced, where necessary ○ Roof support structure [wood trusses] partly removed, but should be checked for structural integrity and should be restored and replaced, where necessary ○ Roof covering [corrugated iron roof sheets] partly removed, but should be restored and replaced, where necessary ○ All interior installations have been removed and should be replaced with authentic items ○ Basic services should be installed and connected 	<ul style="list-style-type: none"> ● Restoration potential: Poor ● Restoration priority: Medium 	To be determined

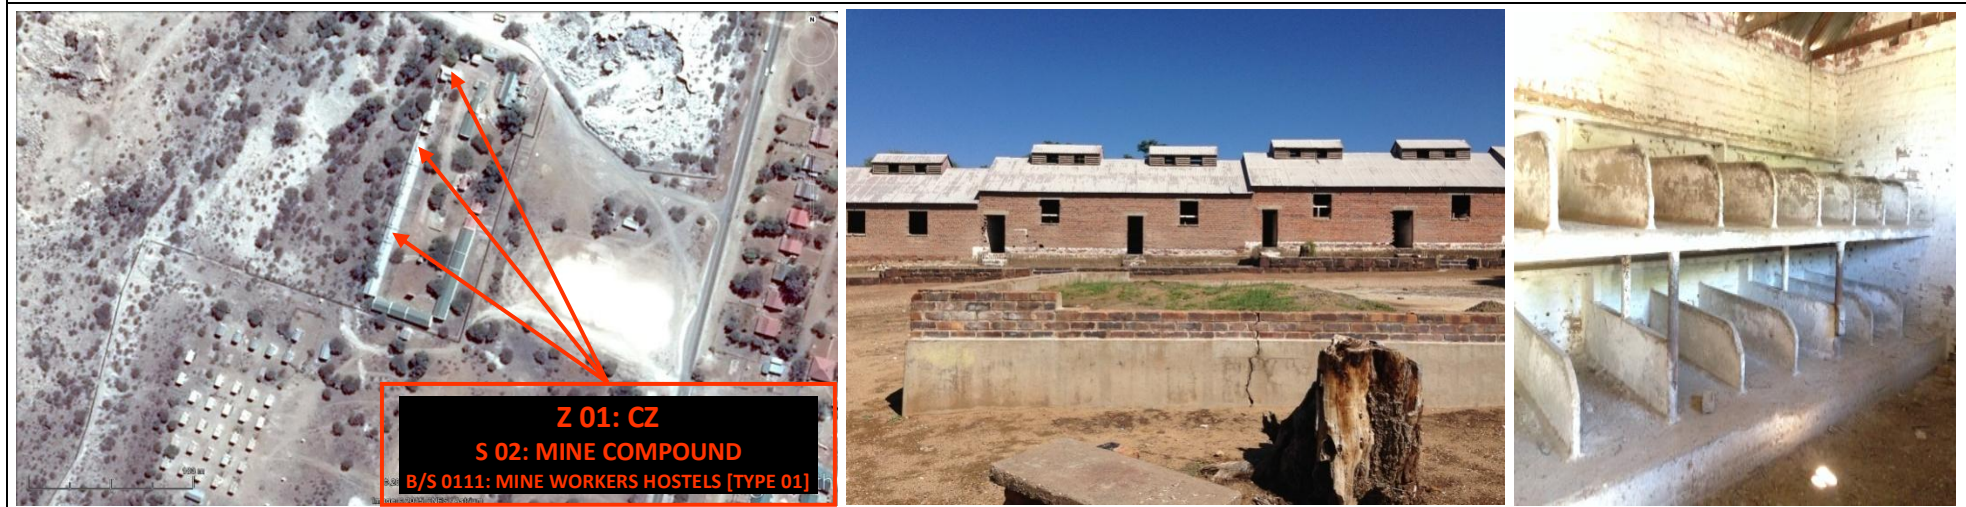
FIGURE 11 • PHOTOGRAPH 11 • Zone 01 [Z 01]: Core Zone [CZ] • Site 02 [S 01]: Mine Compound Complex • Building/Structure 0111 [B/S 0111]: Mine Workers Hostels [Type 01] • Date: 24 February 2015

SITE & RELATIVE LOCALITY	BUILDING/STRUCTURE & RELATIVE POSITION	CONSTRUCTION MATERIALS & METHODS	HISTORICAL & CURRENT USES	CURRENT STATE & CONDITION	RESTORATION POTENTIAL & PRIORITY	PROPOSED FUTURE USES
<ul style="list-style-type: none"> ● Site 02: Mine Compound Complex ● Relative Locality: Approaching from the North, Site 02 is situated on the Western Side of the Main Entrance Road to the Norlim/Buxton Mine Town, after passing over the Road Bridge and just past the Trading Store on the right, just before reaching the Soccer Field [refer to Figure 11] 	<ul style="list-style-type: none"> ● Building/Structure 0111: Mine Workers Hostels [Type 01] [refer to Photograph 11] ● Relative Position: Building on Mine Compound Complex Site [refer to Figure 11] 	<ul style="list-style-type: none"> ● Construction Materials: Bricks, cement, steel, glass, wood and corrugated iron ● Construction Methods: Brick and plaster structure, covered by wooden roof trusses, clad with corrugated iron roof sheets 	<ul style="list-style-type: none"> ● Historical Use: Mine Workers Hostels ● Current Use: Vacant 	<ul style="list-style-type: none"> ● State: Vandalised ● Condition: Fair <ul style="list-style-type: none"> ○ Basic structure in good condition, but should be restored ○ Fenestration and doors [steel and wood] partly removed, but should be restored and replaced, where necessary ○ Floor covering [concrete slabs] present, but should be restored and replaced, where necessary ○ Roof support structure [wood trusses] present, but should be checked for structural integrity and should be restored and replaced, where necessary ○ Roof covering [corrugated iron roof sheets] present, but should be restored and replaced, where necessary ○ All interior installations have been removed and should be replaced with authentic items ○ Basic services should be installed and connected 	<ul style="list-style-type: none"> ● Restoration potential: Good ● Restoration priority: Medium 	To be determined

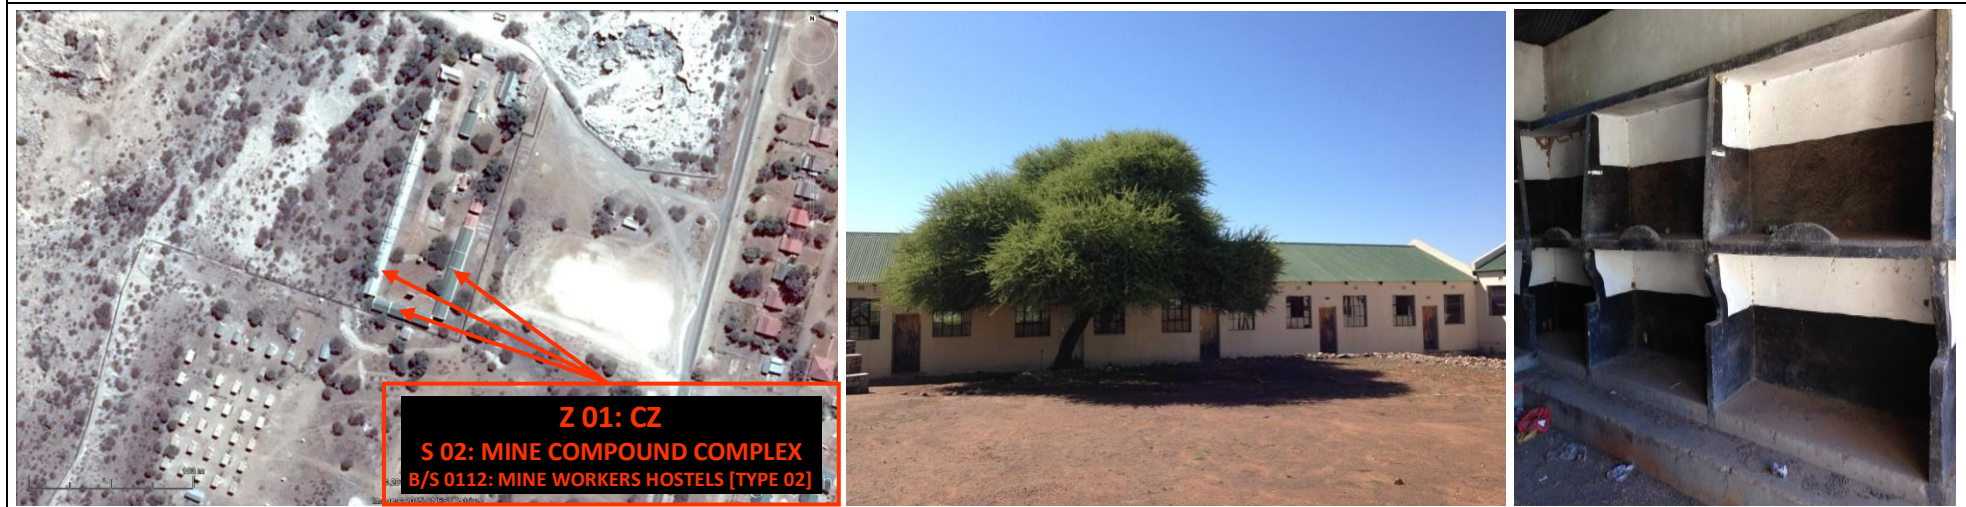
FIGURE 12 • PHOTOGRAPH 12 • Zone 01 [Z 01]: Core Zone [CZ] • Site 02 [S 02]: Mine Compound Complex • Building/Structure 0112 [B/S 0112]: Mine Workers Hostels [Type 02] • Date: 24 February 2015

SITE & RELATIVE LOCALITY	BUILDING/STRUCTURE & RELATIVE POSITION	CONSTRUCTION MATERIALS & METHODS	HISTORICAL & CURRENT USES	CURRENT STATE & CONDITION	RESTORATION POTENTIAL & PRIORITY	PROPOSED FUTURE USES
<ul style="list-style-type: none"> ● Site 02: Mine Compound Complex ● Relative Locality: Approaching from the North, Site 02 is situated on the Western Side of the Main Entrance Road to the Norlim/Buxton Mine Town, after passing over the Road Bridge and just past the Trading Store on the right, just before reaching the Soccer Field [refer to Figure 12] 	<ul style="list-style-type: none"> ● Building/Structure 0112: Mine Workers Hostels [Type 02] ● Relative Position: Building on Mine Compound Complex Site [refer to Figure 12] 	<ul style="list-style-type: none"> ● Construction Materials: Bricks, cement, steel, glass, wood and corrugated iron ● Construction Methods: Brick and plaster structure, covered by wooden roof trusses, clad with corrugated iron roof sheets 	<ul style="list-style-type: none"> ● Historical Use: Mine Workers Hostels ● Current Use: Larger part not in use, except for some of the units on southern side that are used by small entrepreneurs [a sowing business] and some of the units on the western side that are used as overnight accommodation facilities for visiting school groups. 	<ul style="list-style-type: none"> ● State: Partly vandalised and partly revamped ● Condition: Poor and Good <ul style="list-style-type: none"> ○ Basic structure in good condition, but should be restored ○ Fenestration and doors [steel and wood] present in some and partly removed in other, but should be restored and replaced, where necessary ○ Floor covering [concrete slabs] present, but should be restored and replaced, where necessary ○ Roof support structure [wood trusses] present, but should be checked for structural integrity and should be restored and replaced, where necessary ○ Roof covering [corrugated iron roof sheets] present, but should be restored and replaced, where necessary ○ All interior installations have been removed and should be replaced with authentic items ○ Basic services should be installed and connected 	<ul style="list-style-type: none"> ● Restoration potential: Good ● Restoration priority: Medium 	To be determined

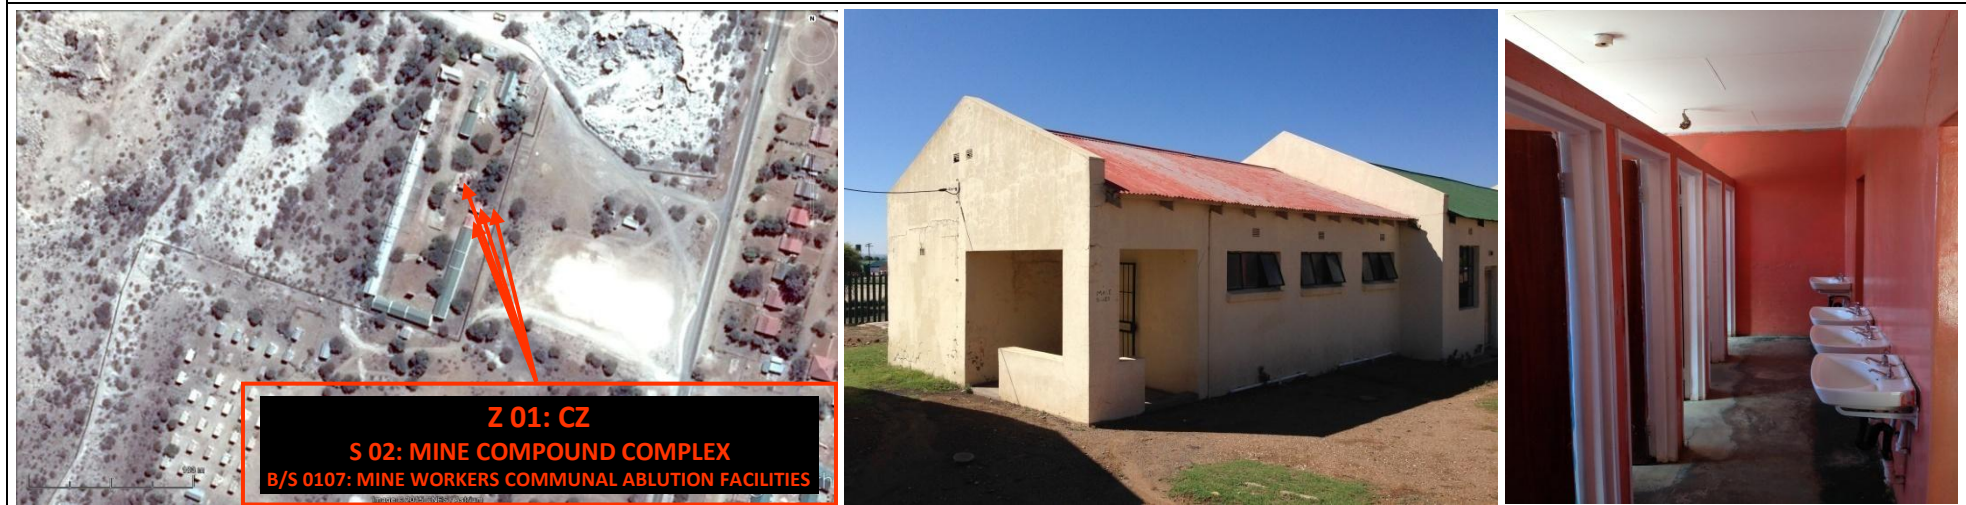
FIGURE 13 • PHOTOGRAPH 13 • Zone 01 [Z 01]: Core Zone [CZ] • Site 02 [S 02]: Mine Compound Complex • Building/Structure 0113 [B/S 0113]: Mine Workers Communal Ablution Facilities • Date: 24 February 2015

SITE & RELATIVE LOCALITY	BUILDING/STRUCTURE & RELATIVE POSITION	CONSTRUCTION MATERIALS & METHODS	HISTORICAL & CURRENT USES	CURRENT STATE & CONDITION	RESTORATION POTENTIAL & PRIORITY	PROPOSED FUTURE USES
<ul style="list-style-type: none"> ● Site 02: Mine Compound Complex ● Relative Locality: Approaching from the North, Site 02 is situated on the Western Side of the Main Entrance Road to the Norlim/Buxton Mine Town, after passing over the Road Bridge and just past the Trading Store on the right, just before reaching the Soccer Field [refer to Figure 13] 	<ul style="list-style-type: none"> ● Building/Structure 0113: Mine Workers Communal Ablution Facilities [refer to Photograph 13] ● Relative Position: Building on Mine Compound Complex Site [refer to Figure 13] 	<ul style="list-style-type: none"> ● Construction Materials: Bricks, cement, steel, glass, wood and corrugated iron ● Construction Methods: Brick and plaster structure, covered by wooden roof trusses, clad with corrugated iron roof sheets 	<ul style="list-style-type: none"> ● Historical Use: Mine Workers Communal Ablution Facilities ● Current Use: In use 	<ul style="list-style-type: none"> ● State: Revamped ● Condition: Good <ul style="list-style-type: none"> ○ Basic structure in good condition, but should be restored ○ Fenestration and doors [steel and wood] present, but should be restored and replaced, where necessary ○ Floor covering [concrete slabs] present, but should be restored and replaced, where necessary ○ Roof support structure [wood trusses] present, but should be checked for structural integrity and should be restored and replaced, where necessary ○ Roof covering [corrugated iron roof sheets] present, but should be restored and replaced, where necessary ○ All interior installations have been removed and should be replaced with authentic items ○ Basic services should be installed and connected 	<ul style="list-style-type: none"> ● Restoration potential: Good ● Restoration priority: Medium 	To be determined
