TAUNG SKULL WORLD HERITAGE SITE: BUILT LANDSCAPE INVENTORY OF SELECTED BUILDINGS AND STRUCTURES

The HIA, which is in the process of being conducted on the TSWHS, provides an opportunity to showcase the value of such an approach and output. The Built Landscape Inventory is a catalogue of buildings falling within both the Core and Buffer Zones and attempts to provide a very simplistic vantage point and baseline, from where the assessment and planning process can unfold. The purpose of the Built Landscape Inventory is to provide a list of key buildings, an assessment of the condition and the possible repurposing of the facilities into functional entities. This provides an initial recording of baseline data on the built landscape that can be further developed into a management [development and maintenance] plan for the built landscape at TSWHS.

The Built Landscape Inventory is compiled for the following Preliminary Zones and Sites on the TSWHS:

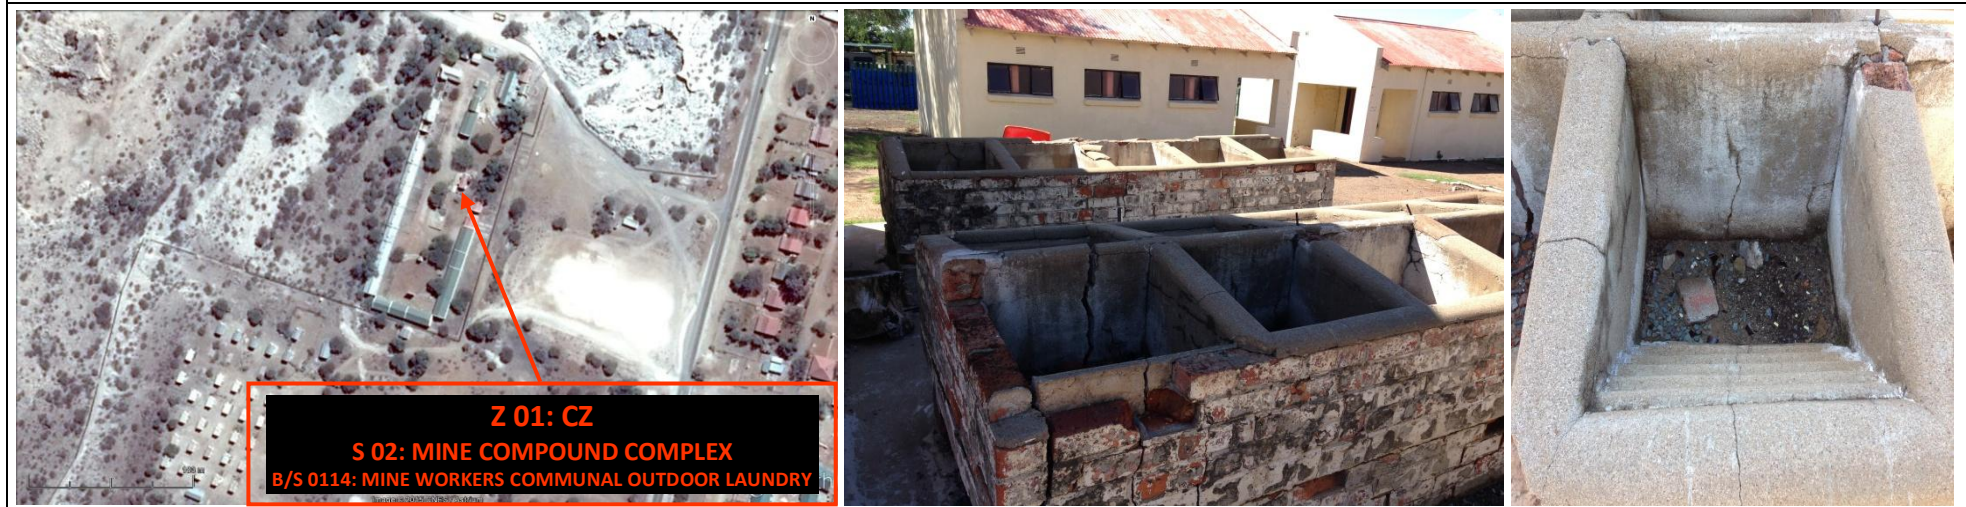
FIGURE 14 • PHOTOGRAPH 14 • Zone 01 [Z 01]: Core Zone [CZ] • Site 02 [S 02]: Mine Compound Complex • Building/Structure 0114 [B/S 0114]: Mine Workers Communal Outdoor Laundry • Date: 24 February 2015

ZONE 01: CORE ZONE						
SITE & RELATIVE LOCALITY	BUILDING/STRUCTURE & RELATIVE POSITION	CONSTRUCTION MATERIALS & METHODS	HISTORICAL & CURRENT USES	CURRENT STATE & CONDITION	RESTORATION POTENTIAL & PRIORITY	PROPOSED FUTURE USES
<ul style="list-style-type: none"> ● Site 02: Mine Compound Complex ● Relative Locality: Approaching from the North, Site 02 is situated on the Western Side of the Main Entrance Road to the Norlim/Buxton Mine Town, after passing over the Road Bridge and just past the Trading Store on the right, just before reaching the Soccer Field [refer to Figure 14] 	<ul style="list-style-type: none"> ● Building/Structure 0114: Mine Workers Communal Outdoor Laundry [refer to Photograph 14] ● Relative Position: Structure on Mine Compound Complex Site [refer to Figure 14] 	<ul style="list-style-type: none"> ● Construction Materials: Bricks, cement, steel, glass, wood and corrugated iron ● Construction Methods: Brick and plaster structure, covered by wooden roof trusses, clad with corrugated iron roof sheets 	<ul style="list-style-type: none"> ● Historical Use: Mine Workers Outdoor Laundry ● Current Use: Not in use 	<ul style="list-style-type: none"> ● State: Vandalised ● Condition: Good <ul style="list-style-type: none"> ○ Basic structure in good condition, but should be restored ○ Floor covering [concrete slabs] partly present, but should be restored and replaced, where necessary ○ All installations have been removed and should be replaced with authentic items ○ Basic services should be installed and connected 	<ul style="list-style-type: none"> ● Restoration potential: Fair ● Restoration priority: Low 	To be determined

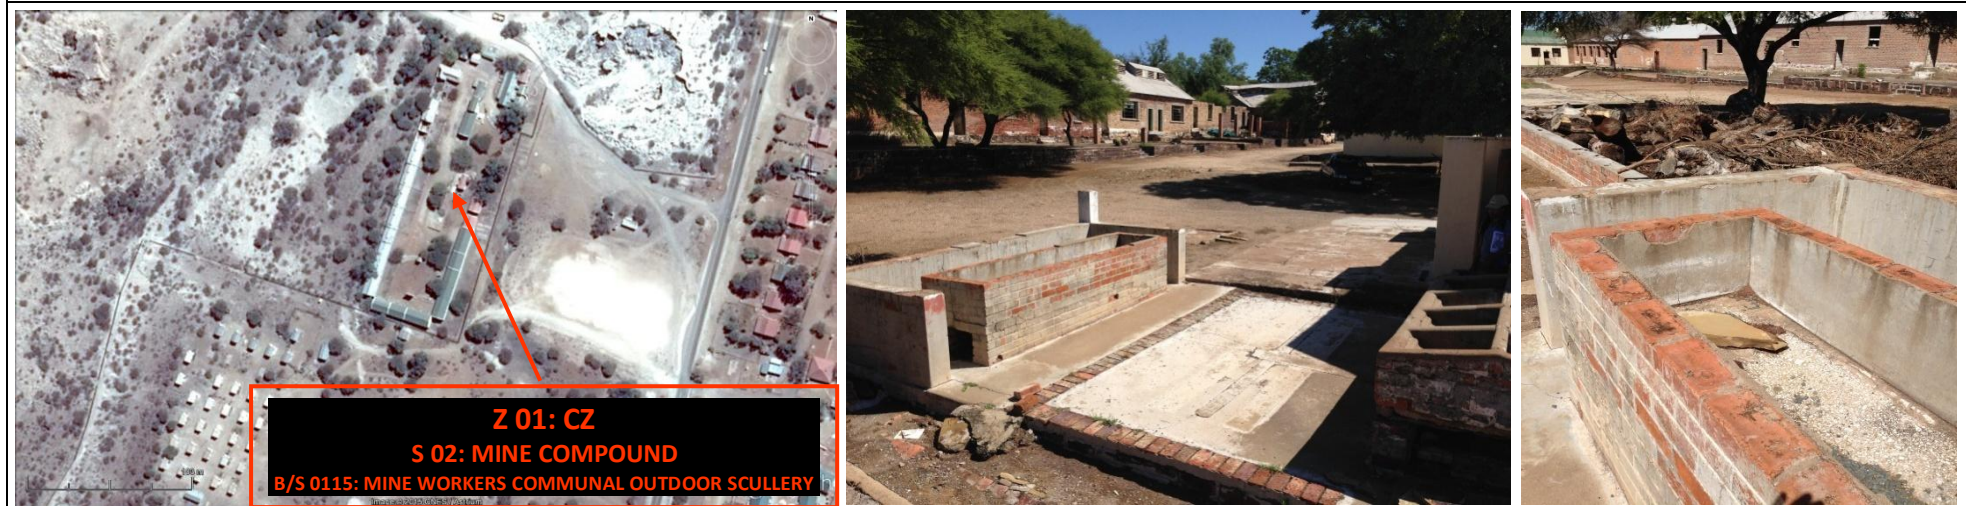
FIGURE 15 • PHOTOGRAPH 15 • Zone 01 [Z 01]: Core Zone [CZ] • Site 02 [S 02]: Mine Compound Complex • Building/Structure 0115 [B/S 0115]: Mine Workers Communal Outdoor Scullery • Date: 24 February 2015

SITE & RELATIVE LOCALITY	BUILDING/STRUCTURE & RELATIVE POSITION	CONSTRUCTION MATERIALS & METHODS	HISTORICAL & CURRENT USES	CURRENT STATE & CONDITION	RESTORATION POTENTIAL & PRIORITY	PROPOSED FUTURE USES
<ul style="list-style-type: none"> ● Site 02: Mine Compound Complex ● Relative Locality: Approaching from the North, Site 02 is situated on the Western Side of the Main Entrance Road to the Norlim/Buxton Mine Town, after passing over the Road Bridge and just past the Trading Store on the right, just before reaching the Soccer Field [refer to Figure 15] 	<ul style="list-style-type: none"> ● Building/Structure 0115: Mine Workers Communal Outdoor Scullery [refer to Photograph 15] ● Relative Position: Structure on Mine Compound Complex Site [refer to Figure 15] 	<ul style="list-style-type: none"> ● Construction Materials: Bricks, cement, steel, glass, wood and corrugated iron ● Construction Methods: Brick and plaster structure, covered by wooden roof trusses, clad with corrugated iron roof sheets 	<ul style="list-style-type: none"> ● Historical Use: Mine Workers Outdoor Scullery ● Current Use: Not in use 	<ul style="list-style-type: none"> ● State: Vandalised ● Condition: Good <ul style="list-style-type: none"> ○ Basic structure in good condition, but should be restored ○ Floor covering [concrete slabs] partly present, but should be restored and replaced, where necessary ○ All installations have been removed and should be replaced with authentic items ○ Basic services should be installed and connected 	<ul style="list-style-type: none"> ● Restoration potential: Fair ● Restoration priority: High 	To be determined

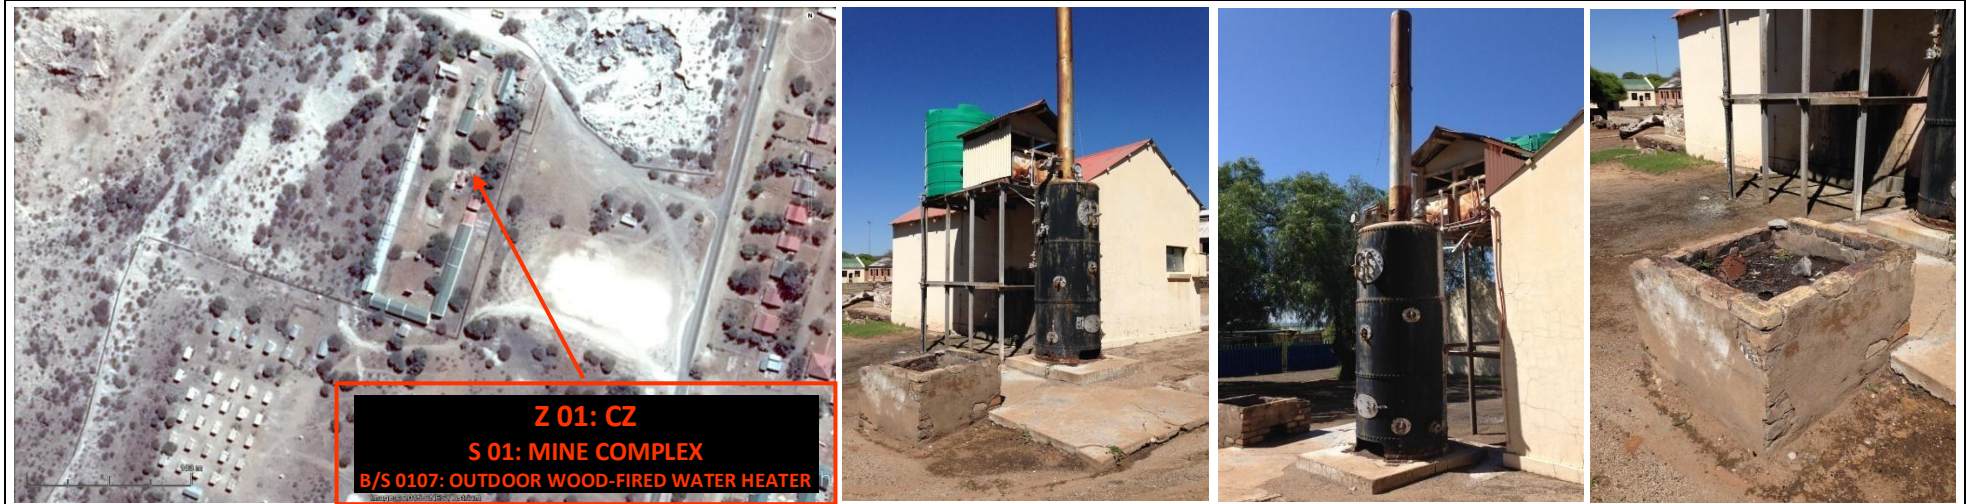
FIGURE 16 • PHOTOGRAPH 16 • Zone 01 [Z 01]: Core Zone [CZ] • Site 02 [S 02]: Mine Compound Complex • Building/Structure 0116 [B/S 0116]: Outdoor Wood-Fired Water Heater • Date: 24 February 2015

SITE & RELATIVE LOCALITY	BUILDING/STRUCTURE & RELATIVE POSITION	CONSTRUCTION MATERIALS & METHODS	HISTORICAL & CURRENT USES	CURRENT STATE & CONDITION	RESTORATION POTENTIAL & PRIORITY	PROPOSED FUTURE USES
<ul style="list-style-type: none"> ● Site 02: Mine Compound Complex ● Relative Locality: Approaching from the North, Site 02 is situated on the Western Side of the Main Entrance Road to the Norlim/Buxton Mine Town, after passing over the Road Bridge and just past the Trading Store on the right, just before reaching the Soccer Field [refer to Figure 16] 	<ul style="list-style-type: none"> ● Building/Structure 0116: Outdoor Wood-Fired Water Heater [refer to Photograph 16] ● Relative Position: Structure on Mine Compound Complex Site [refer to Figure 16] 	<ul style="list-style-type: none"> ● Construction Materials: Bricks, cement, steel, glass, wood and corrugated iron ● Construction Methods: Brick and plaster structure, covered by wooden roof trusses, clad with corrugated iron roof sheets 	<ul style="list-style-type: none"> ● Historical Use: Outdoor Wood-Fired Water Heater ● Current Use: Not in use 	<ul style="list-style-type: none"> ● State: Not vandalised ● Condition: Good <ul style="list-style-type: none"> ○ Basic structure in good condition, but should be restored ○ Floor covering [concrete slabs] partly present, but should be restored and replaced, where necessary ○ Installations have been partly removed and should be replaced with authentic items ○ Basic services should be installed and connected 	<ul style="list-style-type: none"> ● Restoration potential: Fair ● Restoration priority: High 	To be determined

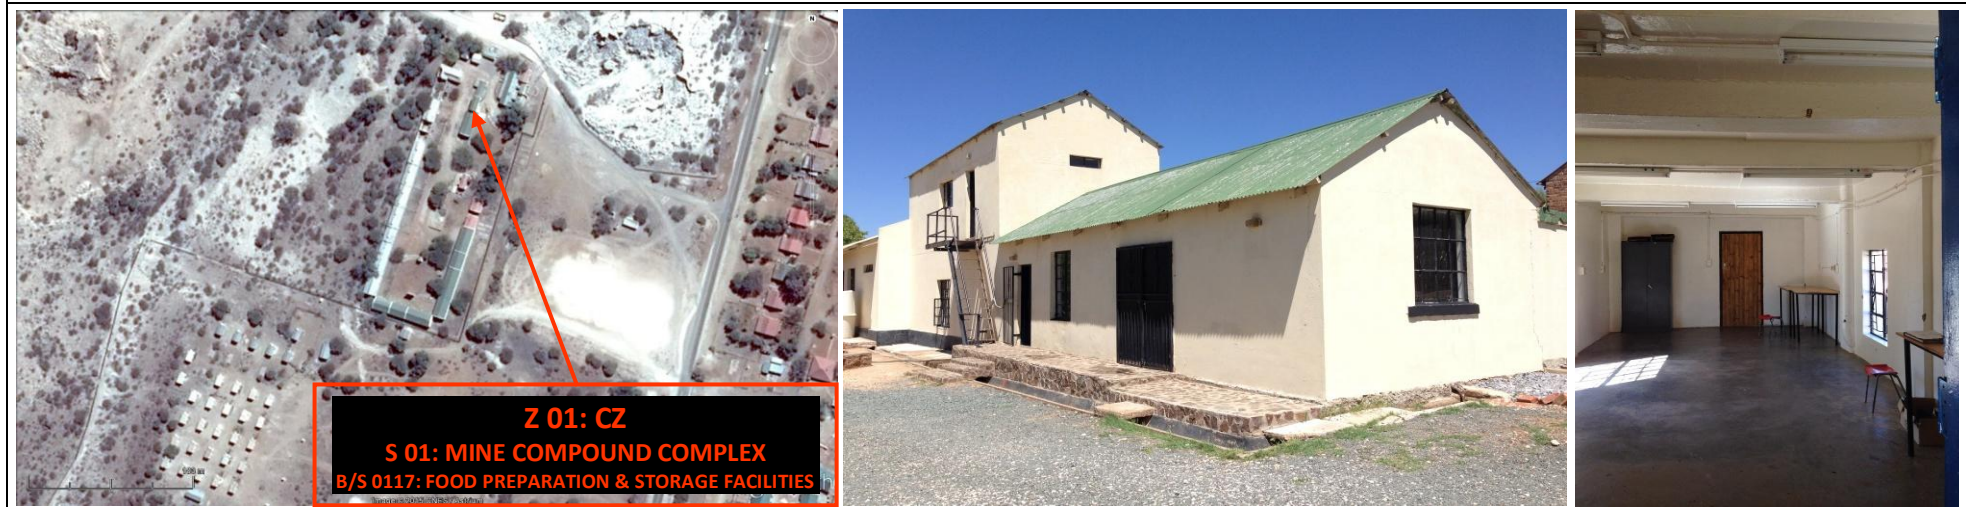
FIGURE 17 • PHOTOGRAPH 17 • Zone 01 [Z 01]: Core Zone [CZ] • Site 02 [S 02]: Mine Compound Complex • Building/Structure 0117 [B/S 0117]: Food Preparation & Storage Facilities • Date: 24 February 2015

SITE & RELATIVE LOCALITY	BUILDING/STRUCTURE & RELATIVE POSITION	CONSTRUCTION MATERIALS & METHODS	HISTORICAL & CURRENT USES	CURRENT STATE & CONDITION	RESTORATION POTENTIAL & PRIORITY	PROPOSED FUTURE USES
<ul style="list-style-type: none"> ● Site 02: Mine Compound Complex ● Relative Locality: Approaching from the North, Site 02 is situated on the Western Side of the Main Entrance Road to the Norlim/Buxton Mine Town, after passing over the Road Bridge and just past the Trading Store on the right, just before reaching the Soccer Field [refer to Figure 17] 	<ul style="list-style-type: none"> ● Building/Structure 0117: Food Preparation and Storage Facilities [refer to Photograph 17] ● Relative Position: Building on Mine Compound Complex Site [refer to Figure 17] 	<ul style="list-style-type: none"> ● Construction Materials: Bricks, cement, steel, glass, wood and corrugated iron ● Construction Methods: Brick and plaster structure, covered by wooden roof trusses, clad with corrugated iron roof sheets 	<ul style="list-style-type: none"> ● Historical Use: Food Preparation and Storage Facilities ● Current Use: Partly used as an Environmental Education Space and as a Security Guard Rest Room at night. 	<ul style="list-style-type: none"> ● State: Partly in use ● Condition: Fair <ul style="list-style-type: none"> ○ Basic structure in good condition, but should be restored ○ Fenestration and doors [steel and wood] present, but should be restored and replaced, where necessary ○ Floor covering [concrete slabs] present, but should be restored and replaced, where necessary ○ Roof support structure [wood trusses and concrete] present, but should be checked for structural integrity and should be restored and replaced, where necessary ○ Roof covering [corrugated iron roof sheets] present, but should be restored and replaced, where necessary ○ All interior installations have been removed and should be replaced with authentic items ○ Basic services should be installed and connected 	<ul style="list-style-type: none"> ● Restoration potential: Good ● Restoration priority: High 	<p>To be determined</p>

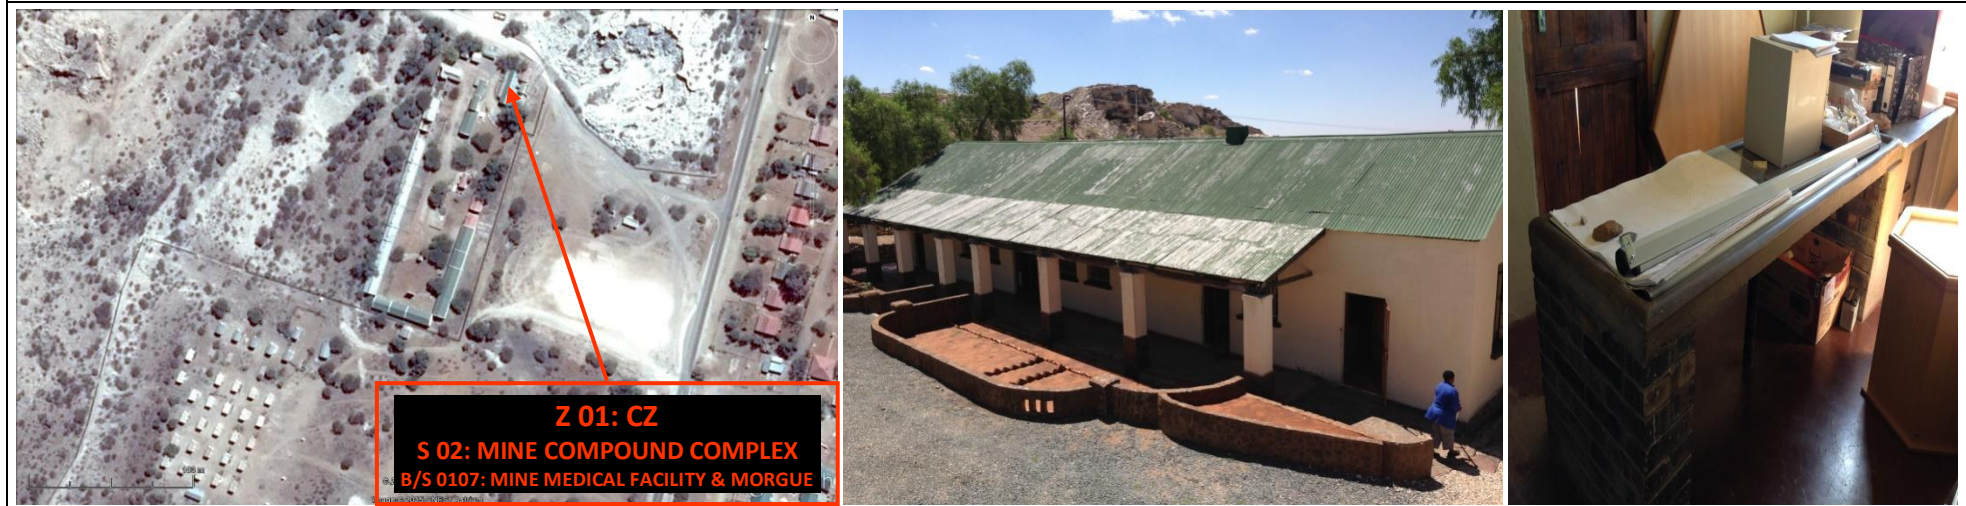
FIGURE 18 • PHOTOGRAPH 18 • Zone 01 [Z 01]: Core Zone [CZ] • Site 02 [S 02]: Mine Compound Complex • Building/Structure 0118 [B/S 0118]: Mine Medical Facility & Morgue • Date: 24 February 2015

SITE & RELATIVE LOCALITY	BUILDING/STRUCTURE & RELATIVE POSITION	CONSTRUCTION MATERIALS & METHODS	HISTORICAL & CURRENT USES	CURRENT STATE & CONDITION	RESTORATION POTENTIAL & PRIORITY	PROPOSED FUTURE USES
<ul style="list-style-type: none"> ● Site 02: Mine Compound Complex ● Relative Locality: Approaching from the North, Site 02 is situated on the Western Side of the Main Entrance Road to the Norlim/Buxton Mine Town, after passing over the Road Bridge and just past the Trading Store on the right, just before reaching the Soccer Field [refer to Figure 18] 	<ul style="list-style-type: none"> ● Building/Structure 0118: Mine Medical Facility and Morgue [refer to Photograph 18] ● Relative Position: Building on Mine Compound Complex Site [refer to Figure 18] 	<ul style="list-style-type: none"> ● Construction Materials: Bricks, cement, steel, glass, wood and corrugated iron ● Construction Methods: Brick and plaster structure, covered by wooden roof trusses, clad with corrugated iron roof sheets 	<ul style="list-style-type: none"> ● Historical Use: Mine Medical Facility and Morgue ● Current Use: Being used as the Taung Skull World Heritage Site Office 	<ul style="list-style-type: none"> ● State: In use ● Condition: Good <ul style="list-style-type: none"> ○ Basic structure in good condition, but should be restored ○ Fenestration and doors [steel and wood] present, but should be restored and replaced, where necessary ○ Floor covering [concrete slabs and carpets] present, but should be restored and replaced, where necessary ○ Roof support structure [wood trusses] present, but should be checked for structural integrity and should be restored and replaced, where necessary ○ Roof covering [corrugated iron roof sheets] present, but should be restored and replaced, where necessary ○ Some of the interior installations have been removed and should be replaced with authentic items ○ Basic services should be installed and connected 	<ul style="list-style-type: none"> ● Restoration potential: Good ● Restoration priority: High 	To be determined

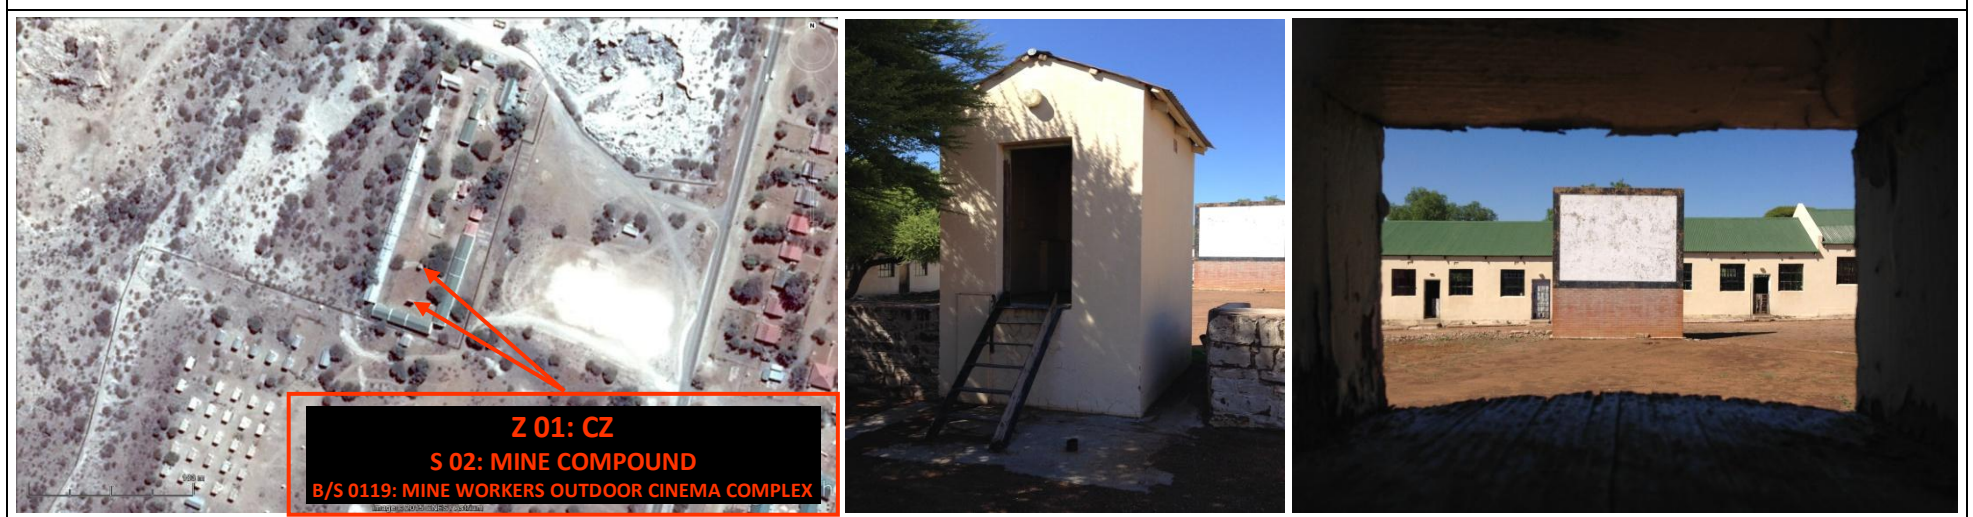
FIGURE 20 • PHOTOGRAPH 19 • Zone 01 [Z 01]: Core Zone [CZ] • Site 02 [S 02]: Mine Compound Complex • Building/Structure 0119 [B/S 0119]: Mine Workers Outdoor Cinema Complex • Date: 24 February 2015

SITE & RELATIVE LOCALITY	BUILDING/STRUCTURE & RELATIVE POSITION	CONSTRUCTION MATERIALS & METHODS	HISTORICAL & CURRENT USES	CURRENT STATE & CONDITION	RESTORATION POTENTIAL & PRIORITY	PROPOSED FUTURE USES
<ul style="list-style-type: none"> ● Site 02: Mine Compound Complex ● Relative Locality: Approaching from the North, Site 02 is situated on the Western Side of the Main Entrance Road to the Norlim/Buxton Mine Town, after passing over the Road Bridge and just past the Trading Store on the right, just before reaching the Soccer Field [refer to Figure 20] 	<ul style="list-style-type: none"> ● Building/Structure 0119: Mine Workers Outdoor Cinema Complex [refer to Photograph 19] ● Relative Position: Building on Mine Compound Complex Site [refer to Figure 19] 	<ul style="list-style-type: none"> ● Construction Materials: Bricks, cement, steel, glass, wood and corrugated iron ● Construction Methods: Brick and plaster structure, covered by wooden roof trusses, clad with corrugated iron roof sheets 	<ul style="list-style-type: none"> ● Historical Use: Mine Workers Outdoor Cinema Complex ● Current Use: Vacant 	<ul style="list-style-type: none"> ● State: Vandalised ● Condition: Good <ul style="list-style-type: none"> ○ Basic structure in good condition, but should be restored ○ Fenestration and doors [steel and wood] partly removed, but should be restored and replaced, where necessary ○ Floor covering [concrete slabs] present, but should be restored and replaced, where necessary ○ Roof support structure [wood trusses] present, but should be checked for structural integrity and should be restored and replaced, where necessary ○ Roof covering [corrugated iron roof sheets] present, but should be restored and replaced, where necessary ○ All interior installations have been removed and should be replaced with authentic items ○ Basic services should be installed and connected 	<ul style="list-style-type: none"> ● Restoration potential: Good ● Restoration priority: High 	To be determined

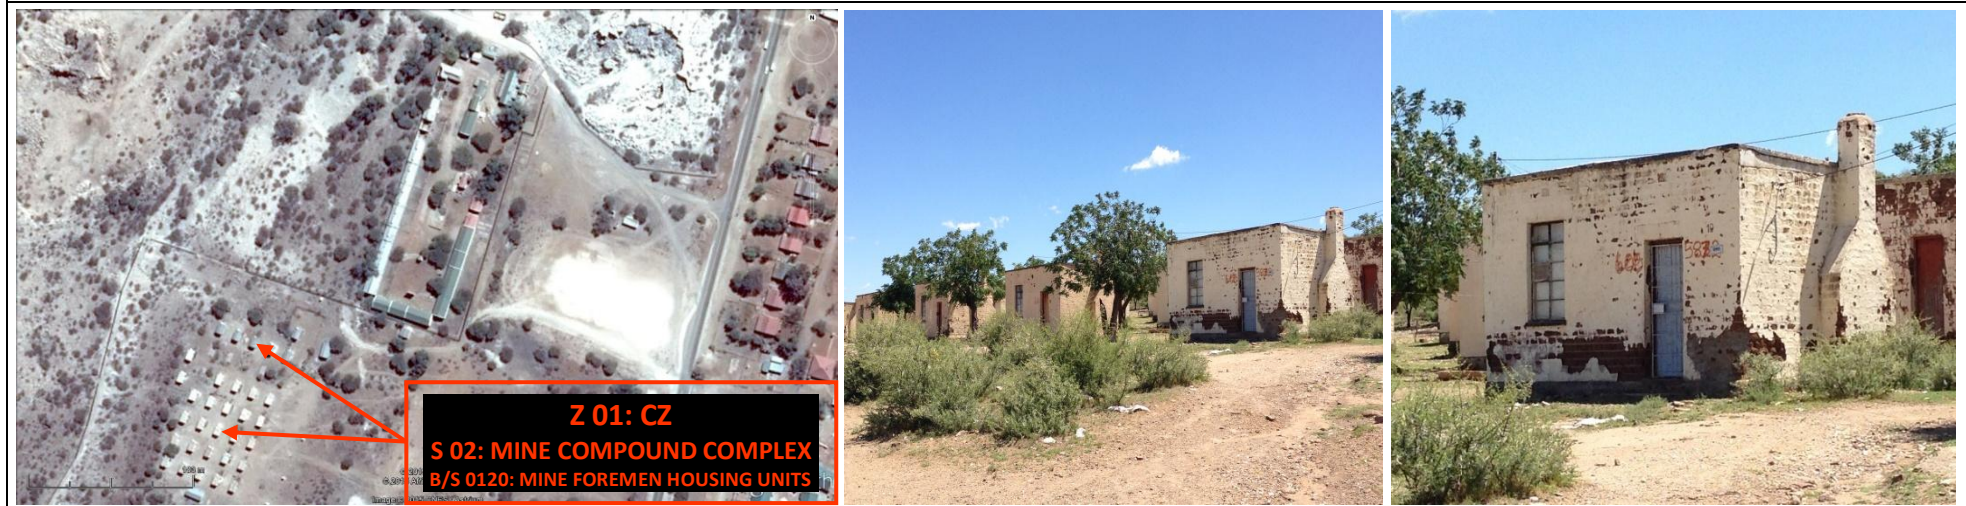
FIGURE 20 • PHOTOGRAPH 20 • Zone 01 [Z 01]: Core Zone [CZ] • Site 02 [S 02]: Mine Compound Complex • Building/Structure 0120 [B/S 0120]: Mine Foremen Housing Units • Date: 24 February 2015

SITE & RELATIVE LOCALITY	BUILDING/STRUCTURE & RELATIVE POSITION	CONSTRUCTION MATERIALS & METHODS	HISTORICAL & CURRENT USES	CURRENT STATE & CONDITION	RESTORATION POTENTIAL & PRIORITY	PROPOSED FUTURE USES
<ul style="list-style-type: none"> ● Site 02: Mine Compound Complex ● Relative Locality: Approaching from the North, Site 02 is situated on the Western Side of the Main Entrance Road to the Norlim/Buxton Mine Town, after passing over the Road Bridge and just past the Trading Store on the right, just before reaching the Soccer Field [refer to Figure 21] 	<ul style="list-style-type: none"> ● Building/Structure 0120: Mine Foremen Housing Units [refer to Photograph 20] ● Relative Position: Building on Mine Compound Complex Site [refer to Figure 20] 	<ul style="list-style-type: none"> ● Construction Materials: Bricks, cement, steel, glass, wood and corrugated iron ● Construction Methods: Brick and plaster structure, covered by wooden roof trusses, clad with corrugated iron roof sheets 	<ul style="list-style-type: none"> ● Historical Use: Mine Foremen Housing Units ● Current Use: Being used by local residents as housing units 	<ul style="list-style-type: none"> ● State: In use ● Condition: Fair <ul style="list-style-type: none"> ○ Basic structure in good condition, but should be restored ○ Fenestration and doors [steel and wood] partly removed, but should be restored and replaced, where necessary ○ Floor covering [not known] should be restored and replaced, where necessary ○ Roof support structure [wood trusses] present, but should be checked for structural integrity and should be restored and replaced, where necessary ○ Roof covering [corrugated iron roof sheets] present, but should be restored and replaced, where necessary ○ All interior installations have been removed and should be replaced with authentic items ○ Basic services should be installed and connected 	<ul style="list-style-type: none"> ● Restoration potential: Good ● Restoration priority: Low 	To be determined

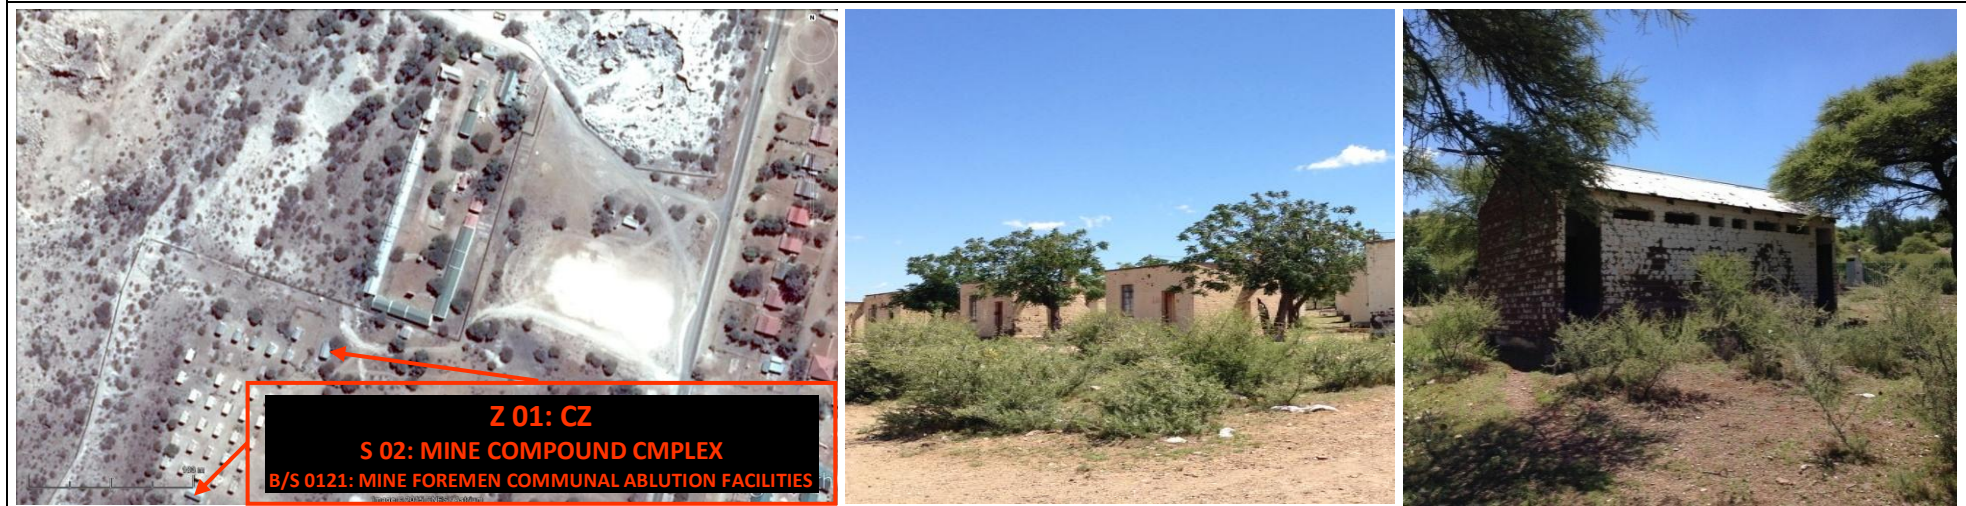
FIGURE 21 • PHOTOGRAPH 21 • Zone 01 [Z 01]: Core Zone [CZ] • Site 02 [S 02]: Mine Compound Complex • Building/Structure 0121 [B/S 0121]: Mine Foremen Communal Ablution Facilities • Date: 24 February 2015

SITE & RELATIVE LOCALITY	BUILDING/STRUCTURE & RELATIVE POSITION	CONSTRUCTION MATERIALS & METHODS	HISTORICAL & CURRENT USES	CURRENT STATE & CONDITION	RESTORATION POTENTIAL & PRIORITY	PROPOSED FUTURE USES
<ul style="list-style-type: none"> ● Site 02: Mine Compound Complex ● Relative Locality: Approaching from the North, Site 02 is situated on the Western Side of the Main Entrance Road to the Norlim/Buxton Mine Town, after passing over the Road Bridge and just past the Trading Store on the right, just before reaching the Soccer Field [refer to Figure 21] 	<ul style="list-style-type: none"> ● Building/Structure 0121: Mine Foremen Communal Ablution Facilities [refer to Photograph 21] ● Relative Position: Building on Mine Compound Complex Site [refer to Figure 21] 	<ul style="list-style-type: none"> ● Construction Materials: Bricks, cement, steel, glass, wood and corrugated iron ● Construction Methods: Brick and plaster structure, covered by wooden roof trusses, clad with corrugated iron roof sheets 	<ul style="list-style-type: none"> ● Historical Use: Mine Foremen Communal Ablution Facilities ● Current Use: Not in use 	<ul style="list-style-type: none"> ● State: Vandalised ● Condition: Good <ul style="list-style-type: none"> ○ Basic structure in good condition, but should be restored ○ Fenestration and doors [steel and wood] removed, but should be restored and replaced, where necessary ○ Floor covering [concrete slabs] present, but should be restored and replaced, where necessary ○ Roof support structure [wood trusses] present, but should be checked for structural integrity and should be restored and replaced, where necessary ○ Roof covering [corrugated iron roof sheets] present, but should be restored and replaced, where necessary ○ All interior installations have been removed and should be replaced with authentic items ○ Basic services should be installed and connected 	<ul style="list-style-type: none"> ● Restoration potential: Fair ● Restoration priority: Low 	To be determined

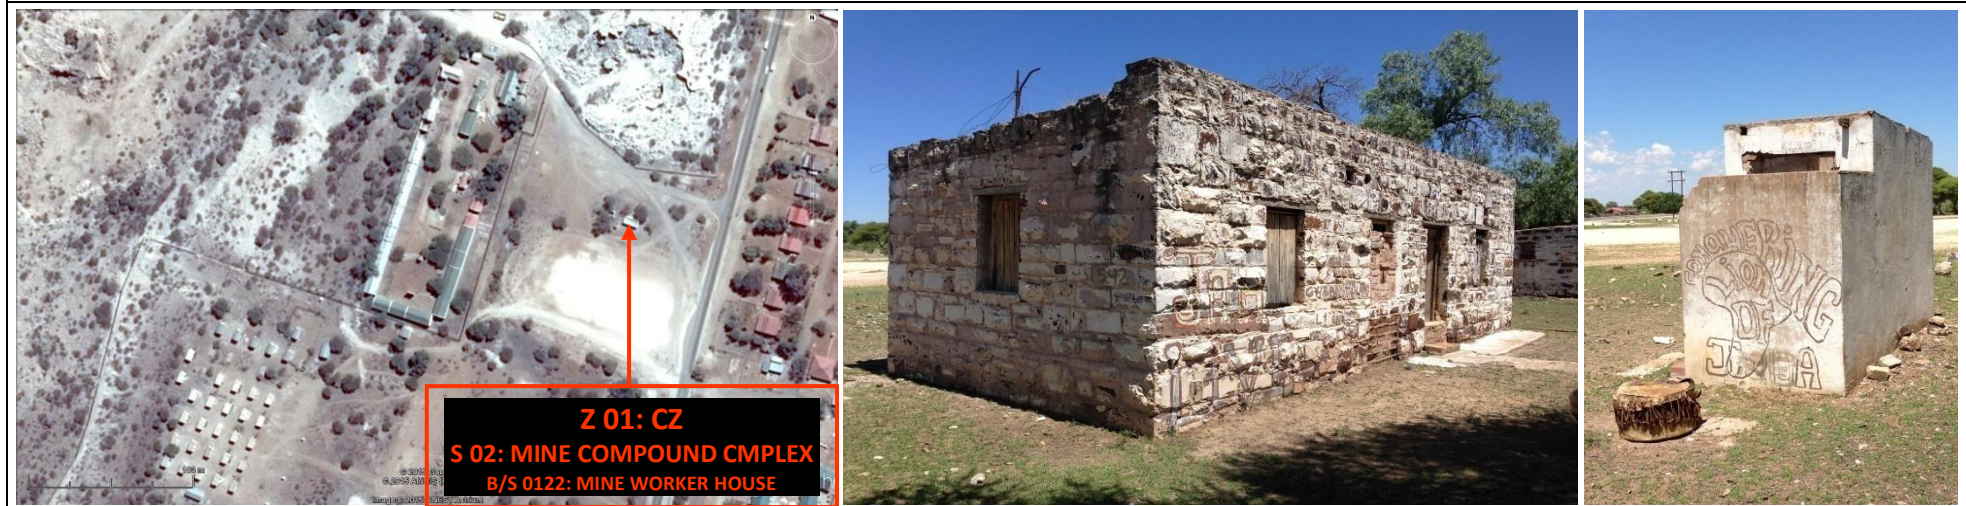
FIGURE 22 • PHOTOGRAPH 22 • Zone 01 [Z 01]: Core Zone [CZ] • Site 02 [S 02]: Mine Compound Complex • Building/Structure 0122 [B/S 0122]: Mine Worker House • Date: 24 February 2015

SITE & RELATIVE LOCALITY	BUILDING/STRUCTURE & RELATIVE POSITION	CONSTRUCTION MATERIALS & METHODS	HISTORICAL & CURRENT USES	CURRENT STATE & CONDITION	RESTORATION POTENTIAL & PRIORITY	PROPOSED FUTURE USES
<ul style="list-style-type: none"> ● Site 02: Mine Compound Complex ● Relative Locality: Approaching from the North, Site 02 is situated on the Western Side of the Main Entrance Road to the Norlim/Buxton Mine Town, after passing over the Road Bridge and just past the Trading Store on the right, just before reaching the Soccer Field [refer to Figure 22] 	<ul style="list-style-type: none"> ● Building/Structure 0122: Mine Worker House [refer to Photograph 22] ● Relative Position: Building on Mine Compound Complex Site [refer to Figure 22] 	<ul style="list-style-type: none"> ● Construction Materials: Bricks, cement, steel, glass, wood and corrugated iron ● Construction Methods: Brick and plaster structure, covered by wooden roof trusses, clad with corrugated iron roof sheets 	<ul style="list-style-type: none"> ● Historical Use: Mine Worker House ● Current Use: Not in use 	<ul style="list-style-type: none"> ● State: Vandalised ● Condition: Good <ul style="list-style-type: none"> ○ Basic structure in good condition, but should be restored ○ Fenestration and doors [wood] partly removed, but should be restored and replaced, where necessary ○ Floor covering [not known] should be restored and replaced, where necessary ○ Roof support structure [not known] present, but should be checked for structural integrity and should be restored and replaced, where necessary ○ Roof covering [corrugated iron roof sheets] present, but should be restored and replaced, where necessary ○ All interior installations have been removed and should be replaced with authentic items ○ Basic services should be installed and connected 	<ul style="list-style-type: none"> ● Restoration potential: Good ● Restoration priority: Low 	<p>To be determined</p>

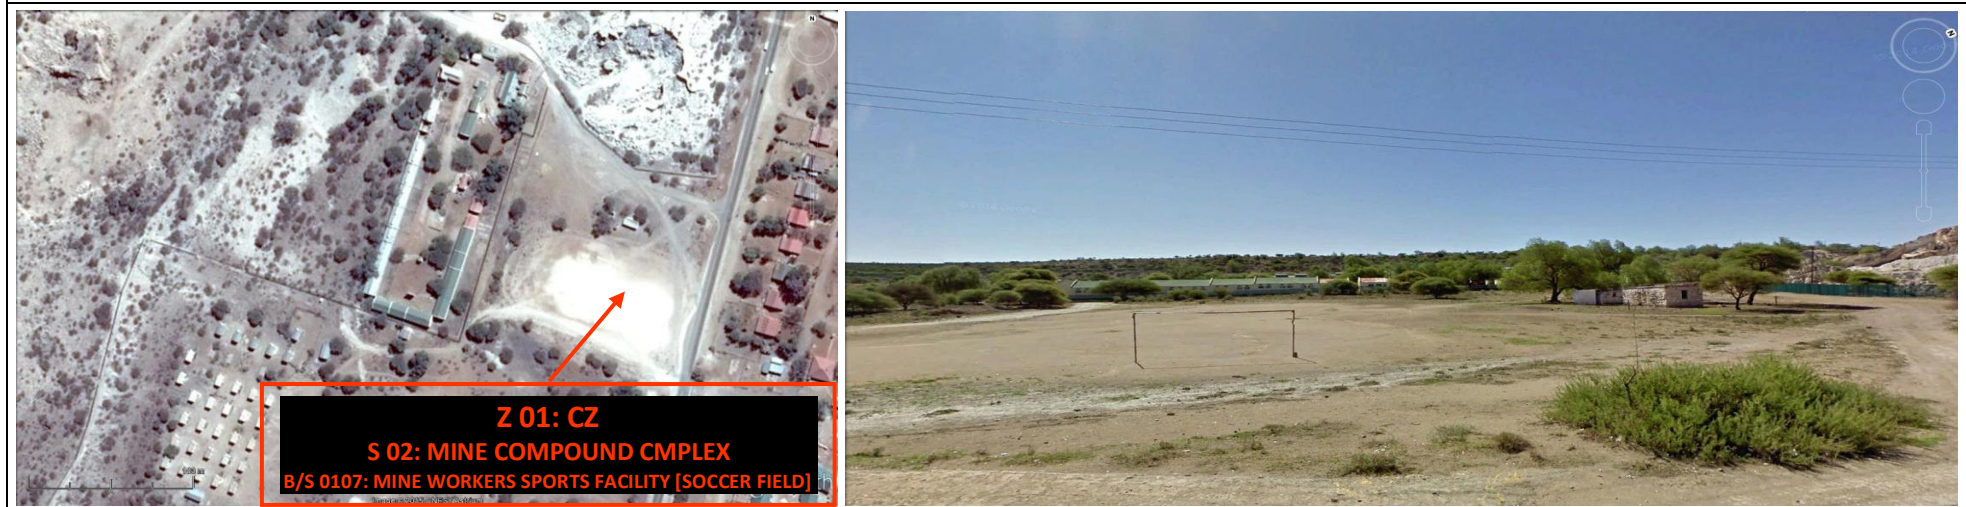
FIGURE 23 • PHOTOGRAPH 23 • Zone 01 [Z 01]: Core Zone [CZ] • Site 02 [S 02]: Mine Compound Complex • Building/Structure 0123 [B/S 0123]: Mine Workers Sports Facility [Soccer Field] • Date: 24 February 2015

SITE & RELATIVE LOCALITY	BUILDING/STRUCTURE & RELATIVE POSITION	CONSTRUCTION MATERIALS & METHODS	HISTORICAL & CURRENT USES	CURRENT STATE & CONDITION	RESTORATION POTENTIAL & PRIORITY	PROPOSED FUTURE USES
<ul style="list-style-type: none"> ● Site 02: Mine Compound Complex ● Relative Locality: Approaching from the North, Site 02 is situated on the Western Side of the Main Entrance Road to the Norlim/Buxton Mine Town, after passing over the Road Bridge and just past the Trading Store on the right, just before reaching the Soccer Field [refer to Figure 23] 	<ul style="list-style-type: none"> ● Building/Structure 0123: Mine Workers Sports Facility [Soccer Field] [refer to Photograph 23] ● Relative Position: Structure on Mine Compound Complex Site [refer to Figure 23] 	<ul style="list-style-type: none"> ● Construction Materials: Bricks, cement, steel, glass, wood and corrugated iron ● Construction Methods: Brick and plaster structure, covered by wooden roof trusses, clad with corrugated iron roof sheets 	<ul style="list-style-type: none"> ● Historical Use: e Manager ● Current Use: In use by community 	<ul style="list-style-type: none"> ● State: In use ● Condition: Poor <ul style="list-style-type: none"> ○ Basic facility in poor condition, but should be restored 	<ul style="list-style-type: none"> ● Restoration potential: Poor ● Restoration priority: Low 	<p>To be determined</p>

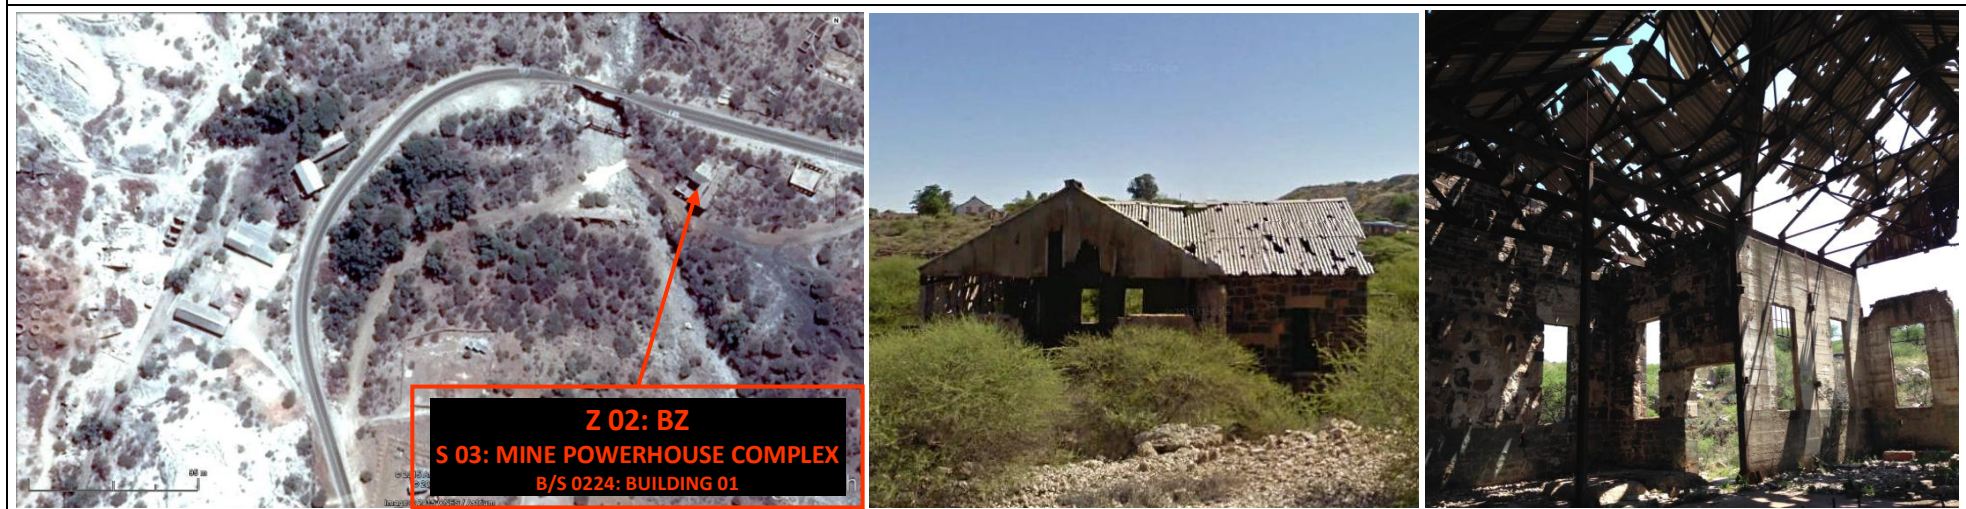
FIGURE 24 • PHOTOGRAPH 24 • Zone 02 [Z 02]: Buffer Zone [BZ] • Site 03 [S 03]: Mine Powerhouse Complex • Building/Structure 0224 [B/S 0224]: Building 01 • Date: 24 February 2015

SITE & RELATIVE LOCALITY	BUILDING/STRUCTURE & RELATIVE POSITION	CONSTRUCTION MATERIALS & METHODS	HISTORICAL & CURRENT USES	CURRENT STATE & CONDITION	RESTORATION POTENTIAL & PRIORITY	PROPOSED FUTURE USES
<ul style="list-style-type: none"> ● Site 03: Mine Powerhouse Complex ● Relative Locality: Approaching from the North, Site 03 is situated on the Southern Side of the Main Entrance Road to the Norlim/Buxton Mine Town, just before passing over the Road Bridge [refer to Figure 24] 	<ul style="list-style-type: none"> ● Building/Structure 0224: Building 01 [refer to Photograph 24] ● Relative Position: Building on Mine Powerhouse Complex Site [refer to Figure 24] 	<ul style="list-style-type: none"> ● Construction Materials: Bricks, cement, steel, glass, wood and asbestos ● Construction Methods: Brick and plaster structure, covered by steel and wooden roof trusses, clad with asbestos roof sheets 	<ul style="list-style-type: none"> ● Historical Use: Power generation ● Current Use: Not in use 	<ul style="list-style-type: none"> ● State: Vandalised ● Condition: Poor <ul style="list-style-type: none"> ○ Basic structure in good condition, but should be restored ○ Fenestration and doors [steel and wood] removed, but should be restored and replaced, where necessary ○ Floor covering [concrete slabs] partly removed, but should be restored and replaced, where necessary ○ Roof support structure [steel and wood trusses] present, but should be checked for structural integrity and should be restored and replaced, where necessary ○ Roof covering [asbestos sheets] partly present, but should be restored and replaced, where necessary ○ All interior installations have been removed and should be replaced with authentic items ○ Basic services should be installed and connected 	<ul style="list-style-type: none"> ● Restoration potential: Poor ● Restoration priority: Low 	To be determined

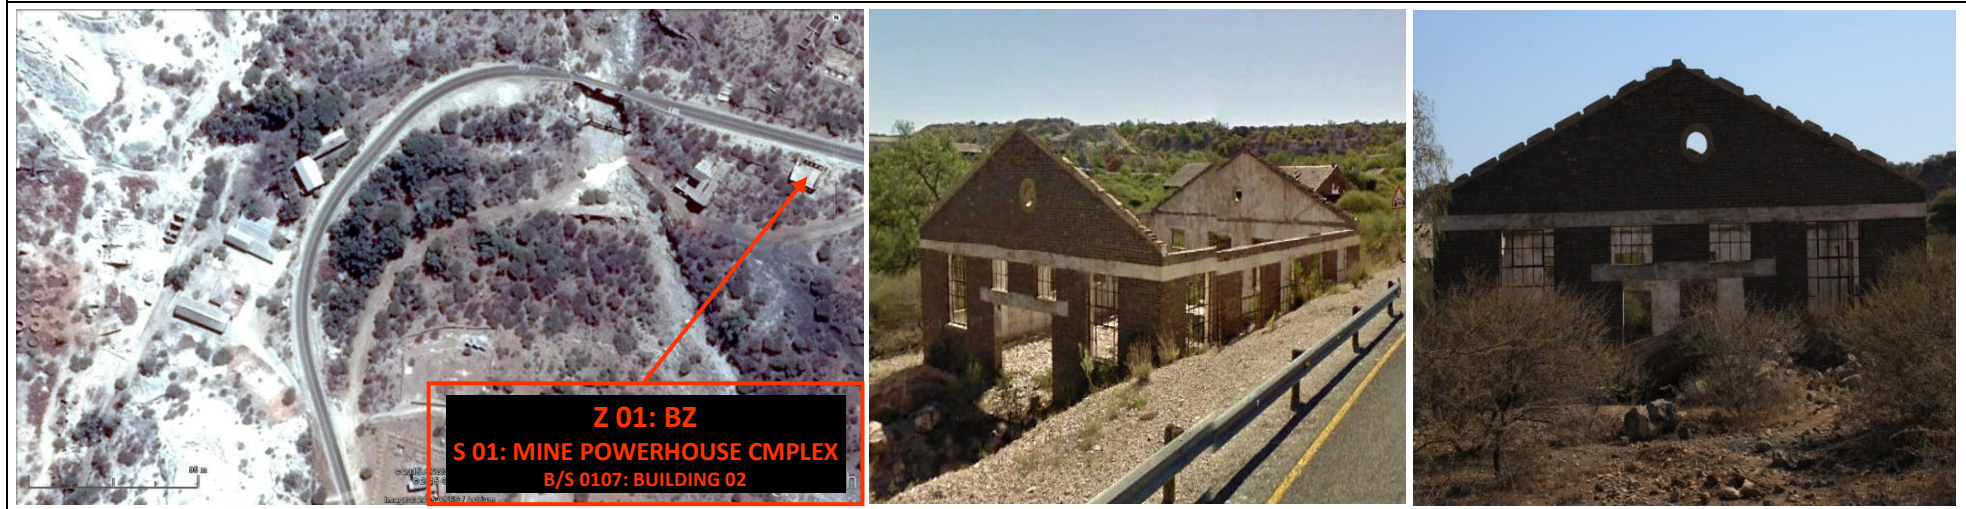
FIGURE 25 • PHOTOGRAPH 25 • Zone 02 [Z 02]: Buffer Zone [BZ] • Site 03 [S 01]: Mine Powerhouse Complex • Building/Structure 0225 [B/S 0225]: Building 02 • Date: 24 February 2015

SITE & RELATIVE LOCALITY	BUILDING/STRUCTURE & RELATIVE POSITION	CONSTRUCTION MATERIALS & METHODS	HISTORICAL & CURRENT USES	CURRENT STATE & CONDITION	RESTORATION POTENTIAL & PRIORITY	PROPOSED FUTURE USES
<ul style="list-style-type: none"> ● Site 03: Mine Powerhouse Complex ● Relative Locality: Approaching from the North, Site 03 is situated on the Southern Side of the Main Entrance Road to the Norlim/ Buxton Mine Town, just before passing over the Road Bridge [refer to Figure 25] 	<ul style="list-style-type: none"> ● Building/Structure 0225: Building 02 [refer to Photograph 25] ● Relative Position: Building on Mine Compound Complex Site [refer to Figure 25] 	<ul style="list-style-type: none"> ● Construction Materials: Bricks, cement, steel, glass, wood and corrugated iron ● Construction Methods: Brick and plaster structure, covered by wooden roof trusses, clad with corrugated iron roof sheets 	<ul style="list-style-type: none"> ● Historical Use: Office of Mine Manager ● Current Use: Vacant 	<ul style="list-style-type: none"> ● State: Vandalised ● Condition: Poor <ul style="list-style-type: none"> ○ Basic structure in good condition, but should be restored ○ Fenestration and doors [steel and wood] partly removed, but should be restored and replaced, where necessary ○ Floor covering [concrete slabs] partly removed, but should be restored and replaced, where necessary ○ Roof support structure [wood trusses] removed, but should be checked for structural integrity and should be restored and replaced, where necessary ○ Roof covering [corrugated iron roof sheets] removed, but should be replaced ○ All interior installations have been removed and should be replaced with authentic items ○ Basic services should be installed and connected 	<ul style="list-style-type: none"> ● Restoration potential: Poor ● Restoration priority: Low 	To be determined

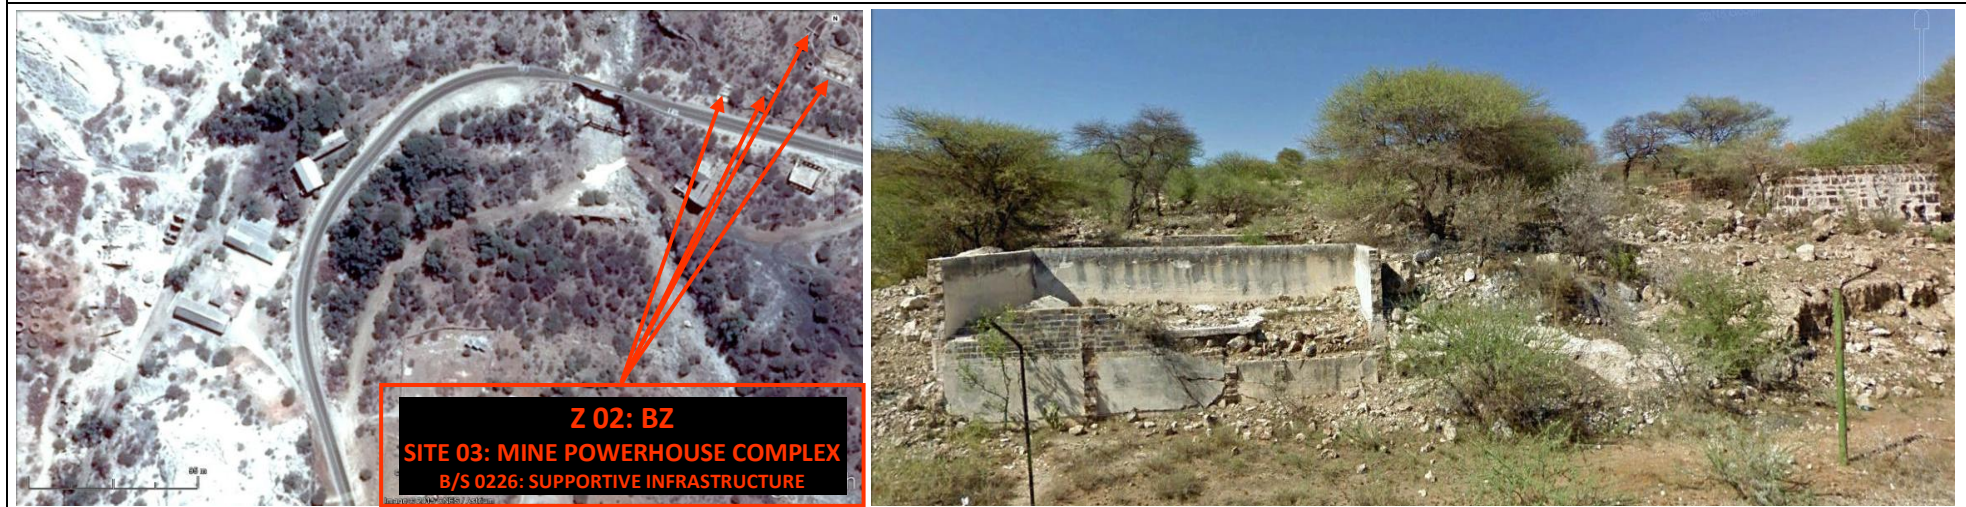
FIGURE 26 • PHOTOGRAPH 26 • Zone 02 [Z 02]: Buffer Zone [BZ] • Site 03 [S 03]: Mine Powerhouse Complex • Building/Structure 0226 [B/S 0226]: Supportive Infrastructure • Date: 24 February 2015

SITE & RELATIVE LOCALITY	BUILDING/STRUCTURE & RELATIVE POSITION	CONSTRUCTION MATERIALS & METHODS	HISTORICAL & CURRENT USES	CURRENT STATE & CONDITION	RESTORATION POTENTIAL & PRIORITY	PROPOSED FUTURE USES
<ul style="list-style-type: none"> ● Site 03: Mine Powerhouse Complex ● Relative Locality: Approaching from the North, Site 03 is situated on the Northern Side of the Main Entrance Road to the Norlim/Buxton Mine Town, just before passing over the Road Bridge [refer to Figure 26] 	<ul style="list-style-type: none"> ● Building/Structure 0226: Supportive Infrastructure [refer to Photograph 26] ● Relative Position: Structures [ruins] on Mine Compound Complex Site [refer to Figure 26] 	<ul style="list-style-type: none"> ● Construction Materials: Bricks, cement, steel, glass, wood and corrugated iron ● Construction Methods: Brick and plaster structure, covered by wooden roof trusses, clad with corrugated iron roof sheets 	<ul style="list-style-type: none"> ● Historical Use: Supportive Infrastructure ● Current Use: Not in use 	<ul style="list-style-type: none"> ● State: Vandalised ● Condition: Poor <ul style="list-style-type: none"> ○ Basic structure in poor condition, but should be restored 	<ul style="list-style-type: none"> ● Restoration potential: Poor ● Restoration priority: Low 	<p>To be determined</p>

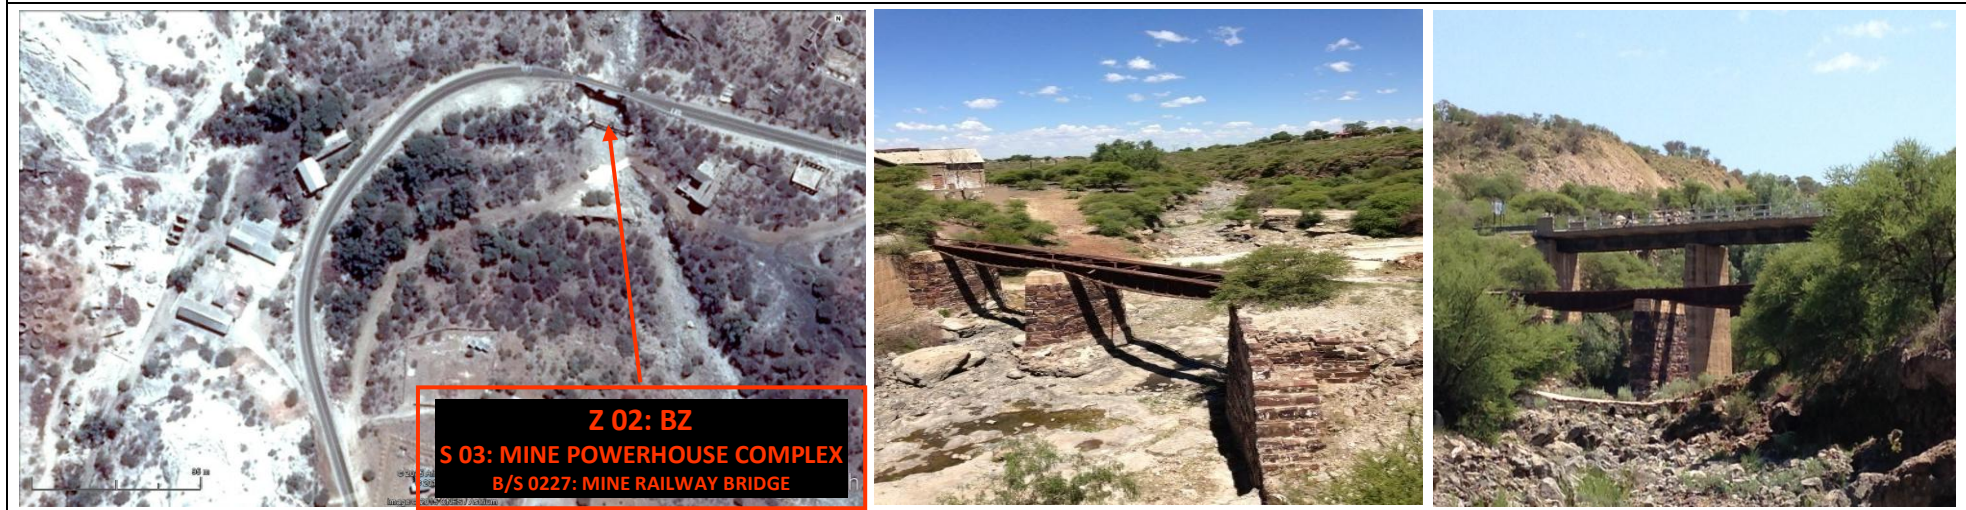
FIGURE 27 • PHOTOGRAPH 27 • Zone 02 [Z 02]: Buffer Zone [BZ] • Site 03 [S 03]: Mine Powerhouse Complex • Building/Structure 0227 [B/S 0227]: Mine Railway Bridge • Date: 24 February 2015

SITE & RELATIVE LOCALITY	BUILDING/STRUCTURE & RELATIVE POSITION	CONSTRUCTION MATERIALS & METHODS	HISTORICAL & CURRENT USES	CURRENT STATE & CONDITION	RESTORATION POTENTIAL & PRIORITY	PROPOSED FUTURE USES
<ul style="list-style-type: none"> ● Site 03: Mine Powerhouse Complex ● Relative Locality: Approaching from the North, Site 03 is situated on the Southern Side of the Main Entrance Road to the Norlim/Buxton Mine Town, just below and as you pass over the Road Bridge [refer to Figure 27] 	<ul style="list-style-type: none"> ● Building/Structure 0227: Mine Railway Bridge [refer to Photograph 27] ● Relative Position: Building on Mine Compound Complex Site [refer to Figure 27] 	<ul style="list-style-type: none"> ● Construction Materials: Steel, concrete and natural stone ● Construction Methods: Concrete foundations, natural stone columns and steel supports 	<ul style="list-style-type: none"> ● Historical Use: Mine Railway Bridge ● Current Use: Not in use 	<ul style="list-style-type: none"> ● State: Vandalised ● Condition: Fair <ul style="list-style-type: none"> ○ Basic structure in good condition, but should be restored ○ Structure should be checked for structural integrity and should be restored and components should be replaced, where necessary 	<ul style="list-style-type: none"> ● Restoration potential: Fair ● Restoration priority: Low 	<p>To be determined</p>
