TAUNG SKULL WORLD HERITAGE SITE: BUILT LANDSCAPE INVENTORY OF SELECTED BUILDINGS AND STRUCTURES

The HIA, which is in the process of being conducted on the TSWHS, provides an opportunity to showcase the value of such an approach and output. The Built Landscape Inventory is a catalogue of buildings falling within both the Core and Buffer Zones and attempts to provide a very simplistic vantage point and baseline, from where the assessment and planning process can unfold. The purpose of the Built Landscape Inventory is to provide a list of key buildings, an assessment of the condition and the possible repurposing of the facilities into functional entities. This provides an initial recording of baseline data on the built landscape that can be further developed into a management [development and maintenance] plan for the built landscape at TSWHS.

The Built Landscape Inventory is compiled for the following Preliminary Zones and Sites on the TSWHS:

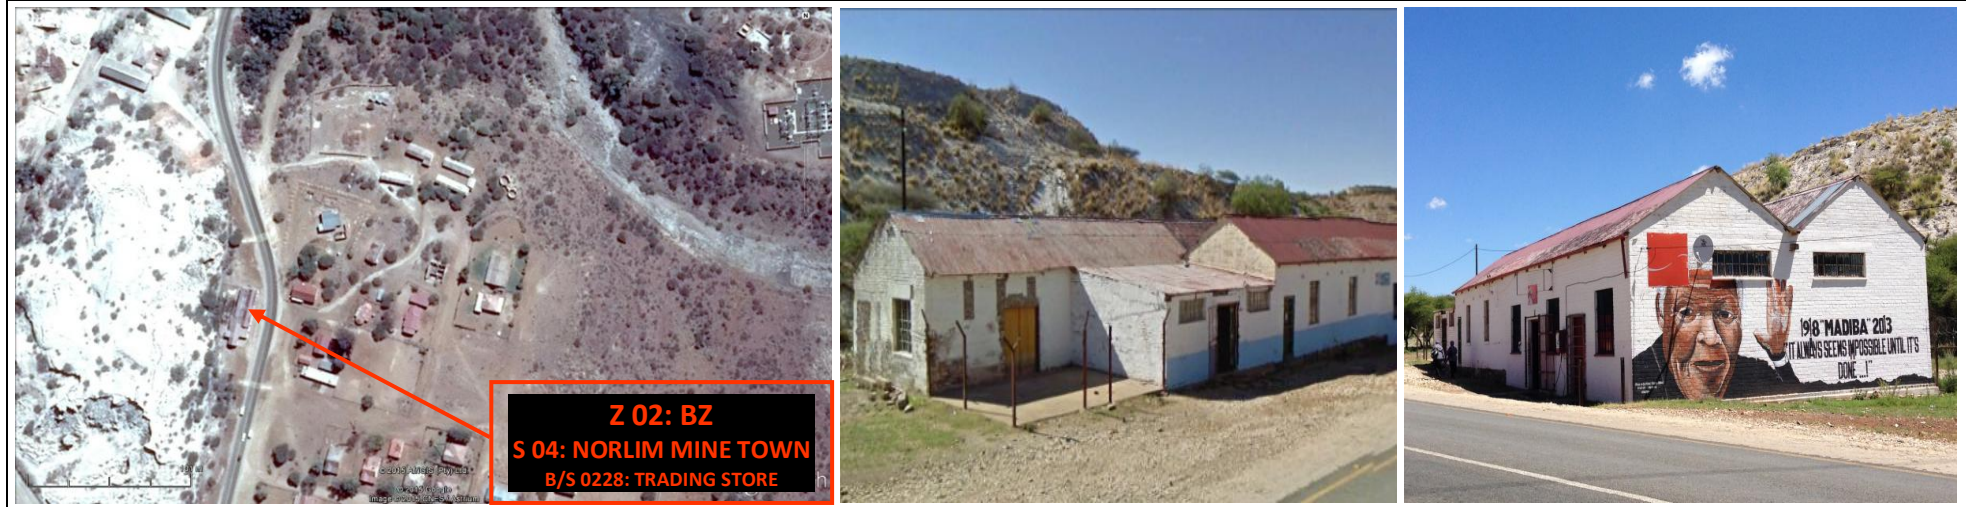
FIGURE 28 • PHOTOGRAPH 28 • Zone 02 [Z 02]: Buffer Zone [BZ] • Site 04 [S 04]: Norlim Mine Town • Building/Structure 0228 [B/S 0228]: Trading Store • Date: 24 February 2015

SITE & RELATIVE LOCALITY	BUILDING/STRUCTURE & RELATIVE POSITION	CONSTRUCTION MATERIALS & METHODS	HISTORICAL & CURRENT USES	CURRENT STATE & CONDITION	RESTORATION POTENTIAL & PRIORITY	PROPOSED FUTURE USES
<ul style="list-style-type: none"> ● Site 04: Norlim Mine Town ● Relative Locality: Approaching from the North, Site 05 is situated on the Eastern Side of the Main Entrance Road to the Norlim/Buxton Mine Town, just past the Mine Complex on the right [refer to Figure 28] 	<ul style="list-style-type: none"> ● Building/Structure 0228: Trading Store [refer to Photograph 28] ● Relative Position: Building on Norlim Mine Town Site [refer to Figure 28] 	<ul style="list-style-type: none"> ● Construction Materials: Bricks, cement, steel, glass, wood and corrugated iron ● Construction Methods: Brick and plaster structure, covered by wooden roof trusses, clad with corrugated iron roof sheets 	<ul style="list-style-type: none"> ● Historical Use: Trading Store ● Current Use: In use 	<ul style="list-style-type: none"> ● State: In use ● Condition: Good <ul style="list-style-type: none"> ○ Basic structure in good condition, but should be restored ○ Fenestration and doors [steel and wood] present, but should be restored and replaced, where necessary ○ Floor covering [concrete slabs] present, but should be restored and replaced, where necessary ○ Roof support structure [wood trusses] present, but should be checked for structural integrity and should be restored and replaced, where necessary ○ Roof covering [corrugated iron roof sheets] present, but should be restored and replaced, where necessary ○ All interior installations have been removed and should be replaced with authentic items ○ Basic services should be installed and connected 	<ul style="list-style-type: none"> ● Restoration potential: Good ● Restoration priority: Low 	<p>To be determined</p>

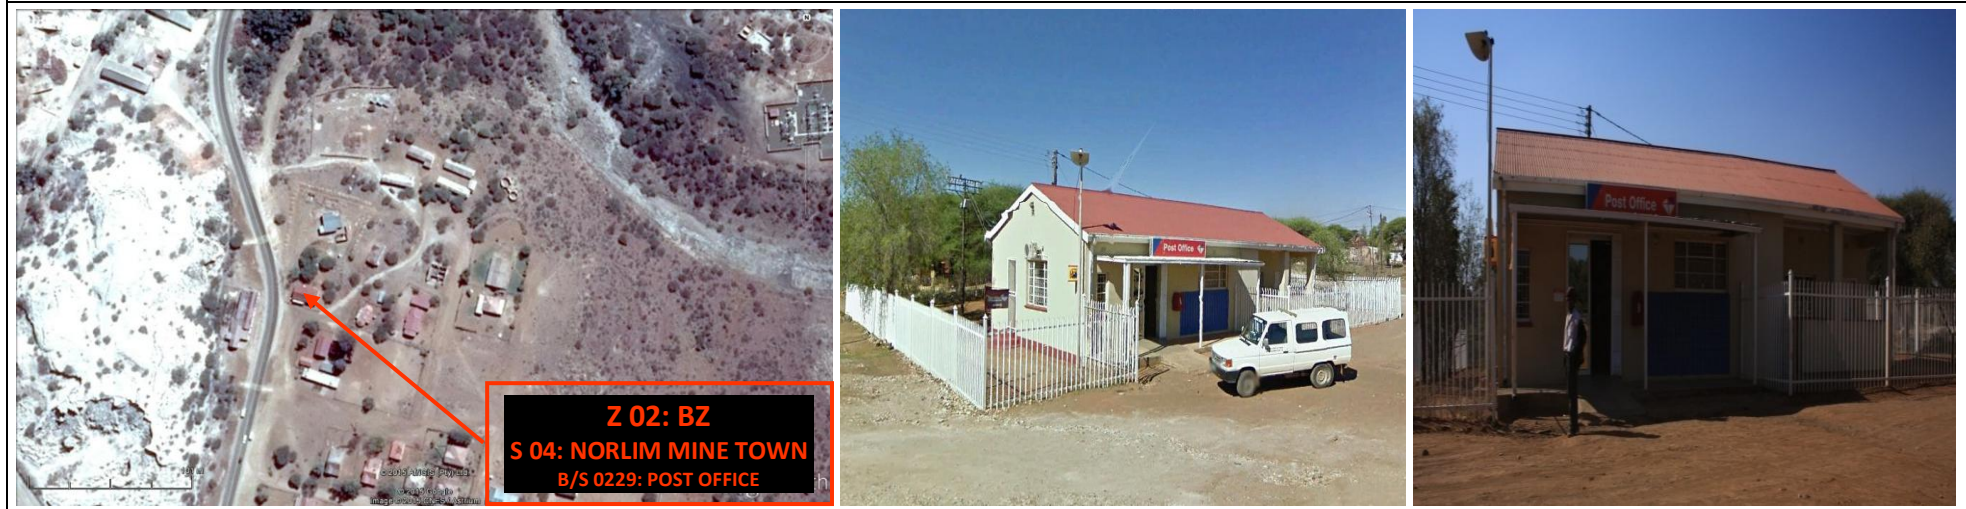
FIGURE 29 • PHOTOGRAPH 29 • Zone 02 [Z 01]: Buffer Zone [BZ] • Site 04 [S 04]: Norlim Mine Town • Building/Structure 0229 [B/S 0229]: Post Office • Date: 24 February 2015

SITE & RELATIVE LOCALITY	BUILDING/STRUCTURE & RELATIVE POSITION	CONSTRUCTION MATERIALS & METHODS	HISTORICAL & CURRENT USES	CURRENT STATE & CONDITION	RESTORATION POTENTIAL & PRIORITY	PROPOSED FUTURE USES
<ul style="list-style-type: none"> ● Site 04: Norlim Mine Town ● Relative Locality: Approaching from the North, Site 05 is situated on the Eastern Side of the Main Entrance Road to the Norlim/ Buxton Mine Town, just past the Mine Complex on the right [refer to Figure 29] 	<ul style="list-style-type: none"> ● Building/Structure 0229: Post Office [refer to Photograph 29] ● Relative Position: Building on Norlim Mine Town Complex [refer to Figure 29] 	<ul style="list-style-type: none"> ● Construction Materials: Bricks, cement, steel, glass, wood and corrugated iron ● Construction Methods: Brick and plaster structure, covered by wooden roof trusses, clad with corrugated iron roof sheets 	<ul style="list-style-type: none"> ● Historical Use: Post Office ● Current Use: In use 	<ul style="list-style-type: none"> ● State: In use ● Condition: Excellent <ul style="list-style-type: none"> ○ Basic structure in good condition, but should be restored, where necessary ○ Fenestration and doors [steel and wood] present, but should be restored and replaced, where necessary ○ Floor covering [not known] should be restored and replaced, where necessary ○ Roof support structure [wood trusses] present, but should be checked for structural integrity and should be restored and replaced, where necessary ○ Roof covering [corrugated iron roof sheets] present, but should be restored, where necessary ○ Some interior installations have been removed and should be replaced with authentic items ○ Basic services should be installed and connected 	<ul style="list-style-type: none"> ● Restoration potential: Good ● Restoration priority: Low 	To be determined

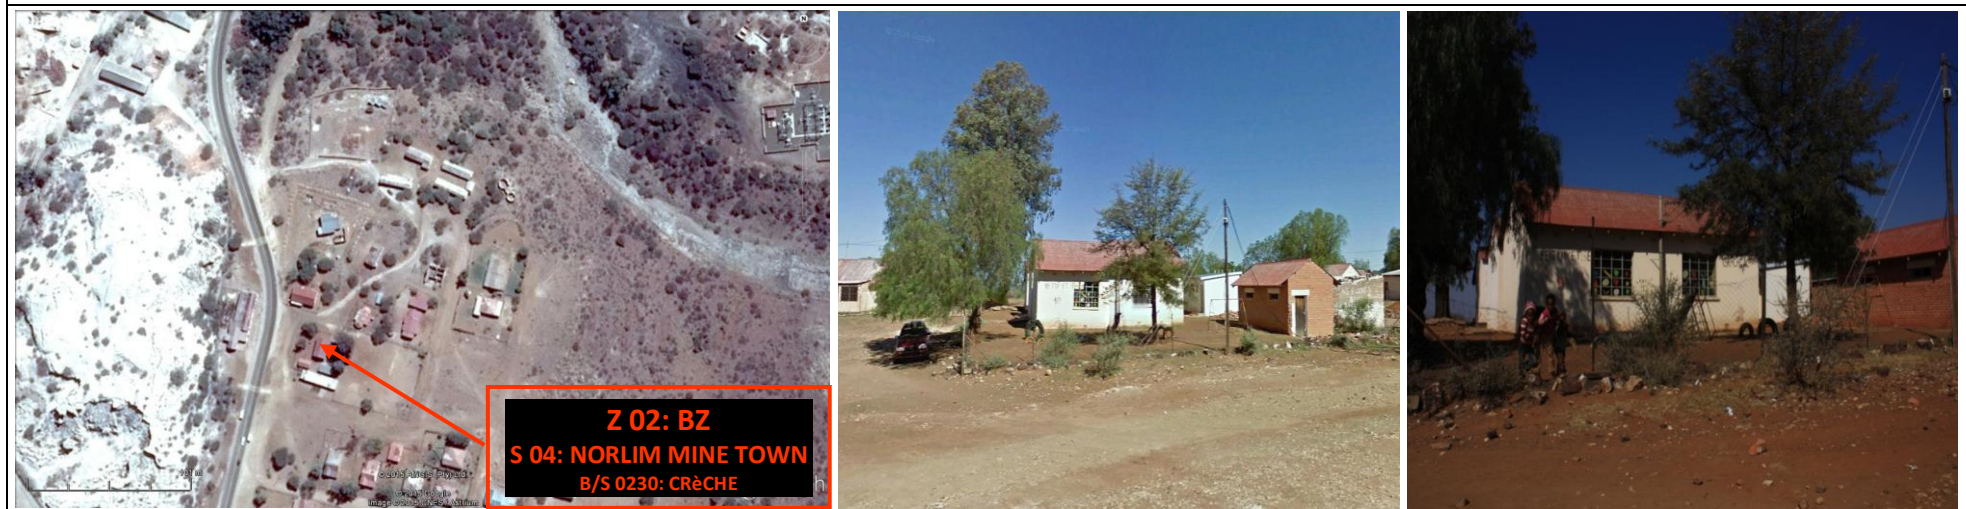
FIGURE 30 • PHOTOGRAPH 30 • Zone 02 [Z 02]: Buffer Zone [BZ] • Site 04 [S 04]: Norlim Mine Town • Building/Structure 0230 [B/S 0230]: Crèche • Date: 24 February 2015

SITE & RELATIVE LOCALITY	BUILDING/STRUCTURE & RELATIVE POSITION	CONSTRUCTION MATERIALS & METHODS	HISTORICAL & CURRENT USES	CURRENT STATE & CONDITION	RESTORATION POTENTIAL & PRIORITY	PROPOSED FUTURE USES
<ul style="list-style-type: none"> ● Site 04: Norlim Mine Town ● Relative Locality: Approaching from the North, Site 05 is situated on the Eastern Side of the Main Entrance Road to the Norlim/ Buxton Mine Town, just past the Mine Complex on the right [refer to Figure 30] 	<ul style="list-style-type: none"> ● Building/Structure 0230: Crèche ● Relative Position: Building on Norlim Mine Town Site [refer to Figure 30] 	<ul style="list-style-type: none"> ● Construction Materials: Bricks, cement, steel, glass, wood and corrugated iron ● Construction Methods: Brick and plaster structure, covered by wooden roof trusses, clad with corrugated iron roof sheets 	<ul style="list-style-type: none"> ● Historical Use: Not Known ● Current Use: Crèche 	<ul style="list-style-type: none"> ● State: In use ● Condition: Good <ul style="list-style-type: none"> ○ Basic structure in good condition, but should be restored ○ Fenestration and doors [steel and wood] present, but should be restored and replaced, where necessary ○ Floor covering [not known] should be restored and replaced, where necessary ○ Roof support structure [wood trusses] present, but should be checked for structural integrity and should be restored and replaced, where necessary ○ Roof covering [corrugated iron roof sheets] present, but should be restored and replaced, where necessary ○ Some interior installations have been removed and should be replaced with authentic items ○ Basic services should be installed and connected 	<ul style="list-style-type: none"> ● Restoration potential: Good ● Restoration priority: Low 	<p>To be determined</p>

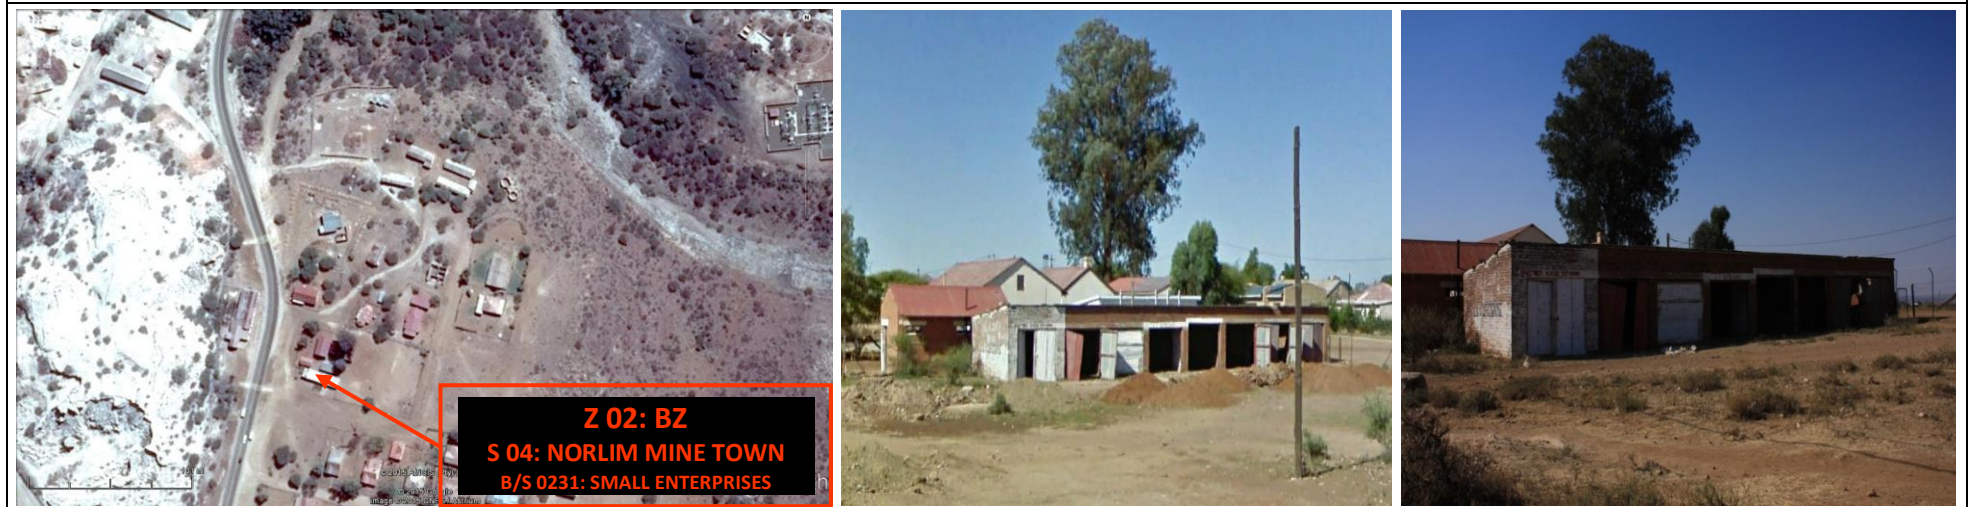
FIGURE 31 • PHOTOGRAPH 31 • Zone 02 [Z 02]: Buffer Zone [BZ] • Site 04 [S 04]: Norlim Mine Town • Building/Structure 0231 [B/S 0231]: Small Enterprises • Date: 24 February 2015

SITE & RELATIVE LOCALITY	BUILDING/STRUCTURE & RELATIVE POSITION	CONSTRUCTION MATERIALS & METHODS	HISTORICAL & CURRENT USES	CURRENT STATE & CONDITION	RESTORATION POTENTIAL & PRIORITY	PROPOSED FUTURE USES
<ul style="list-style-type: none"> ● Site 04: Norlim Mine Town ● Relative Locality: Approaching from the North, Site 05 is situated on the Eastern Side of the Main Entrance Road to the Norlim/Buxton Mine Town, just past the Mine Complex on the right [refer to Figure 31] 	<ul style="list-style-type: none"> ● Building/Structure 0231: Small Enterprises [refer to Photograph 31] ● Relative Position: Building on Norlim Mine Town Site [refer to Figure 31] 	<ul style="list-style-type: none"> ● Construction Materials: Bricks, cement, steel, glass, wood and corrugated iron ● Construction Methods: Brick and plaster structure, covered by wooden roof trusses, clad with corrugated iron roof sheets 	<ul style="list-style-type: none"> ● Historical Use: Not known ● Current Use: Small Enterprises 	<ul style="list-style-type: none"> ● State: Vandalised ● Condition: Poor <ul style="list-style-type: none"> ○ Basic structure in good condition, but should be restored ○ Fenestration and doors [steel and wood] partly removed, but should be restored and replaced, where necessary ○ Floor covering [not known] present should be restored and replaced, where necessary ○ Roof support structure [wood trusses] present, but should be checked for structural integrity and should be restored and replaced, where necessary ○ Roof covering [corrugated iron roof sheets] present, but should be restored and replaced, where necessary ○ All interior installations have been removed and should be replaced with authentic items ○ Basic services should be installed and connected 	<ul style="list-style-type: none"> ● Restoration potential: Poor ● Restoration priority: Low 	To be determined

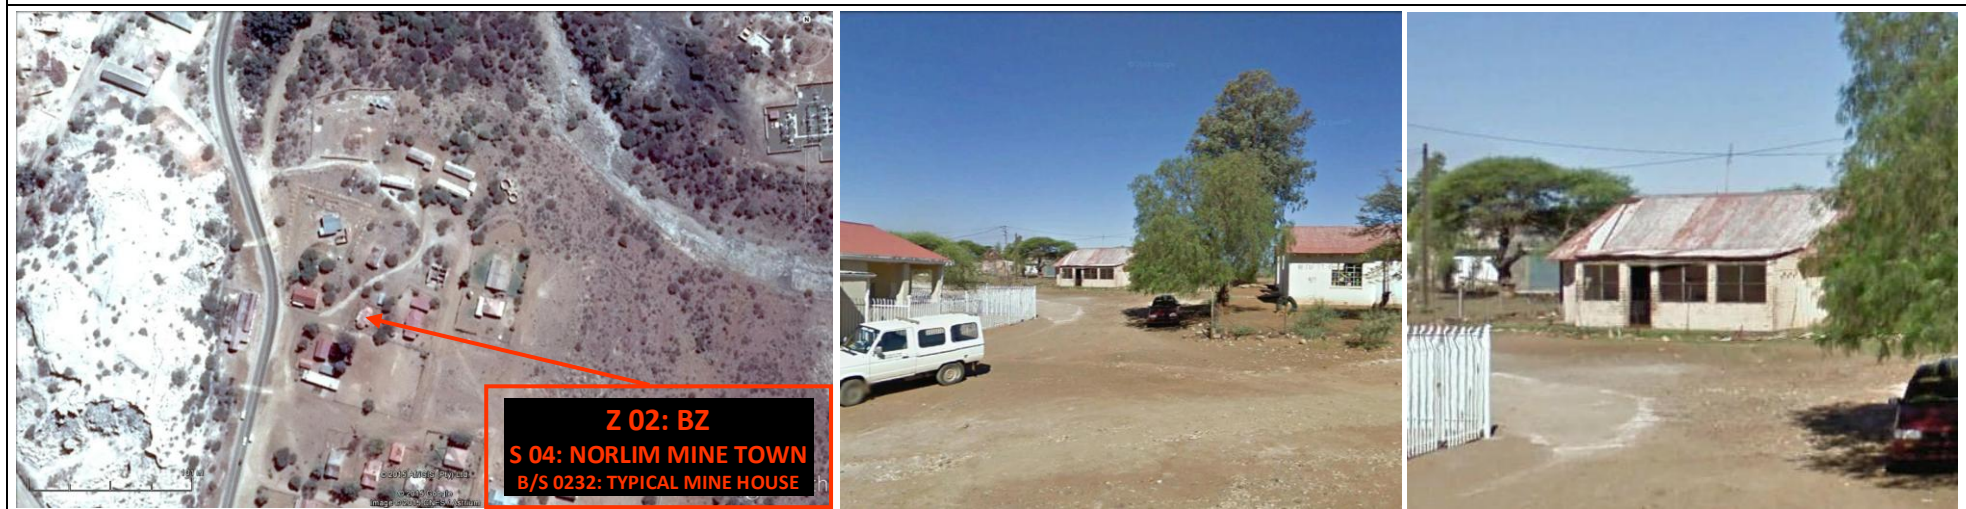
FIGURE 32 • PHOTOGRAPH 32 • Zone 02 [Z 02]: Buffer Zone [BZ] • Site 04 [S 04]: Norlim Mine Town • Building/Structure 0232 [B/S 0232]: Typical Mine House • Date: 24 February 2015

SITE & RELATIVE LOCALITY	BUILDING/STRUCTURE & RELATIVE POSITION	CONSTRUCTION MATERIALS & METHODS	HISTORICAL & CURRENT USES	CURRENT STATE & CONDITION	RESTORATION POTENTIAL & PRIORITY	PROPOSED FUTURE USES
<ul style="list-style-type: none"> ● Site 04: Norlim Mine Town ● Relative Locality: Approaching from the North, Site 05 is situated on the Eastern Side of the Main Entrance Road to the Norlim/Buxton Mine Town, just past the Mine Complex on the right [refer to Figure 32] 	<ul style="list-style-type: none"> ● Building/Structure 0232: Typical Mine House [refer to Photograph 32] ● Relative Position: Building on Norlim Mine Town Site [refer to Figure 32] 	<ul style="list-style-type: none"> ● Construction Materials: Bricks, cement, steel, glass, wood and corrugated iron ● Construction Methods: Brick and plaster structure, covered by wooden roof trusses, clad with corrugated iron roof sheets 	<ul style="list-style-type: none"> ● Historical Use: Typical Mine House ● Current Use: In use 	<ul style="list-style-type: none"> ● State: In use ● Condition: Poor <ul style="list-style-type: none"> ○ Basic structure in good condition, but should be restored ○ Fenestration and doors [steel and wood] in good condition, but should be restored and replaced, where necessary ○ Floor covering [not known] should be restored and replaced, where necessary ○ Roof support structure [wood trusses] in good condition, but should be checked for structural integrity and should be restored and replaced, where necessary ○ Roof covering [corrugated iron roof sheets] present, but should be restored and replaced, where necessary ○ Some interior installations have been removed and should be replaced with authentic items ○ Basic services should be installed and connected 	<ul style="list-style-type: none"> ● Restoration potential: Good ● Restoration priority: Low 	To be determined

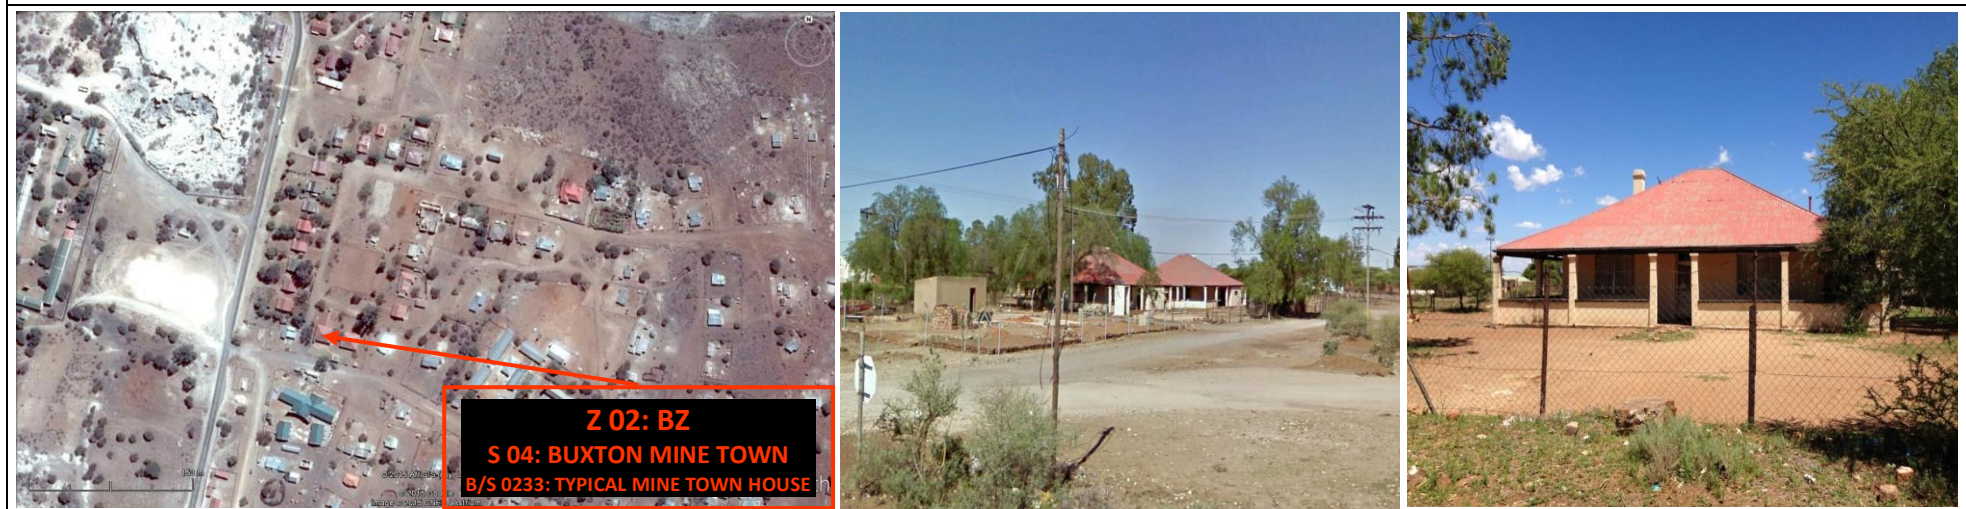
FIGURE 33 • PHOTOGRAPH 33 • Zone 02 [Z 02]: Buffer Zone [BZ] • Site 05 [S 05]: Buxton Mine Town • Building/Structure 0233 [B/S 0233]: Typical Mine Town House • Date: 24 February 2015

SITE & RELATIVE LOCALITY	BUILDING/STRUCTURE & RELATIVE POSITION	CONSTRUCTION MATERIALS & METHODS	HISTORICAL & CURRENT USES	CURRENT STATE & CONDITION	RESTORATION POTENTIAL & PRIORITY	PROPOSED FUTURE USES
<ul style="list-style-type: none"> ● Site 05: Buxton Mine Town ● Relative Locality: Approaching from the North, Site 05 is situated on the Eastern Side of the Main Entrance Road to the Norlim/Buxton Mine Town, past the Mine Complex on the right, past the Trading Store on the right, the Post Office on the left, and the Soccer Field on the right Figure 33] 	<ul style="list-style-type: none"> ● Building/Structure 0233: Typical Mine Town House [refer to Photograph 33] ● Relative Position: Building on Buxton Mine Town Site [refer to Figure 33] 	<ul style="list-style-type: none"> ● Construction Materials: Bricks, cement, steel, glass, wood and corrugated iron ● Construction Methods: Brick and plaster structure, covered by wooden roof trusses, clad with corrugated iron roof sheets 	<ul style="list-style-type: none"> ● Historical Use: Typical Mine Town House ● Current Use: Vacant 	<ul style="list-style-type: none"> ● State: In use ● Condition: Good <ul style="list-style-type: none"> ○ Basic structure in good condition, but should be restored ○ Fenestration and doors [steel and wood] present, but should be restored and replaced, where necessary ○ Floor covering [not known] should be restored and replaced, where necessary ○ Roof support structure [wood trusses] present, but should be checked for structural integrity and should be restored and replaced, where necessary ○ Roof covering [corrugated iron roof sheets] present, but should be restored and replaced, where necessary ○ Some interior installations have been removed and should be replaced with authentic items ○ Basic services should be installed and connected 	<ul style="list-style-type: none"> ● Restoration potential: Good ● Restoration priority: Low 	<p>To be determined</p>
