HERITAGE STATEMENT

118 Smiso Nkwanyana Rd (Goble Rd)

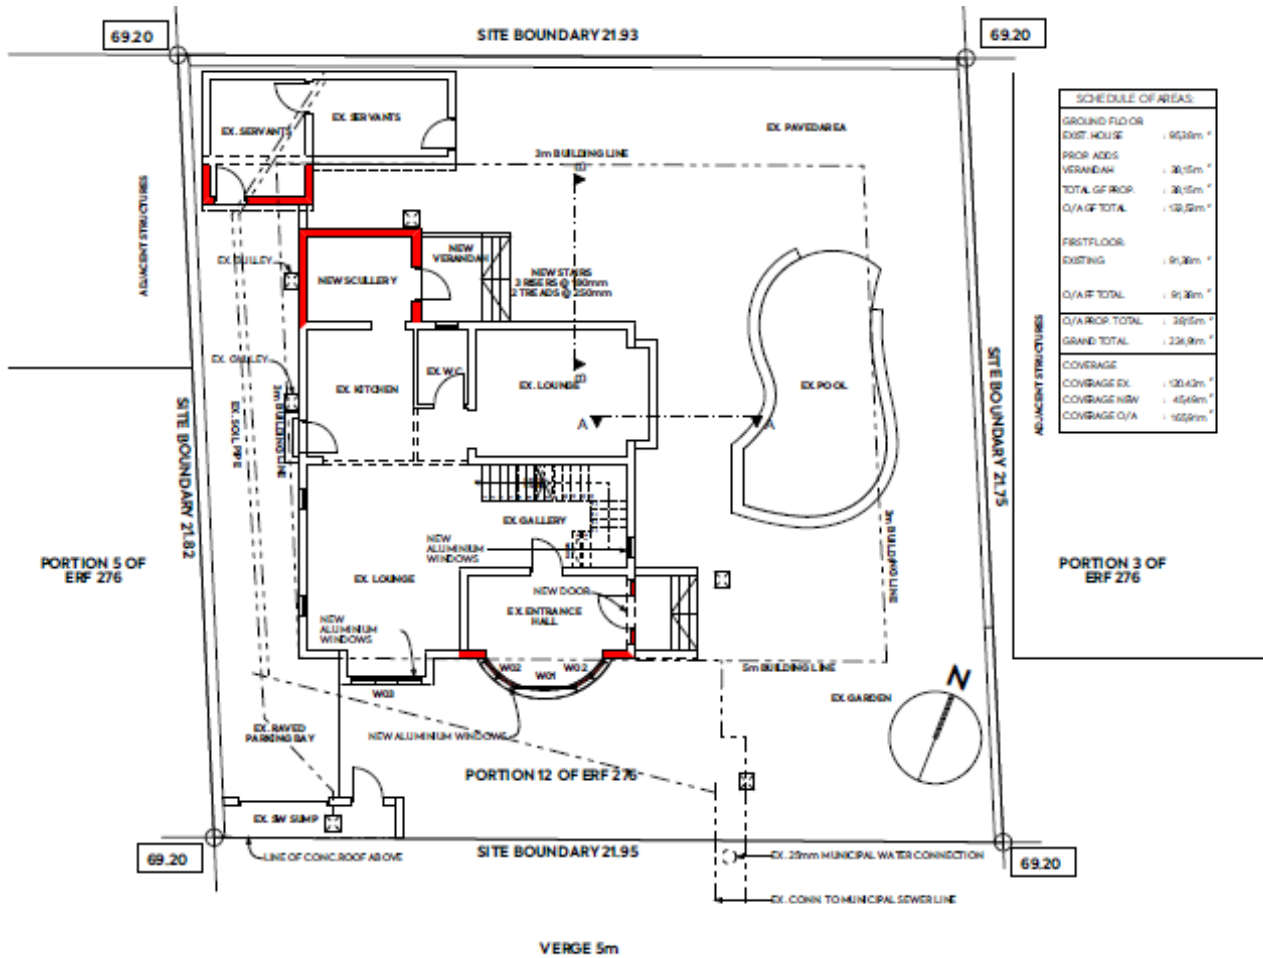
Figure 2: Ground Floor Plan: Illegal Work

The windows in several places have been replaced with aluminium, most likely due to borer infestation, as is currently observed in the house. The original timber windows have been replaced in all rooms except the lounge, entrance foyer, front entrance doorway and domestic quarters. The aluminium windows which have replaced the original windows also have a cottage pane style, except those on the north eastern elevation, which are discussed below. Please see plan for window schedule of new windows.

The front porch has been enclosed with timber cottage pane windows to match the existing window style, and a new doorway has been created from the North eastern façade. The original staircase to the porch has been retained. The Oregon pine timber detailing around the front door as well as the staircase has been retained. An awning has been built over the existing entrance stairs. The awning has been designed to match the timber construction with clay tiles.

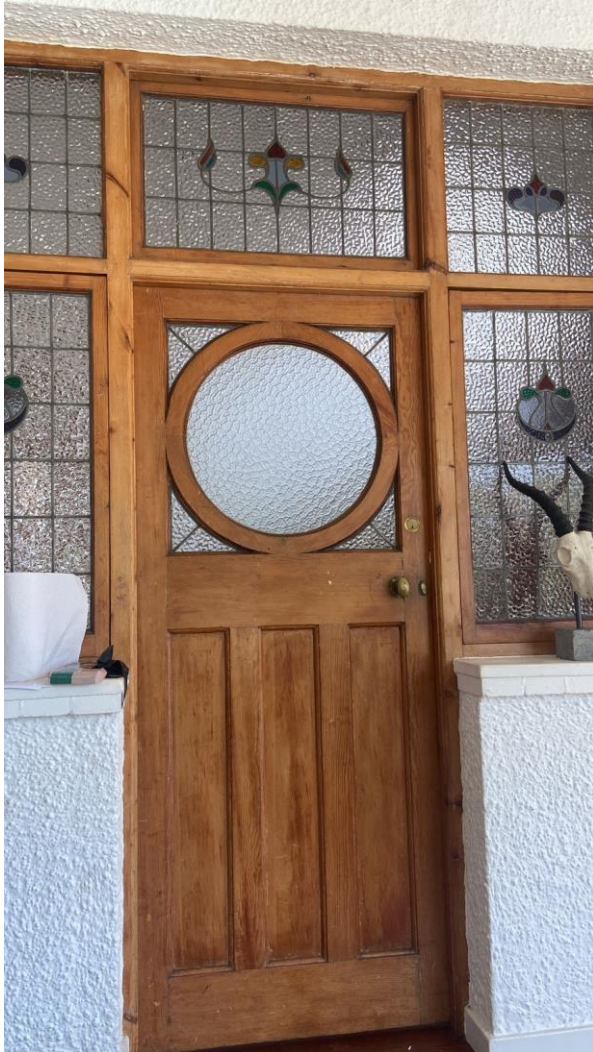
Figure 3: Original Front Door

All internal doors, floor finishes and timberwork have been retained. The original front door, which is existing, is shown in Figure 3 below.

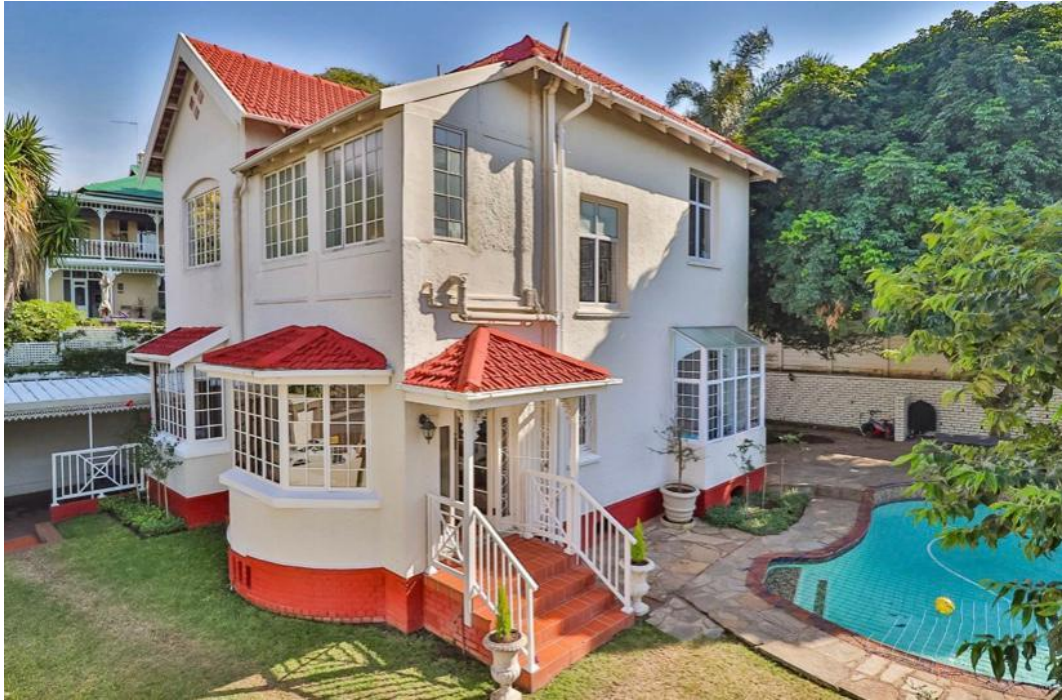
Figure 4: Image of Existing House

As shown in Figure 4 below, the stairwell and the bathroom window on the north eastern façade have been significantly altered from the original as designed by Mr Rorvik. Unlike the other windows which have been replaced, the cottage pane style has not been utilized in the new design. This change could possibly be mitigated by adding stick on aluminium flat bars to match the other windows as well as resembles the original windows, should AMAFA require this. However, it must be noted that these windows are not visible from the street.

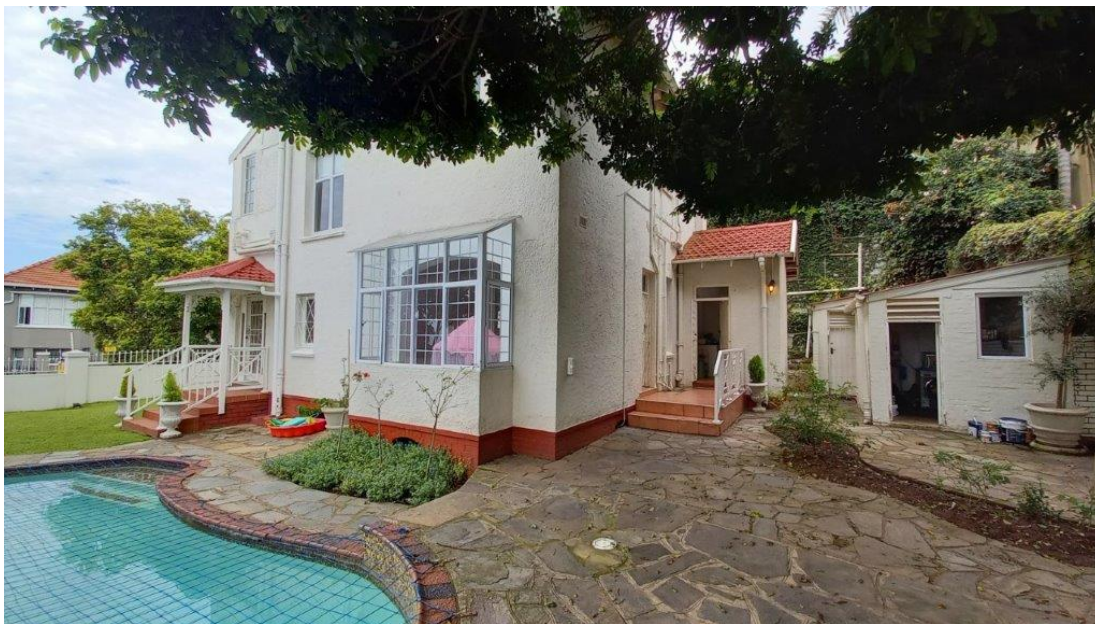
Figure 5: Image showing Addition of Scullery and Extension of Servants Quarters

As shown in Figure 5 below, there has been an addition made to the domestic quarters toward the South western façade, the style of which and brickwork matches the existing.

The scullery was extended using brickwork, plaster and paint to match the existing house, toward the North Western boundary. The roof pitch and finish of which have been made to match the existing roof.

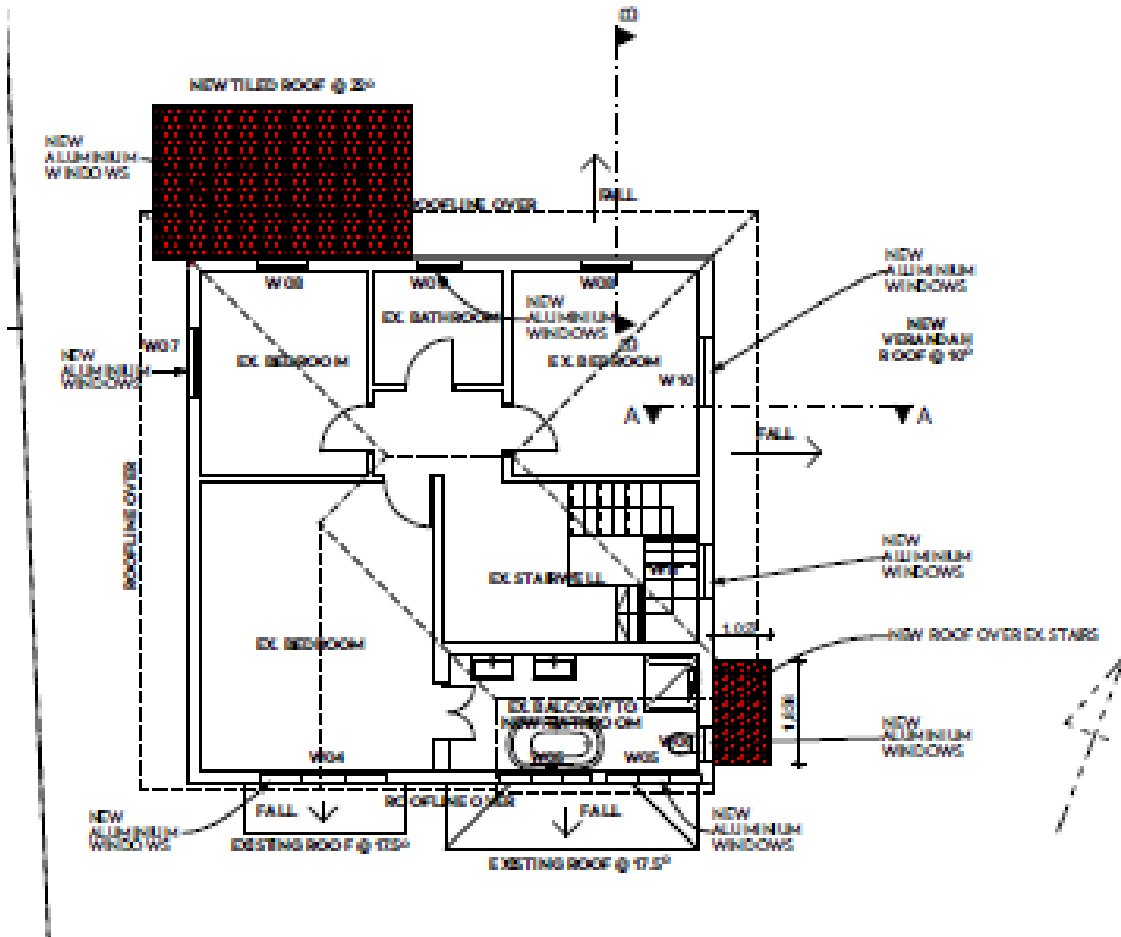
Figure 6: First Floor Plan: Illegal Work

The balcony has been enclosed on the first floor using cottage pane windows to match the existing.

The windows in several places have been replaced with aluminium, most likely due to borer infestation as is currently observed in the house. New aluminium windows have replaced the existing timber windows at various locations around the house. Please see plan for window schedule of new windows.

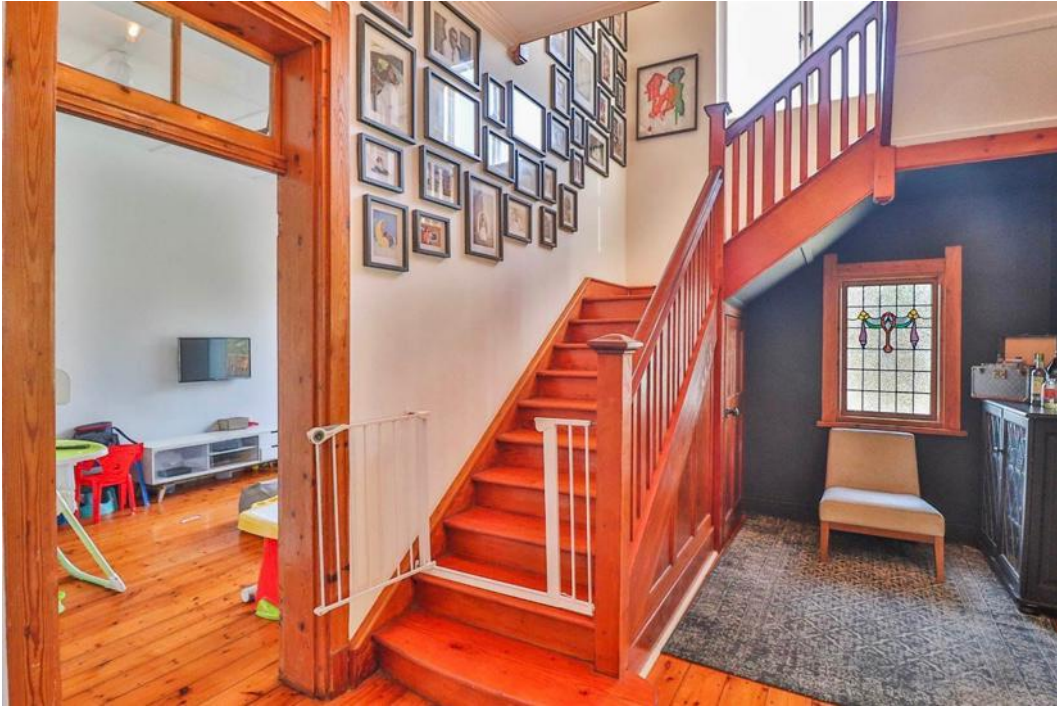
Figure 7: Existing Staircase

As shown in Figure 1 above, the original house plans drawn in 1925, the internal staircase was built at the same time as the original house. Please note that this staircase has not been altered as shown in Figure 7, a current image of the house.
