# **WIMS 070196 : MOTOR LICENSING BUREAU MORNINGSIDE**

## **VISUAL ASSESSMENT REPORT**

**MAY 2022**

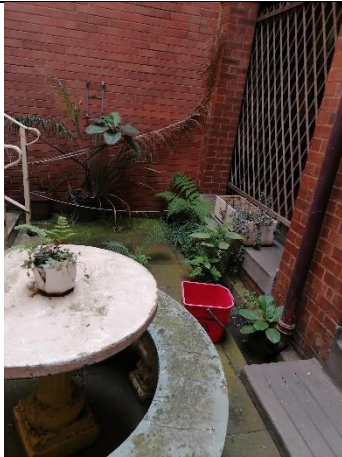
Mildew was identified on internal walls, paint blisters and delamination visible in majority of offices.

Open Courtyard: vegetation, mildew and moss.

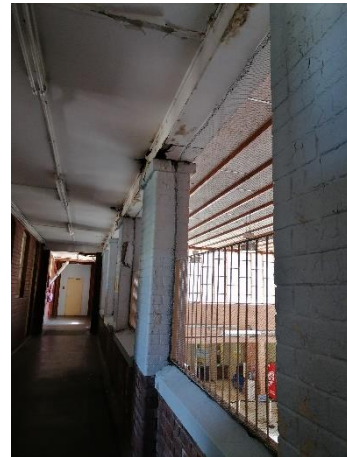
The courtyard is a portal frame structure, the roof drains onto the existing adjacent slab and down into the gutter system. There are signs of damp on the internal ceiling of the service area suggestive of leaks.

Passage : Ceiling damp and deteriorated.

The location of the leak needs to be identified, the associated roof sheeting and isolation repaired/replaced. Rust proofing of structural steel will may be required.

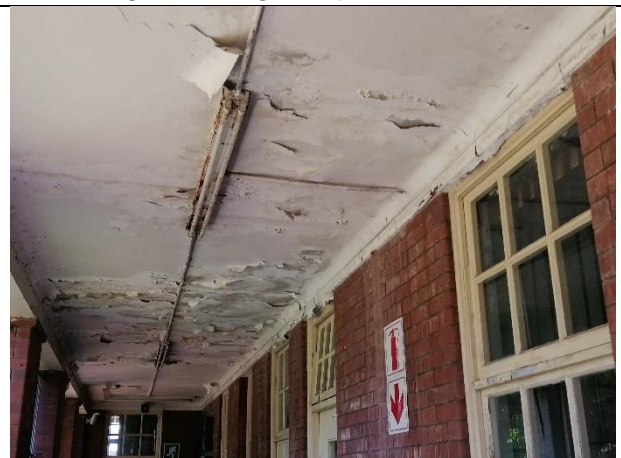
Passage : Ceiling damp

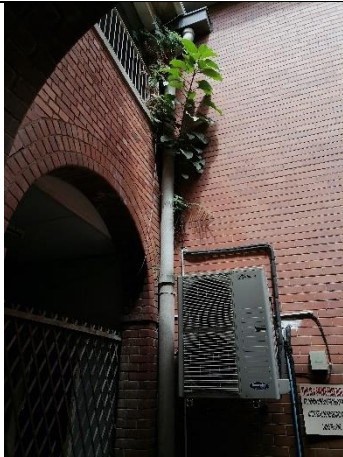
The roof drains externally to stormwater gutter along the perimeter and internally to a flat slab that has a fall to drain into a full-bore gutter. There is vegetation in the gutters and downpipes which suggestive that maintenance was not carried out. The capacity of the gutters will require assessment the initial arrangement, as this would not have catered for additional runoff from the portal roof covering the service area.

Vegetation along down pipe.

A maintenance schedule will be required to prevent gutters and downpipes from being blocked with debris.

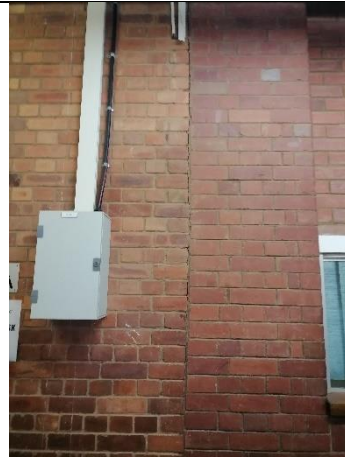
Construction Joint.

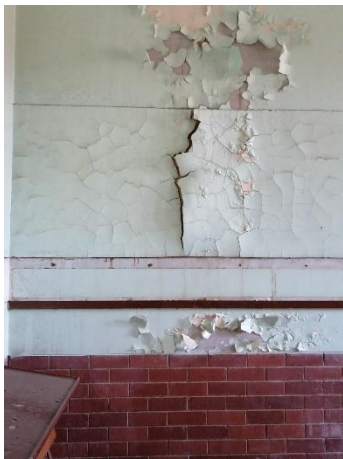
Paint Peeling.

Mildew, paint blisters and delamination are to be addressed as per architect requirements after structural repairs are carried out.

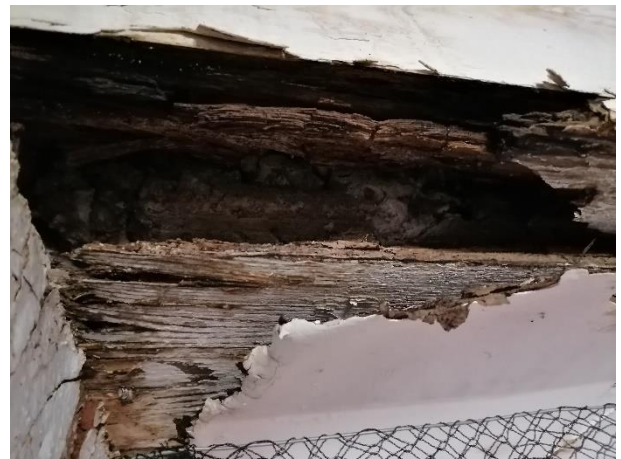
The building has a pin style duo-pitch timber truss with clay tiles, no evidence of roof plastic membrane was identified during the inspection. Wood borer was noted in numerous trusses. External light was visible inside the ceiling cavity indicating possible cracked tiles and a route for water to pass through into the building.

Timber rot.

Replacement of the timber trusses system is advised; the existing tiles are to be reclaimed and reused to maintain the existing aesthetics of the building. (A beetle inspection can be carried out with rehabilitation measures; this would require ongoing periodic maintenance and may prove to be problematic)

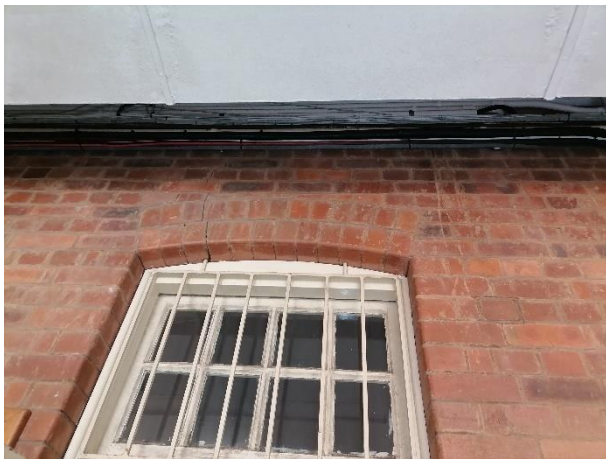
There are visible cracks along the external wall, these cracks are typical throughout at the window lintels and corner-wall interaction with ceiling. Some cracks on the external coincide with internal cracks at window lintel location. Some cracks resemble general masonry cracks suggestive that it may be plaster cracks.

Crack on above window.

The walls exhibit similar strains of cracking throughout, exposing of cracks on brickwork will be required to verify degree and extent. Superficial plaster cracks can be filled and replastered. Cracks that permeate through mortar and brickwork are to be metal stitched. (Refer to annexure for Metal stitch detail)

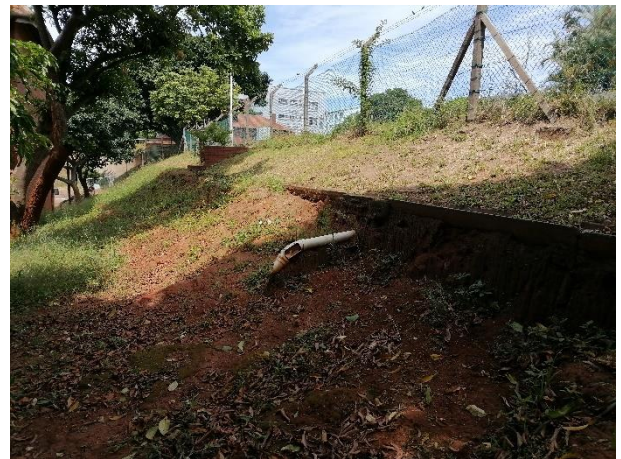
Stormwater from the building and portal frame is directed downwards into the open area of the courtyard, the stormwater flows towards the east under the building and towards municipal drainage catchpit network at the driveway.

Open channel drain.

The Stormwater from the building and portal frame is directed downwards into the open area of the courtyard, the stormwater flows towards the east under the building and towards municipal drainage catchpit network at the driveway. The capacity of the drain under the building will have to be increased for the additional runoff from the roof.

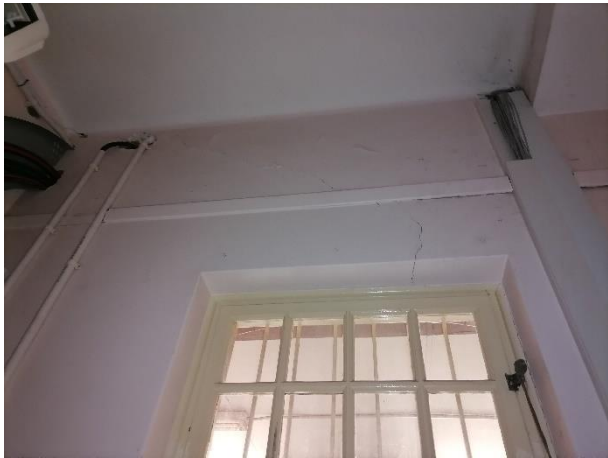
The cracks identified are of concern as these cracks are evident on internal and external wall skins at same location, there is a possibility that the fracture continues through the wall, compromising the structure. Localised exposing of plaster will be required to verify the extent of cracks and differentiate plaster cracks from structural cracks.

Crack on external wall coincides with internal cracks.

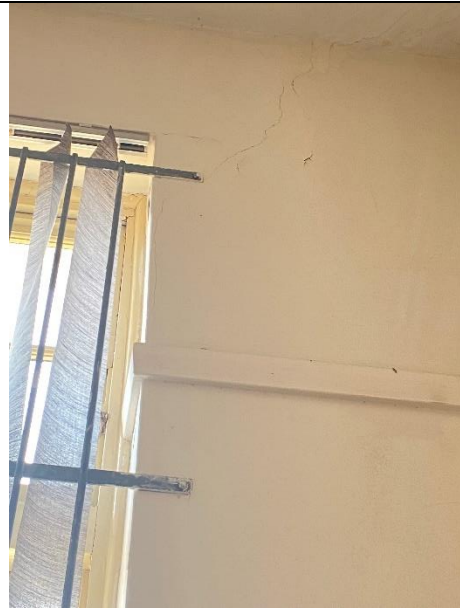
Crack on external wall coincides with internal cracks.

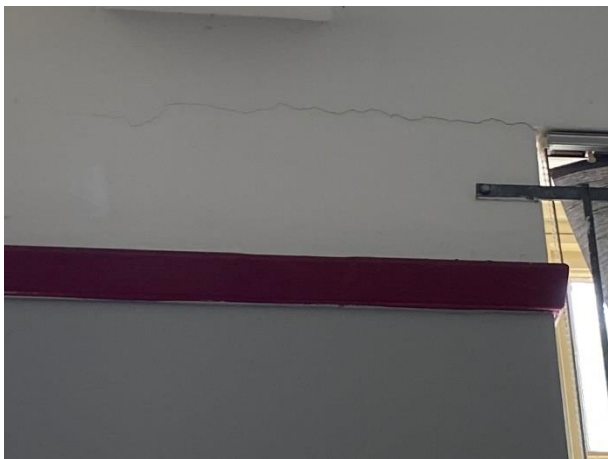
Typical Crack at window lintel.

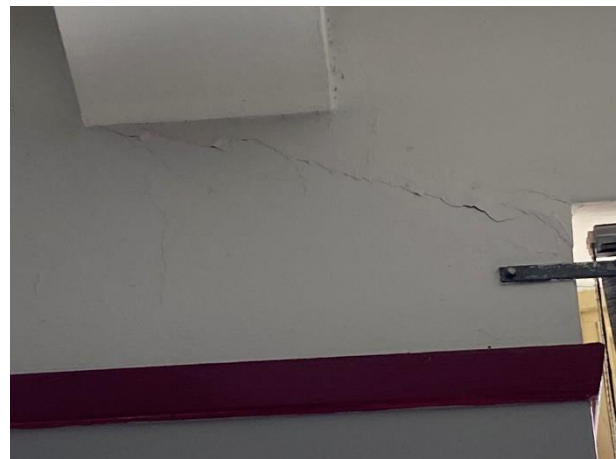
Typical crack around windows.

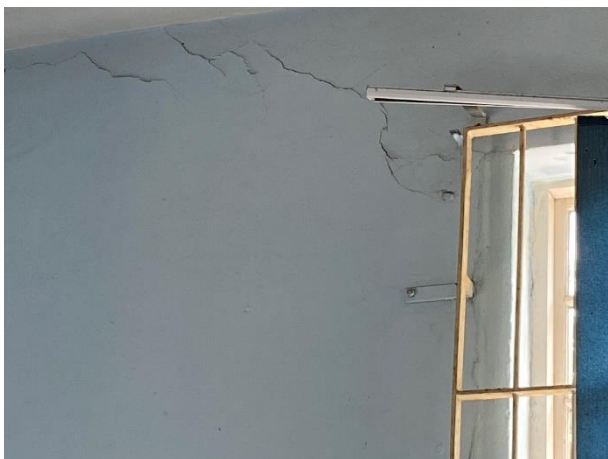
Typical crack around windows.

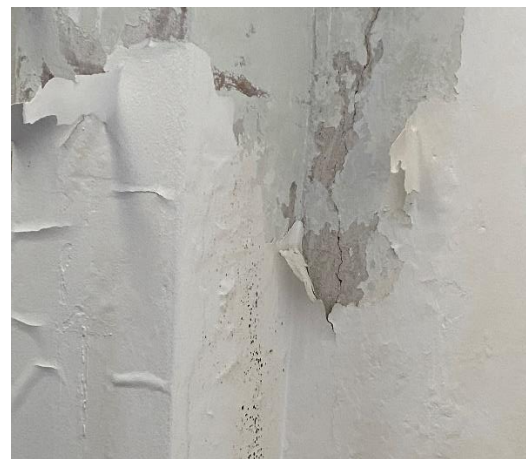
Crack adjacent to internal beam, further investigation required.
