## **130 BOOM ST. ERF 2213 PIETERMARITZBURG**

### **HERITAGE REPORT**

Prepared for VNA Consulting

03 November 2020

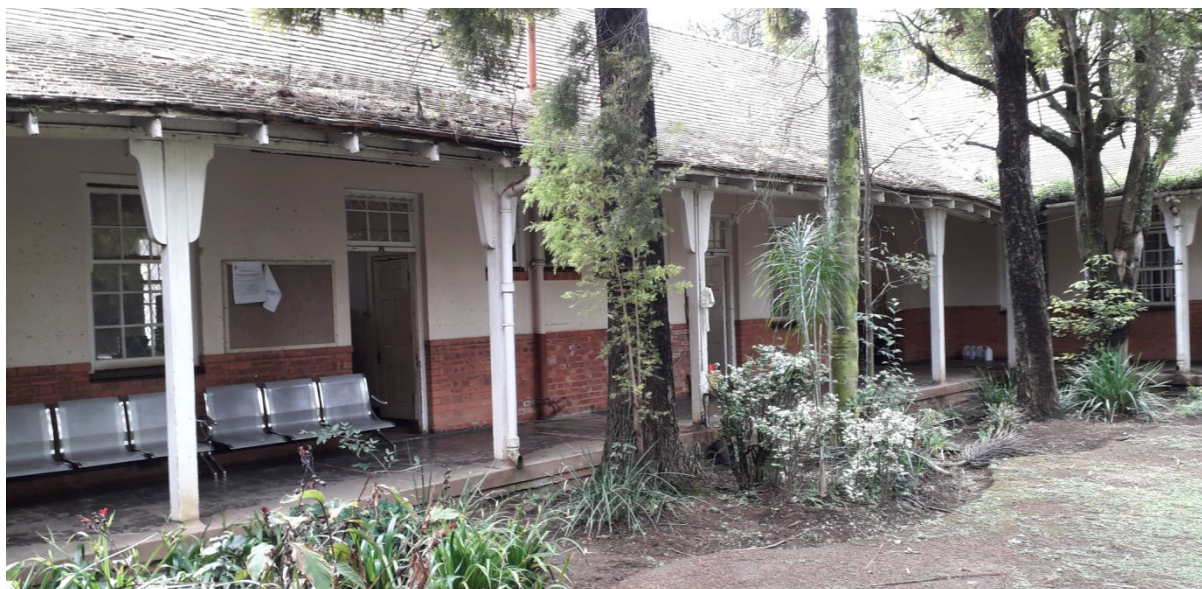
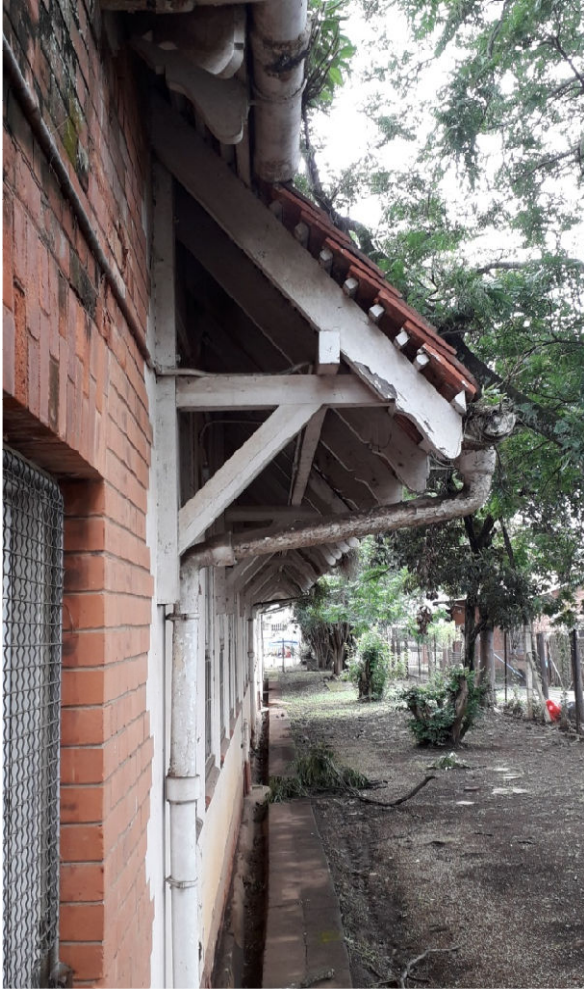
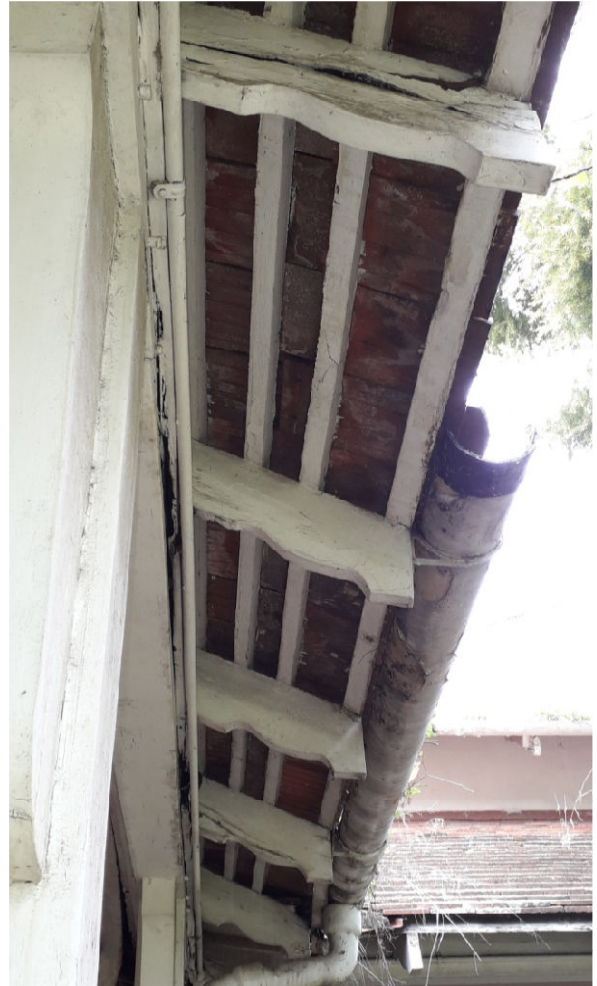
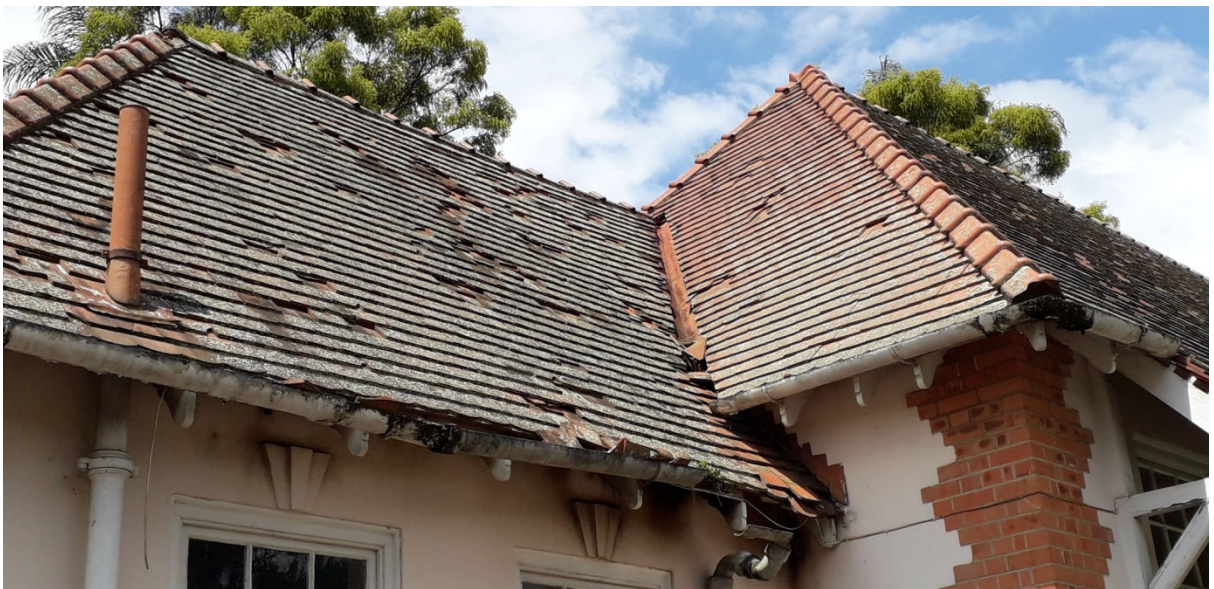
#### 3.1 ROOF :

Unfortunately, the battens have rotted over the years where water has crept in, resulting in odd tiles sliding off the roof, creating a “domino” effect and allowing more water to penetrate the battens.

A small percentage of tiles have been lost from each large roof plane.

The valleys at each corner have collapsed over the walkways, due to lack of maintenance and build-up of plant material in the gutters and valleys. Trees that were planted close to the walkway roofs have impacted on the gutters and roofs with falling branches and leaves.

It is recommended that the roof tiles be lifted and all the battens replaced with a new insulating underlay. Roof tiles are to be cleaned and reused and the balance of missing tiles replaced with matching “recycled” or specially made tiles. All ridge cappings, valley gutters and flashings are to be replaced or refixed and waterproofed.

Damaged roof timbers are to be replaced with matching members in modern structural timber. Where roof trusses have been compromised by termites or borer, these members are to be strengthened under a structural engineer’s supervision.

The bell-tower is to be checked for stability and maintenance.

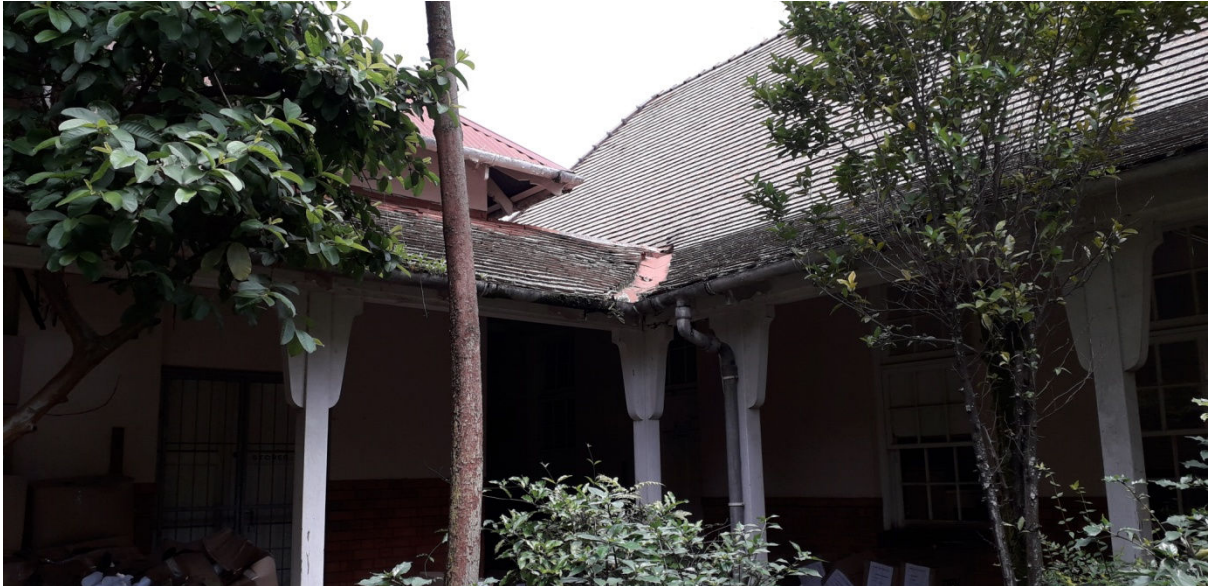
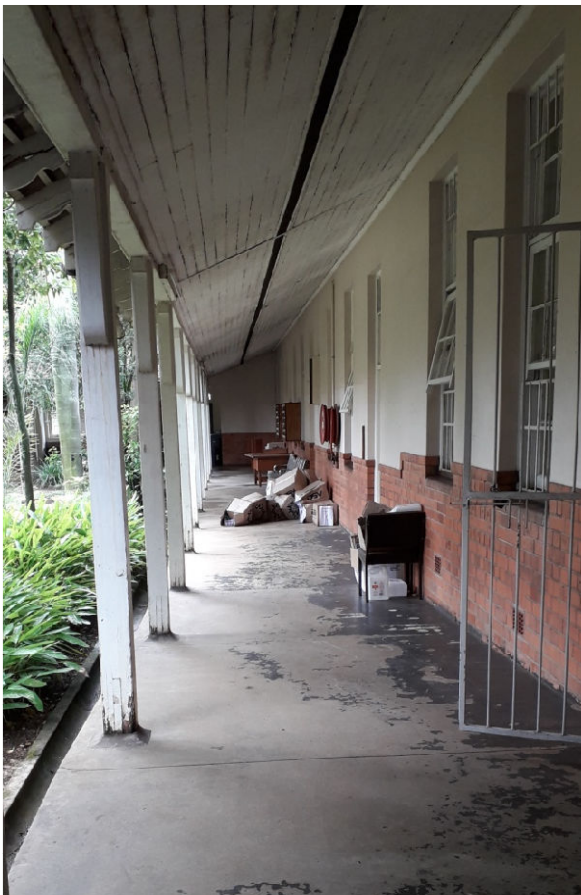
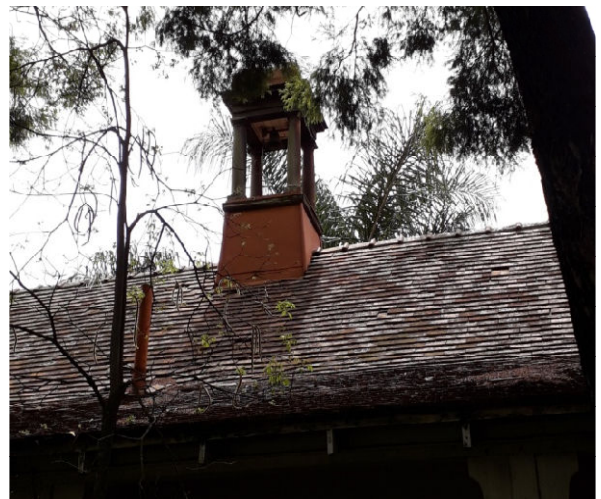
### 3.2 WALKWAYS

The concrete floor of the walkway has been worn over the years and can be restored with “Stoep paint”.

The tongue and groove ceiling has deteriorated and been damaged by the failing roof.

Timber posts are to be restored and painted in-situ, missing posts are to be replaced with Balau or Iroko timber and painted to match existing. The roof beam and fascia is to be restored and strengthened where necessary.

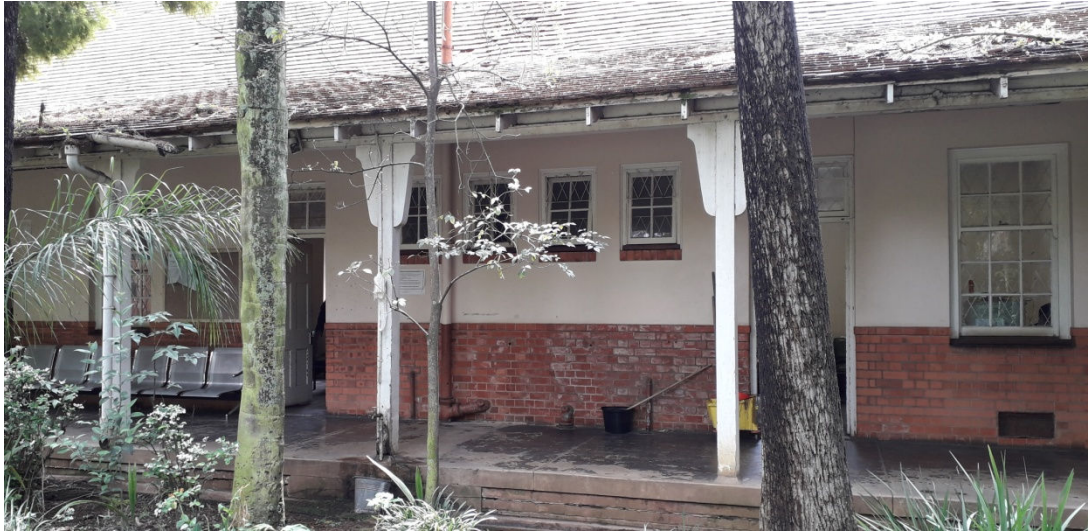
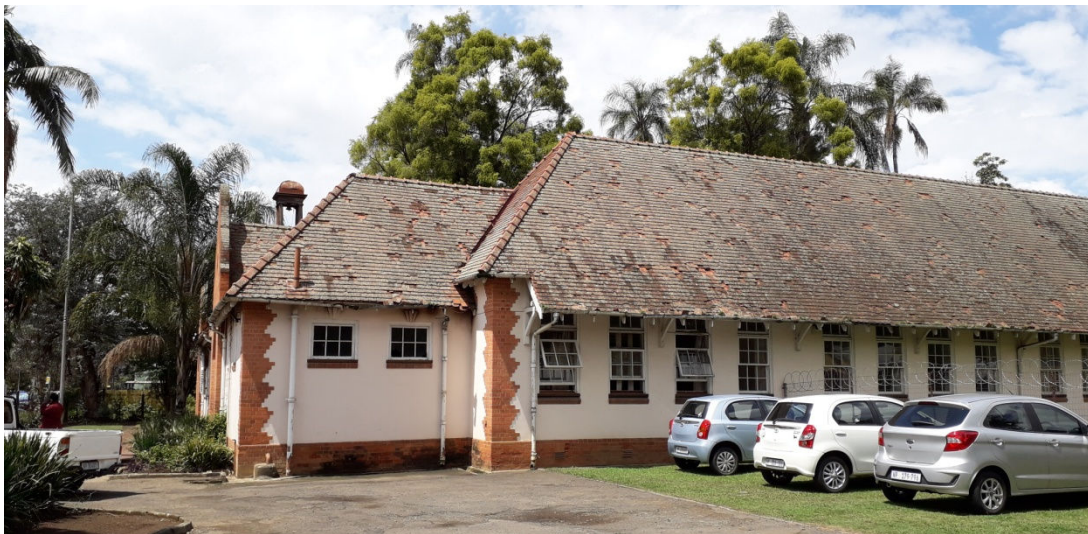
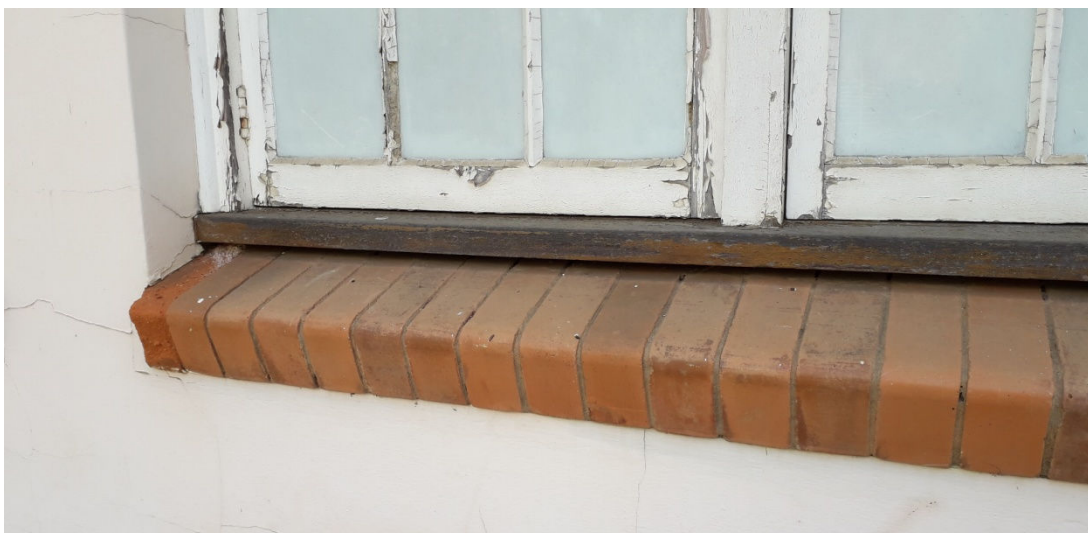
### 3.3 WALL DETAIL

The outer walls of the complex have facebrick plinths, quoining on the corners and facebrick window cills. The majority of the walls are plastered and painted.

The inner courtyard walls have facebrick plinths to one course above window cill height and plastered and painted above.

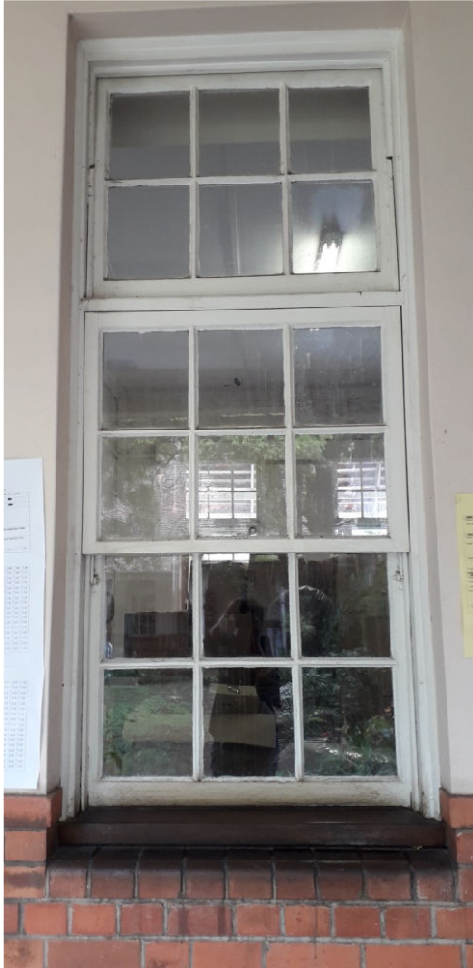
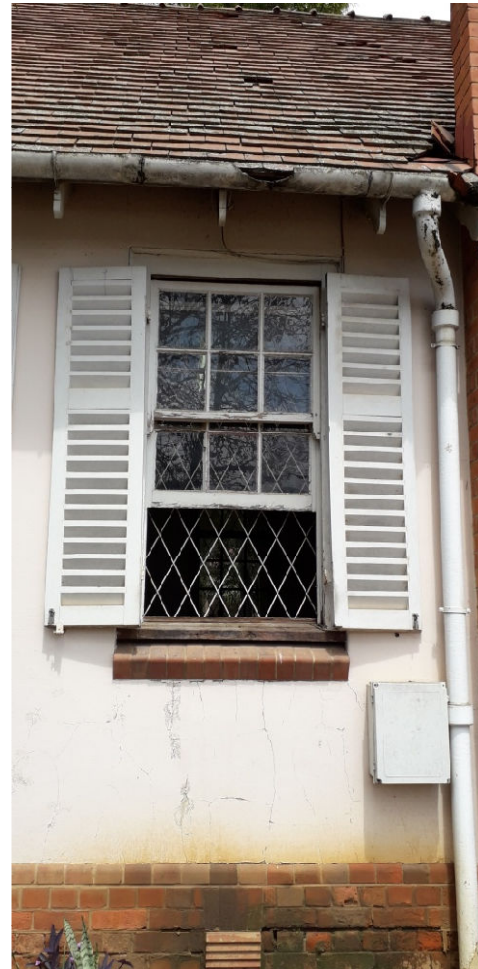
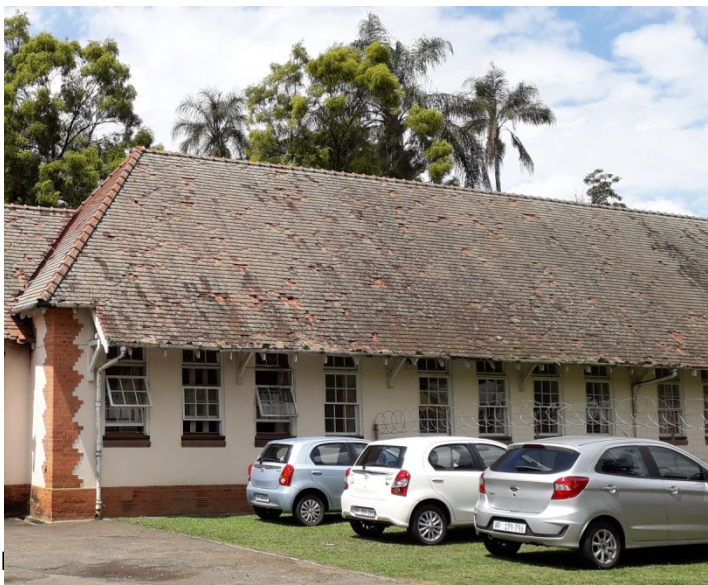
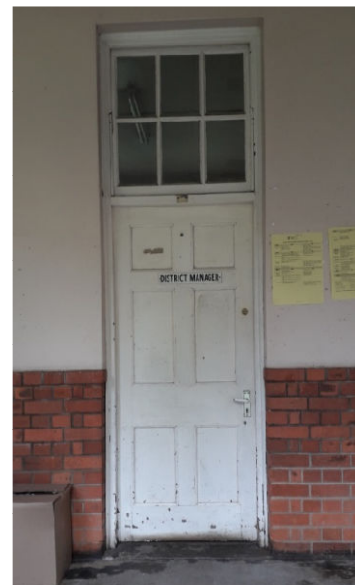
### 3.4 WINDOWS AND DOORS :

Windows are a variety of small pane windows, painted and sitting on a mahogany cill piece.

Notable “school-type” windows are in the outer walls of the classrooms, sash windows with fanlights are in the walkway walls.

Windows in the staff rooms facing Boom street have timber louvred shutters.

Ablutions have openings in the wall, barred for security.

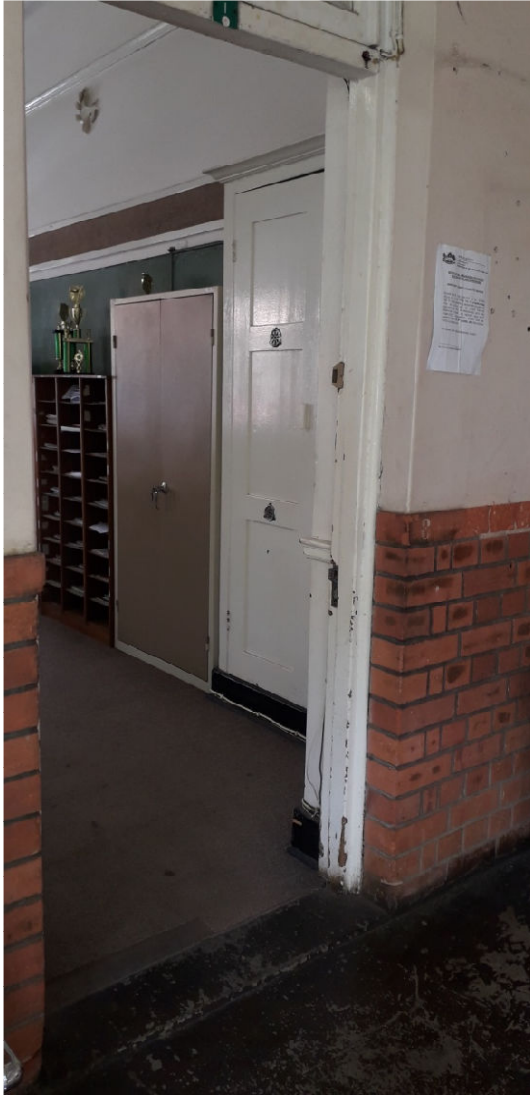
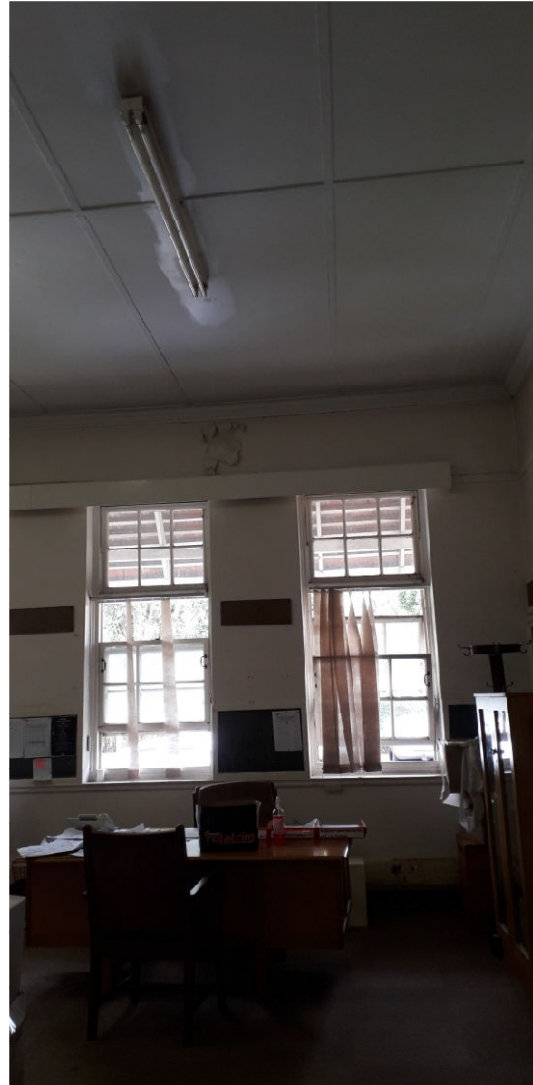
Each classroom has timber “fittings” typical of a modern classroom in that period. These include picture rails, pinboards, chalkboards, a built-in storage cupboard, dado and window cills, skirting boards. All are painted hardwood. Ceilings are plaster board with coverstrips. Original tongue and groove ceiling boards existing in the roof space, concealed by the newer plasterboard at some stage.
