ANNEXURE A STRETCH'S COURT FABRIC ANALYSIS

>> COTTAGE 12 (C.1858)

>> Degree of Intactness: 1
 >> Recommended Grading: IIIB

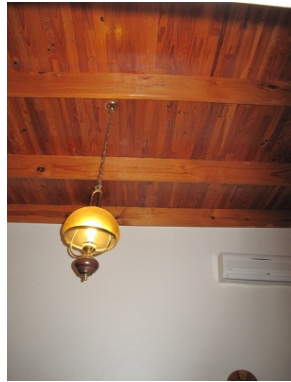
Bedroom A: Oregon Pine ceiling

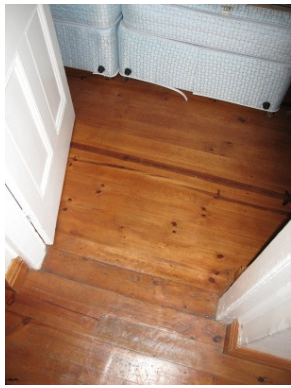
Bedroom A: Oregon Pine wood strip floor

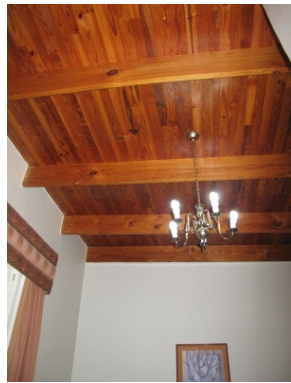
Bedroom B: Oregon Pine ceiling

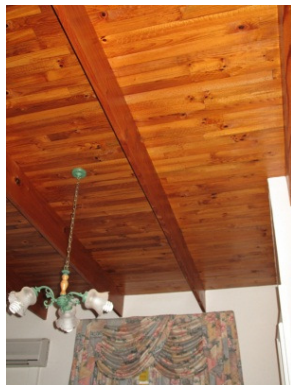
Bedroom C: Oregon Pine ceiling

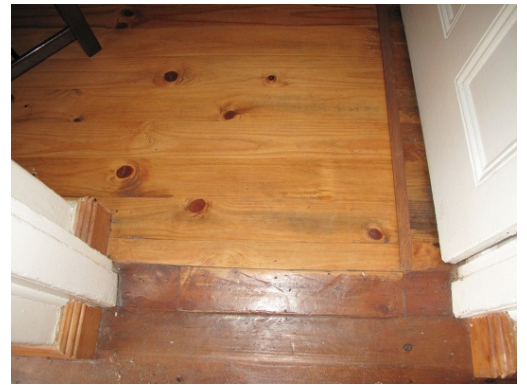
Bedroom B & C: Pine wood strip floor (patched in part)

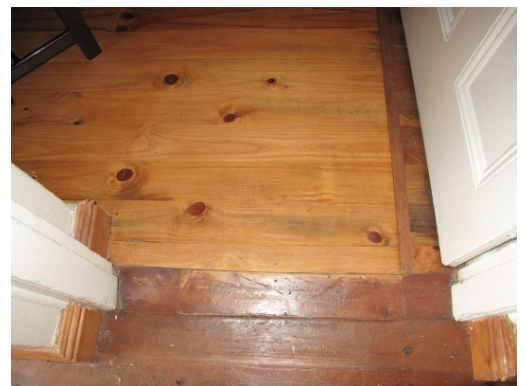
Bedroom B & C: Pine wood strip floor (patched in part)

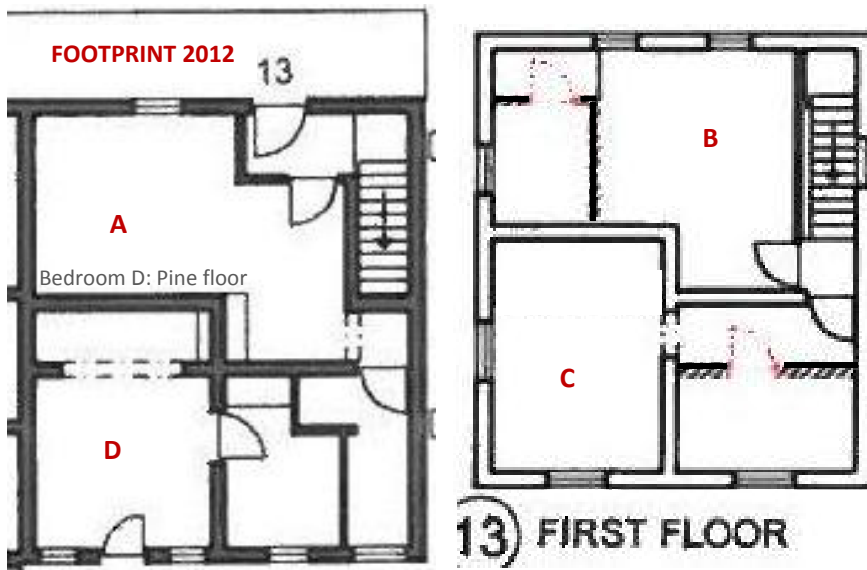
Bedroom C: Oregon Pine and laminate mix floor
