**133 Helen Joseph Rd**

**HERITAGE IMPACT ASSESSMENT : ILLEGAL WORK AND PROPOSED CHANGES TO EXISTING HOUSE (CONVERTED TO BUSINESS) AT 133 HELEN JOSEPH (DAVENPORT) RD, GLENWOOD**

Prepared by : Lindsay Napier

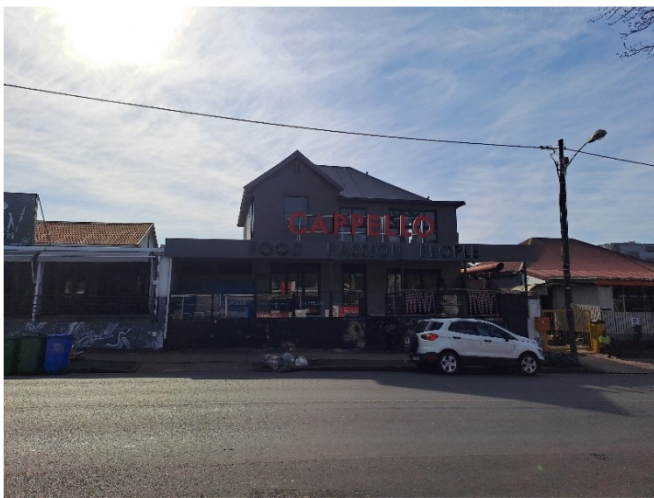
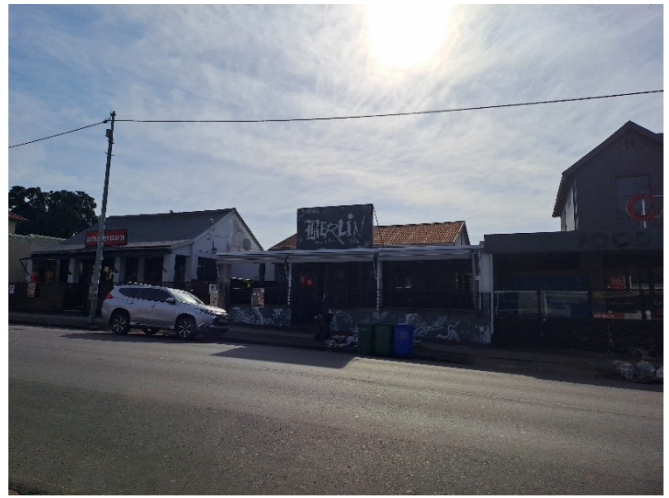
The house currently has lost all the architectural features noted above, but retains the gable and hipped roof form.

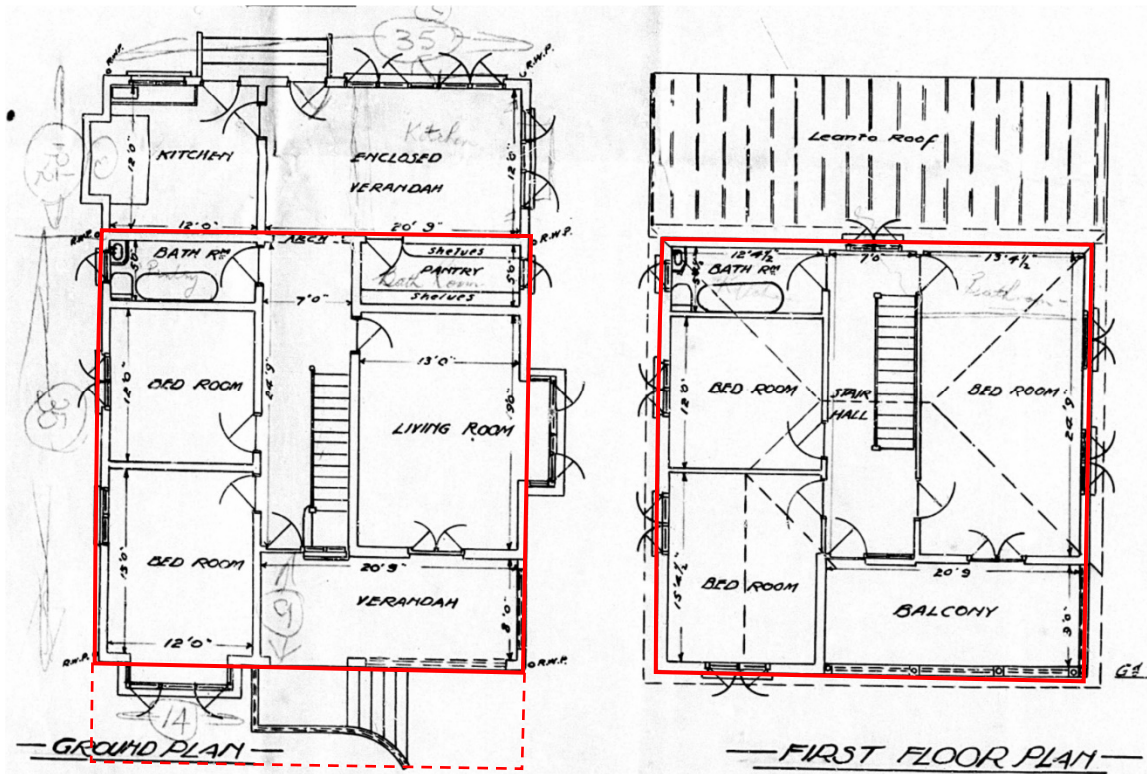
Architects plans 1922 (red-line shows the part of the house that is proposed to be retained)

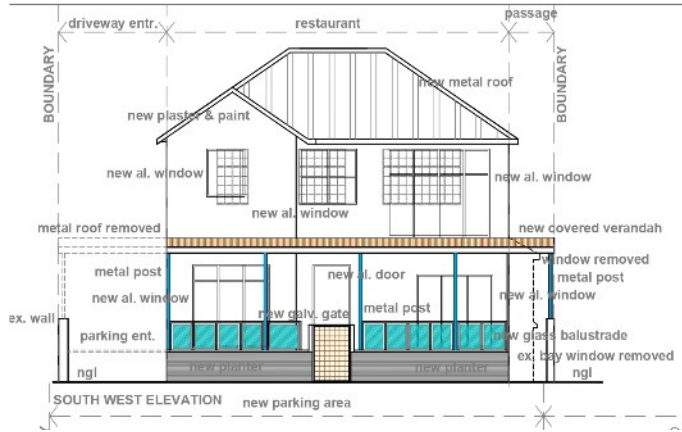
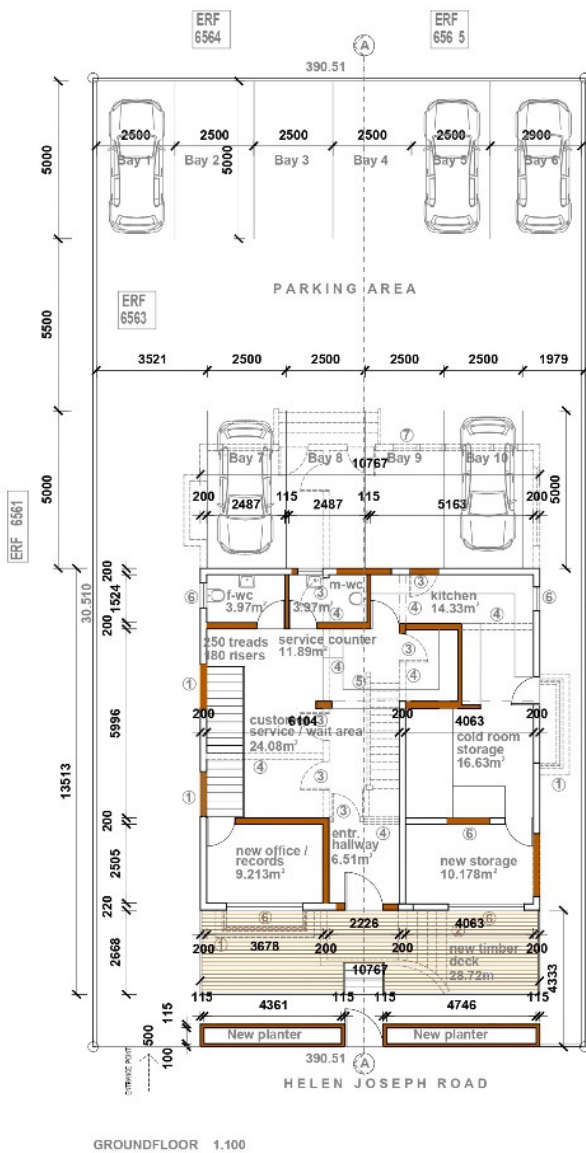
- LEGEND**
1. Window removed & bricked where shown
  2. Stairs removed
  3. Ex. doors removed and bricked up where shown
  4. Ex. walls removed
  5. Ex. stairs removed
  6. Ex. windows replaced where shown
  7. Ex. kitchen & verandah & roof removed
