HERITAGE STATEMENT HOUSE 86

The statement is a supplement to the application for a permit for repairs and maintenance to the exterior of the structure to be made to SAHRA in terms of the National Heritage Resources Act, 25 of 1999.

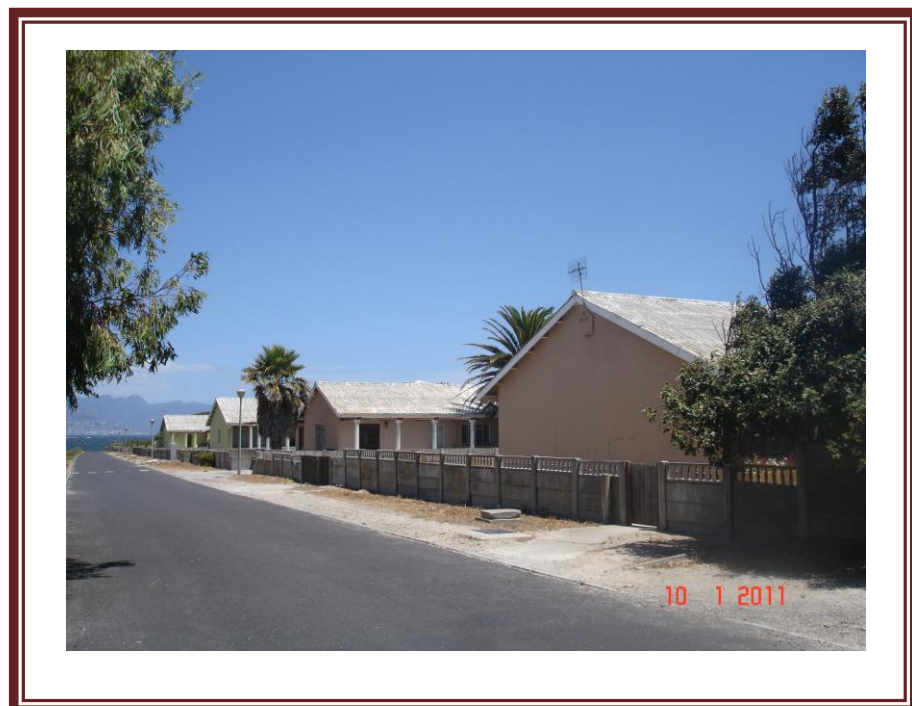
Fig.6.1. Streetscape looking south.

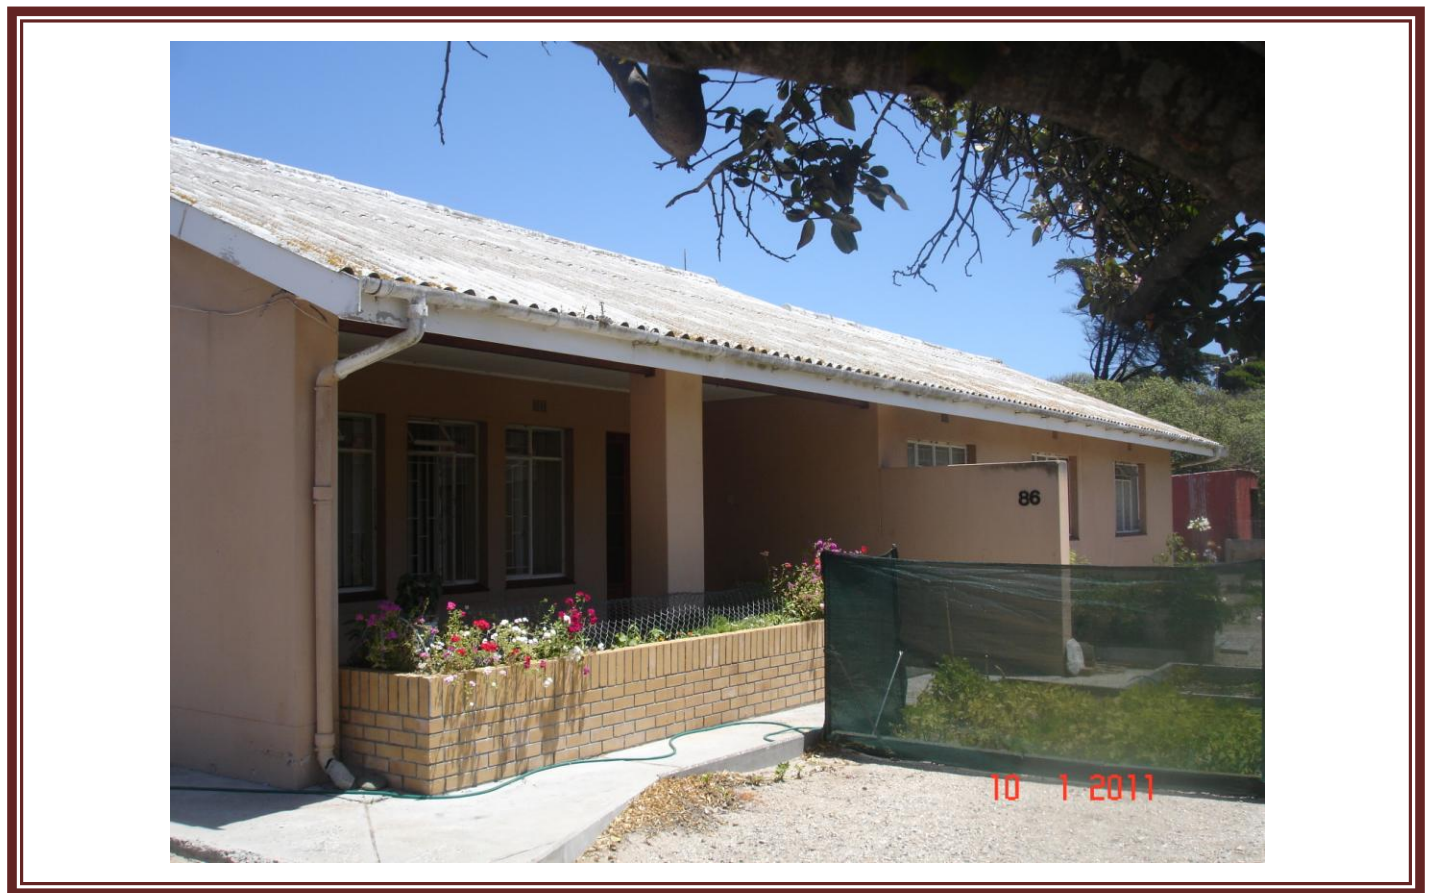
Fig.6.2. North face main entrance.
