**REPORT ON THE STATE OF CONSERVATION OF THE FABRIC OF 'A'
SECTION OF THE MAXIMUM SECURITY PRISON ROBBER ISLAND.**

PREPARED FOR ROBBER ISLAND MUSEUM

RON VINEY T/A AD ASTRA FESTINA

GROENEWALD PRELLER ARCHITECTS

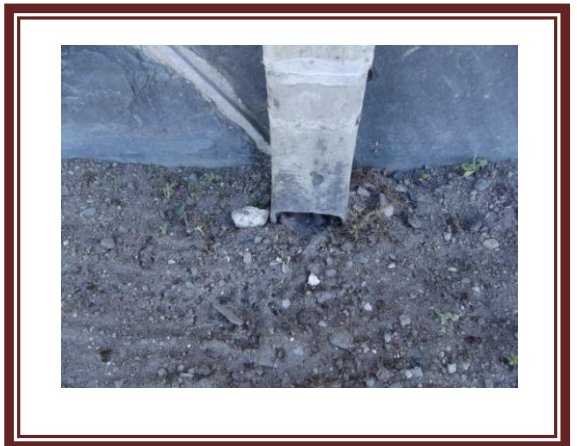
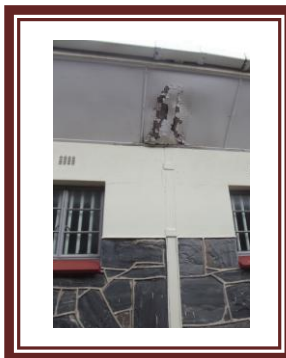
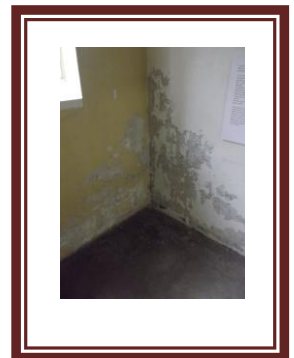
The peeling on the interior of cell 29 was sealed in the NE corner in 2008 to prevent the deterioration from spreading. The success of this cannot be adequately assessed because of no monitoring of the process. There is enough evidence to suggest that the damp is spreading and causing peeling of the paint beyond the seal.

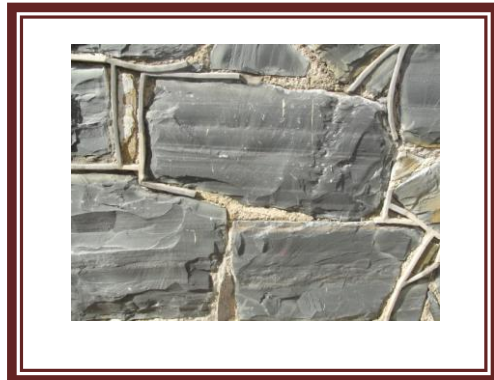
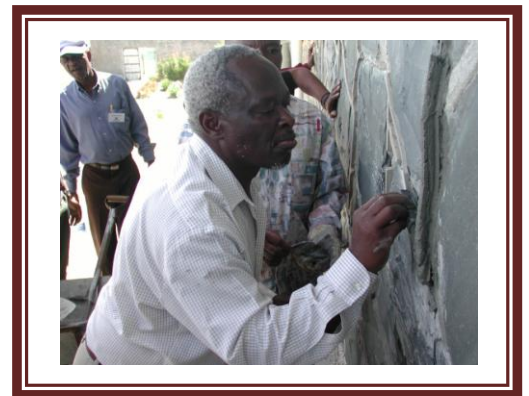
The piping around each blue stone on the outside must be maintained on a regular basis. The piping speaks to the intangible act by prisoners of painstakingly applying the mortar to surround each block of stone. This skill is being lost as it is not being transferred which endangers the authenticity of workmanship. The piping protects the tangible fabric by forming a 'mini-gutter' that allows water to drain off rather than seep in behind the cladding.
