**EXTENSION OF PHASE 1 (SAHRA ID 4150) HIA FOR
PROPOSED BRT SERVICE, PAUL KRUGER STREET,
PRETORIA, TSHWANE
FROM BLOED STREET TO SCHEIDING STREET,
EXCLUDING CHURCH SQUARE WITH SPECIFIC
REFERENCE TO SIDEWALKS AND VERANDAS**

November 2013

Report compiled by Sidney Miller.

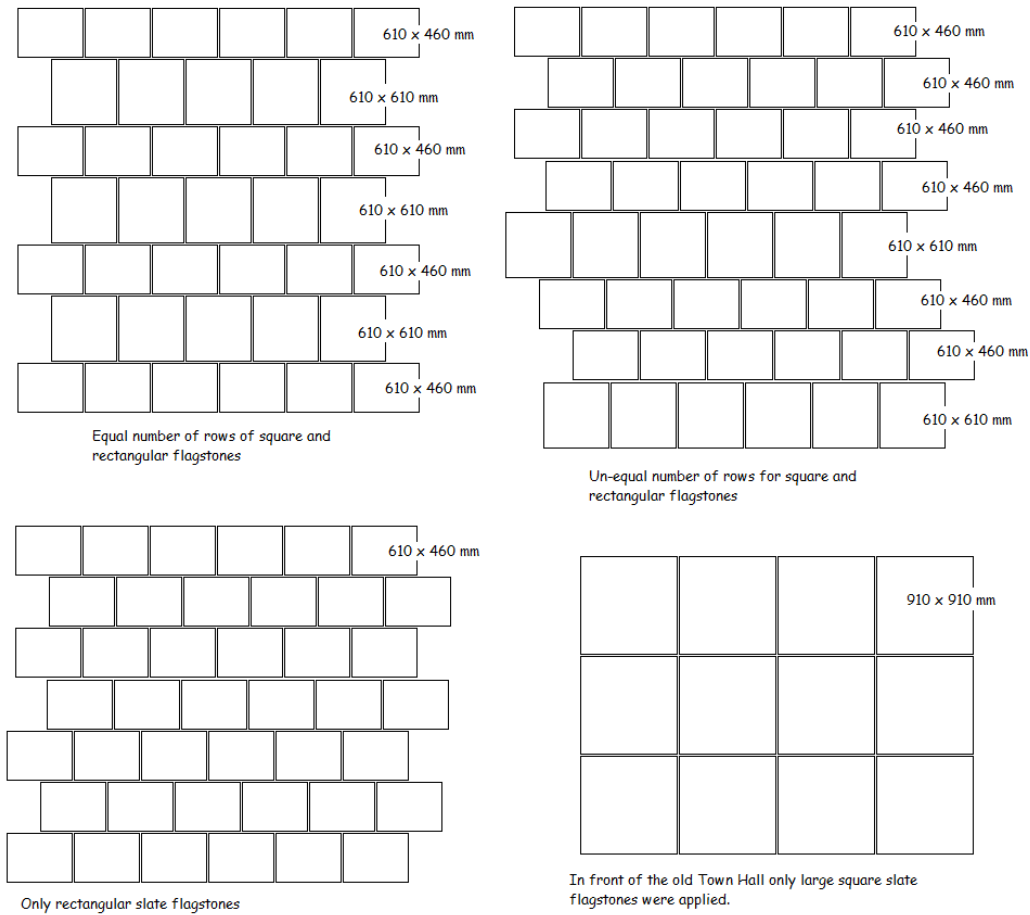
Fig. 1 The dimensions of the slate flagstones as measured and the typical paving patterns. The fourth format, laid only in front of the old Town Hall, has been exceptionally damaged and will require special attention to design.

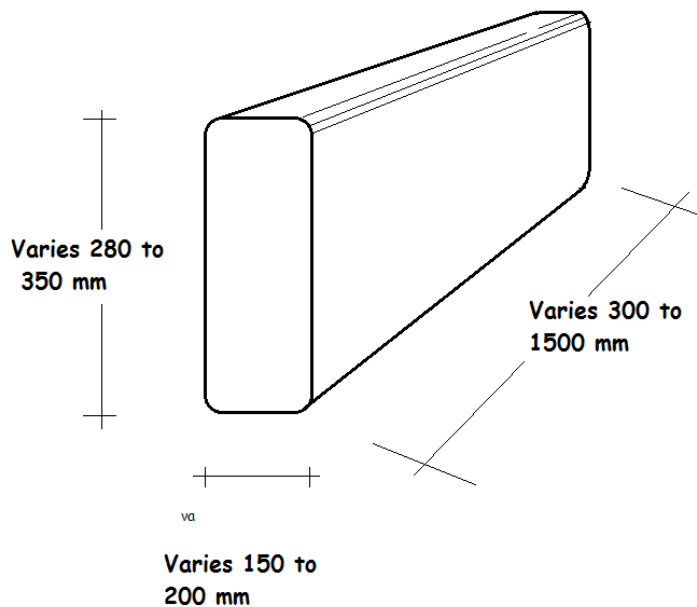
Fig. 1 Typical measurements of the granite kerb stones.

Granite kerb stones must be salvaged and reutilised as per architectural details if so approved by PHRA-G.

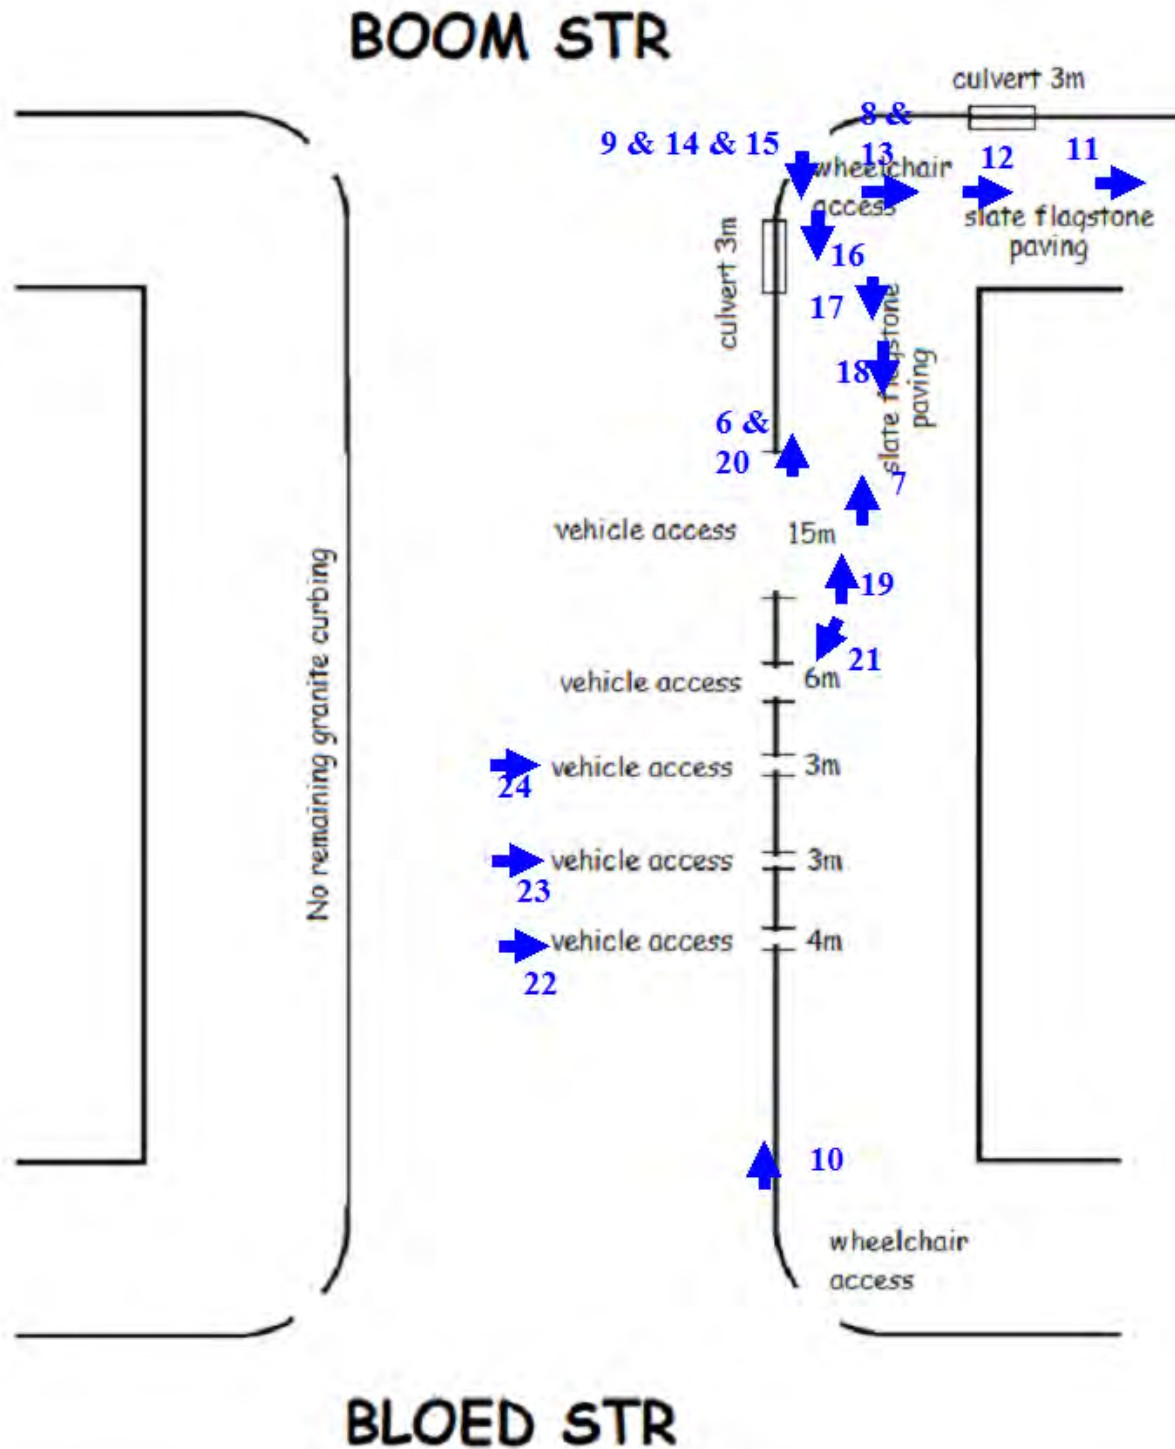
- 1.1 Contains approximately 90 square meters of slate flagstone paving at north-eastern corner.
- 1.2 Approximately 60 square meters are cracked and damaged in this area.
- 1.3 Approximately 30 square meters may be recovered from this area for reutilisation elsewhere.
- 2.1 Block 1 total length ~ 132 meters.
- 2.2 Approximately 100 meters of granite kerbing remain on eastern side of Paul Kruger Street. (See Fig. 5)
- 2.3 No granite kerbing remains on western side of Paul Kruger Street. (See Fig. 5)

Fig. 5 Block 1, schematic representation for photo documentation. The drawing also indicates remaining portions of granite kerbing, wheelchair access, vehicular access and culverts. These are all factors that reduce the extent of remaining granite kerbing.

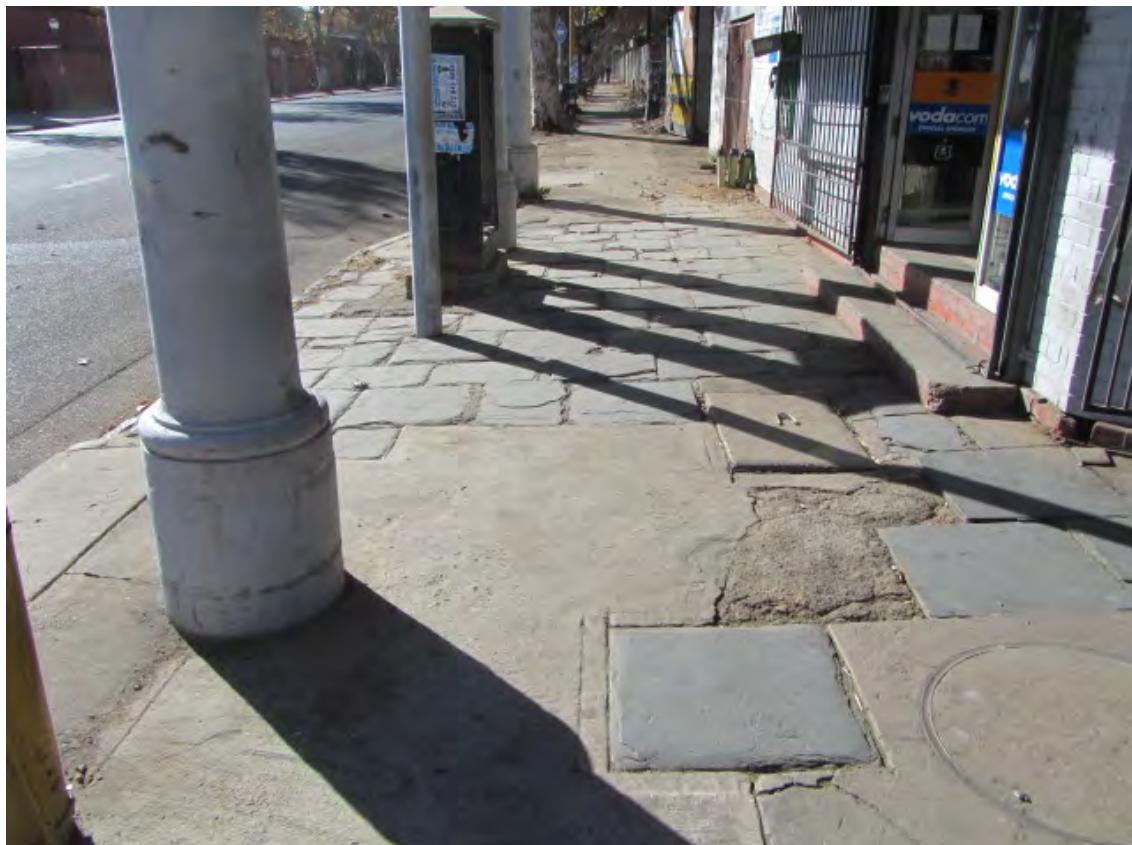
Fig. 8 Historical slate flagstones, granite kerbing and pillars of sidewalk in front of protected building. (Photograph SM Miller 2012)

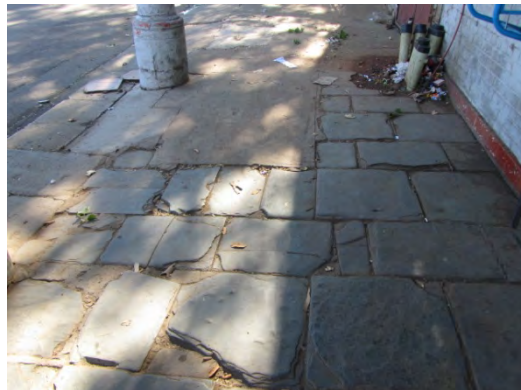
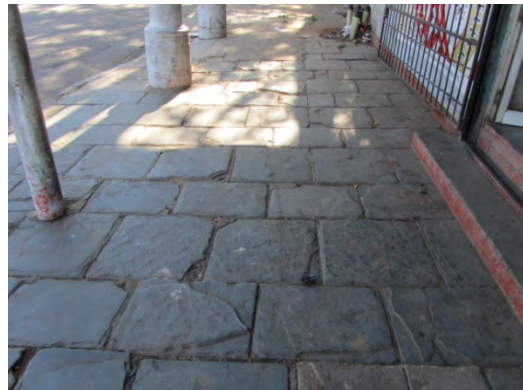
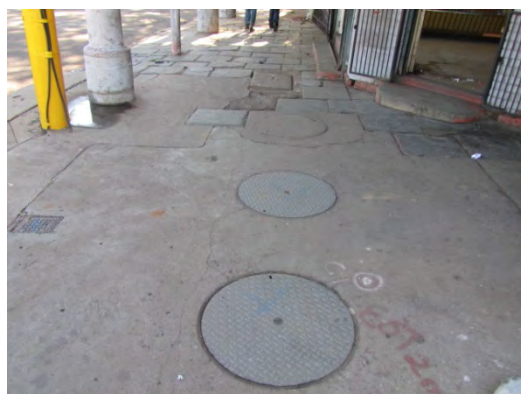
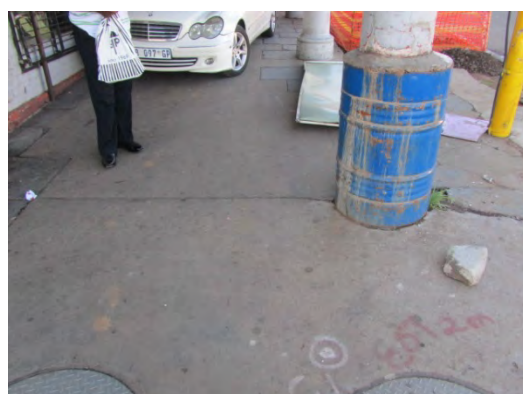
Figs 11 to 14 Historical slate flagstones on sidewalk in front of protected buildings along Bloed Street. These photographs illustrate the generally poor condition of the paving. (Photographs SM Miller 2013)

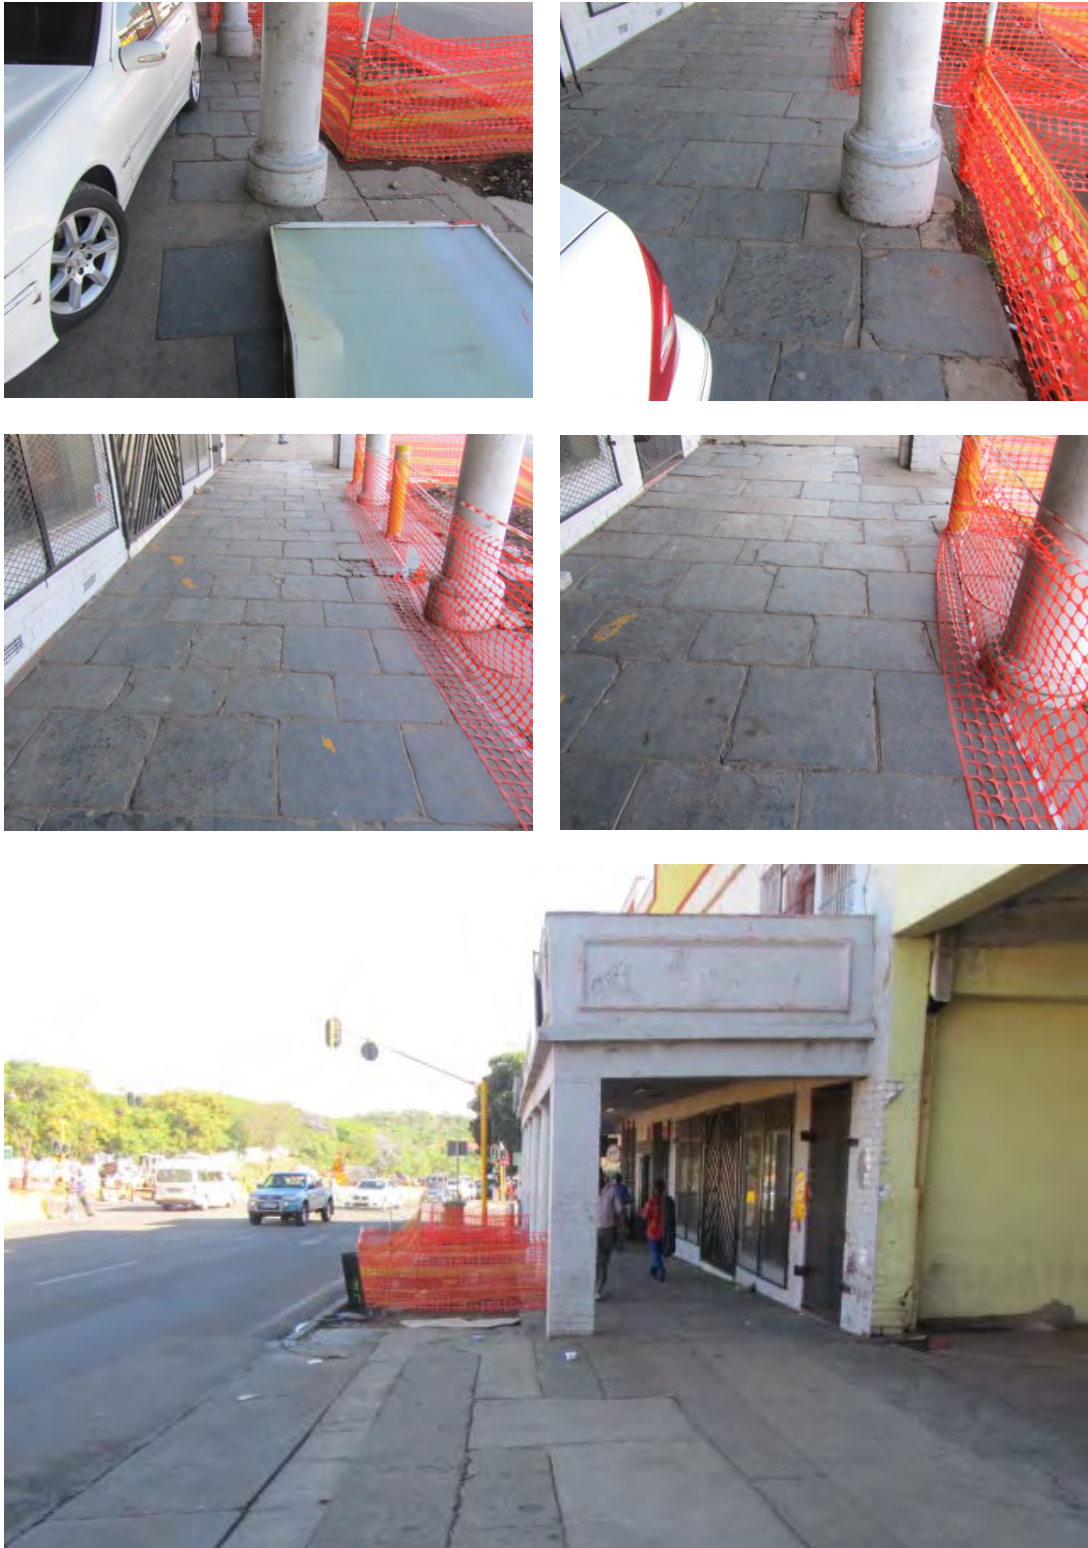
Figs 15 to 19 Above can be seen historical slate flagstones on the sidewalk in front of a protected building in Block 1 on the eastern side of Paul Kruger Street.

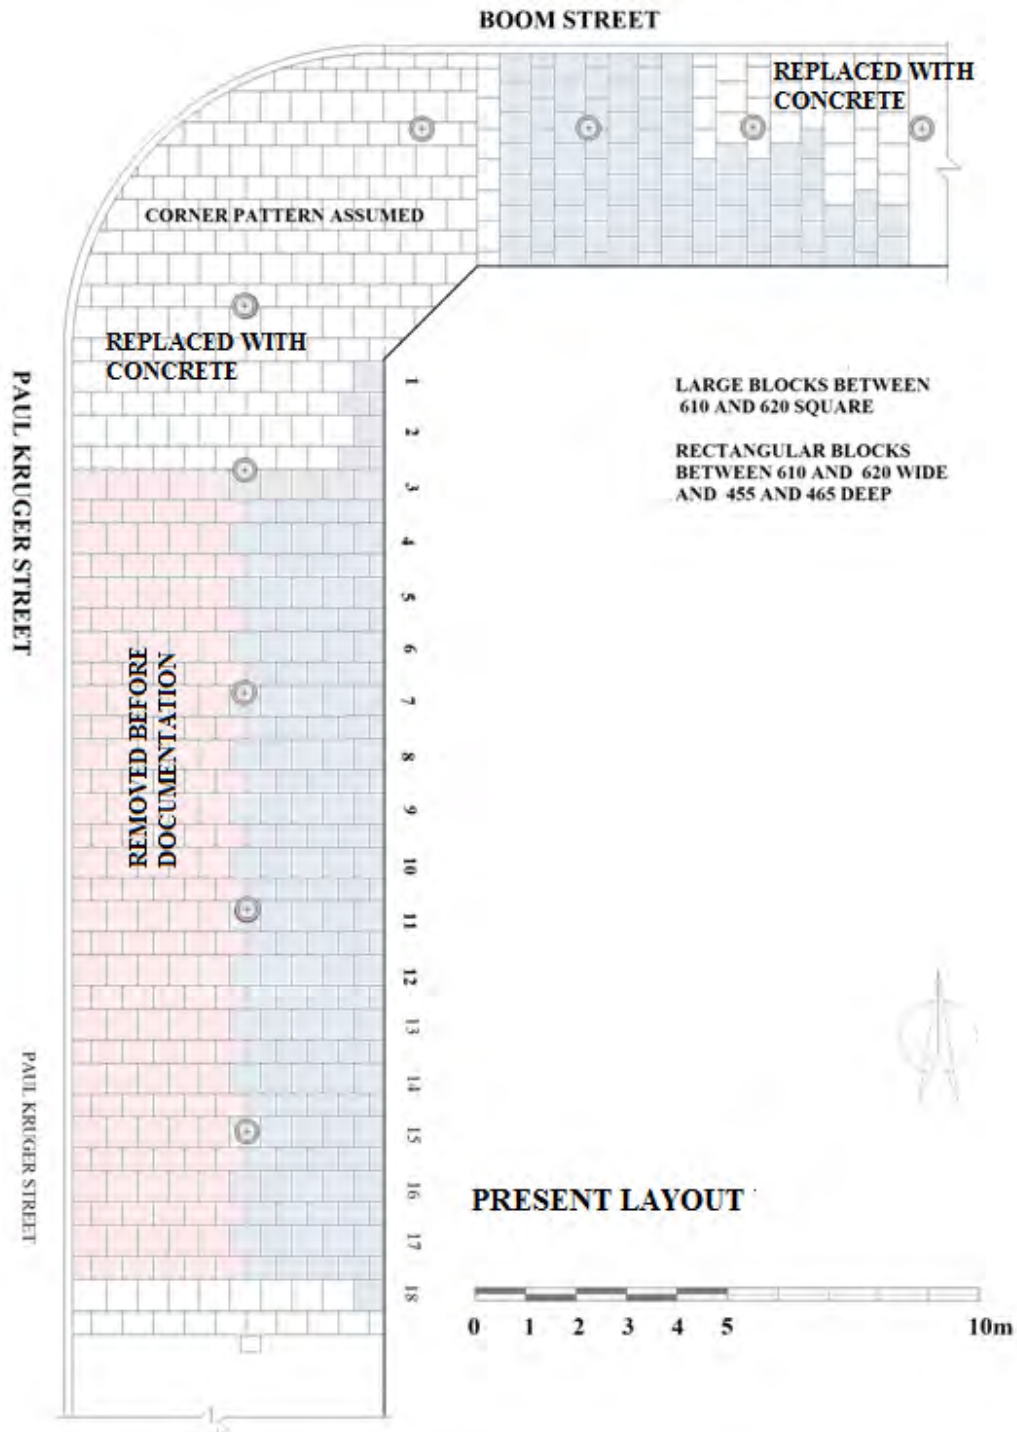
Fig. 25 Reconstruction of present slate flagstone paving on the north-eastern corner of Paul Kruger and Boom streets, disregarding cracked units. It also forms a benchmark for the possible original layout of the flagstone paving in general.

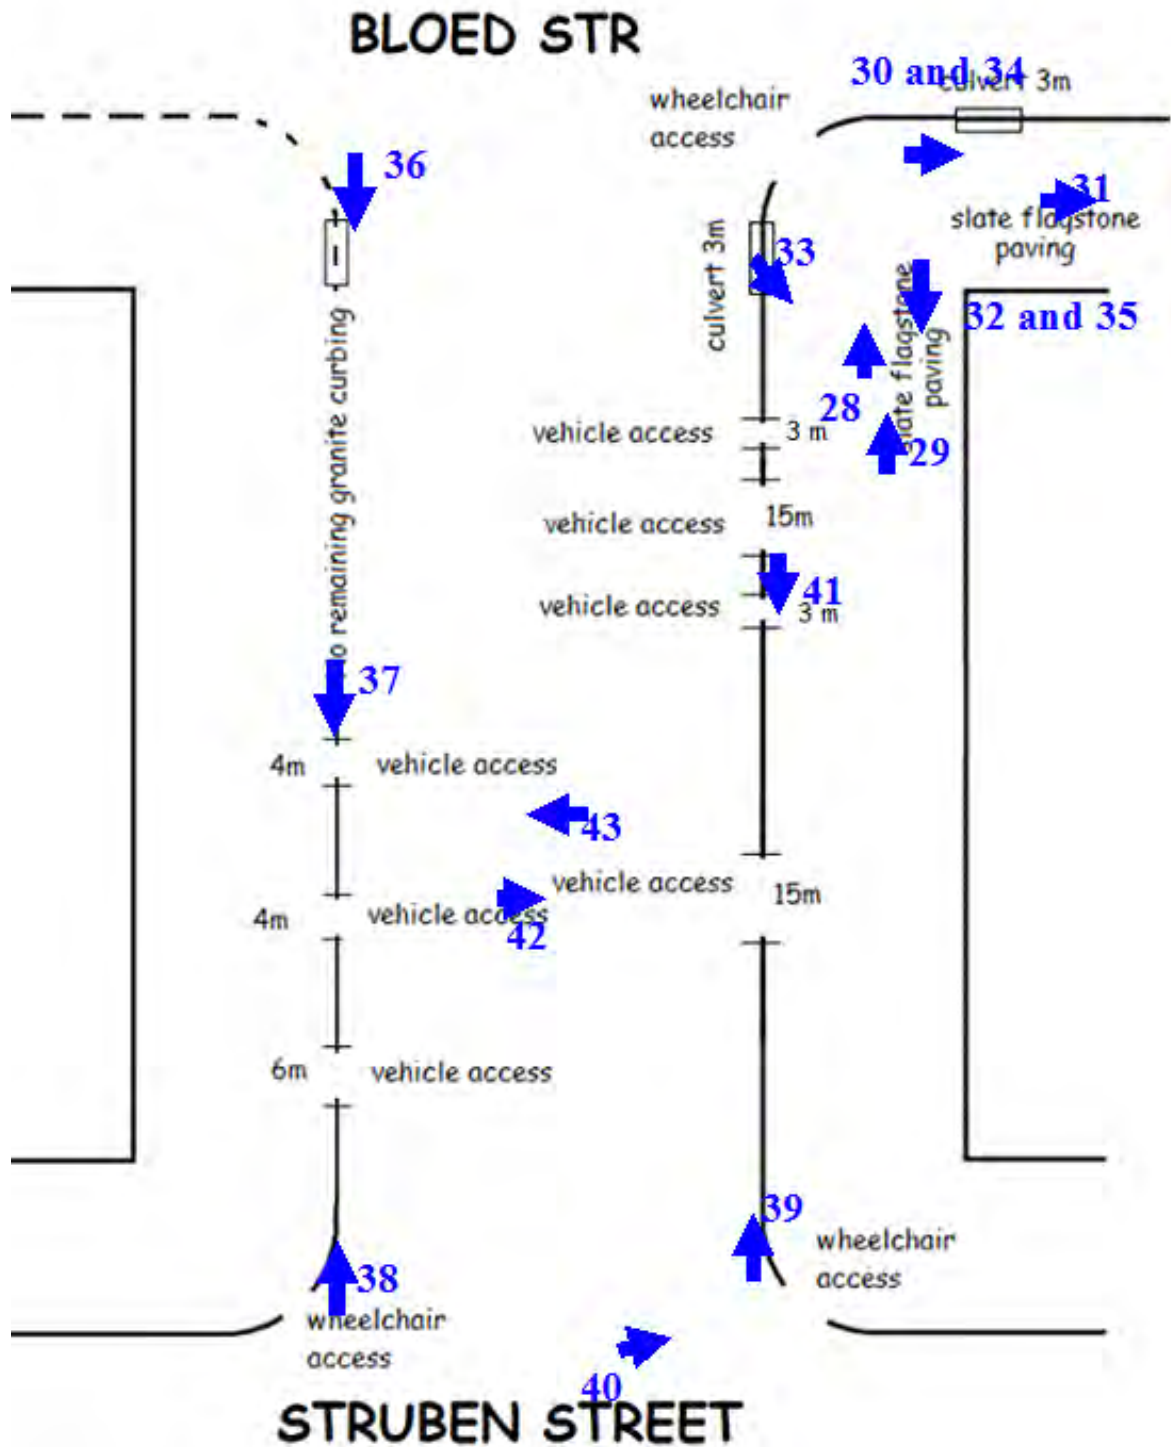
- 1.1 Contains approximately 50 square meters of slate flagstone paving at north-eastern corner.
- 1.2 Approximately 25 square meters are cracked and damaged in this area.
- 1.3 Approximately 25 square meters may be recovered from this area and reutilised elsewhere.
2. 1 Block 2 total length ~ 144 meters.
- 2.2 Approximately 120 meters of granite kerbing remain on eastern side of Paul Kruger Street. (See Fig. 27)
- 2.3 Approximately 62 meters of granite kerbing remain on western side of Paul Kruger Street. (See Fig. 27)

Fig. 27 Block 2, schematic representation for photo documentation. The drawing also indicates remaining portions of granite kerbing, wheelchair access, vehicular access and culverts, all factors that reduced the length of remaining granite kerbing.

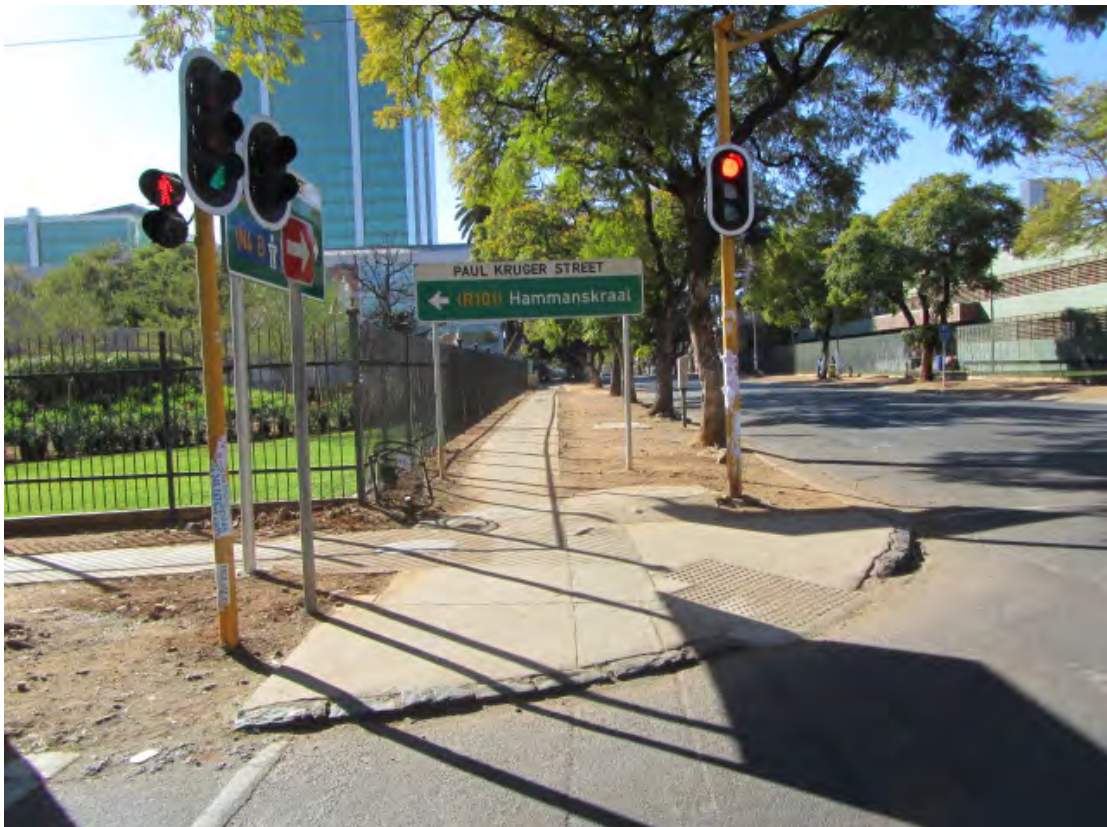
Fig. 40 Granite kerbing was adapted throughout the study area at street corners to accommodate physically-disadvantaged people. In some cases granite kerb stones were retained, while at other places modern materials were used. (Photograph SM Miller 2012)

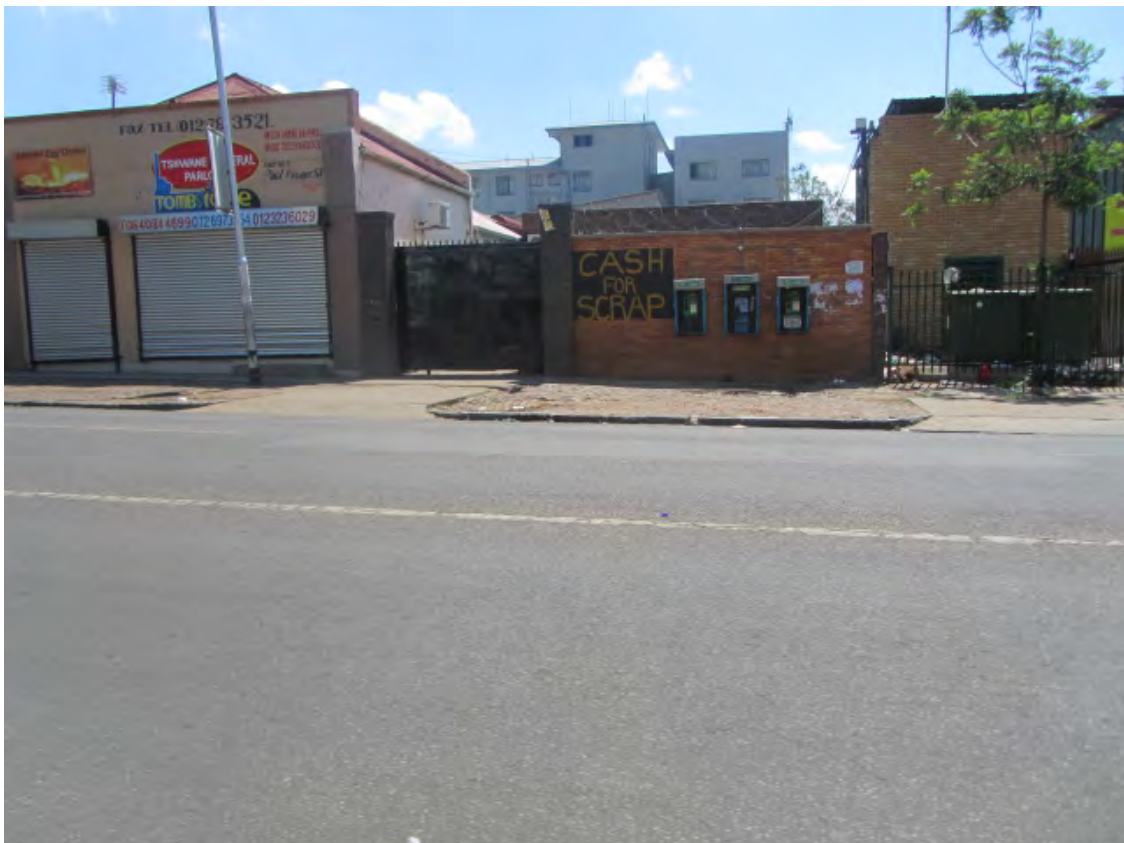
Figs 43 Granite kerbing on the west side of Block 2 and vehicular access areas for the building in the background. (Photograph SM Miller 2013)

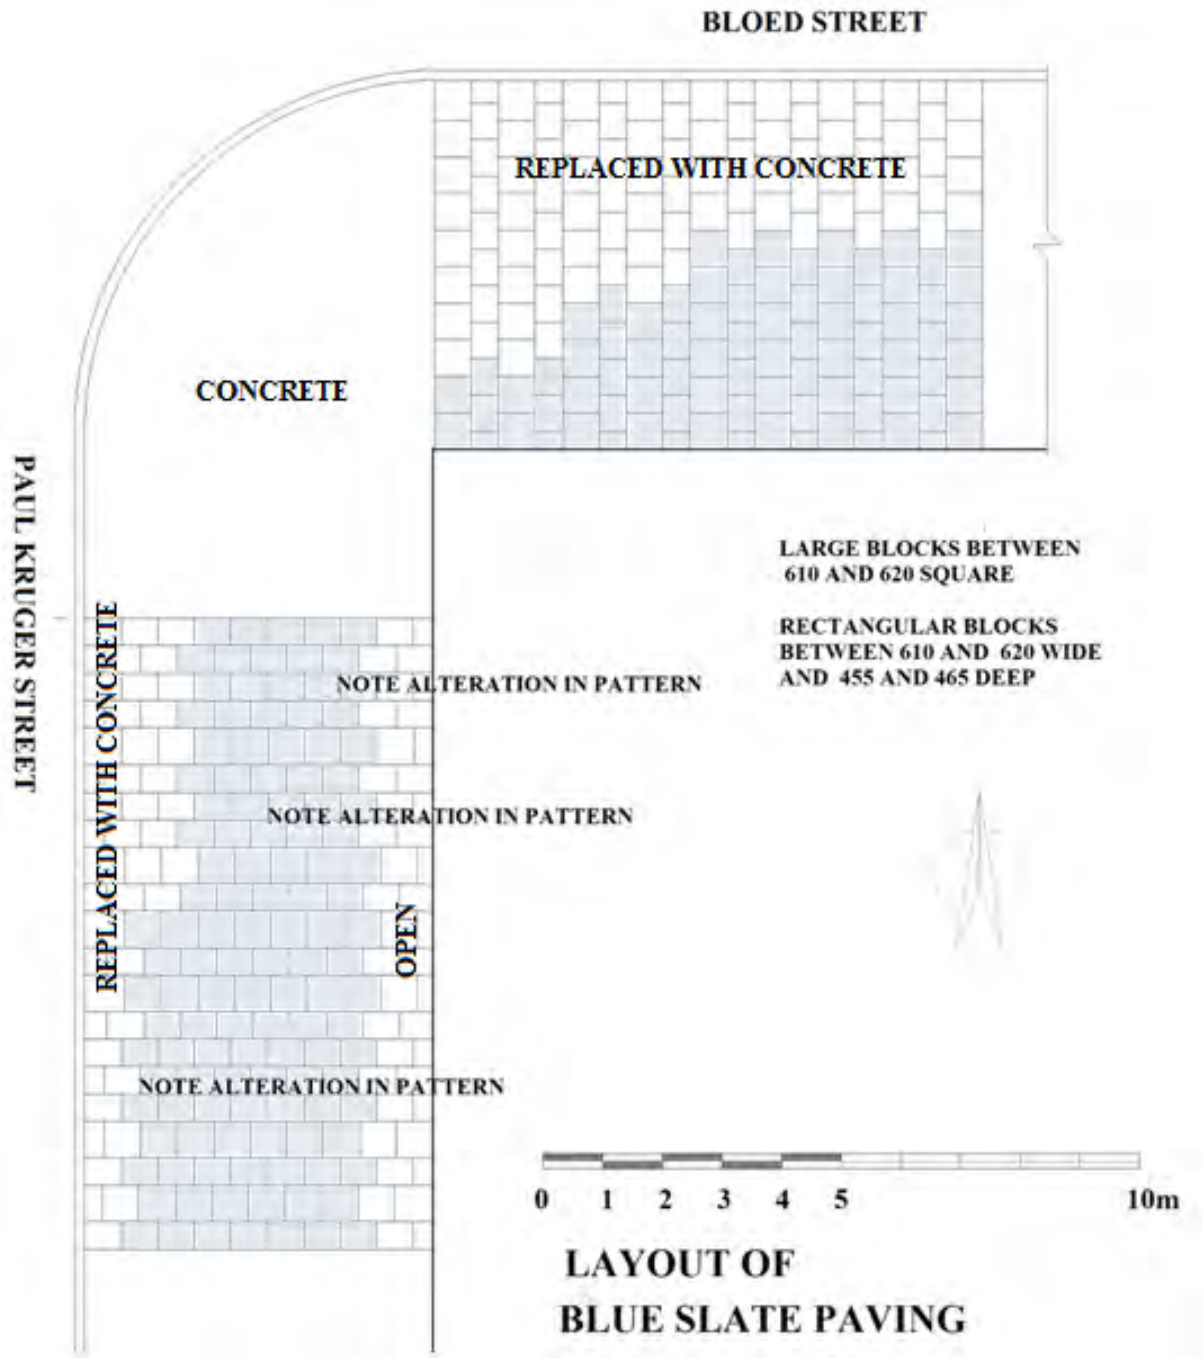
Fig. 44 Reconstruction of present slate flagstone paving on the north-eastern corner of Paul Kruger and Bloed streets, disregarding cracked units.

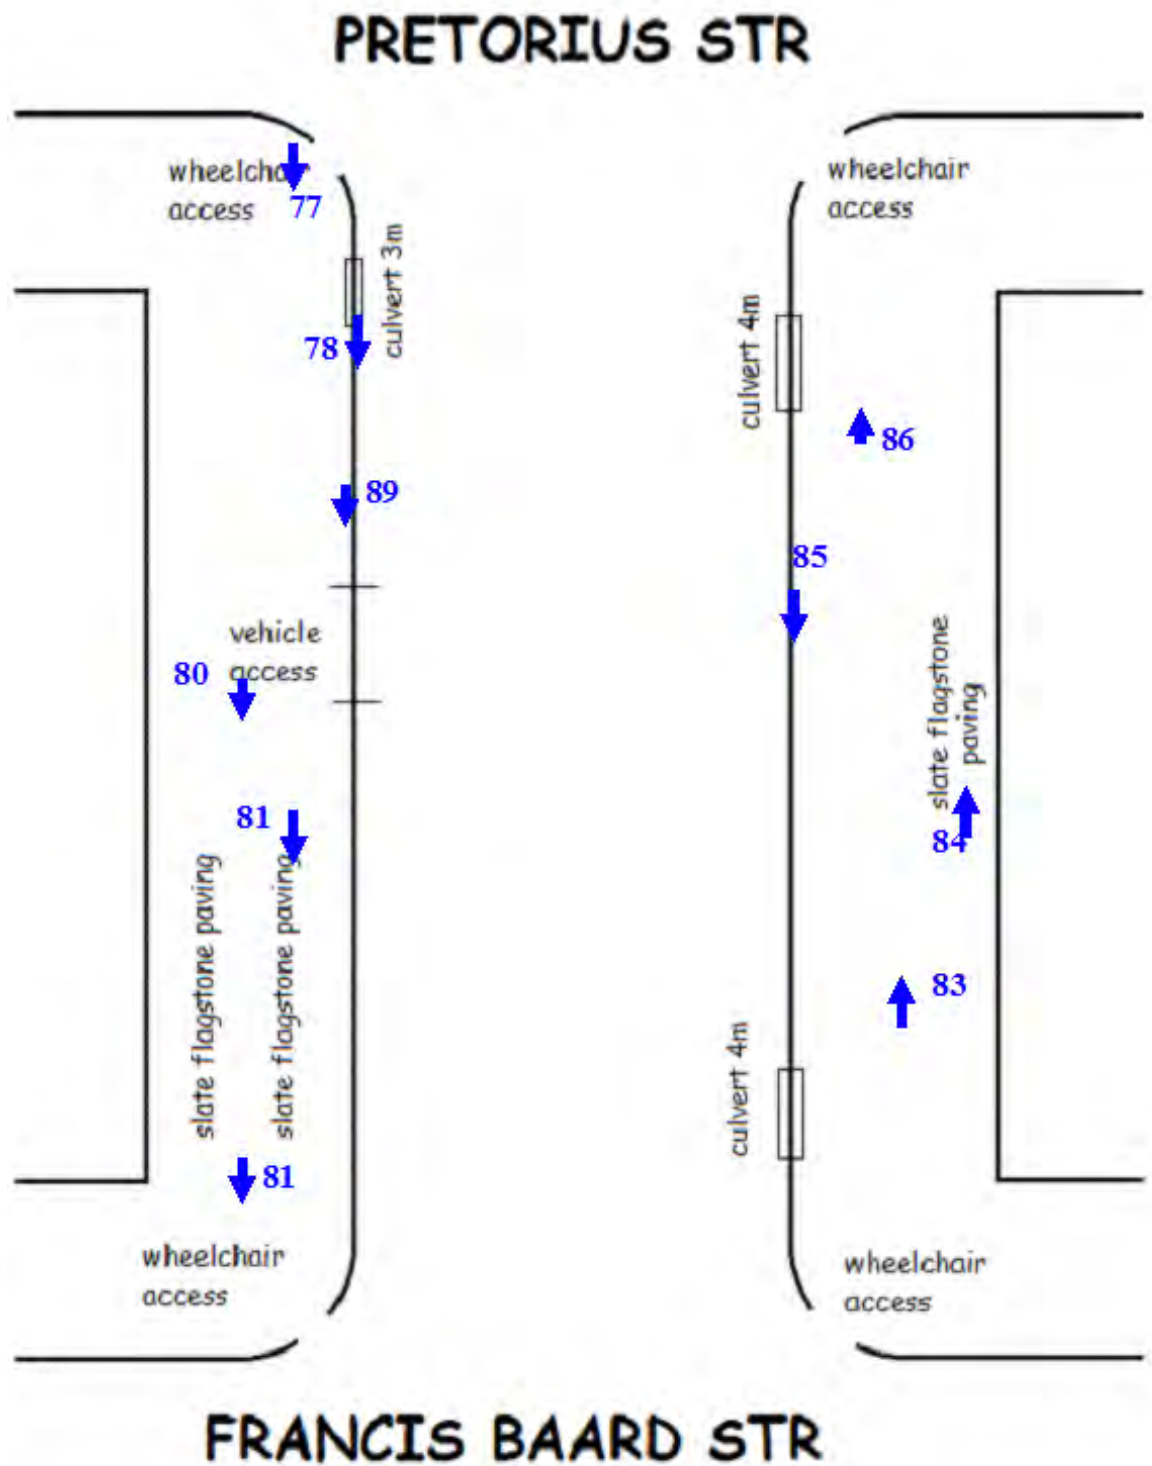
- 1.1 Contains approximately 170 square meters of slate flagstone paving at south-western corner and 4 square meters in the central part of the eastern side of the block.
- 1.2 Approximately 80 square meters are cracked and damaged.
- 1.3 Approximately 94 square meters may be recovered and reused elsewhere.
- 2.1 Block 5 total length ~ 138 meters.
- 2.2 Approximately 130 meters of granite kerbing remain on eastern side of Paul Kruger Street. (See Fig. 76)
- 2.3 Approximately 130 meters of granite kerbing remain on western side of Paul Kruger Street. (See Fig. 76)

Fig. 76 Block 5, schematic representation for photo documentation. The drawing also indicates remaining portions of granite kerbing, wheelchair access, vehicular access and culverts, all factors that reduce the length of remaining granite kerbing.

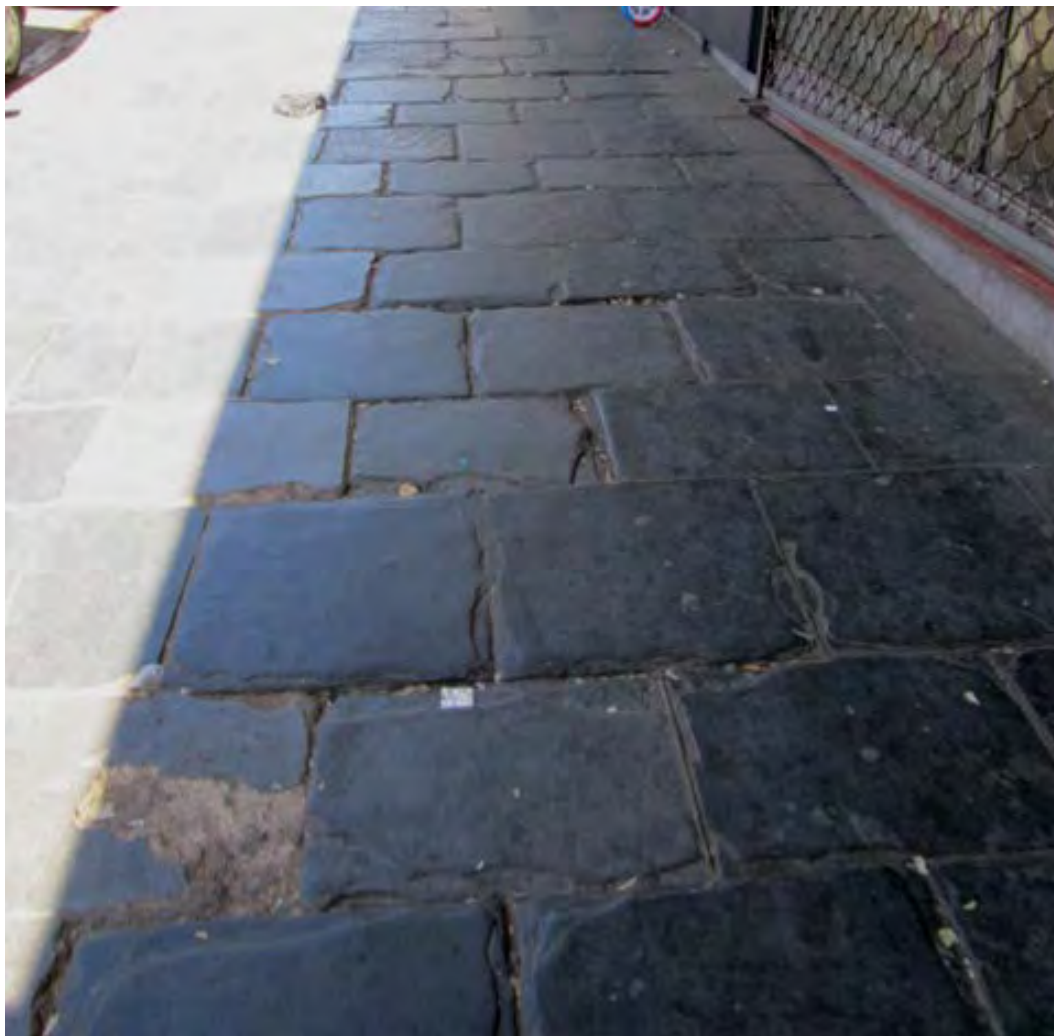
Fig. 81 Remaining historical slate flagstone paving. (Photograph SM Miller 2012)

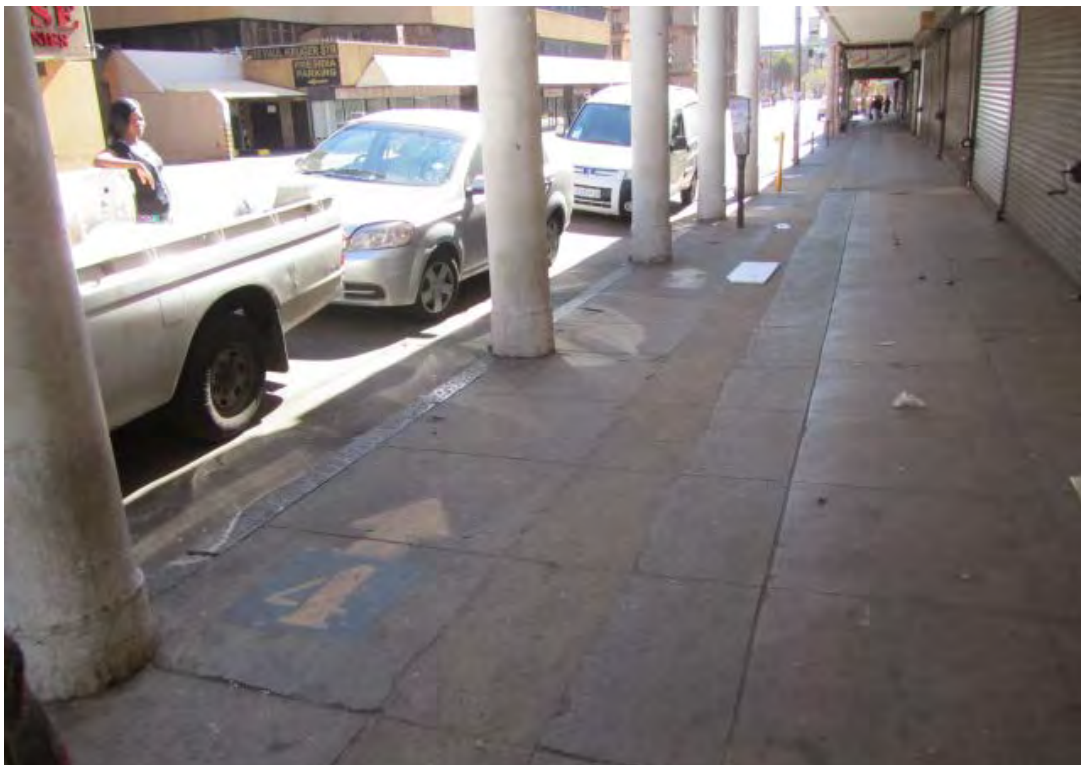
Fig. 83 Granite kerbing on the central eastern side of Block 5. Fracturing of the granite kerbing at column bases probably explains the discontinuation of granite kerbing elsewhere along the street. (Photograph SM Miller 2012)

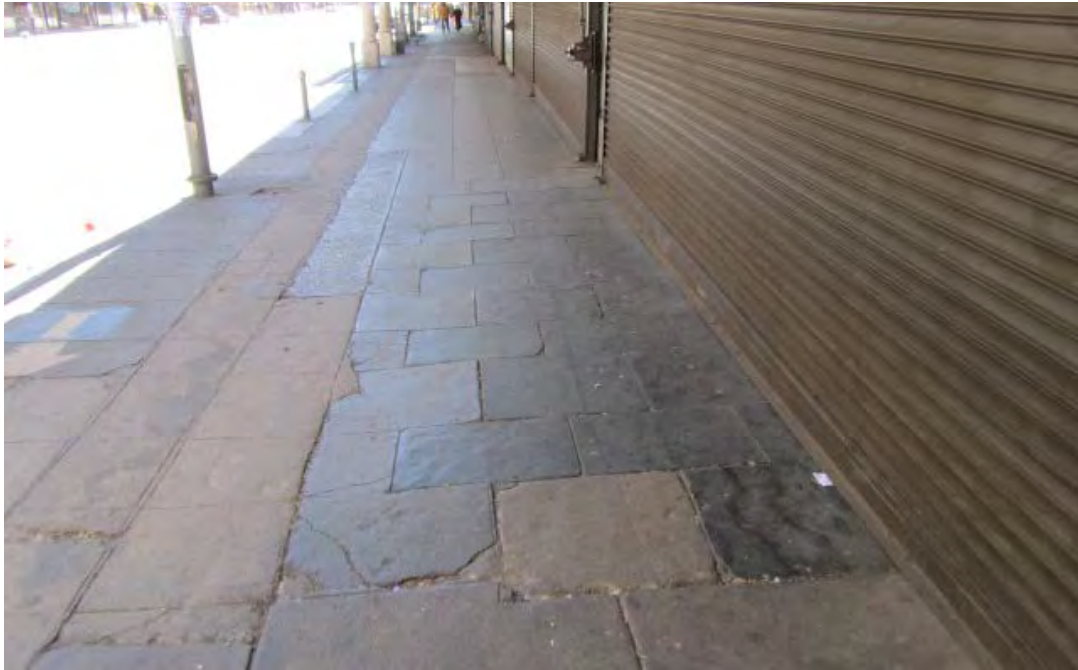
Figure 8 *Remains of historical slate flagstone on the eastern side of Block 5. (Photograph SM Miller 2012)*

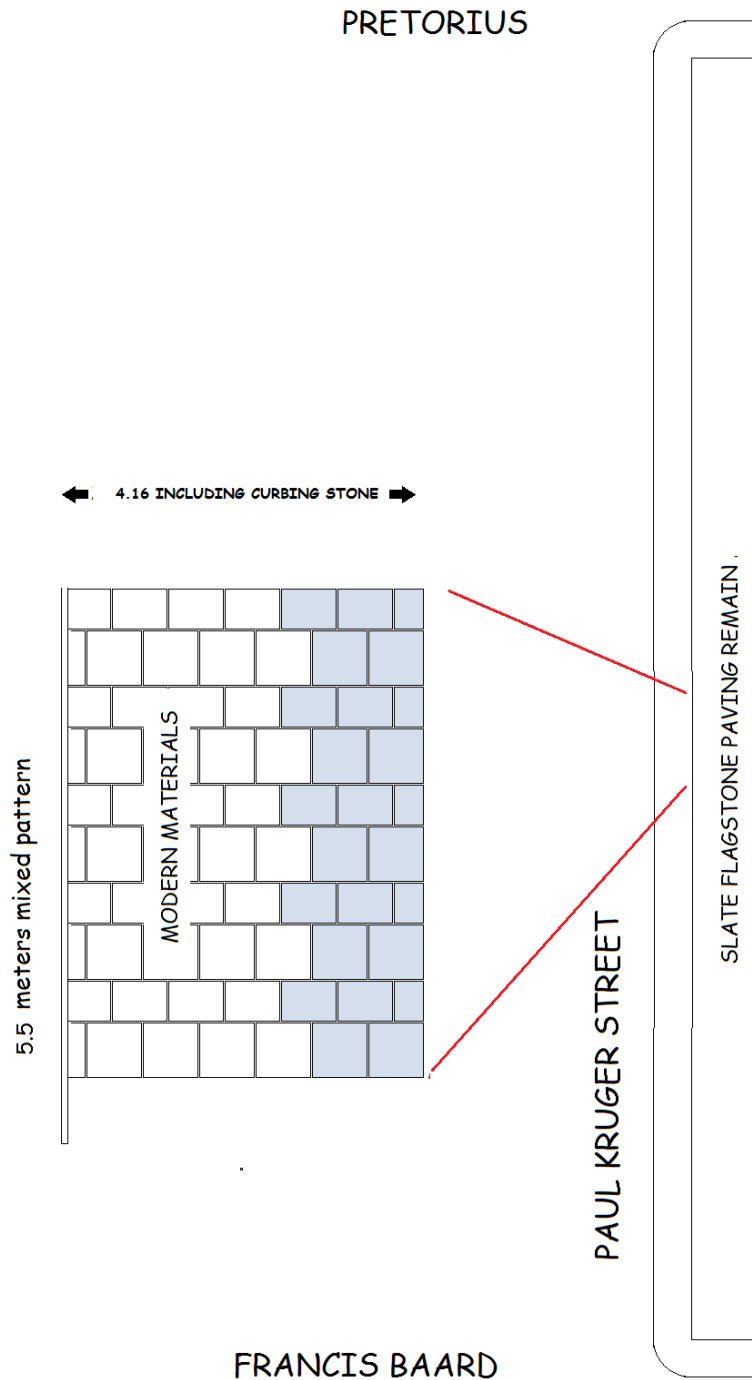
Fig. 86 Reconstruction of present condition of the slate flagstone paving on the eastern side of Paul Kruger in block 5. The few remaining flagstones are in a relative good condition. The paving pattern conforms to documentation of paving elsewhere.

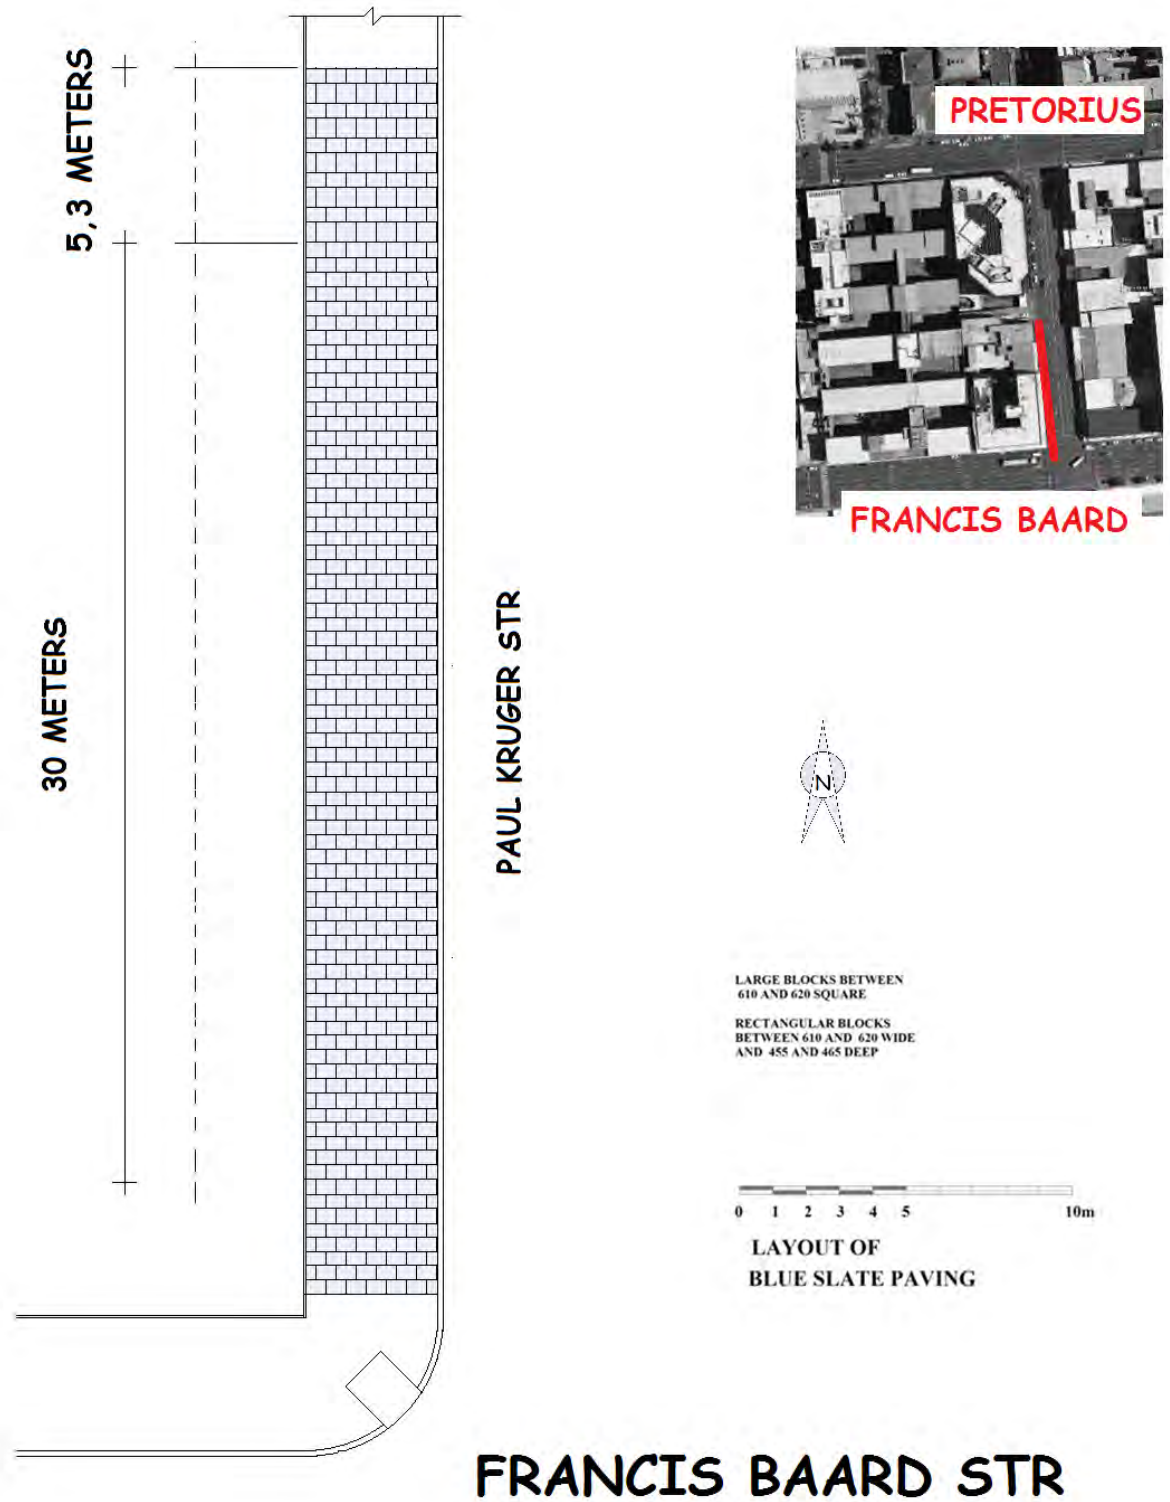
Fig. 87 Reconstruction of present condition of slate flagstone paving on the south-western side of Paul Kruger Street in Block 5. Although there appears to be around 120 square meters of slate flagstones intact their general condition is poor. Many have been lost through the installation of services.

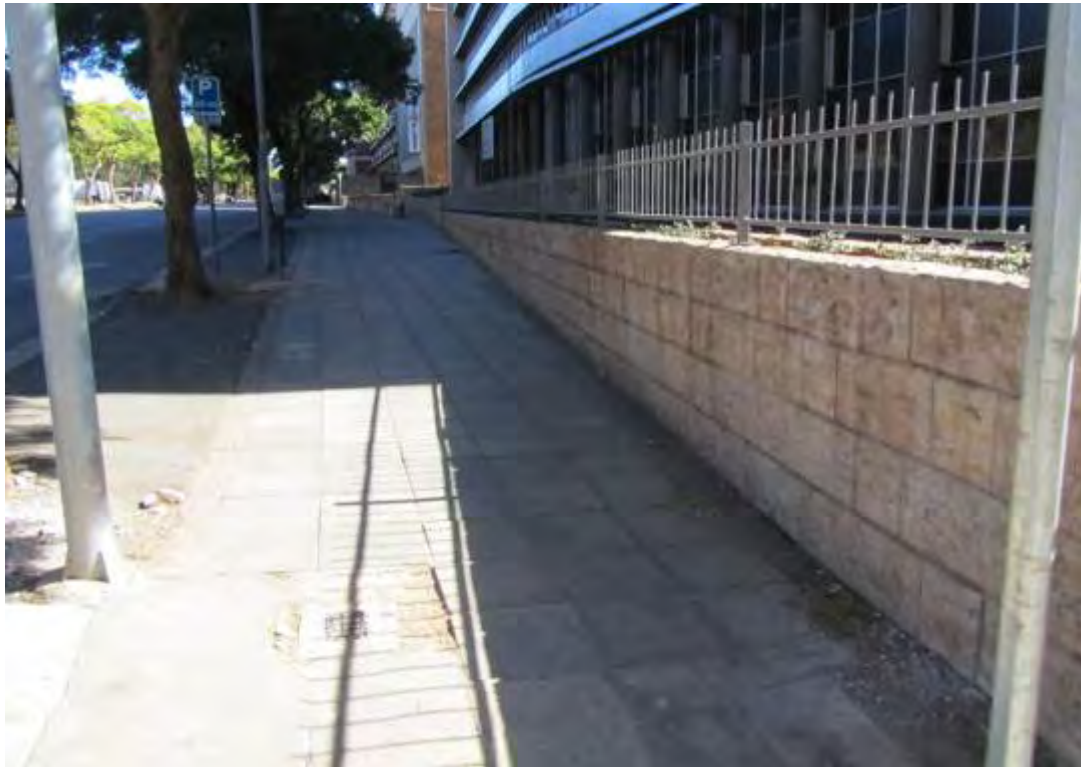
Fig. 113 Note condition of the paving along Visagie Street from Paul Kruger Street. (Photograph SM Miller 2012)
