**EXTENSION OF PHASE 1 (SAHRA ID 4150) HIA FOR
PROPOSED BRT SERVICE, PAUL KRUGER STREET,
PRETORIA, TSHWANE
FROM BLOED STREET TO SCHEIDING STREET,
EXCLUDING CHURCH SQUARE WITH SPECIFIC
REFERENCE TO SIDEWALKS AND VERANDAS**

November 2013

Report compiled by Sidney Miller.

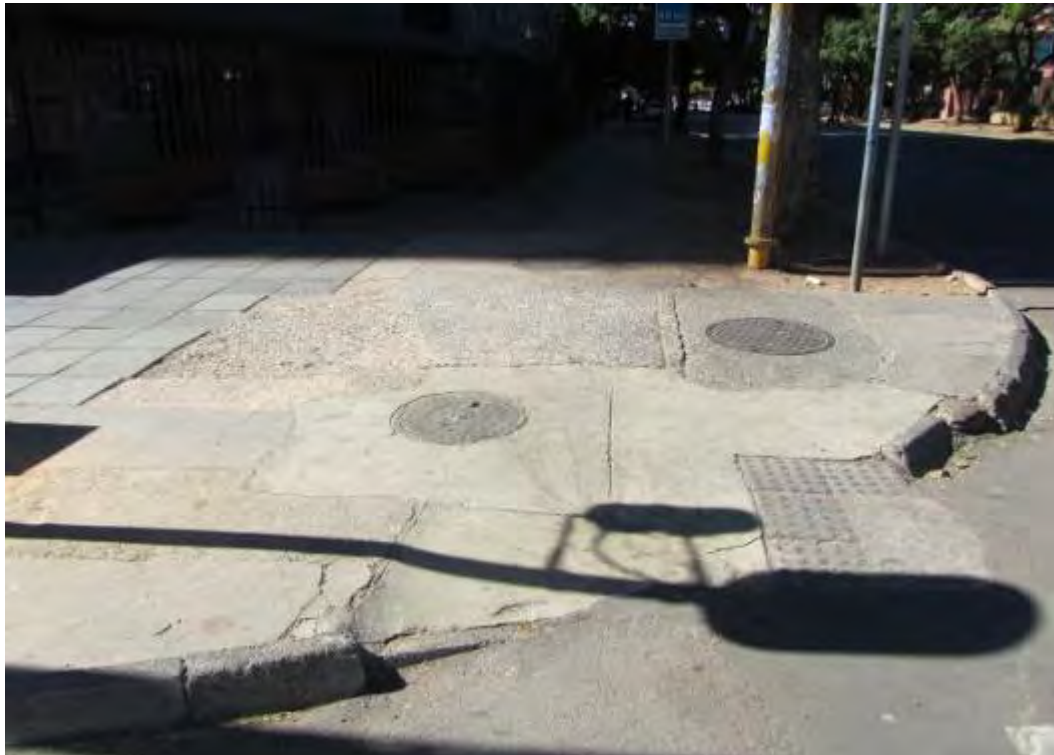
Fig. 114 Note wheelchair access on the south-eastern corner of Block 7. (Photograph SM Miller 2012)

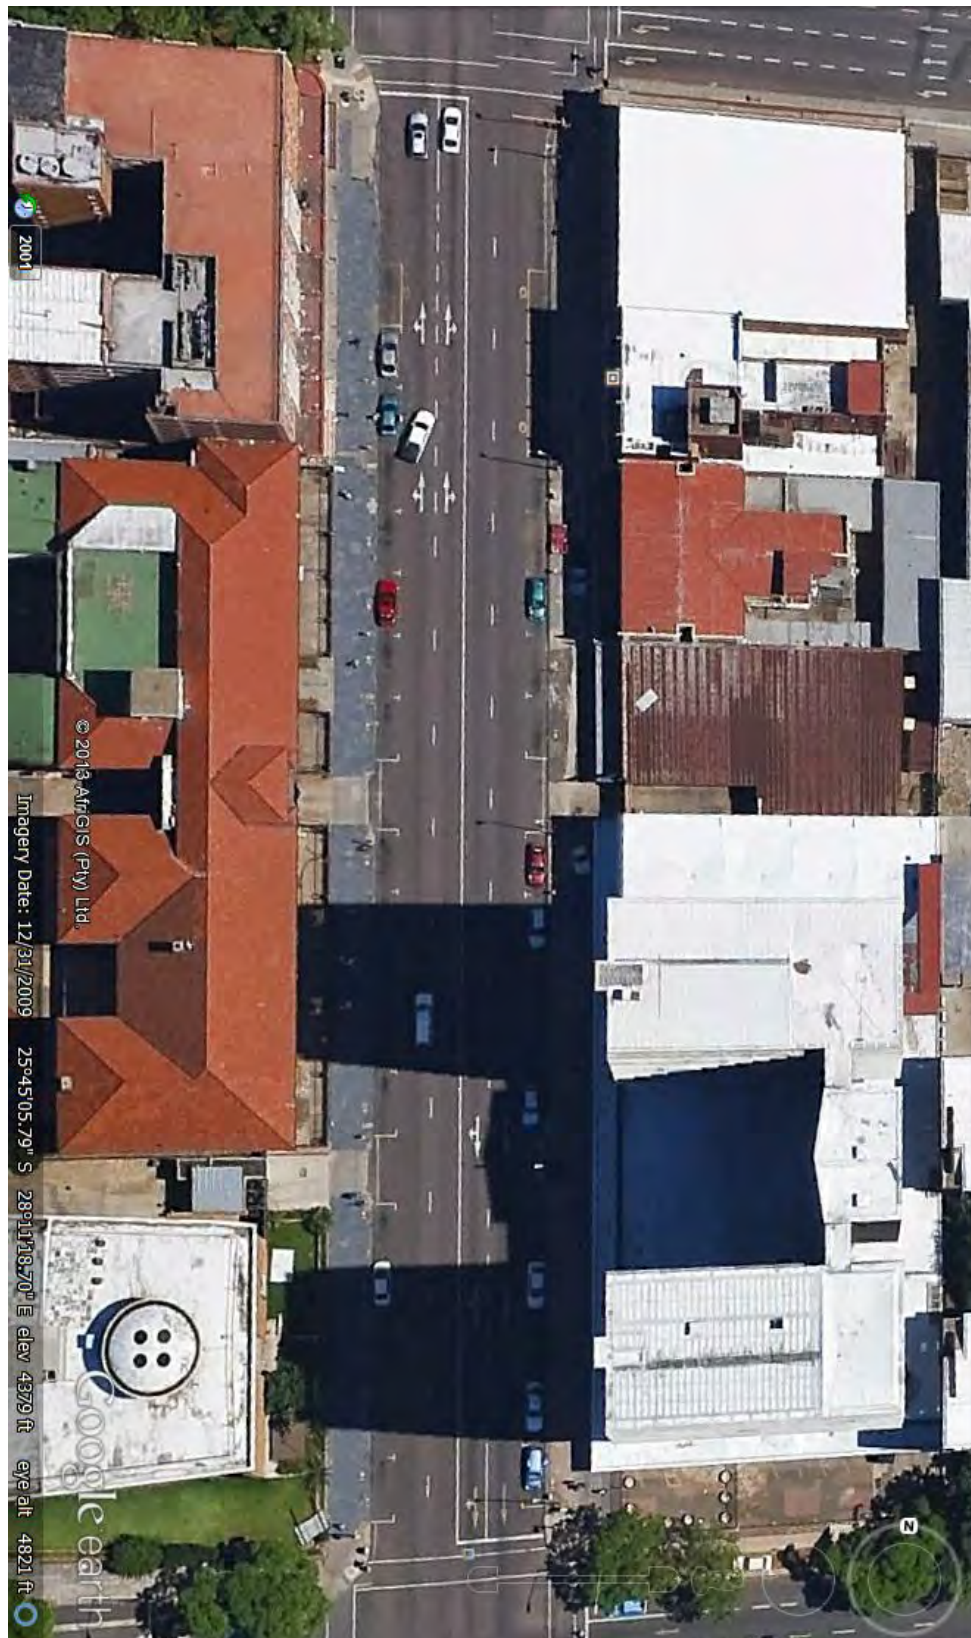
Fig. 116 Google Earth (2009) image. Although it appears as if most flagstones are intact, on-site inspection reveals that many are cracked, damaged or have been replaced. Removal and replacement will negatively impact on the preservation of flag stones.

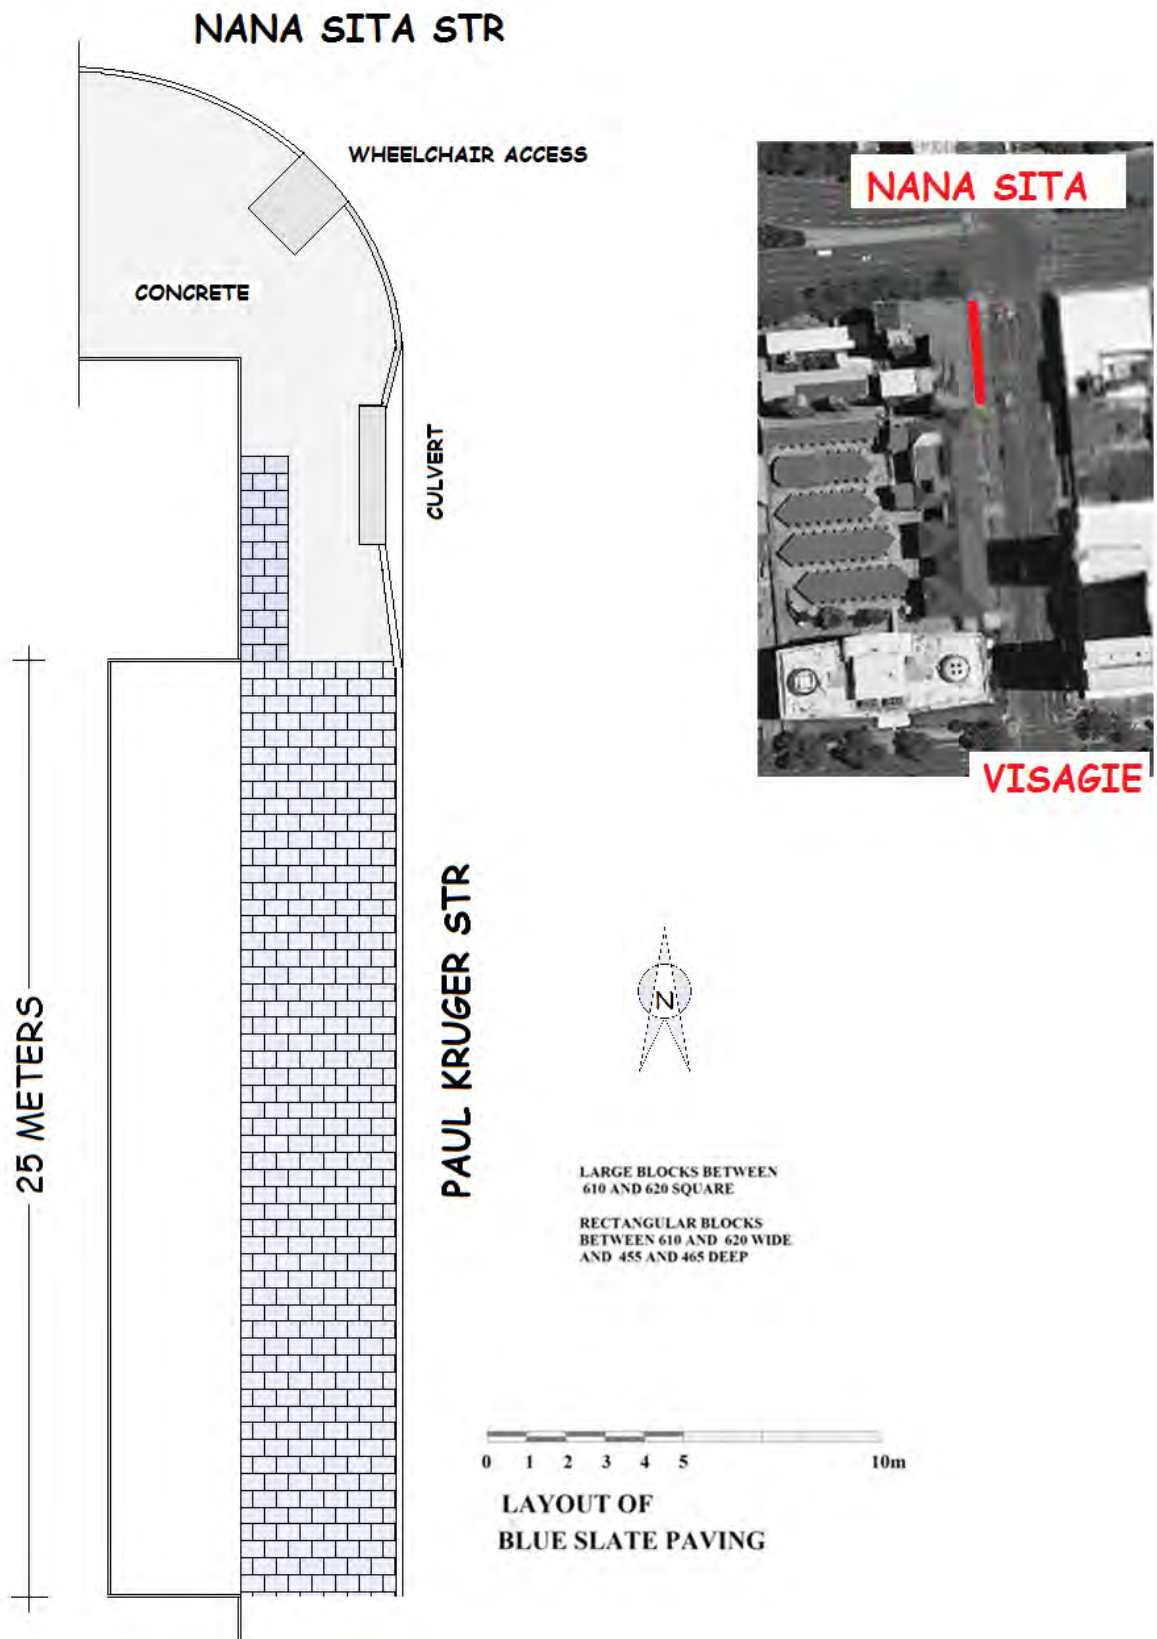
Fig. 117 Reconstruction of present condition of slate flagstone paving on the northwest corner of Paul Kruger and Nana Sita streets, disregarding cracked and lost units. Its position is indicated with a red line on the inset.

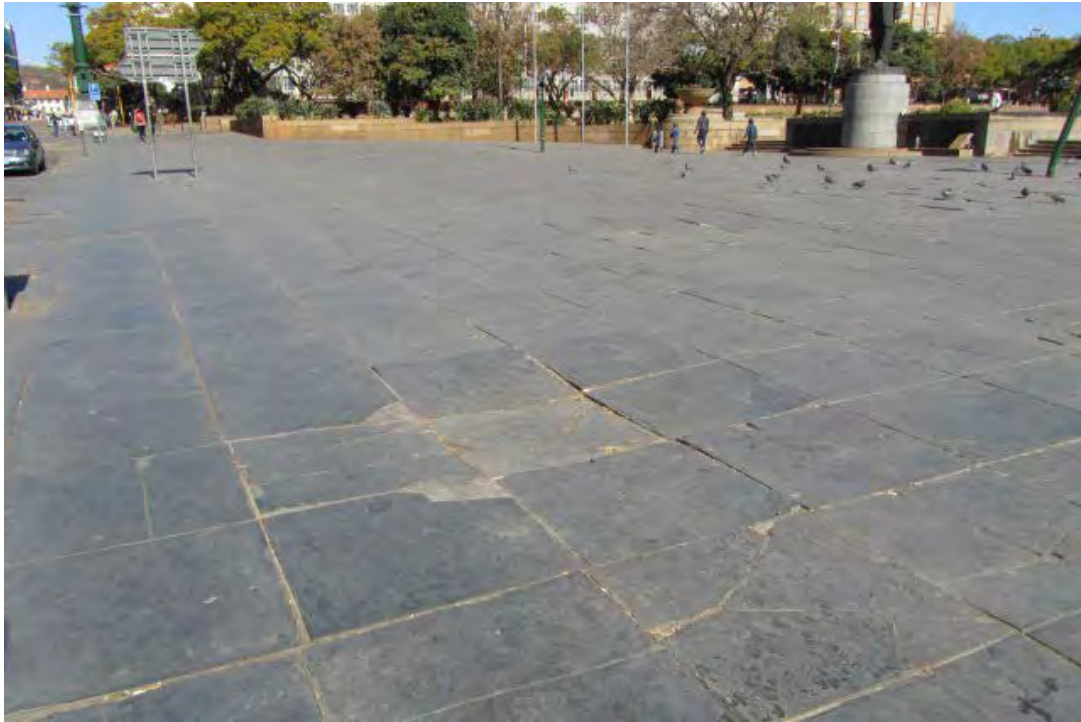
Fig. 127 The central section of the area in front of the Old Town Hall before the installation of the security fence. Although the flagstones are cracked and uneven, a sense of place is brought about by the presence of people relaxing and birds feeding peacefully in a public place. (Photograph SM Miller 2012)

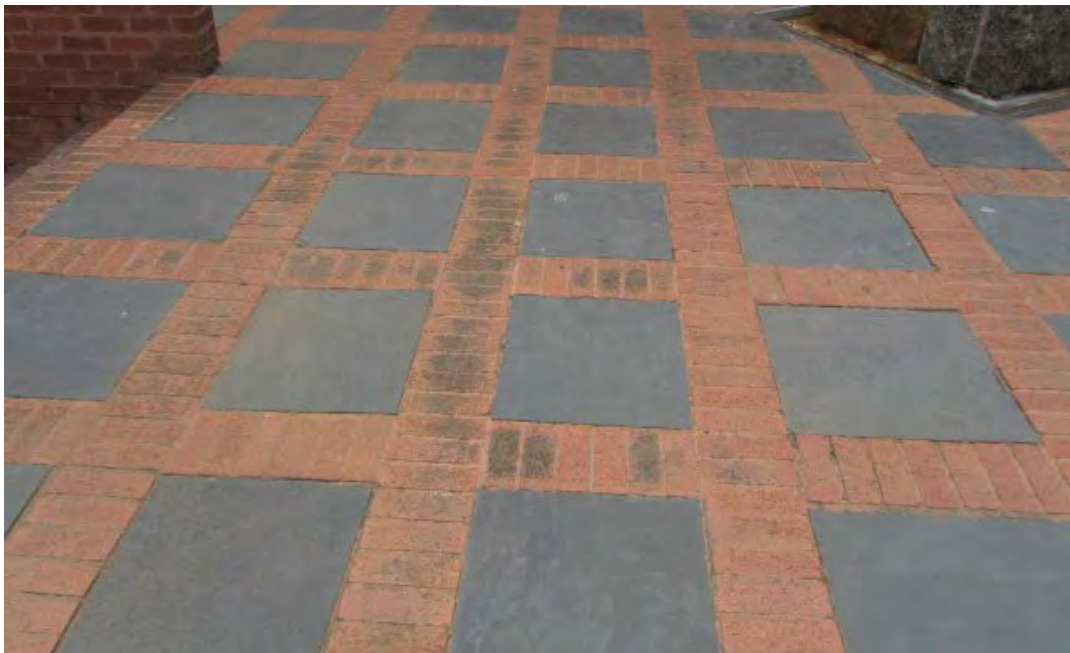
Fig. 128 With the extension of the Museum Building some years ago the original paving was removed and replaced. This is an example where some form of the historical slate flagstone paving has been retained. The poor preservation of the flagstones, which can be seen in front of the Old Town Hall, probably required a combination of original and new paving. Although attractive and well designed, it should be the last option where original paving exists. (Photograph SM Miller 2012)

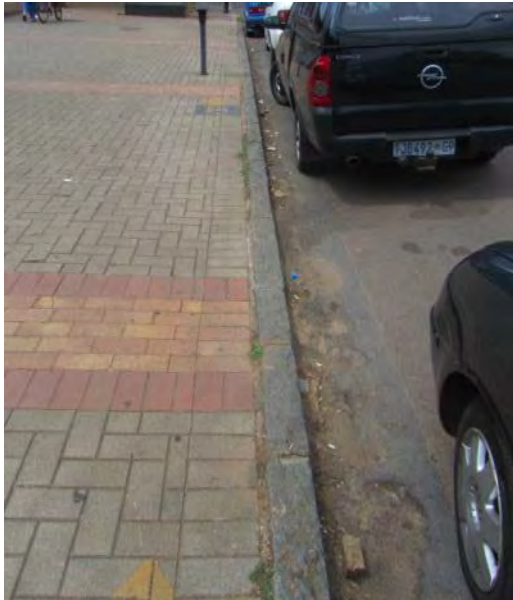
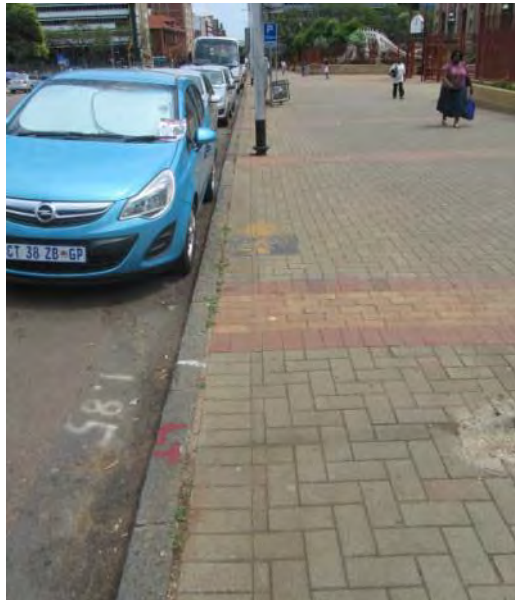
Figs 129 and 130 More views of paving that resulted from the extension of the Museum some years ago. Also note the original granite kerbing along both sides of the street. (Photograph SM Miller 2012)

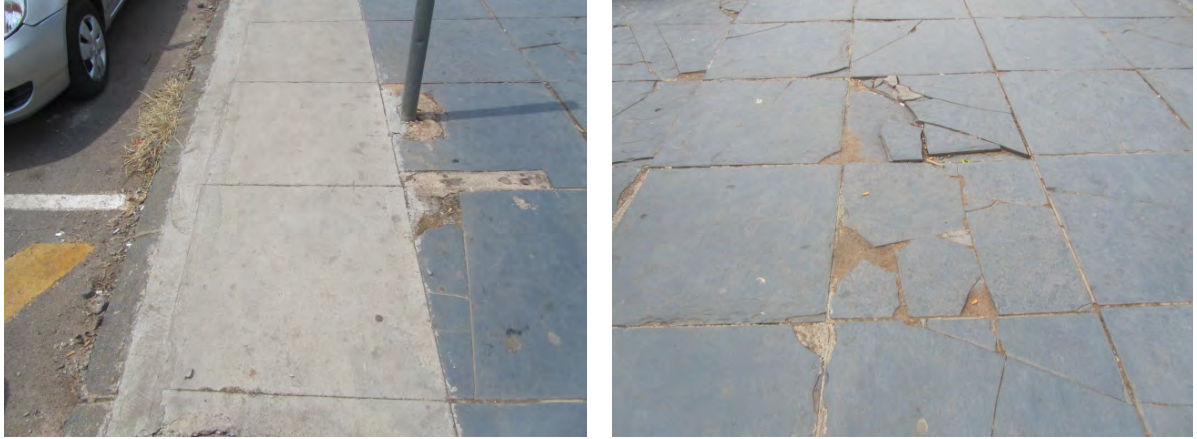
Figs 132 and 133 Both the above images illustrate how the placement of services and damage to flagstones over the past century have left the surface in a poor state of repair. (Photograph SM Miller 2013)

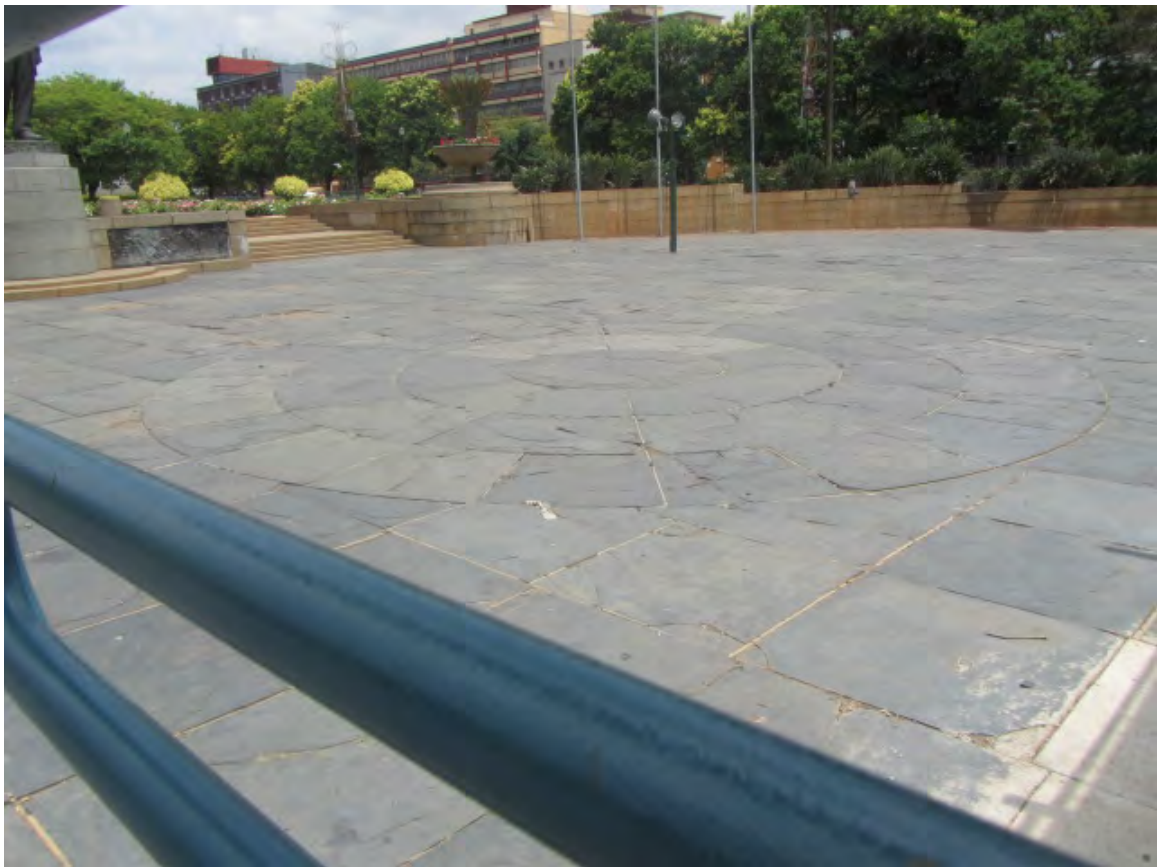
Fig. 134 This is the only decorative pattern in areas that retain slate flagstone paving. Unfortunately a security gate does not allow access into the paved area in front of the Town Hall. (Photograph SM Miller 2013)

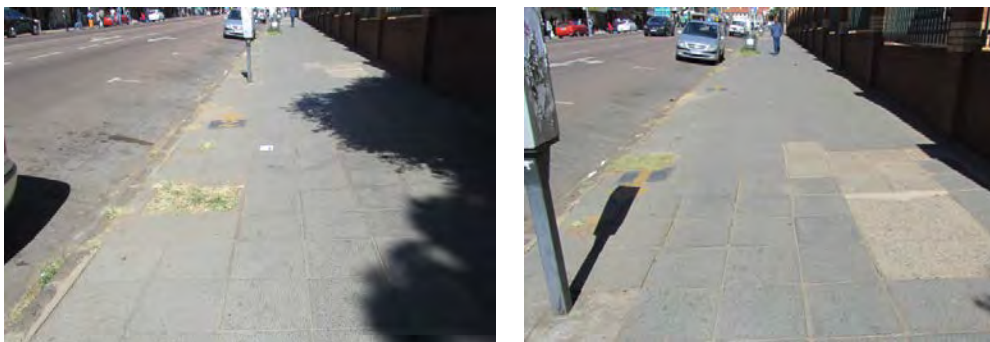
Figs 150 and 151 In this location the slate flagstones were replaced with modern paving blocks. It appears as if some attempt was made to imitate the colour of the flagstones as these blocks have a blue tinge. (Photograph SM Miller 2012)

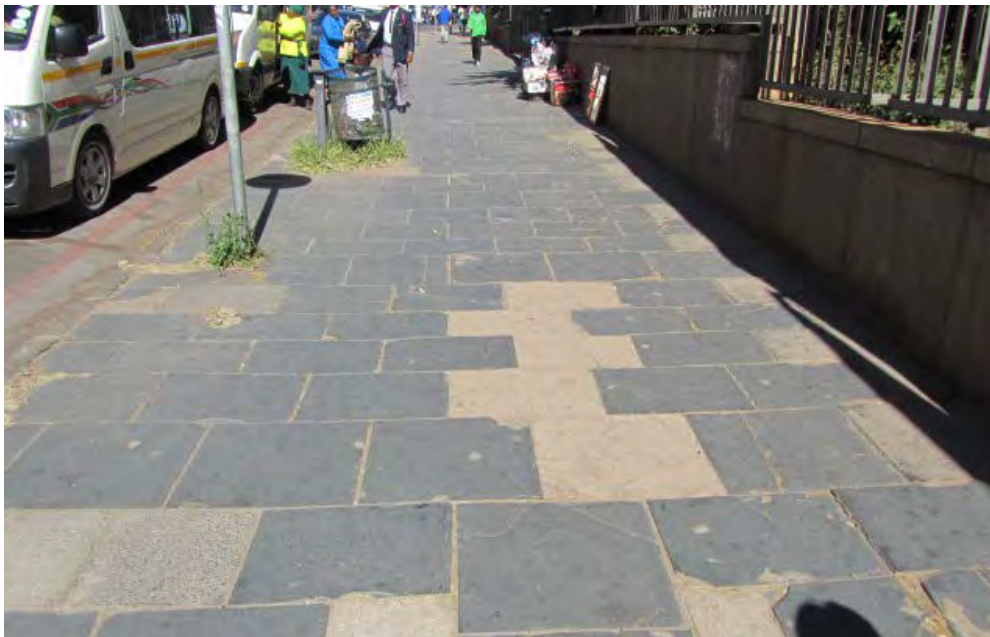
Fig. 152 In the south-western half of Block 9 most of the original slate flagstone paving remains. As elsewhere in the study area the paving is in a poor state of repair. Note variation in pattern of different types of flagstones. (Photograph SM Miller 2012)

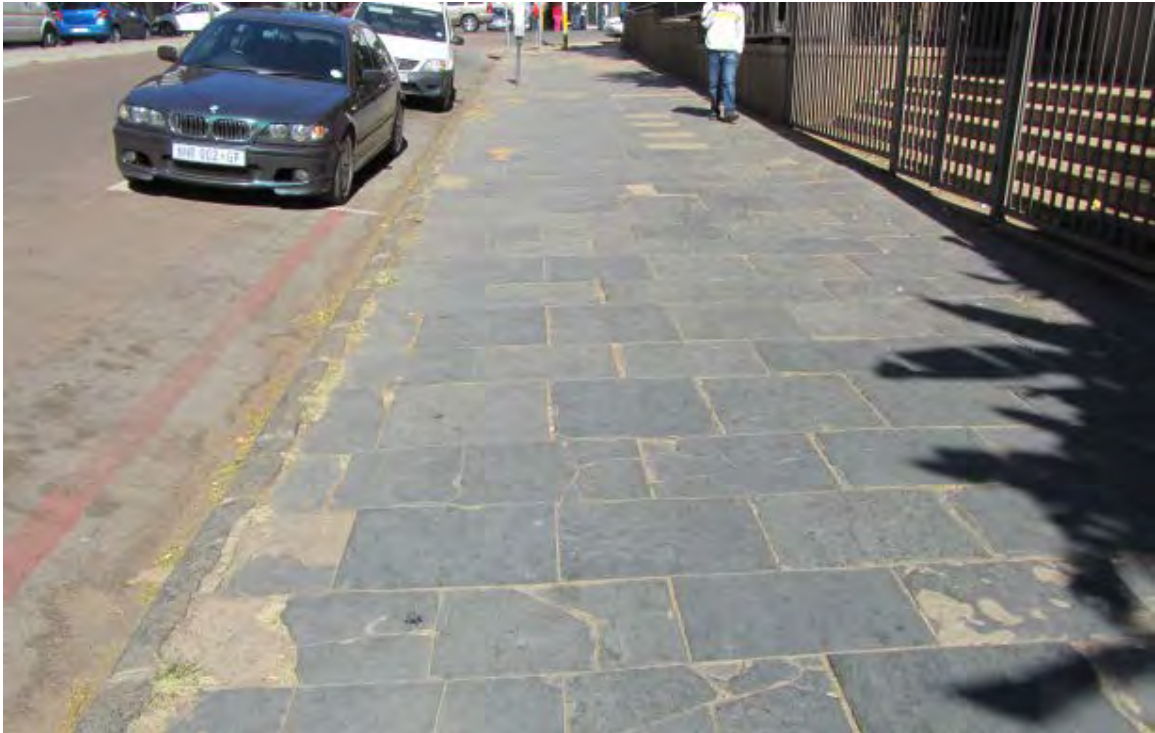
Fig. 153 Another view of the south-western part of Block 9 where most of the original slate flagstone paving blocks remain. As elsewhere in the study area the paving is in a poor state of repair. Note variation in the placement of different types of flagstones. (Photograph SM Miller 2012)

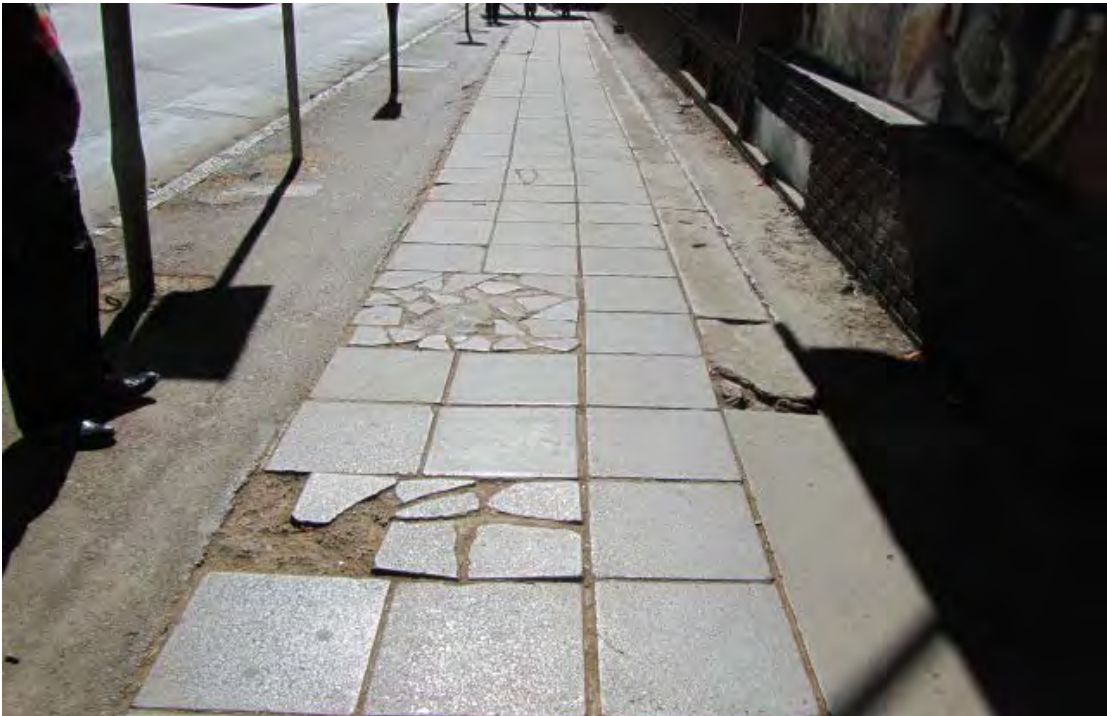
Fig. 154 On the eastern side of Block 9 only the granite kerb stones remain. All slate flagstones have been removed and replaced with modern materials. (Photograph SM Miller 2012)

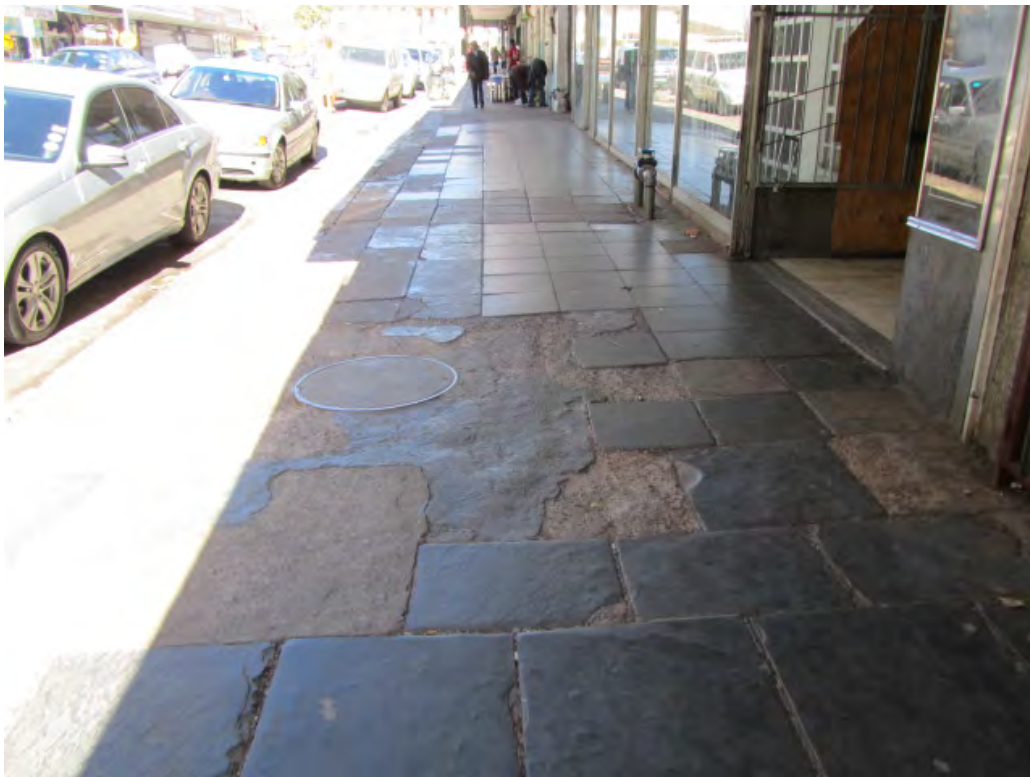
Fig. 164 Termination of the slate flagstone paving in the central western side of Block 10. Note the general condition of the modern paving. (Photograph SM Miller 2012)

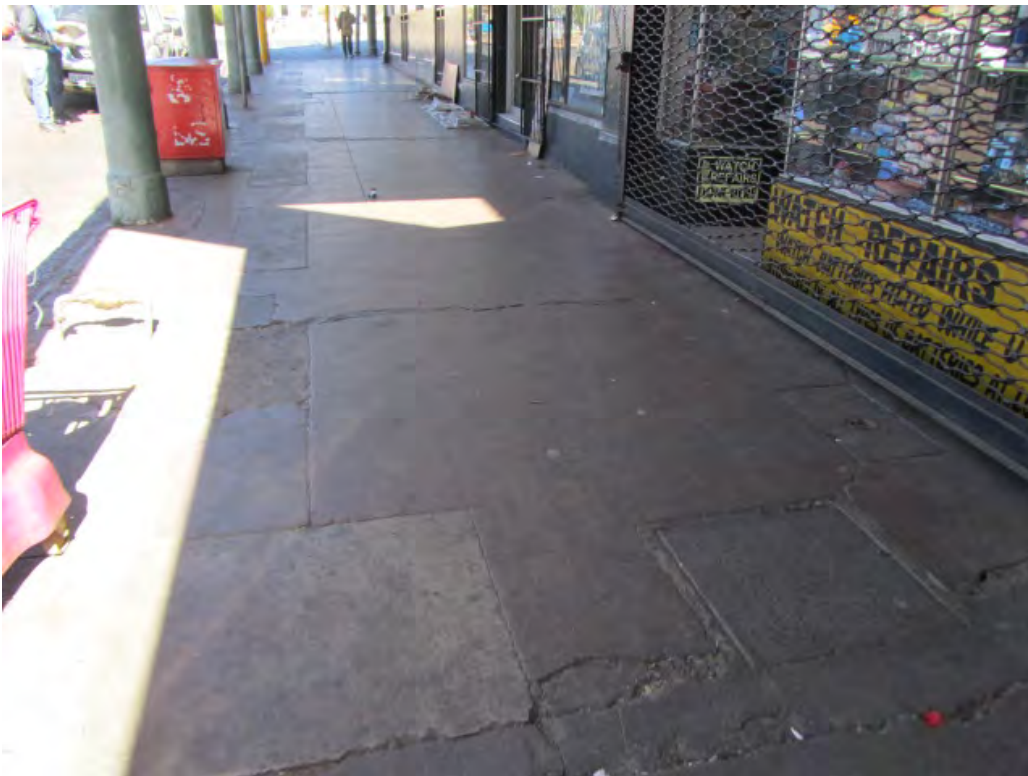
Fig. 166 Another view of the canopy support columns of the old Victoria Hotel. Note replacement of the slate flagstones with ferro-granolite concrete panels. (Photograph SM Miller 2012)
