**Bo-Kaap Erf 149971, 25 Pentz Street**

**Section 34 Application to Heritage Western Cape in terms of the National  
Heritage Resources Act**

**Report on Existing Housing Condition and Assessment of Recommended  
Work on City Owned House in Bo-Kaap.**

**Compiled by Dieter Bossow of Architects Associated for the City of Cape Town.  
April 2018.**

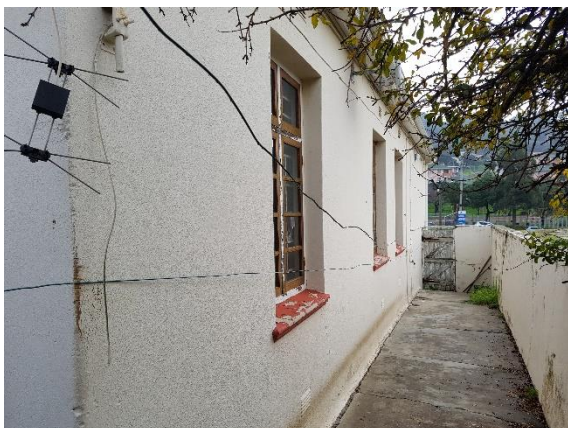
Side space east

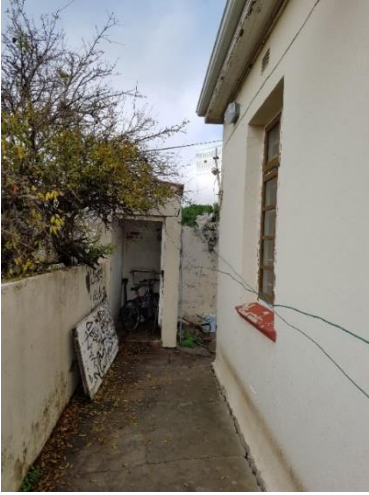
Side space east

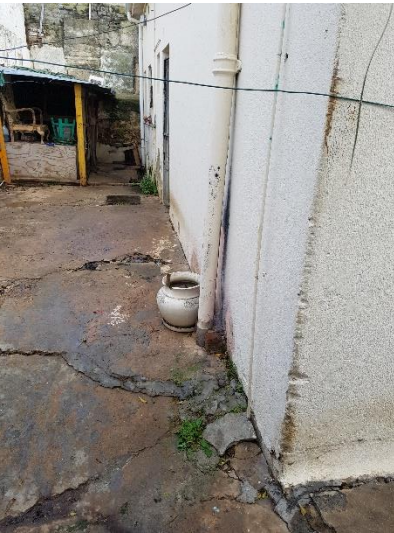
The yard has cement paving that is showing signs of cracking.

Courtyard paving

Repair cement screed where required.

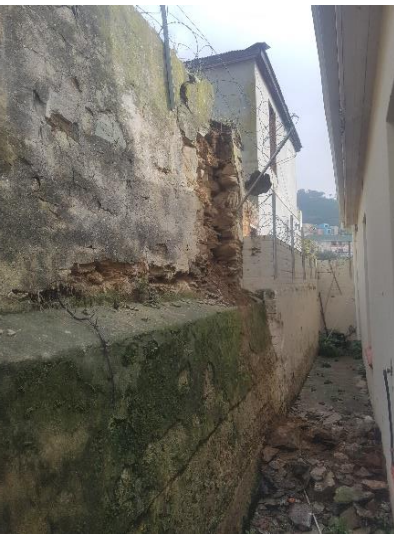
Plaster repair needs to be carried out to a portion of the common boundary wall on the south western side. Soft bricks are exposed and are crumbling into the side space of 149971

Side space west looking north

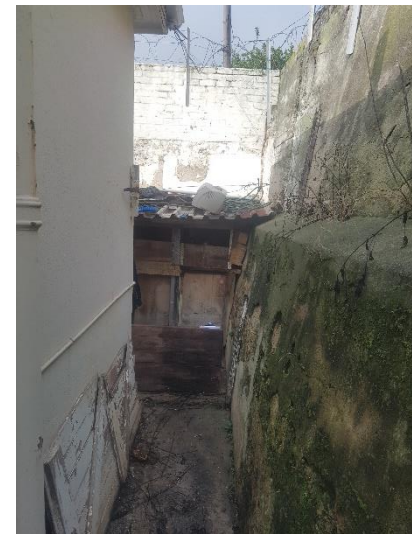
Side space west looking south
