**New Multi Product Pipeline
(NMPP) Project**

Final Heritage Audit

2684358-J-A00-AM-ST-004-12

June 2013

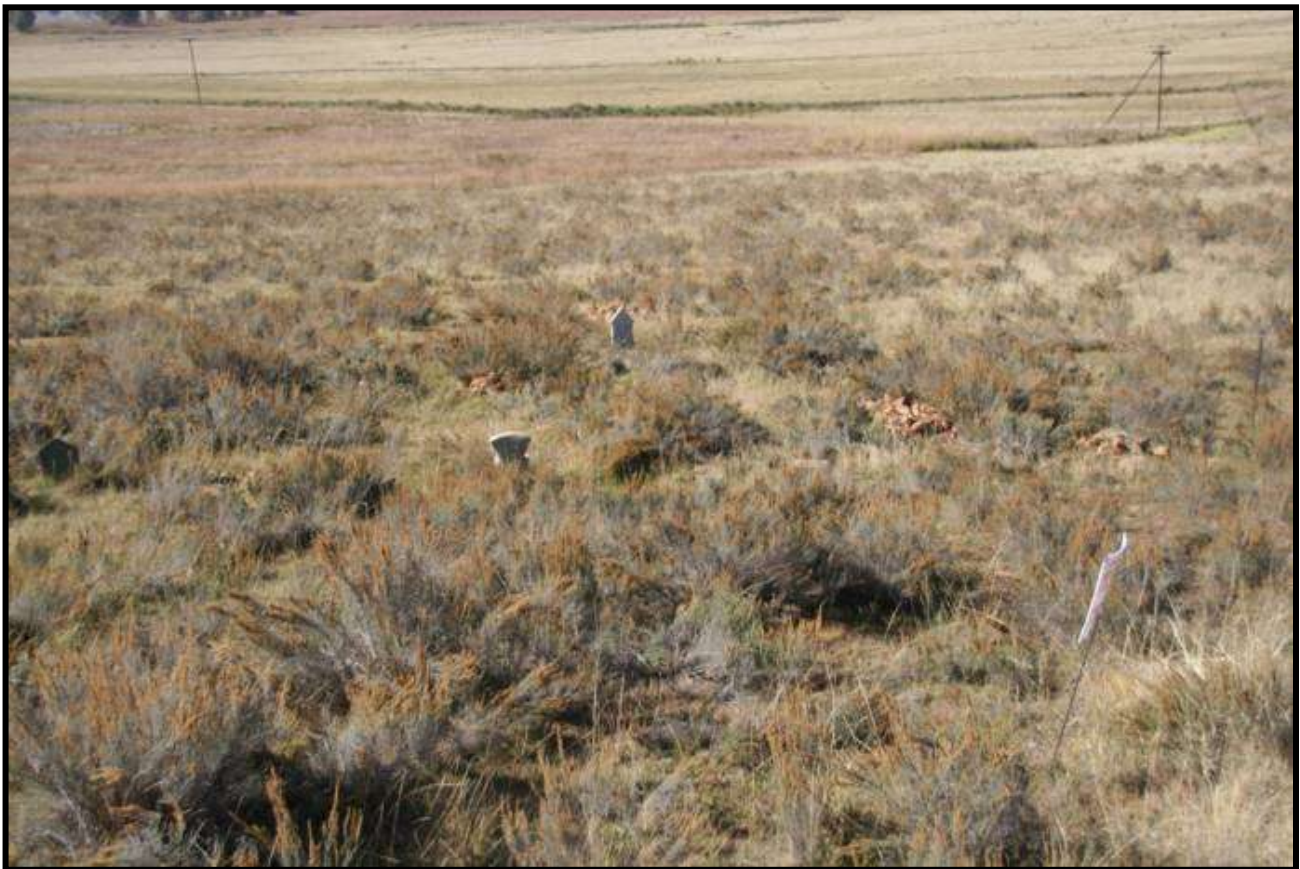
Fig. 2: Cemetery at 'Graves 1 - 2

The cemetery was noted by the ECO of the area before construction. The site consists of ~15 . graves that probably belong to farm labourers (Fig. 2). Some of the graves have headstones. The cemetery occurs just outside of the RoW. The site was fenced off and demarcated and not affected by construction.

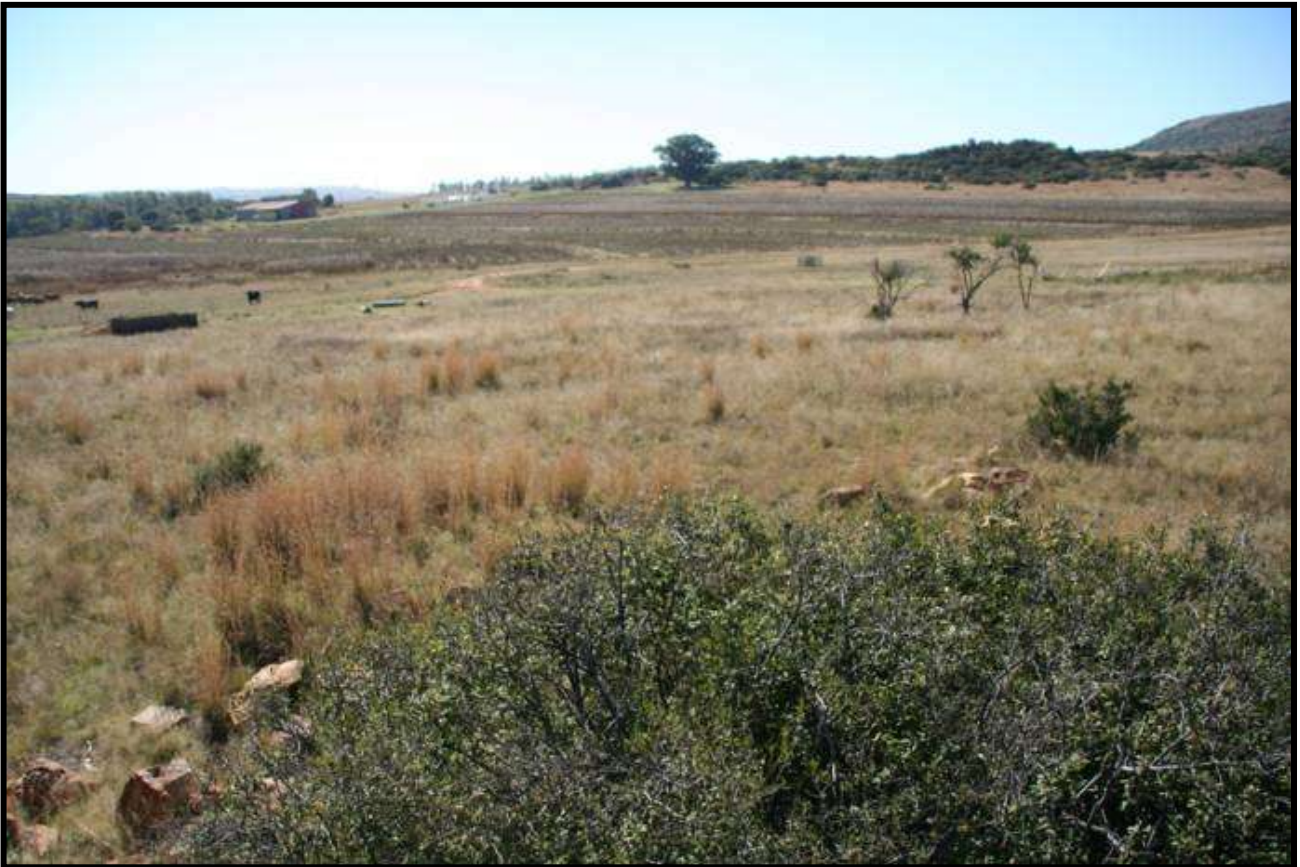
Fig. 3: GLK025 general view

GLK025 is located on the eastern side of a small rock outcrop. The site consists of the foundations of a house, stone walling for a kraal, and two cairns that could be human graves (fig. 3). The graves were demarcated before construction. The site occurs ~20m east of the RoW, and on the other side of the outcrop.

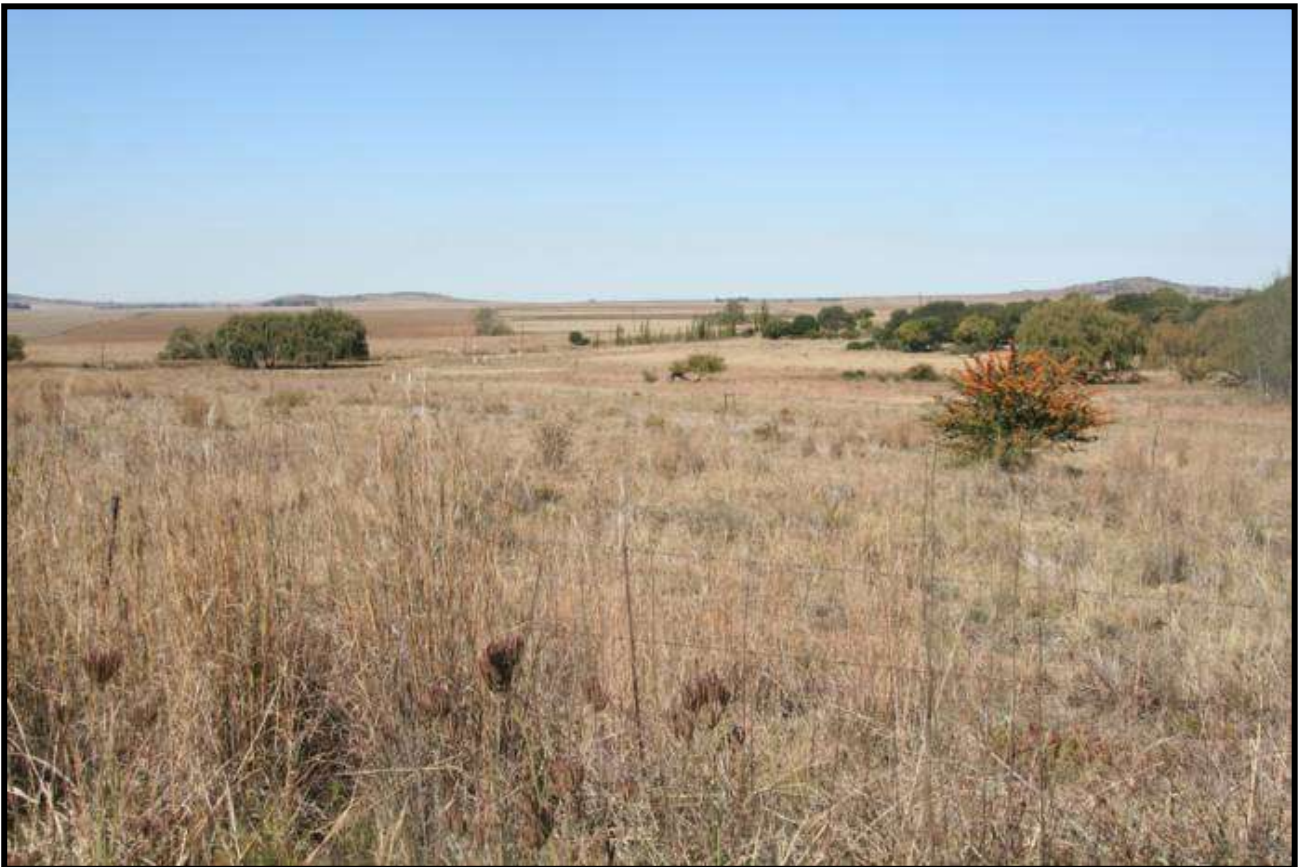
Fig. 43: View of battlefield and Herbstfontein

GLK055 consists of an historical cemetery and farm buildings, as well as a skirmish between British and Boer Forces in the 2ABW. This was called “The Battle of Herbstfontein”. Only the margins of the area of the skirmish area were affected by the RoW.

The Row was surveyed with a metal detector prior to construction (Fig. 4). No artefacts were noted during the survey. A permit was granted for this area to be destroyed.

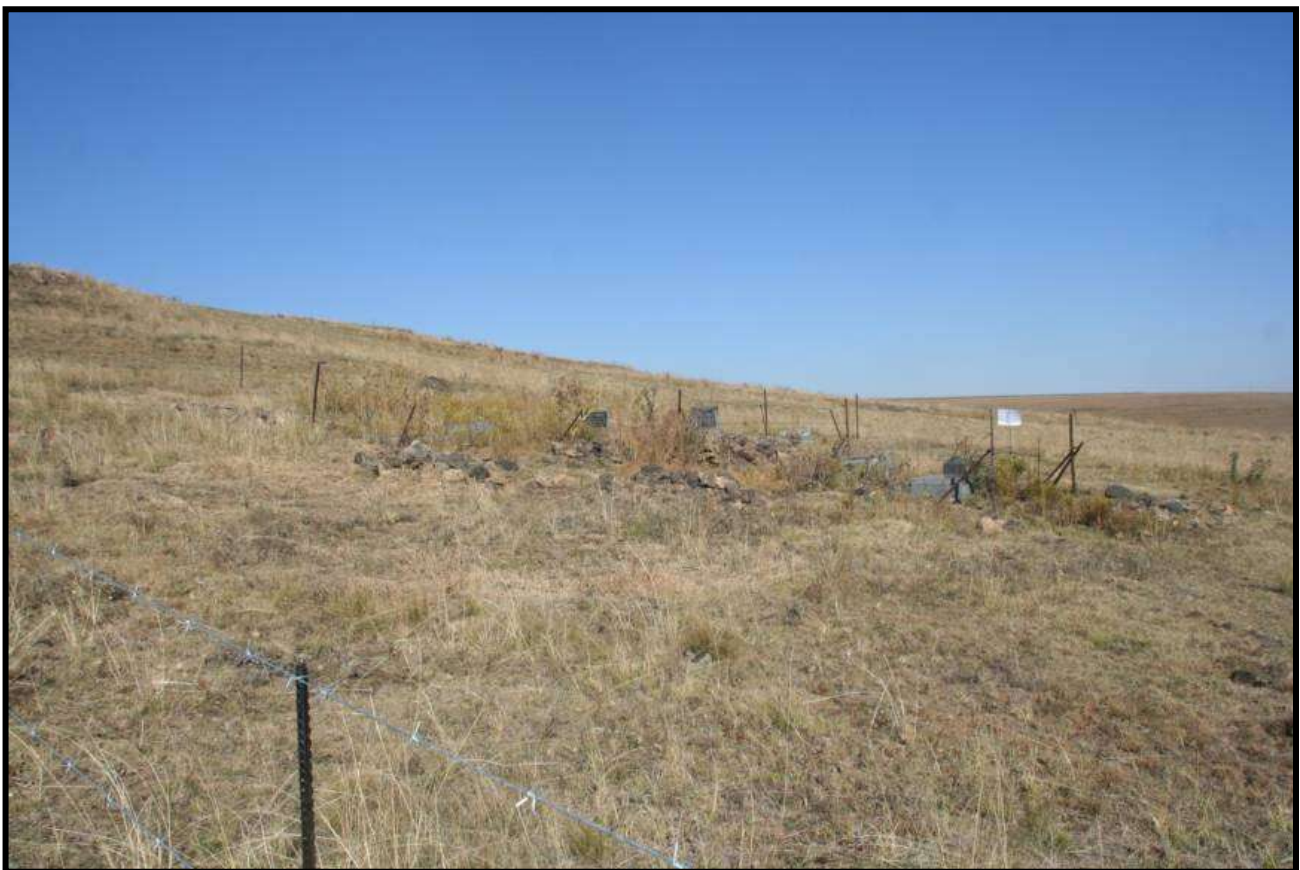
Fig. 5: Cemetery at GLK031

GLK031 consists of mud brick houses and a cemetery of ~20 graves. The site was recorded during the initial survey. The graves were fenced and demarcated before construction and have not been affected (Fig. 5)

Management: Fencing should remain in place. The fencing should remain so as to demarcate the graves in case maintenance people accidentally drive off the RoW and over the graves. NMPPP should however, not be responsible for the continual upkeep of the fencing as the fencing may be broken or stolen. Furthermore, any development within 50m of a grave needs to fence off a grave.

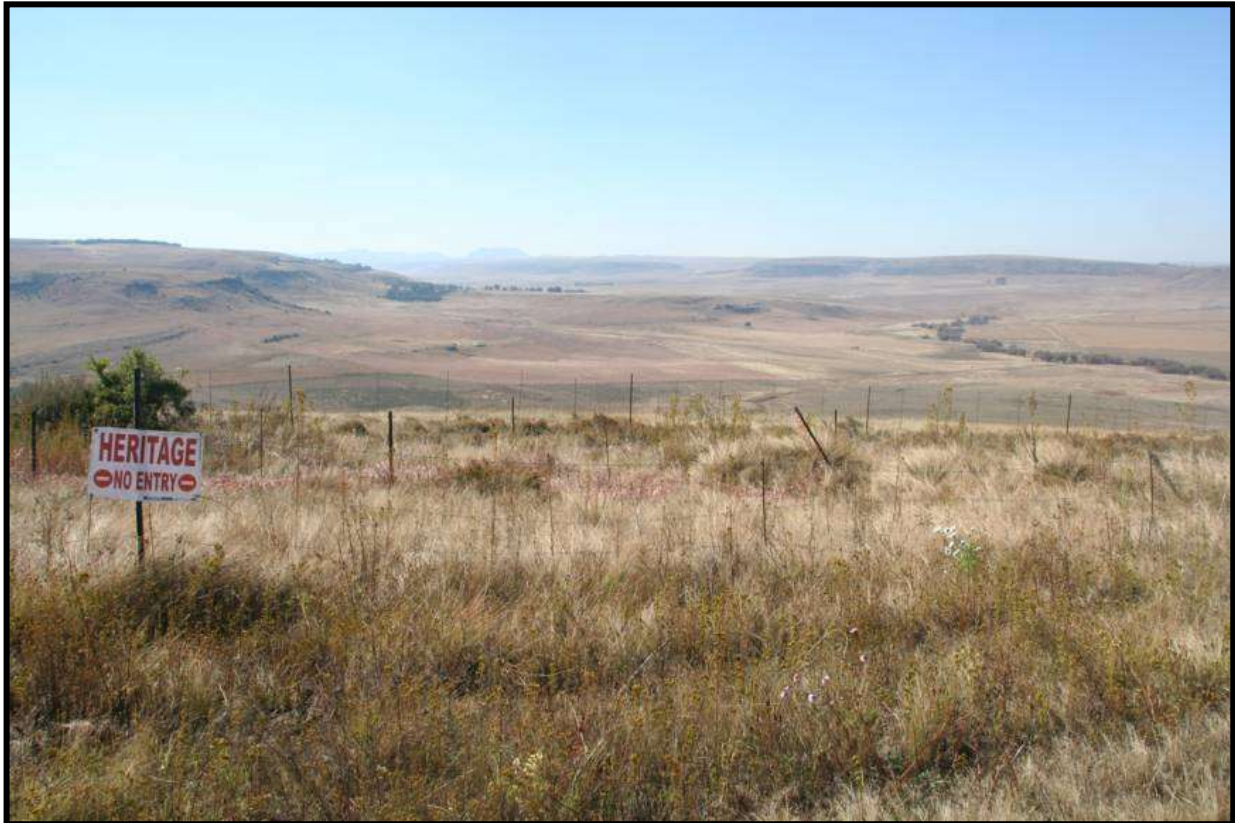
Fig. 6: Cemetery at KP370.600

This cemetery was discovered during construction. The stones used for the cairns had been affected by mechanical equipment, and the ECO had rebuilt some of the cairns. The matter had been reported to SAHRA Gauteng and a site meeting was undertaken. Thereupon a report regarding the damages was written by Umlando and submitted to SAHRA Gauteng. Umlando and Transnet requested a response from SAHRA on several occasions and have never received one. Umlando and NMPPP consider the matter closed due to the lack of response. The cemetery is currently fenced (Fig. 6).

Management: Fencing should remain

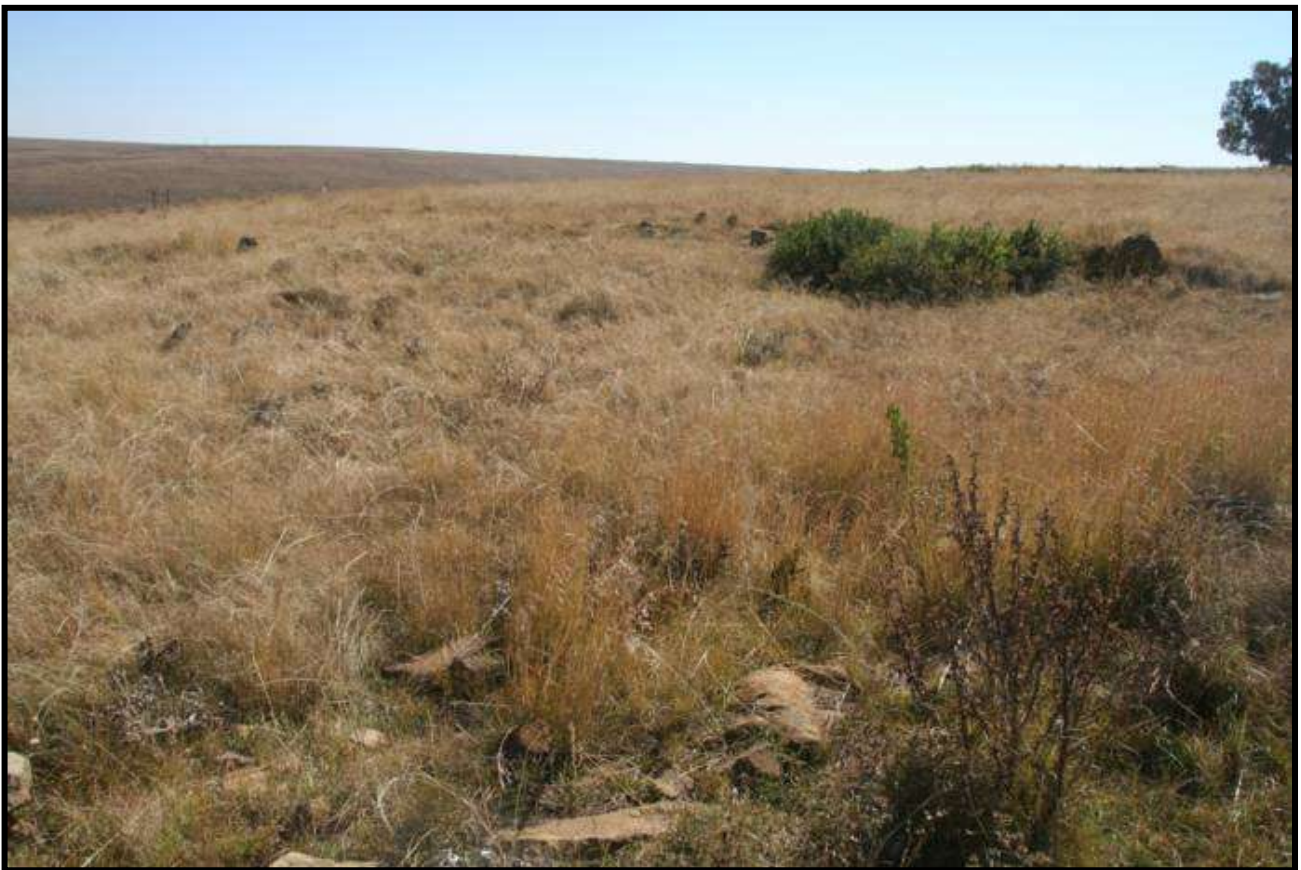
Fig. 6: Stone Kraal at GLK035a

This site was recorded during the initial survey. The site is a large square kraal with the foundation stones remaining (Fig. 6).

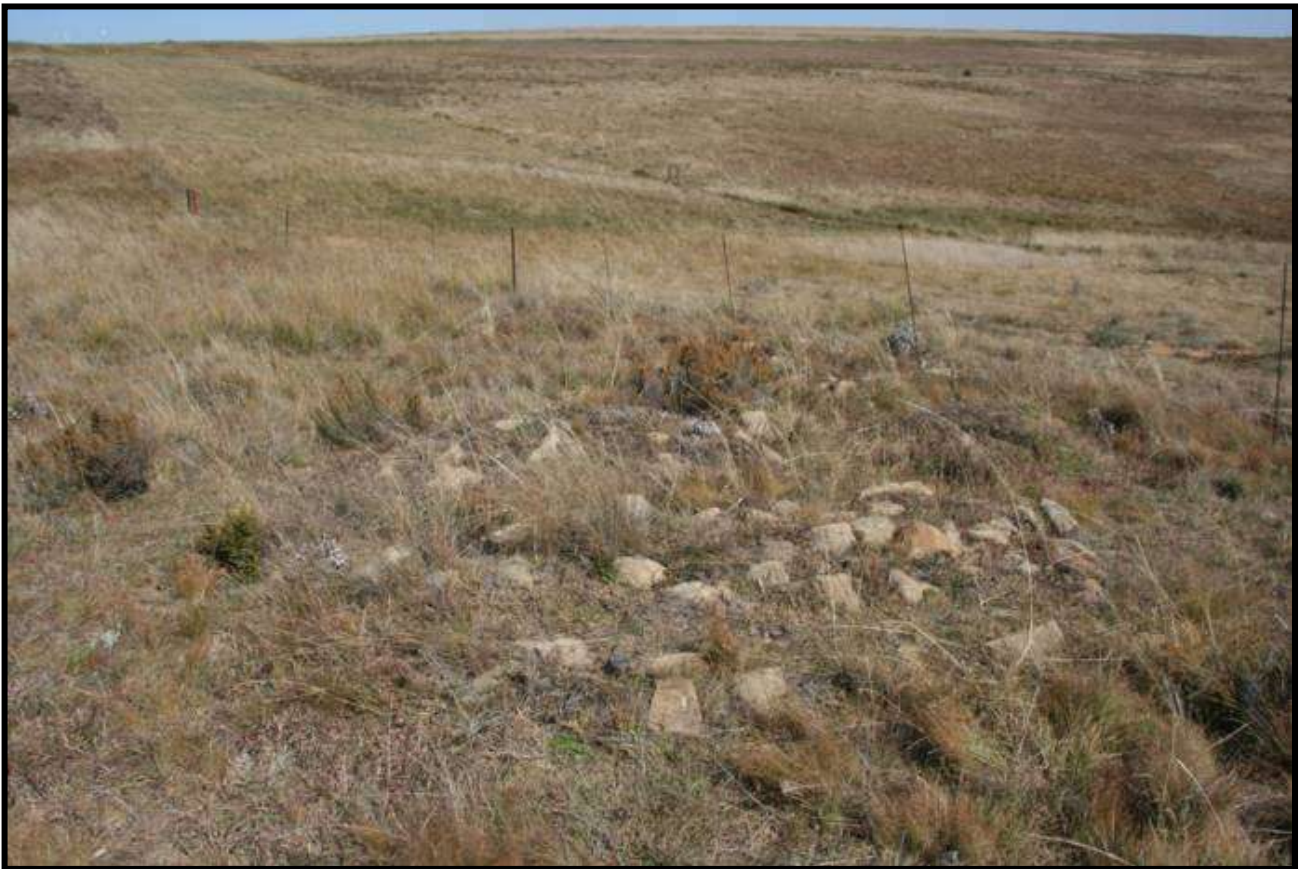
Fig. 7: Graves at KP344.34

KP344.34 is a group of three graves at the edge of the RoW (fig. 7). It was recorded by the ECOs. Two of the graves are outside of the RoW, while one grave occurs inside the RoW. The graves were fenced off and demarcated during construction; however now the demarcations are missing..

Management: The fencing should be replaced, and include the parts of the grave in the RoW. The RoW fencing should be realigned so as not to be within 5m of the graves.

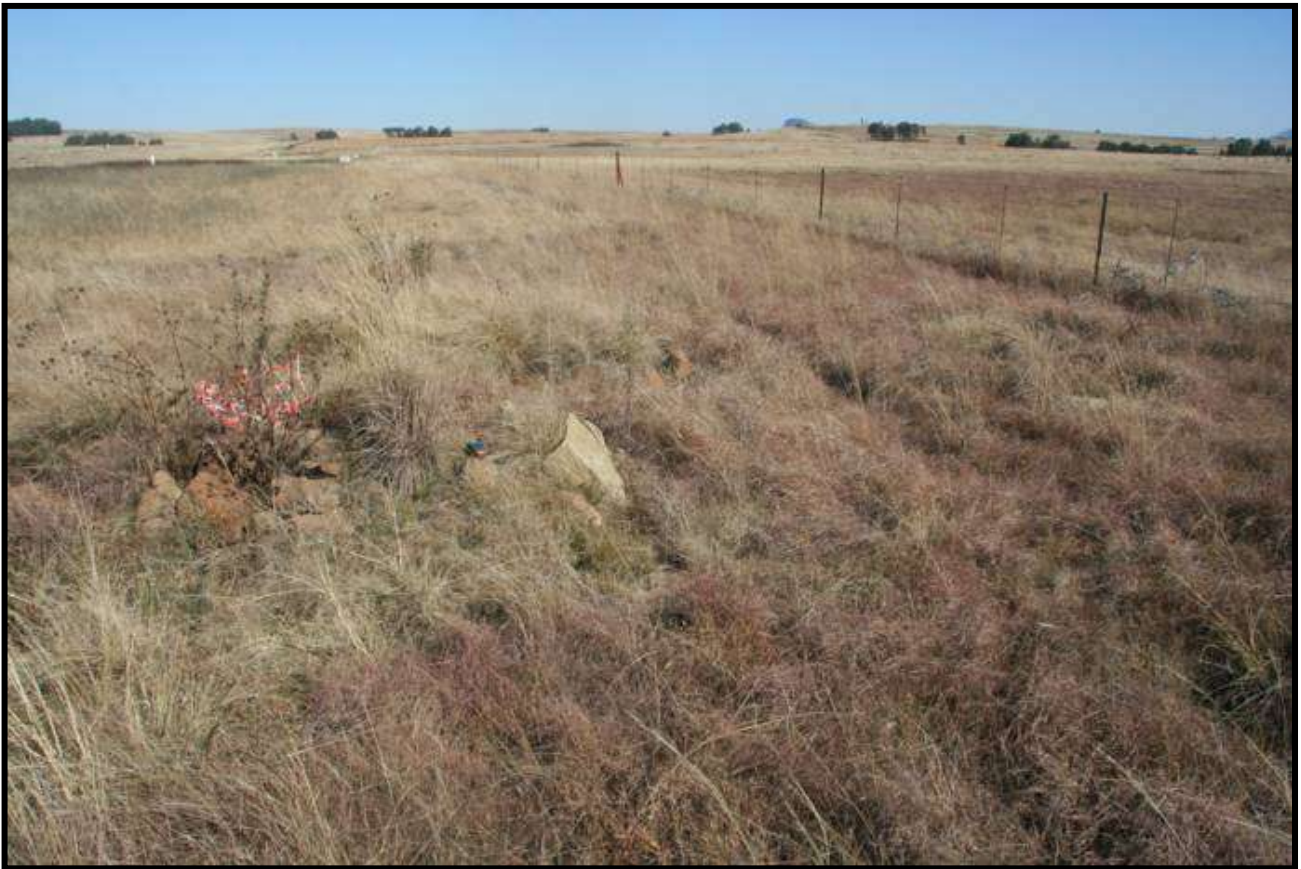
Fig. 8: Grave at KP304.010

This site occurs on the top of the hill and was recorded by the ECO. There were initially two GPS readings for the graves suggesting that there were two sets of graves. However, there is only one set of graves. The graves occur in the RoW. The graves were fenced off and demarcated before construction. The graves were not damaged (Fig. 8).

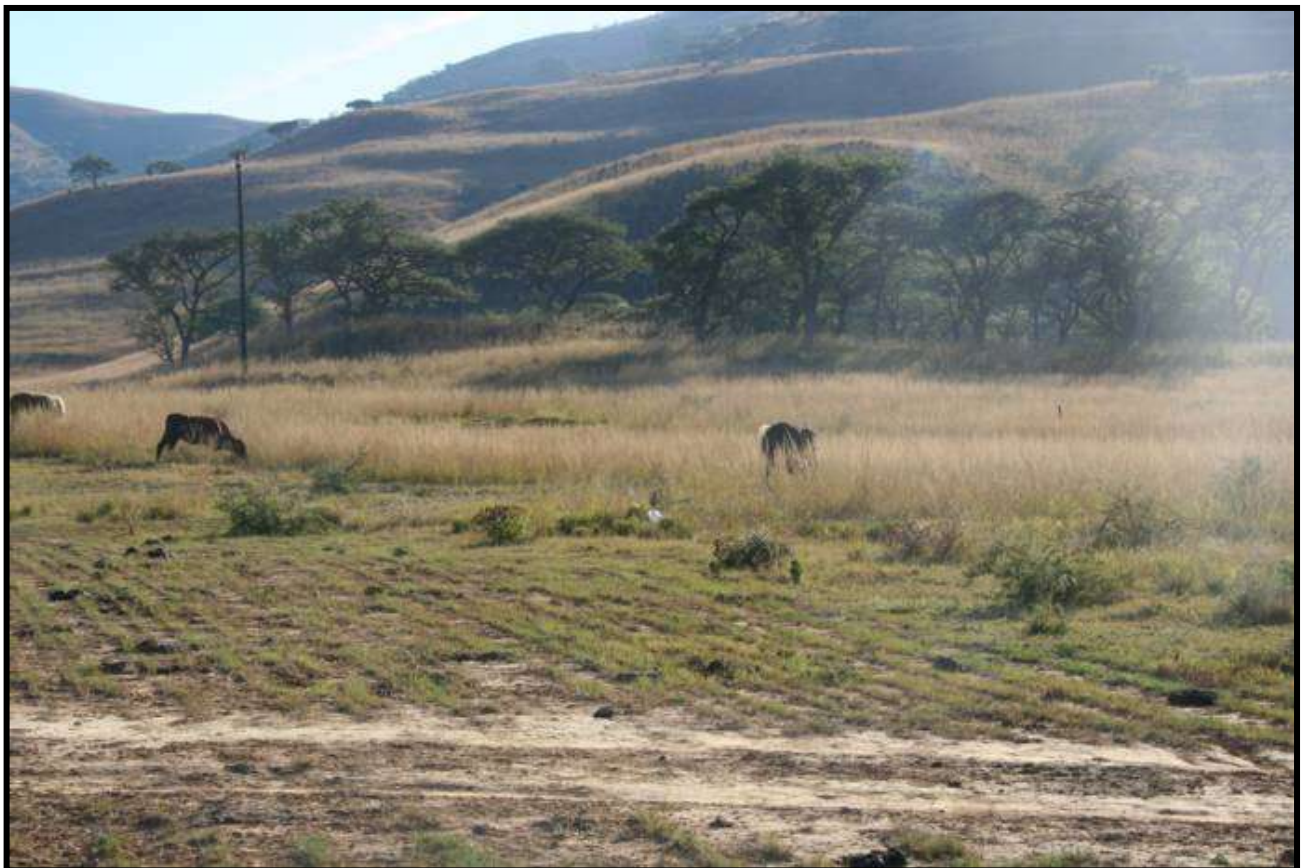
Fig. 9: Rehabilitated are near A01

A01 was a small stone circle filled with stones approximately 1.5m in diameter. The feature was probably a granary floor (fig. 9).

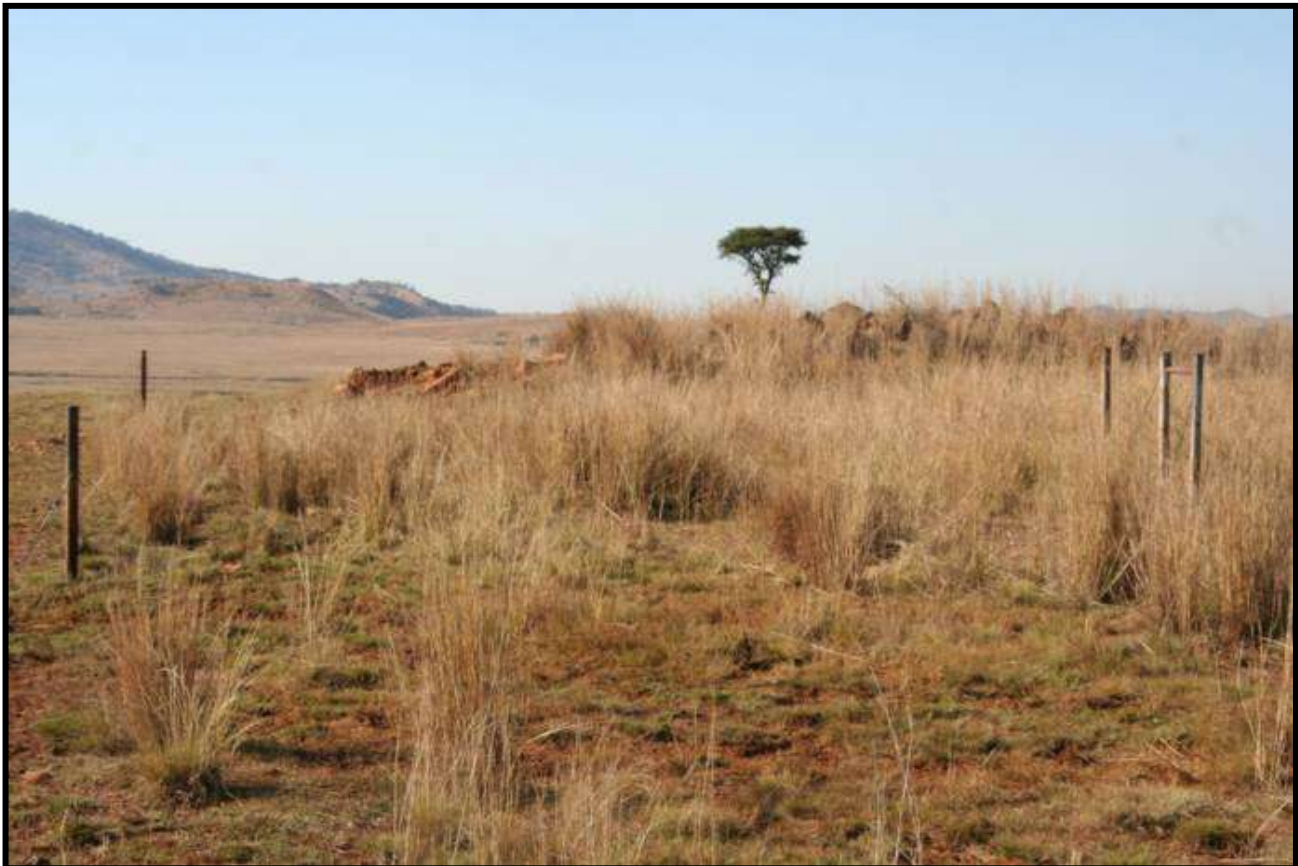
Fig. 10: Grave at KP274.08

The graves at GLK063a (KP274.08) were recorded during the initial survey. They graves were fenced off and demarcated before RoW clearance, and monitored during construction (fig. 10).

These graves were not damaged.

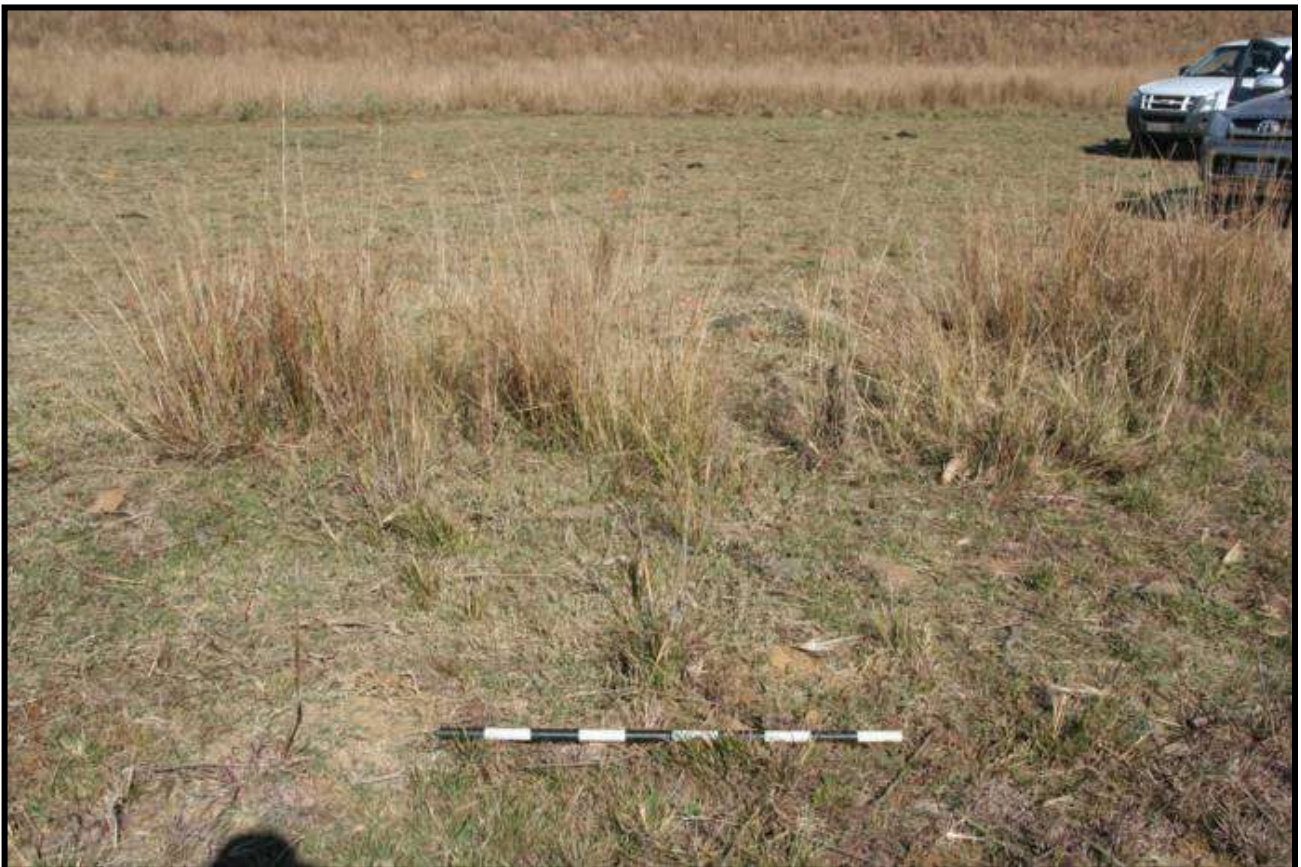
Fig. 11: Grave #564 at GLK063a

The graves at GLK063a (feature 564) were recorded during the initial survey (fig. 11). They were fenced off and demarcated before RoW clearance, and monitored during RoW clearance.

These graves were not damaged.

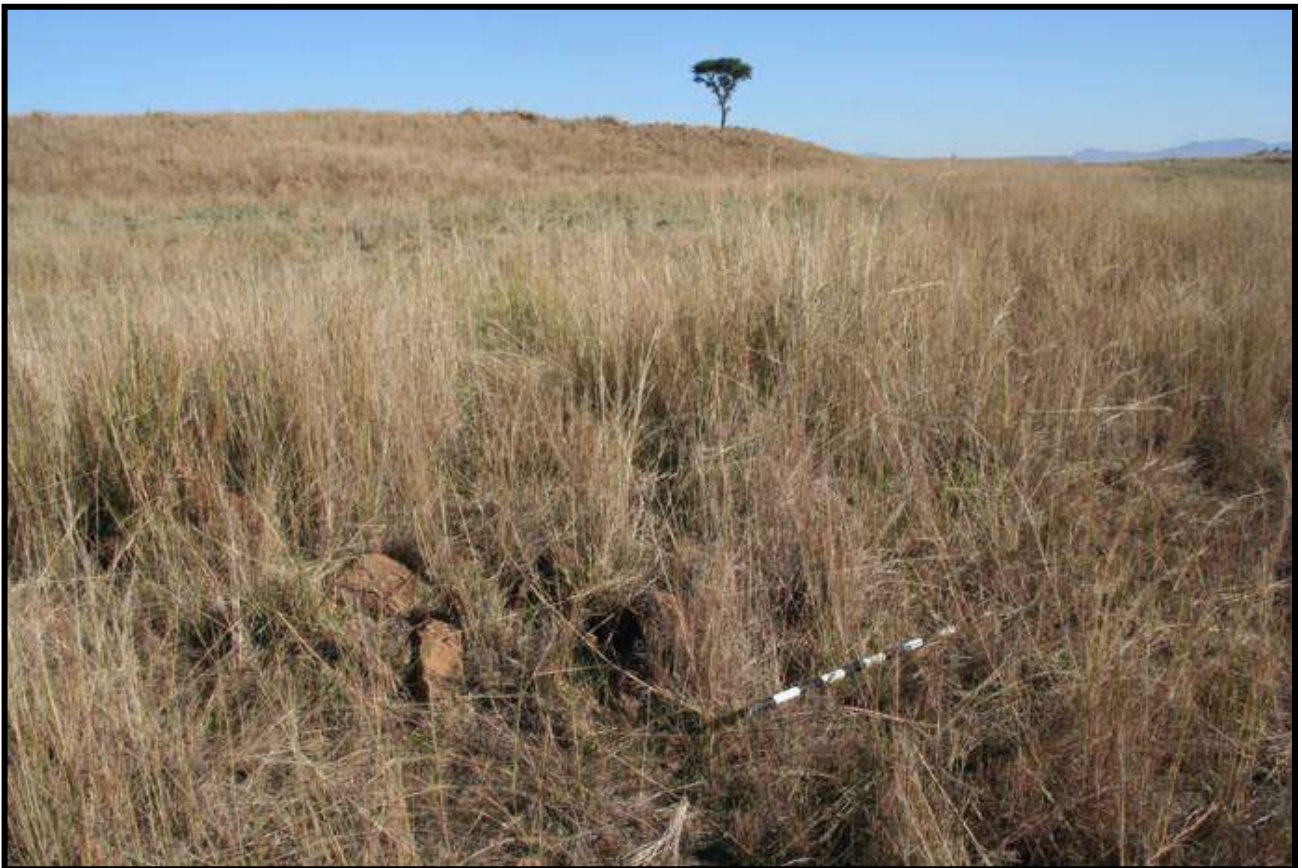
Fig. 12: GLK063a – Grave KP273.75

The Graves #031a at GLK063a (KP273.75) were recorded during the initial survey. They graves were fenced off and demarcated before RoW clearance, and monitored during Row clearance. (fig. 12)

During construction the graves were covered with bedrock. The heritage specialist and the projects Environmental Manager arrived on-site as the machinery was about to demolish the graves. The area was cordoned off, and the bedrock material was removed from the area. The graves were exposed and cleaned up. These graves were affected, but not damaged.

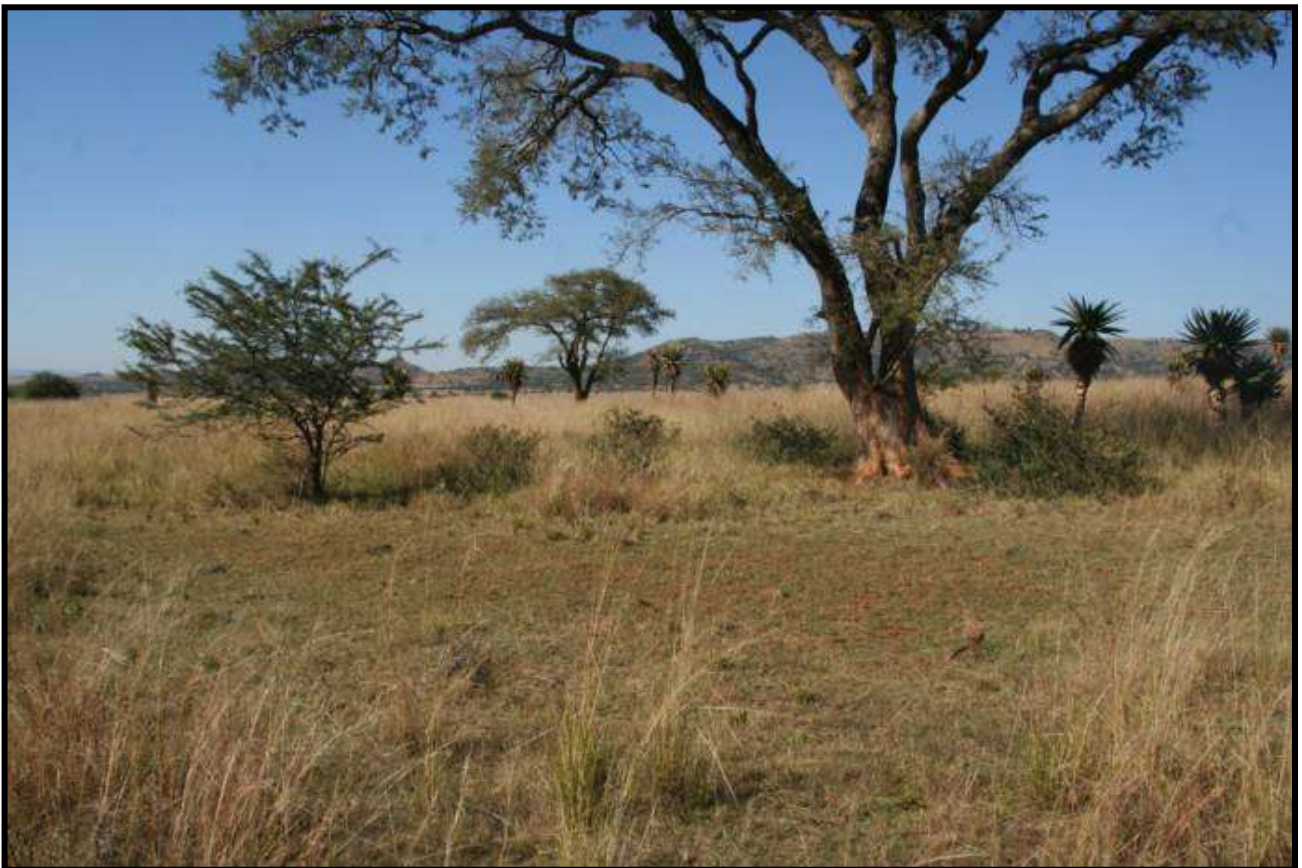
Fig. 13: GLK066 – Feature 572

GLK066 was recorded in the initial survey. The site is the remains of a LIA village with several stone walled features and graves. All the features within the RoW were recorded and systematic excavations were undertaken at the site. All features outside of the RoW were not fenced off. The contractor had widened one section at the site and subsequently demolished two graves (fig. 13). Subsequent excavations could not locate the features, apart from the southern part of the stone walling.

The damaged features at this site, and other sites, were reported to Amafa KZN, and a site visit was undertaken. A report detailing the damage was submitted to Amafa KZN. Amafa KZN has decided not to press charges. The damages to the various sites are in the main heritage report (UmlandoHIA_NMPP_2684358-UM-PL1- ENV-RP-004)

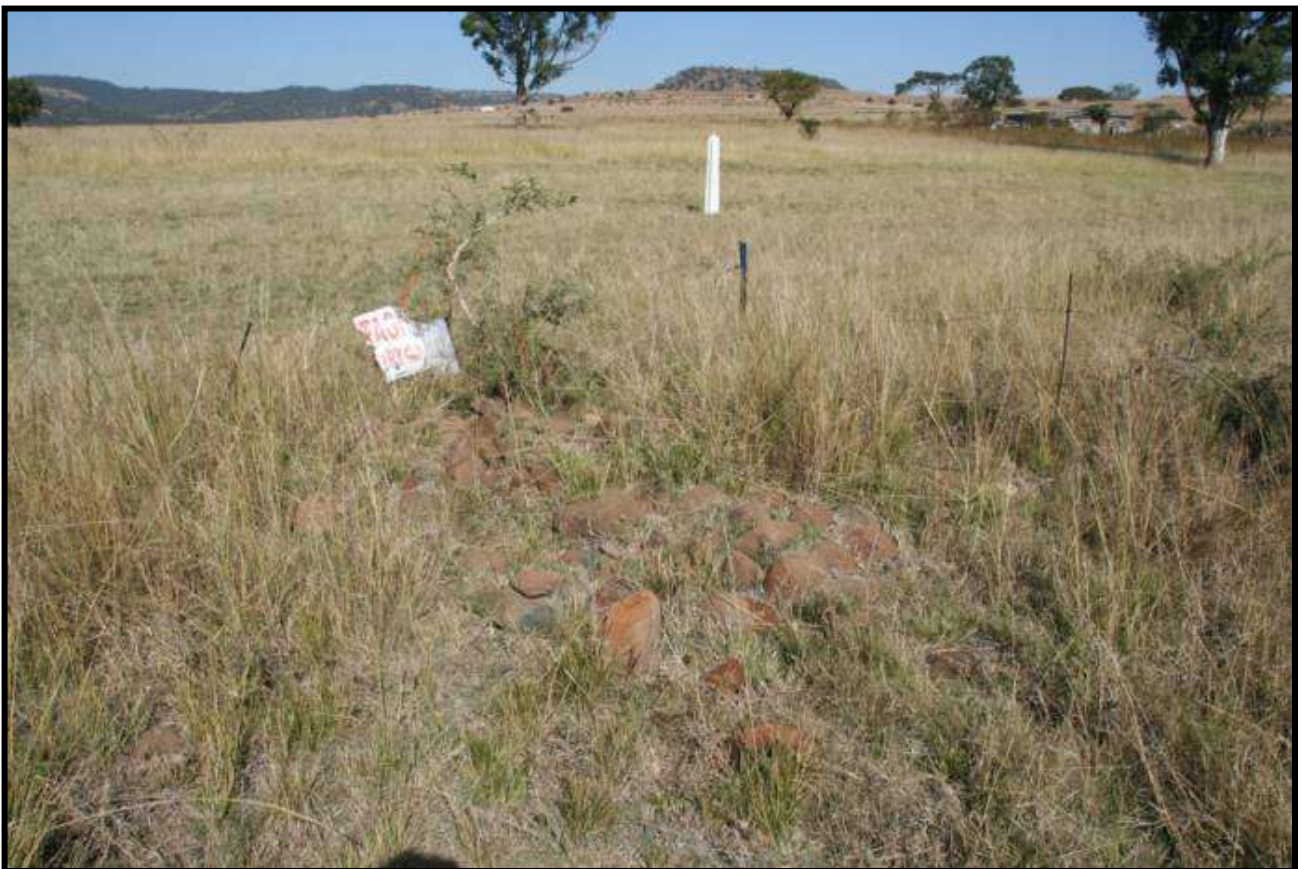
Fig. 14: Graves at GLK118A

The site was recorded during the initial surveys. The site consists of two graves and stone walling (fig. 14). The graves were demarcated before RoW clearance and monitored during RoW clearance. During construction, the bedrock was placed partially over the graves. The graves were cleaned up and did not have any damage to them.

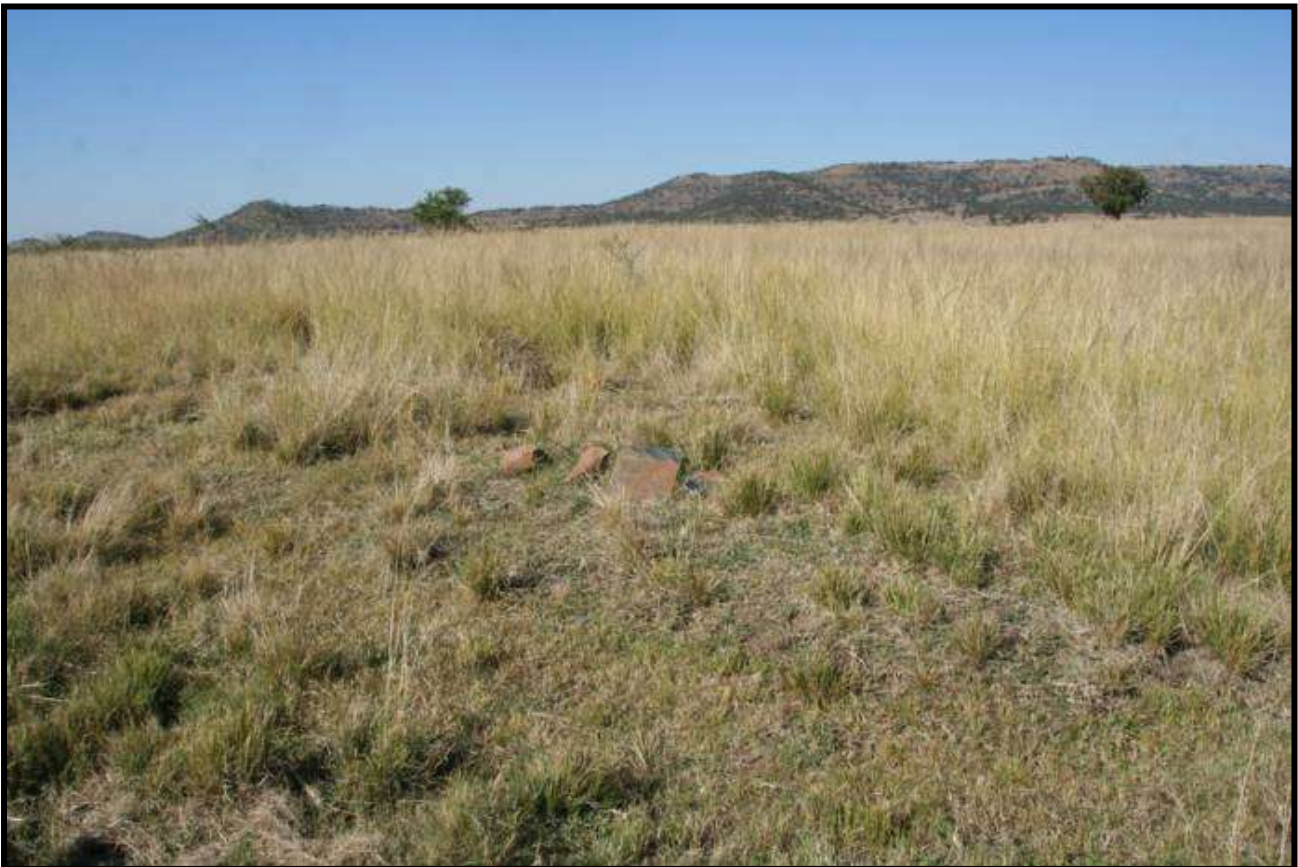
Fig. 15: Graves at GLK118

The site was recorded during the initial surveys. The site consists of two possible graves and stone walling (fig. 15). The graves were demarcated before RoW clearance and monitored during RoW clearance.

During construction the bedrock was placed partially over the graves. The graves were cleaned up and did not have any damage to them.

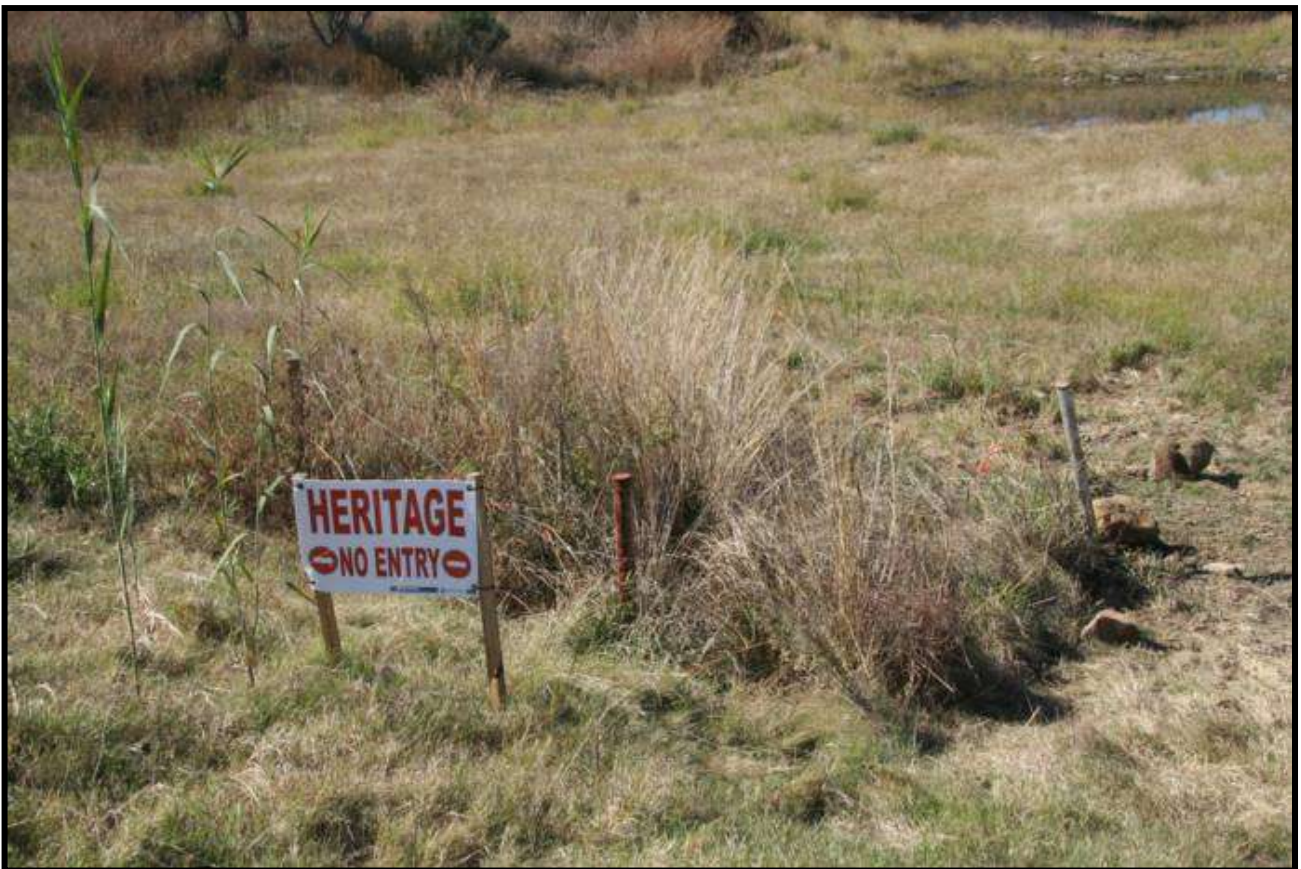
Fig. 16: Possible Graves at 'N3'

These possible graves were noted by the ECO during pre-construction. Two cairns were the appropriate sizes for graves and were deemed as such by the heritage specialist (fig. 16). The graves were fenced off and demarcated before RoW clearance as a precautionary measure. The graves were partially damaged during construction as bedrock had been placed over the graves.

The grave area was cleaned following the placing of bedrock, and the possible locations of the graves were noted. New cairns were placed in the demarcated area.

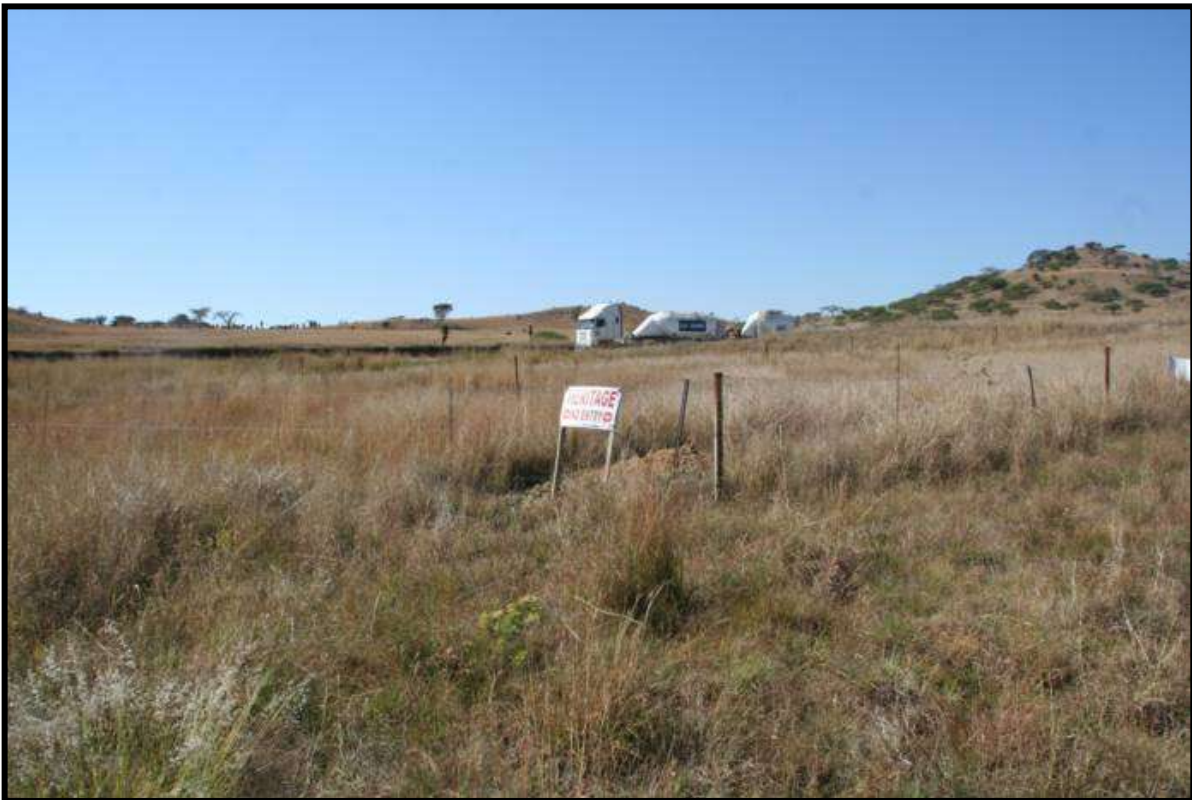
Fig. 17: Walling at GLK125

GLK125 was located during the initial surveys. The main part of the site consists of a low circular stone wall dating to the LIA. The walling was demarcated before RoW clearance and the site monitored (fig. 17).

No damage has occurred to the walling.

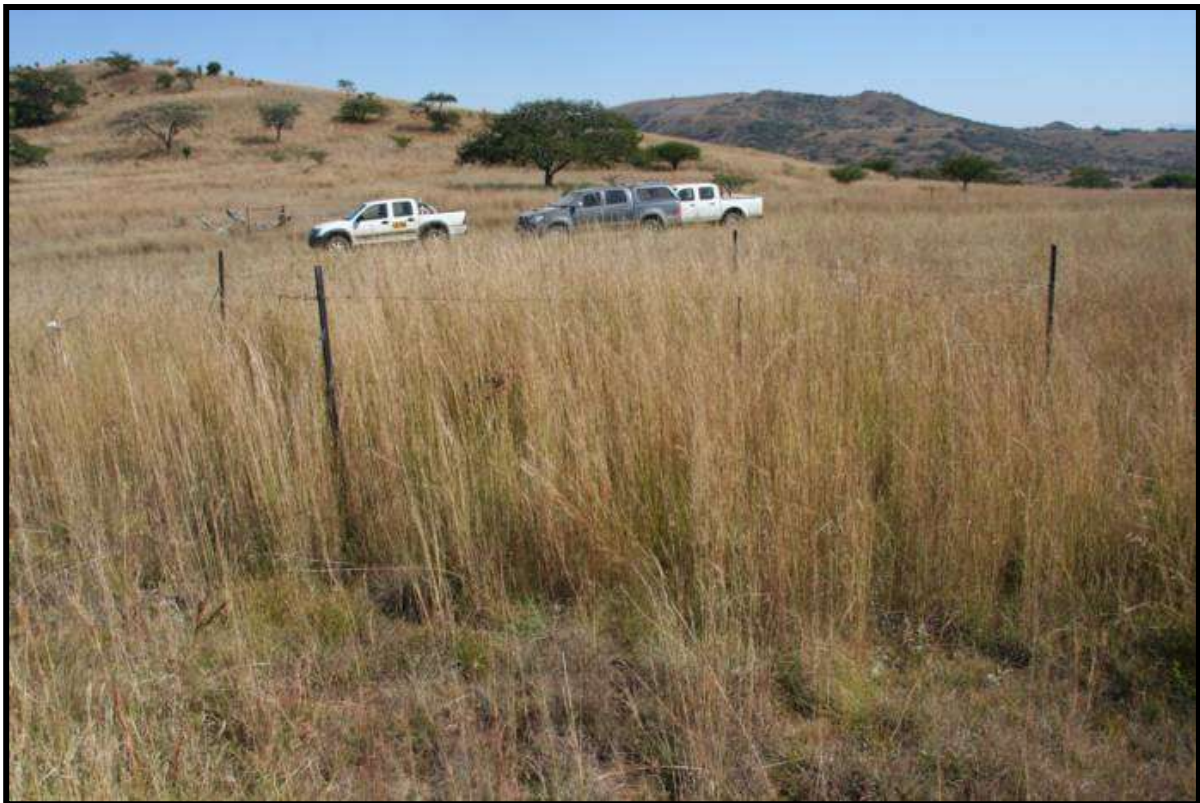
Fig. 18: Stone Walling at GLK122a

GLK122a was recorded during the initial surveys. The site was systematically mapped and excavated before RoW clearance. A permit for the destruction of the site was obtained. One stone wall was demarcated and fenced off (fig. 18). It was not damaged during construction.
