**New Multi Product Pipeline
(NMPP) Project**

Final Heritage Audit

2684358-J-A00-AM-ST-004-12

June 2013

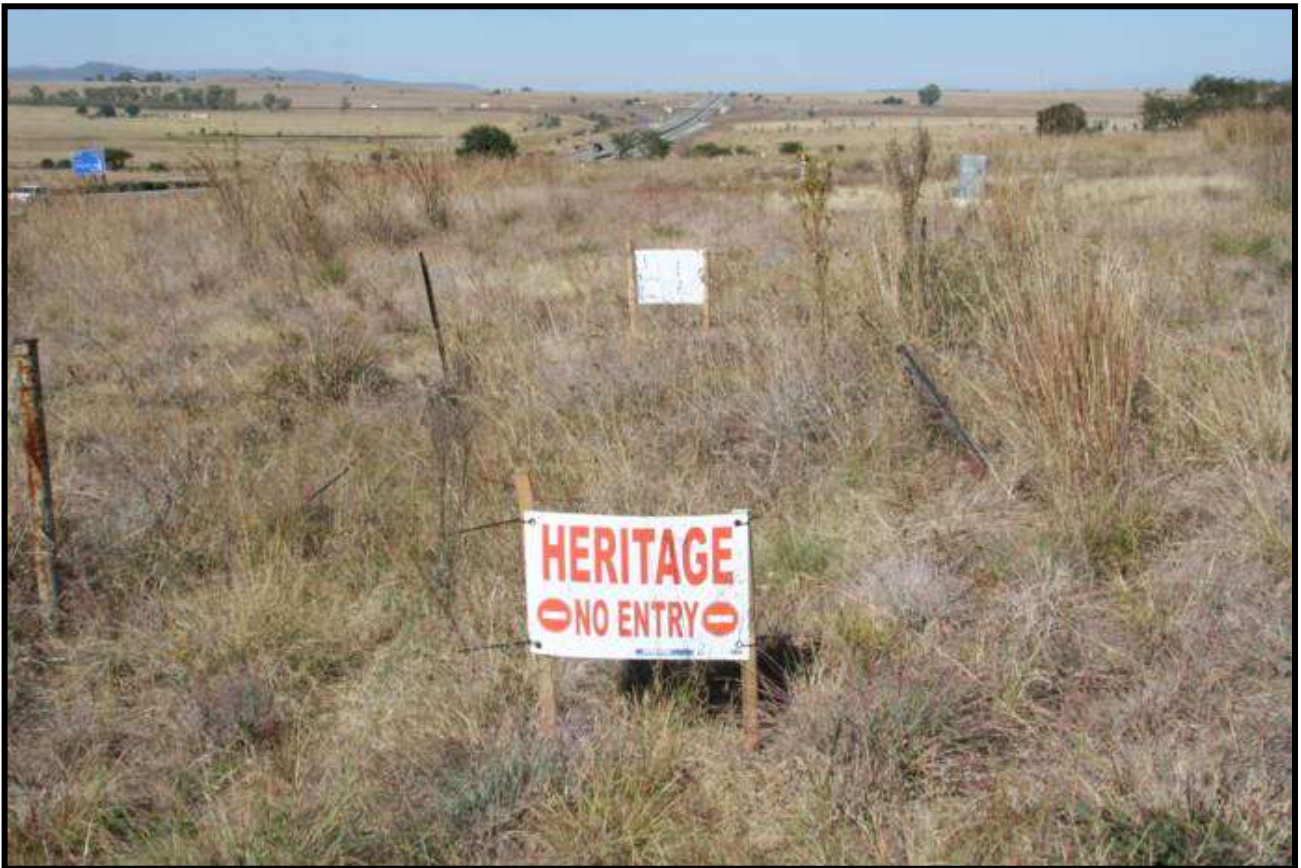
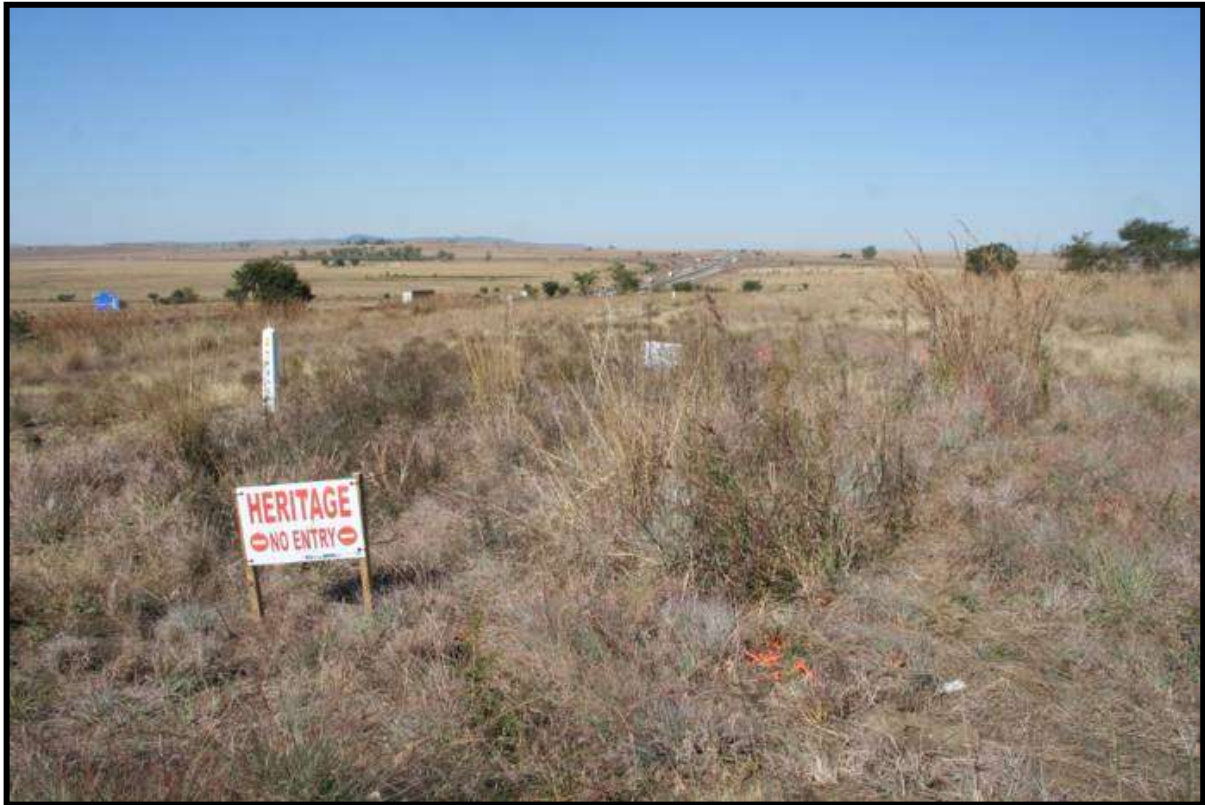
The two graves were demolished/removed during construction (fig. 20 – 21). The kraal was not damaged (fig. 22).

Fig. 20: GLK122c – Feature 578

Fig. 21: GLK122c – Feature 337

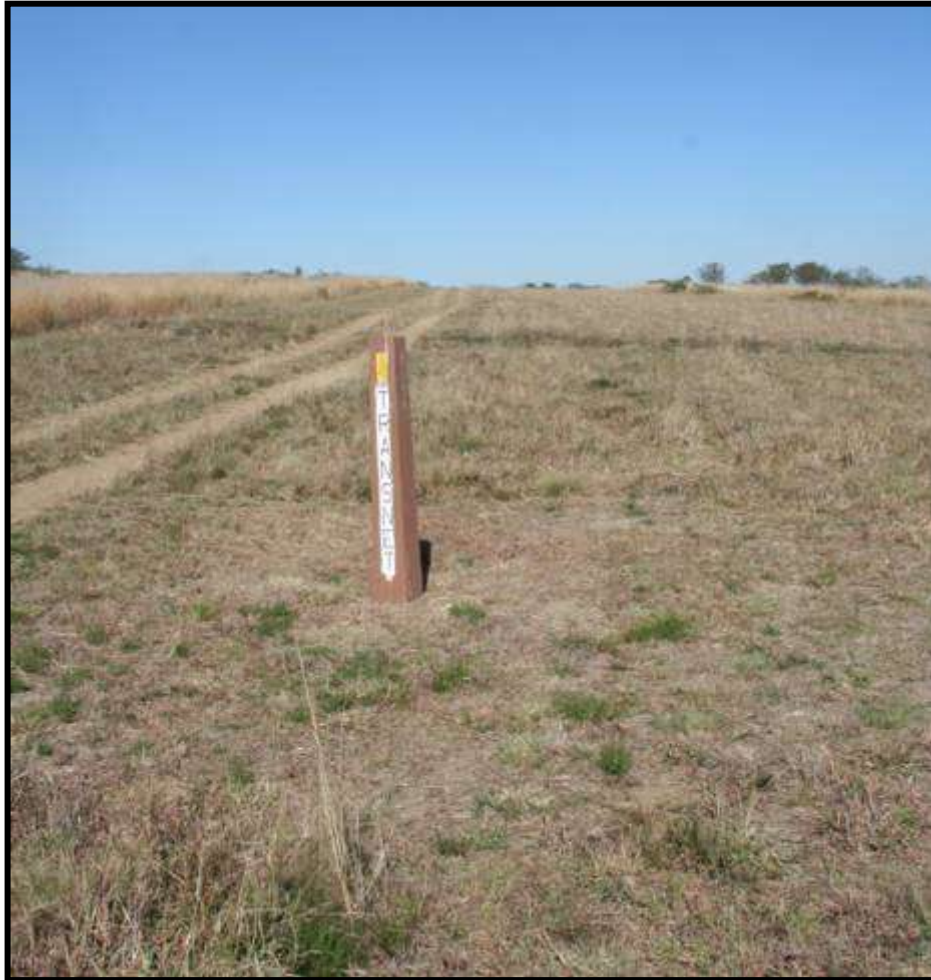
Fig. 23: Vaalkrans Battlefield

The mitigation along the Vaalkrans Battlefield was completed via metal detector surveys and fencing sensitive areas. The overall status for this area is good (or '0'). The pipeline marker posts have been painted in a non-intrusive manner so as to blend with the landscape and not be confused with cairns and other features on Battlefields that are painted white.(fig. 23)

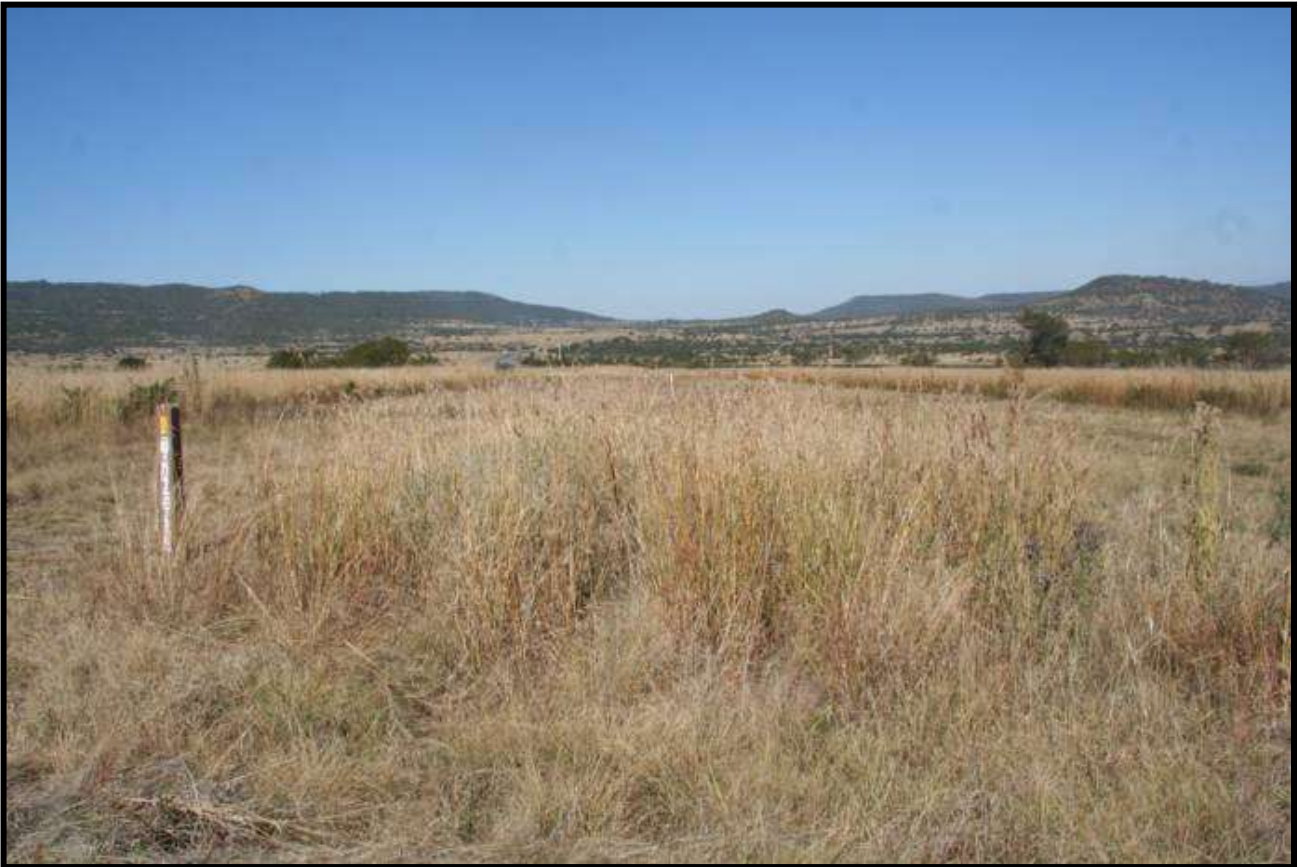
Fig. 25: Grave at VAL47

The grave at VAL47 was fenced and demarcated before RoW clearance and the pipeline was realigned accordingly. The grave was nearly affected during construction; however, mitigation resulted in the grave being missed (fig. 25).

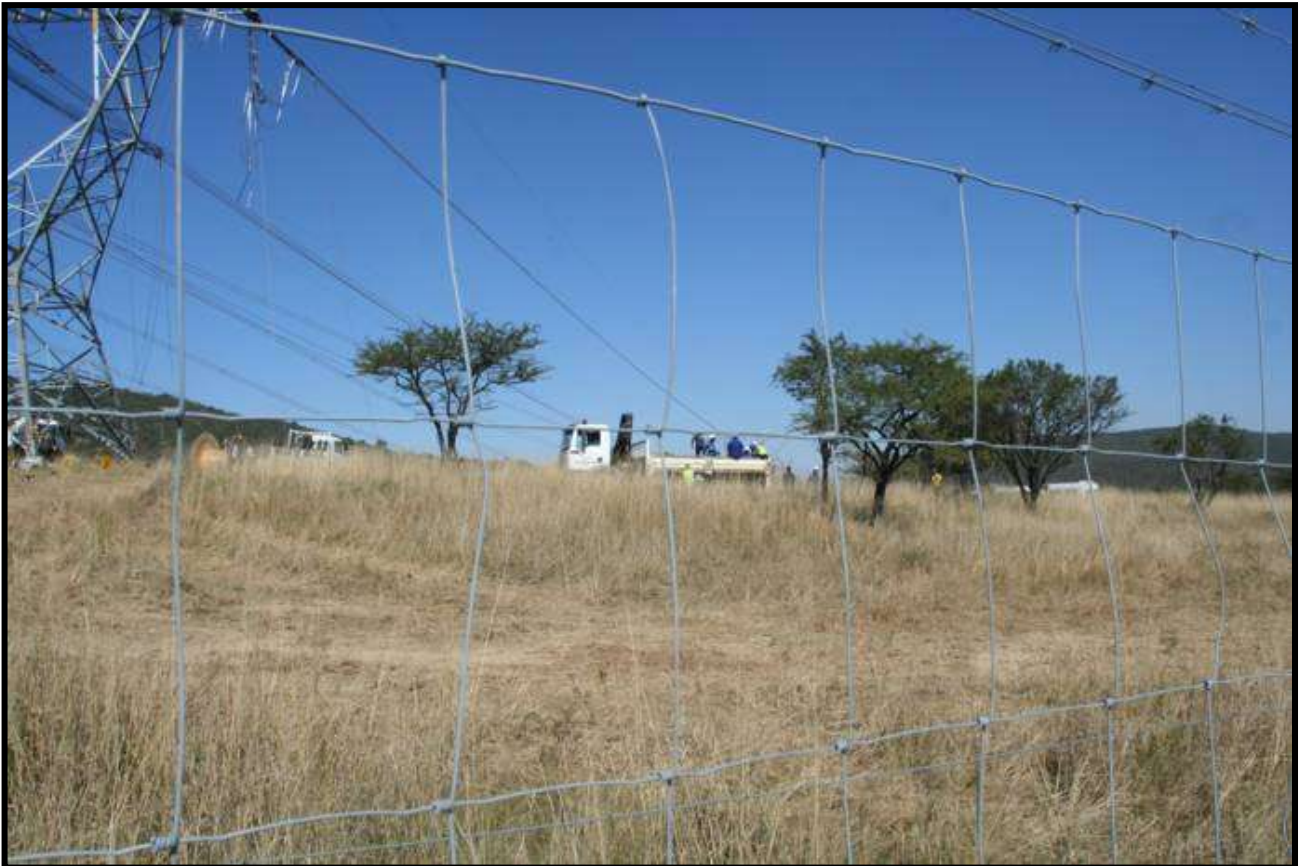
Fig. 28: Kraals at GLK075 K2

GLK075 K2 – K9 are a series of LIA and HP settlements. Only the stone walled kraals are visible. There are some fossils on the lower slopes of the hill. None of these kraals occurred within the RoW, and the NMPPP construction did not damage any of these features.

Subsequent to the NMPPP project, an electrical transmission line was placed between these kraals (fig. 28). Umlando did not assess if this had damaged any of the kraals as it was not part of the scope of work. There was no visible mitigation or demarcation of the sites for the transmission line conducted by Eskom during the construction of this new transmission line.

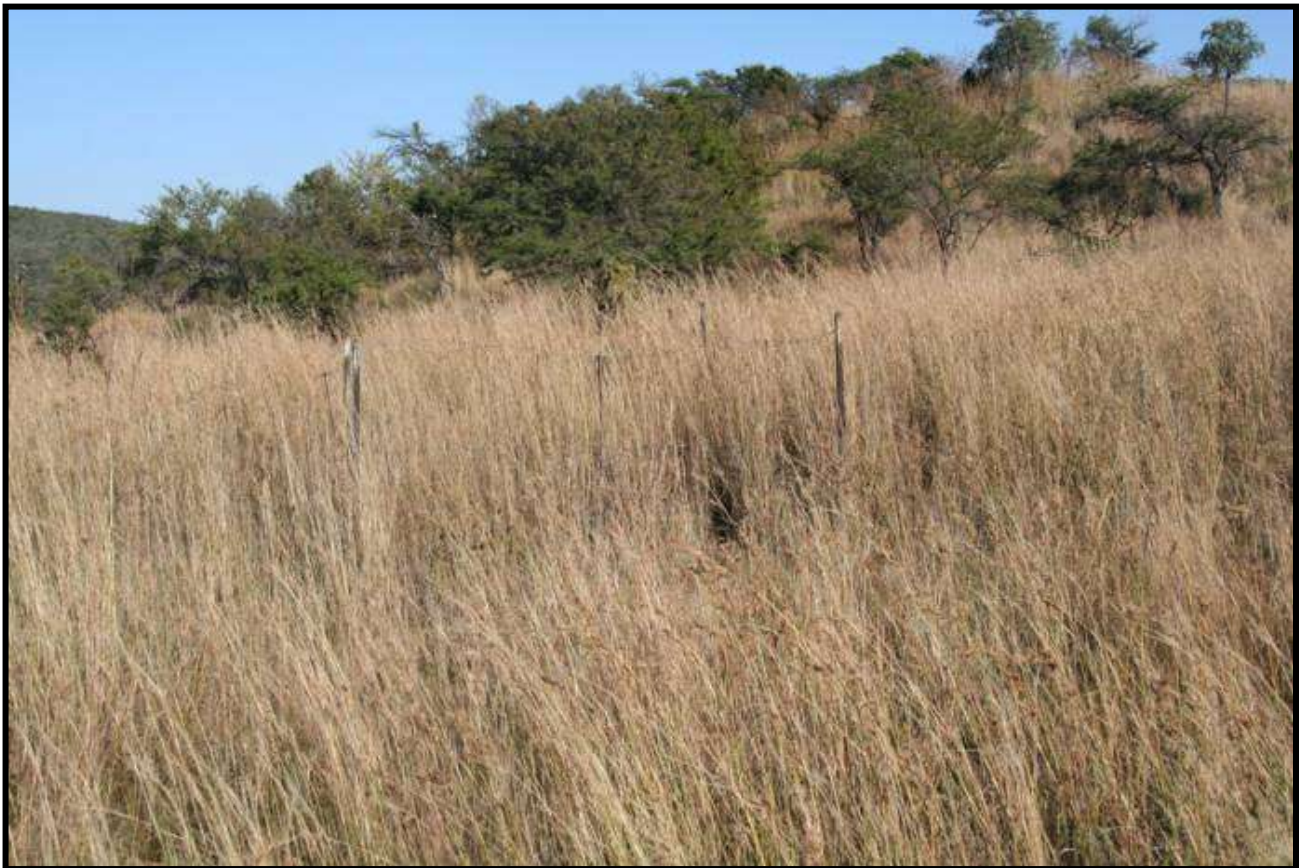
Fig. 29: Grave at KP243.580

The grave at KP243.580 was fenced off and demarcated before RoW clearance (fig. 29). It was not affected by the NMPPP line.

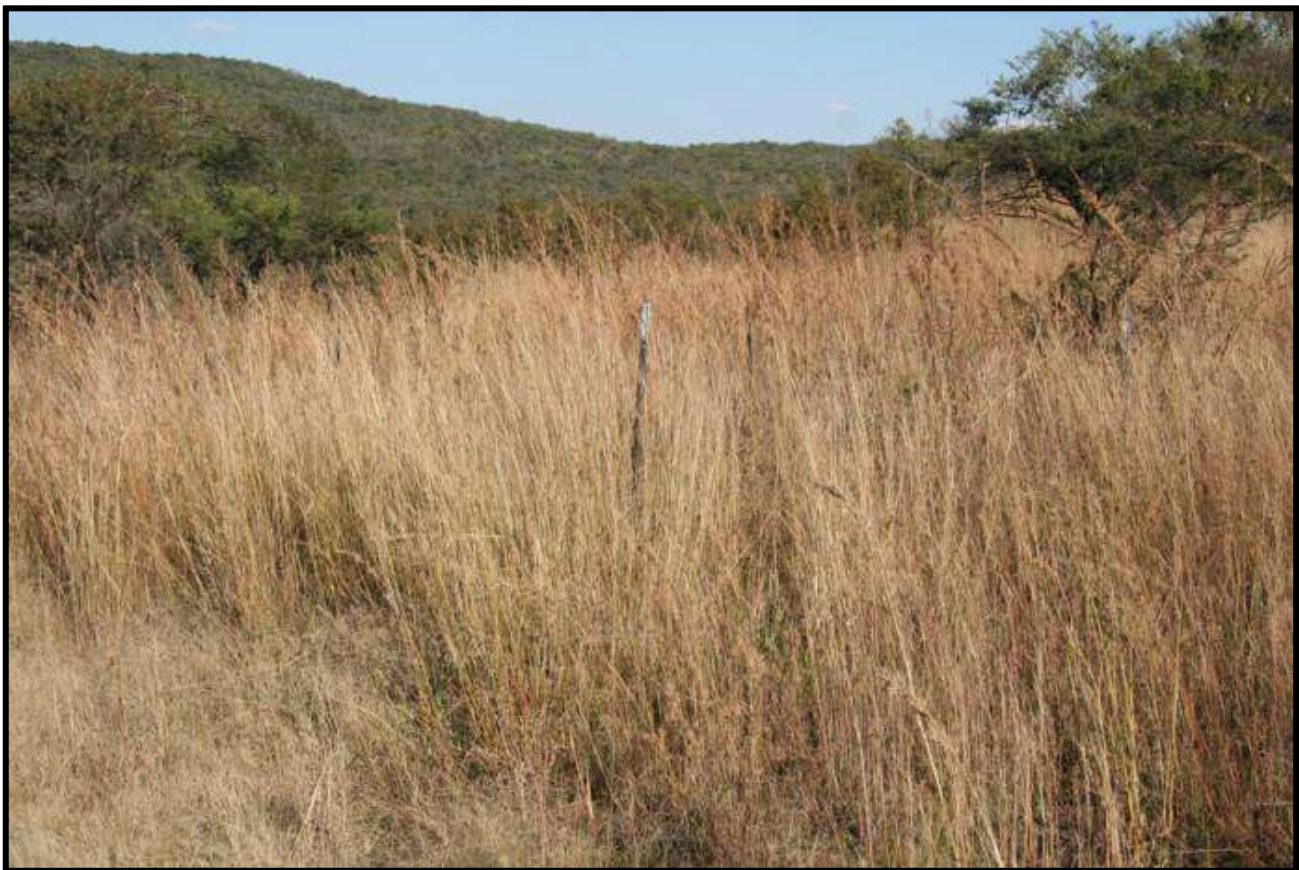
Fig. 30: Grave at VAL9

The grave at VAL9 was fenced off and demarcated before RoW clearance (fig. 30). It was not affected by the NMPPP line

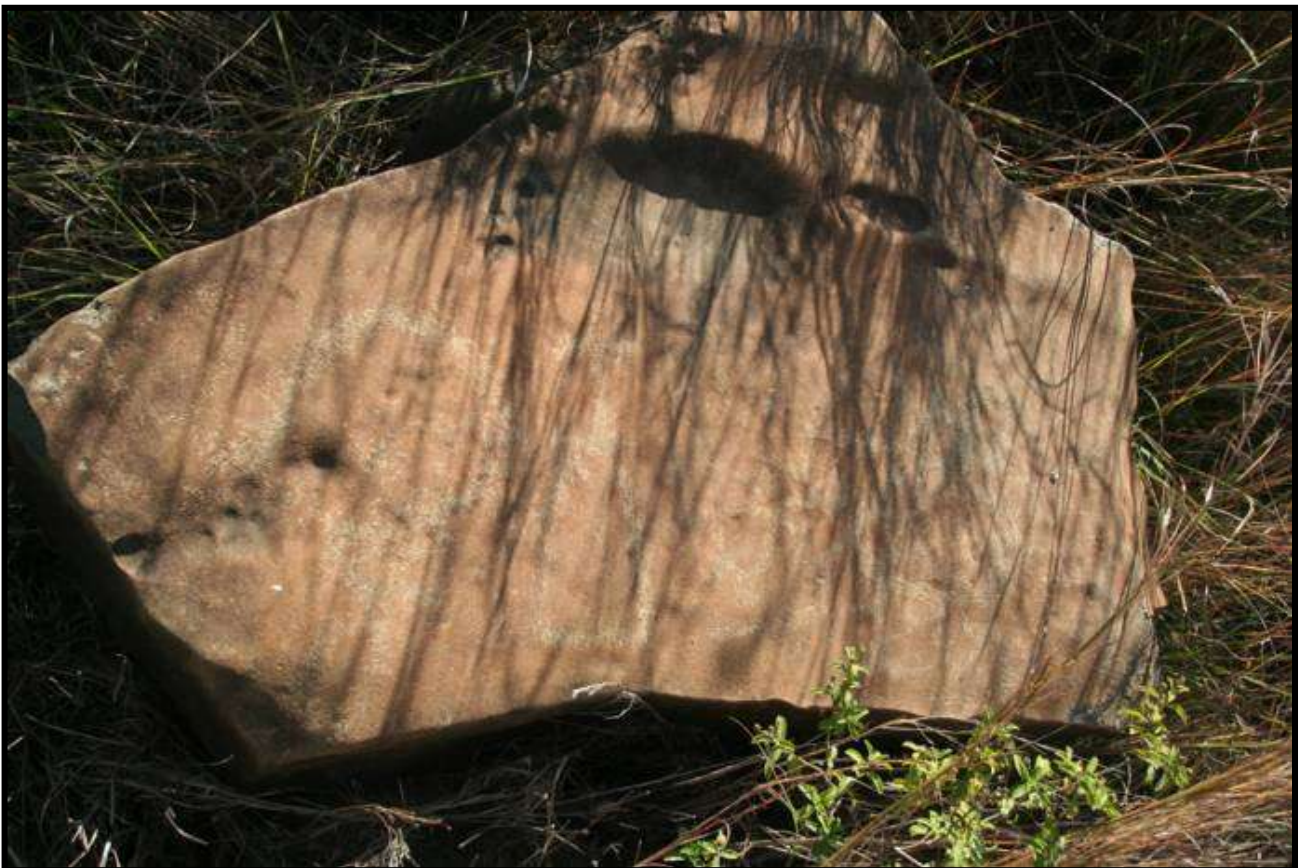
Fig. 31: 2ABW Engraving:

The engraving was recorded during the mitigation of the battlefield. The engraving was in the RoW and was moved outside the RoW. The engravings relate to the 2ABW and are similar to ones recorded 10km to the north. The locations of the original and relocated engraving were noted. The engravings have not been damaged by the NMPPP.

Management: No further mitigation is required. The engraving should not be relocated to its original position as it may get damaged during any activity along the pipeline.

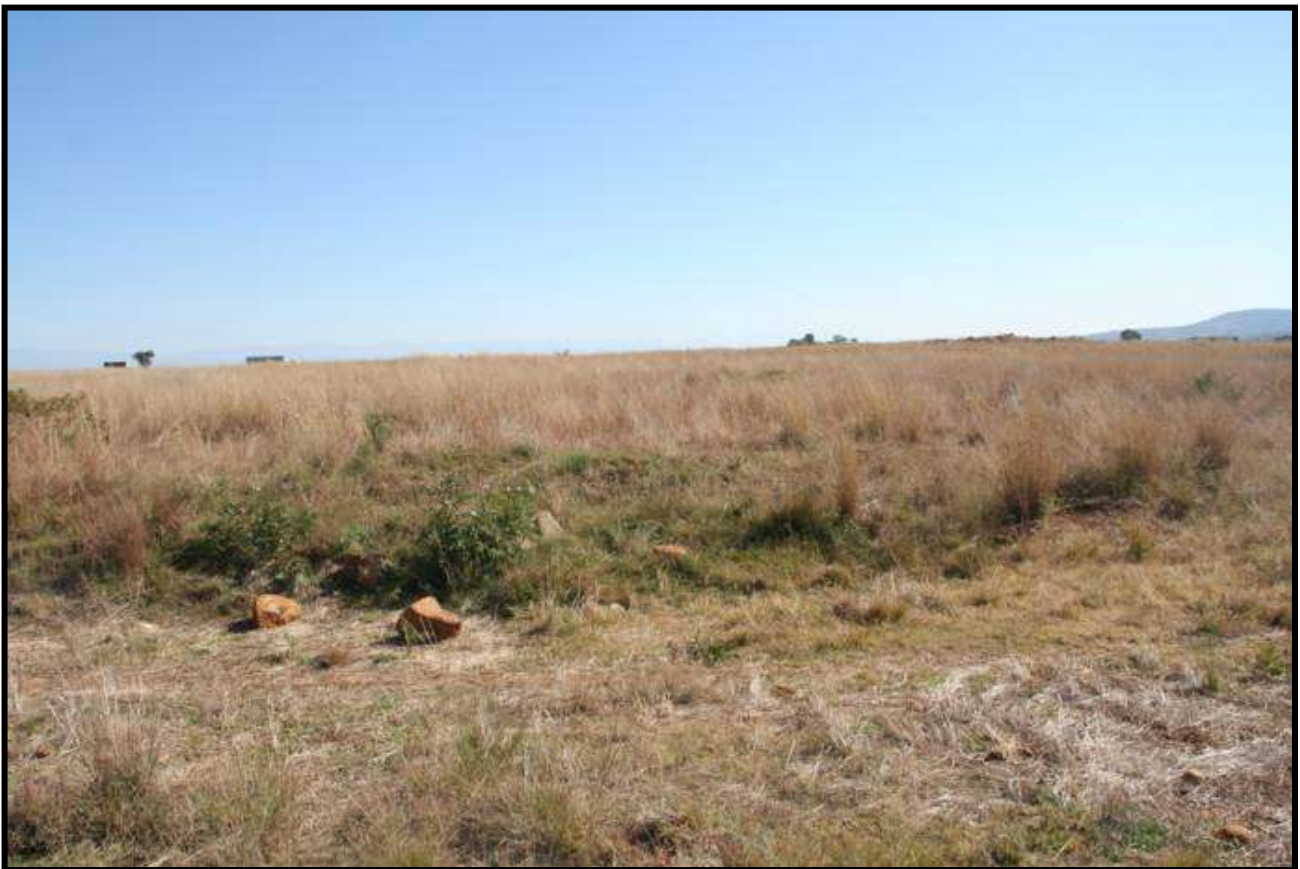
Fig. 32: Walling at GLK78b – Feature 613

Feature 613 is a LIA stone walled circle, or kraal (fig. 32). The kraal occurred within the RoW, but was fenced off as RoW clearance began. The feature was not damaged during construction.

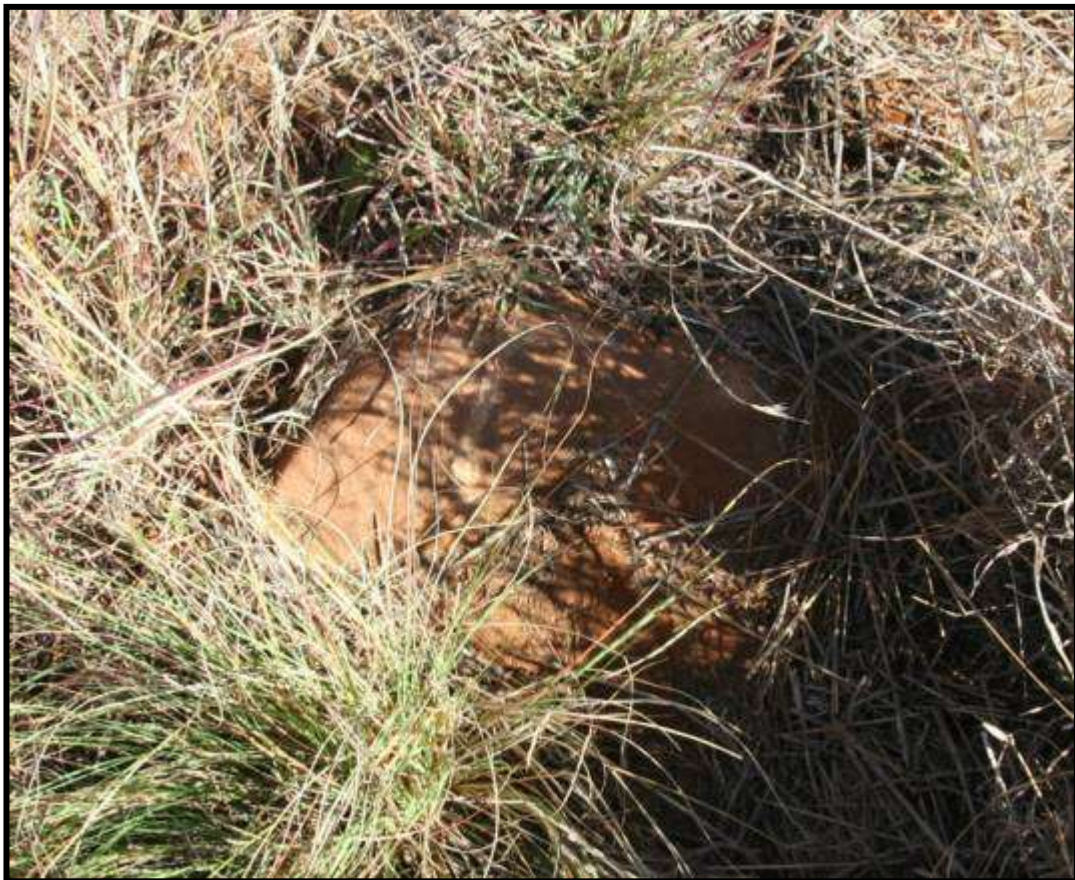
Fig. 33: GLK078b Engraving #615

The engraving (fig. 33) was demarcated before RoW clearance. The RoW was modified to avoid the engraving. Between the RoW clearance and construction the area was blasted without undertaking the required mitigation, and the engraving was covered by rock fragments.

The engravings were relocated and the rock material was removed. The engraving did not have any damage. The engravings were not affected by construction.

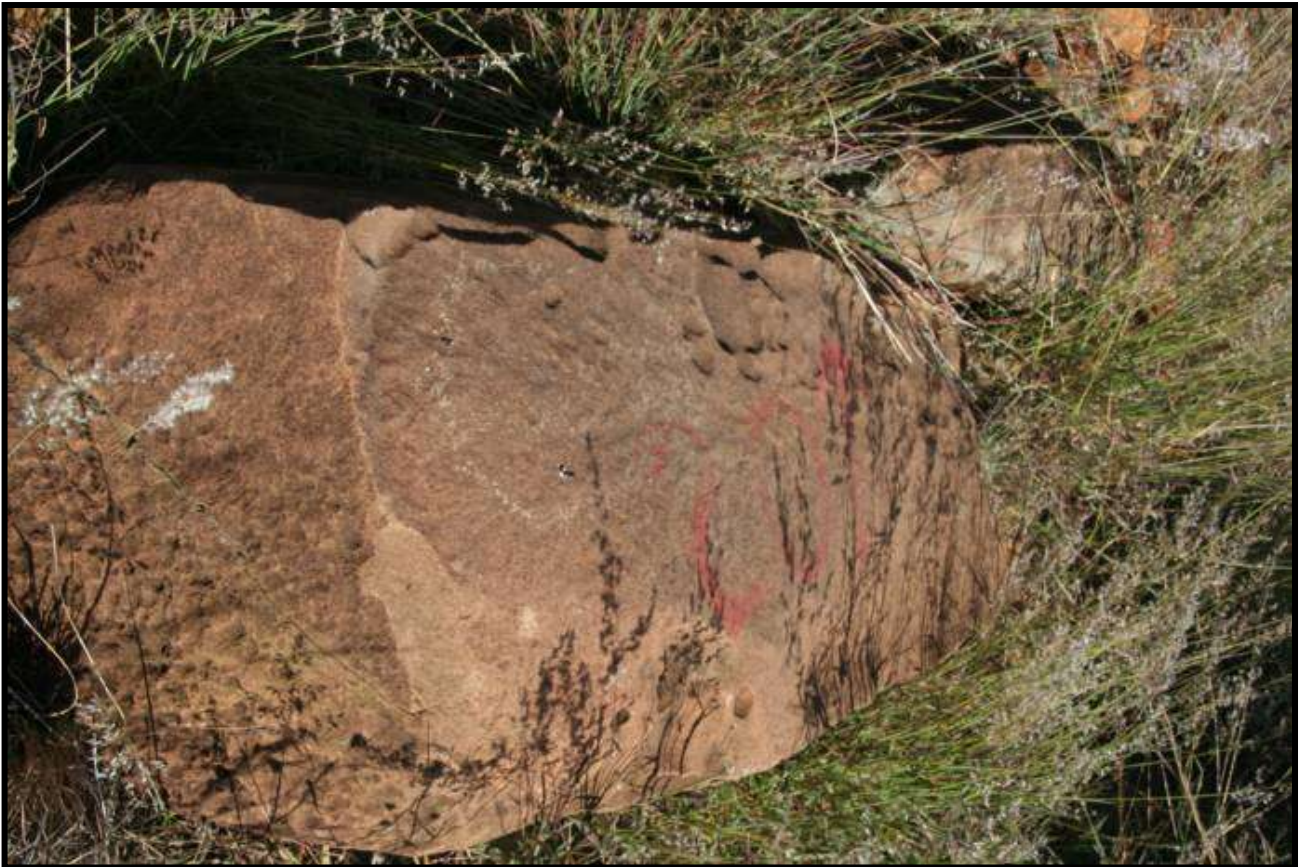
Fig. 34: GLK078b Engraving 17

The engraving (fig. 34) was demarcated before RoW clearance. The RoW was modified to avoid the engraving. Between the RoW clearance and construction the area was blasted without undertaking the required mitigation, and the engraving was covered by rock fragments.

The engravings were relocated and the rock material was removed. The engraving did not have any damage. The engravings were not affected by construction.

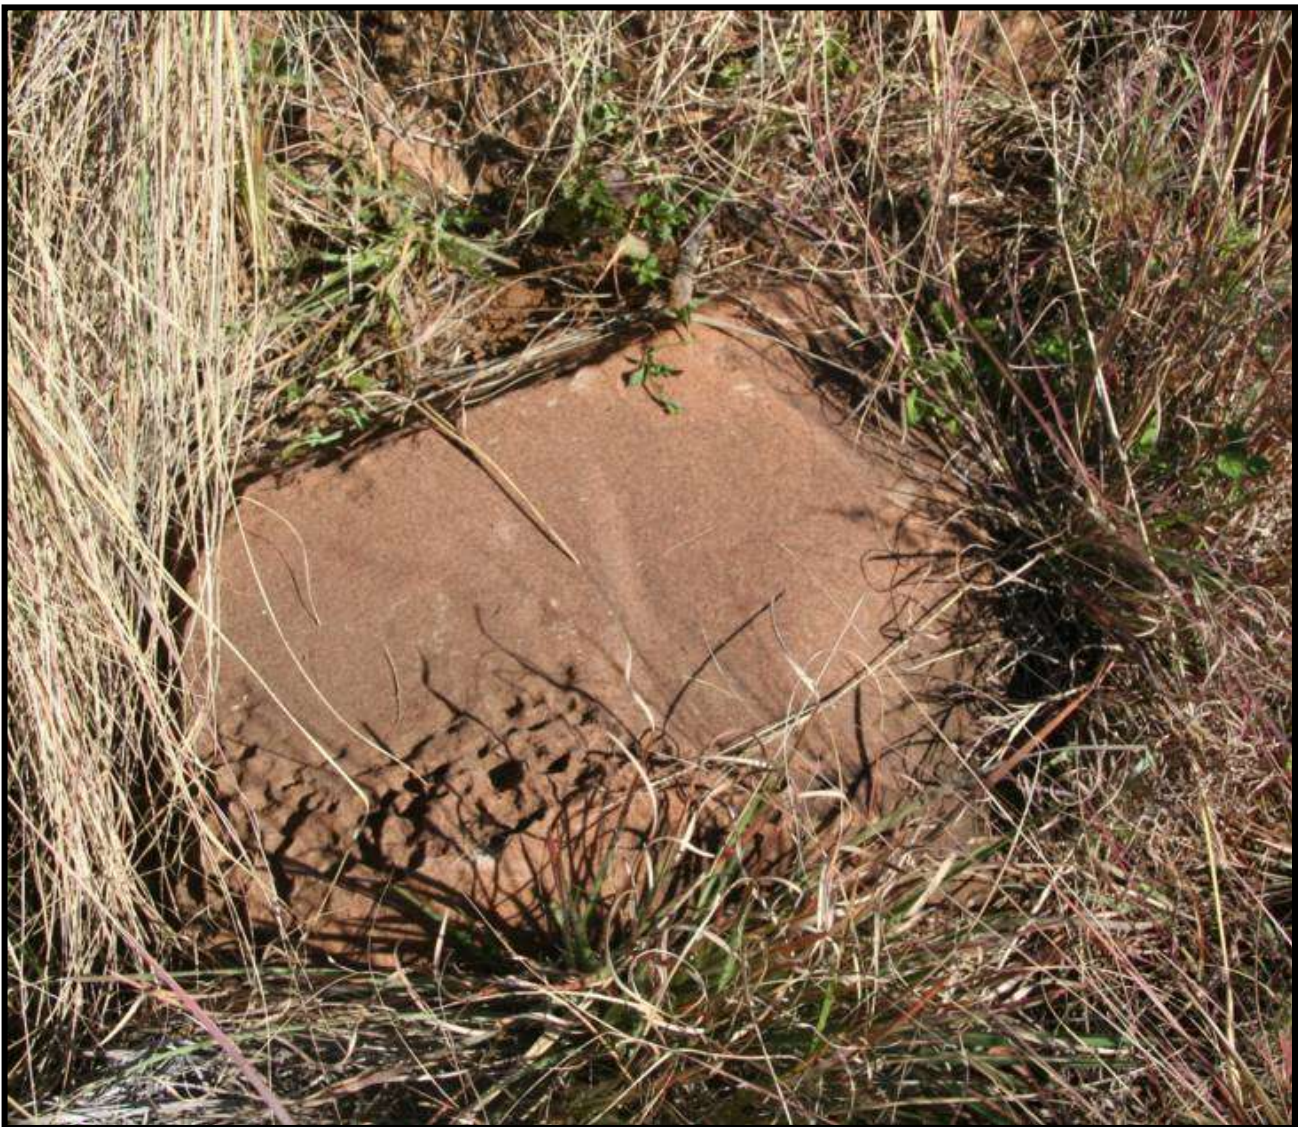
Fig. 35: GLK078b Engraving 20

The engraving (fig. 35) was demarcated before RoW clearance. The RoW was modified to avoid the engraving. Between the RoW clearance and construction the area was blasted without undertaking the required mitigation, and the engraving was covered by rock fragments.

The engravings were relocated and the rock material was removed. The engraving did not have any damage. The engravings were not affected by construction.

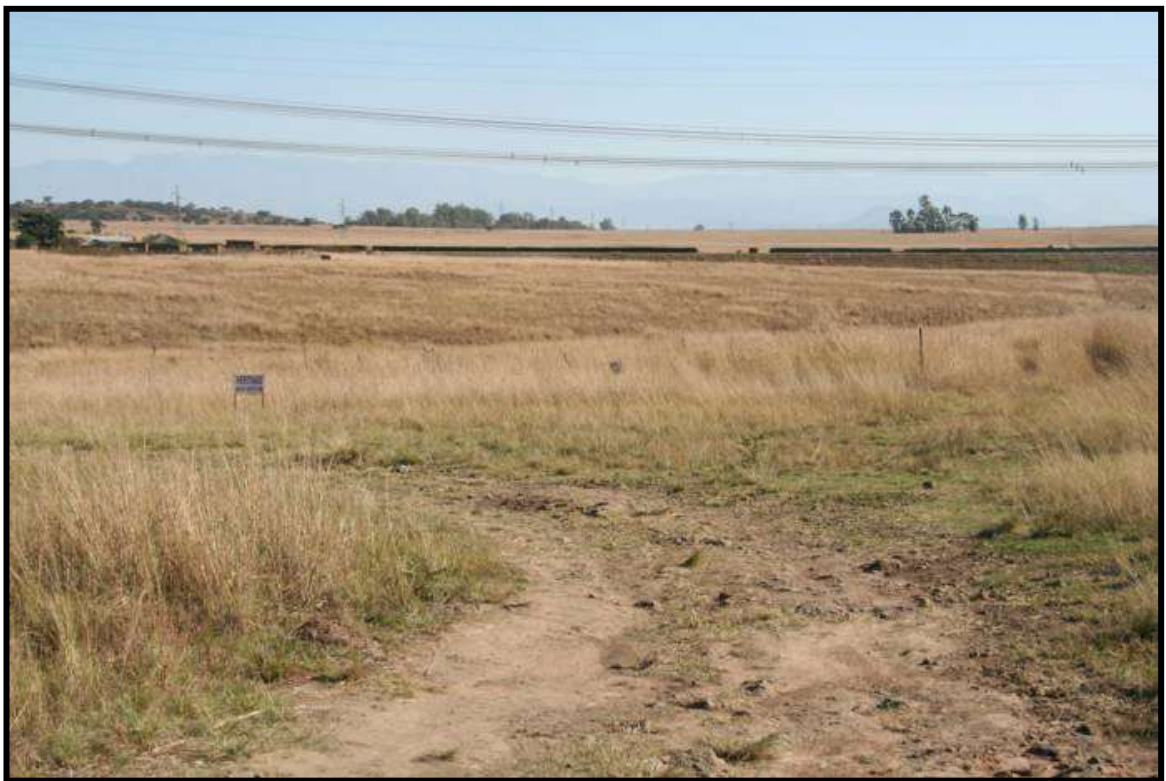
Fig. 36: Cemetery at GLK082a

The cemetery occurred in the RoW; however the RoW was realigned. The cemetery was fenced off before RoW clearance (fig. 36) and no damage to the cemetery has occurred.

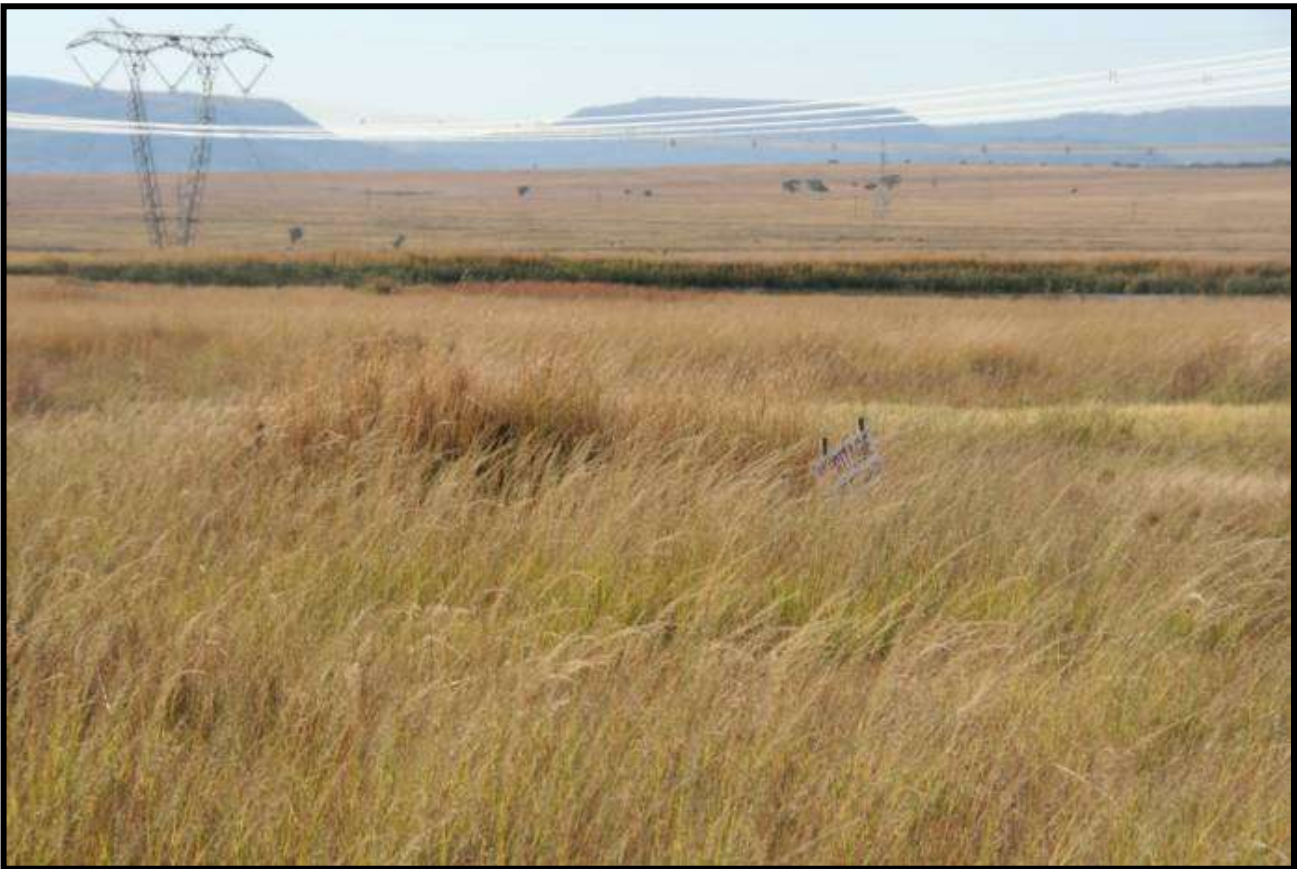
Fig. 37: Grave at GLK127

The grave was recorded during the initial survey (fig. 37). The grave was fenced and demarcated before RoW clearance. There has been no damage to the grave.

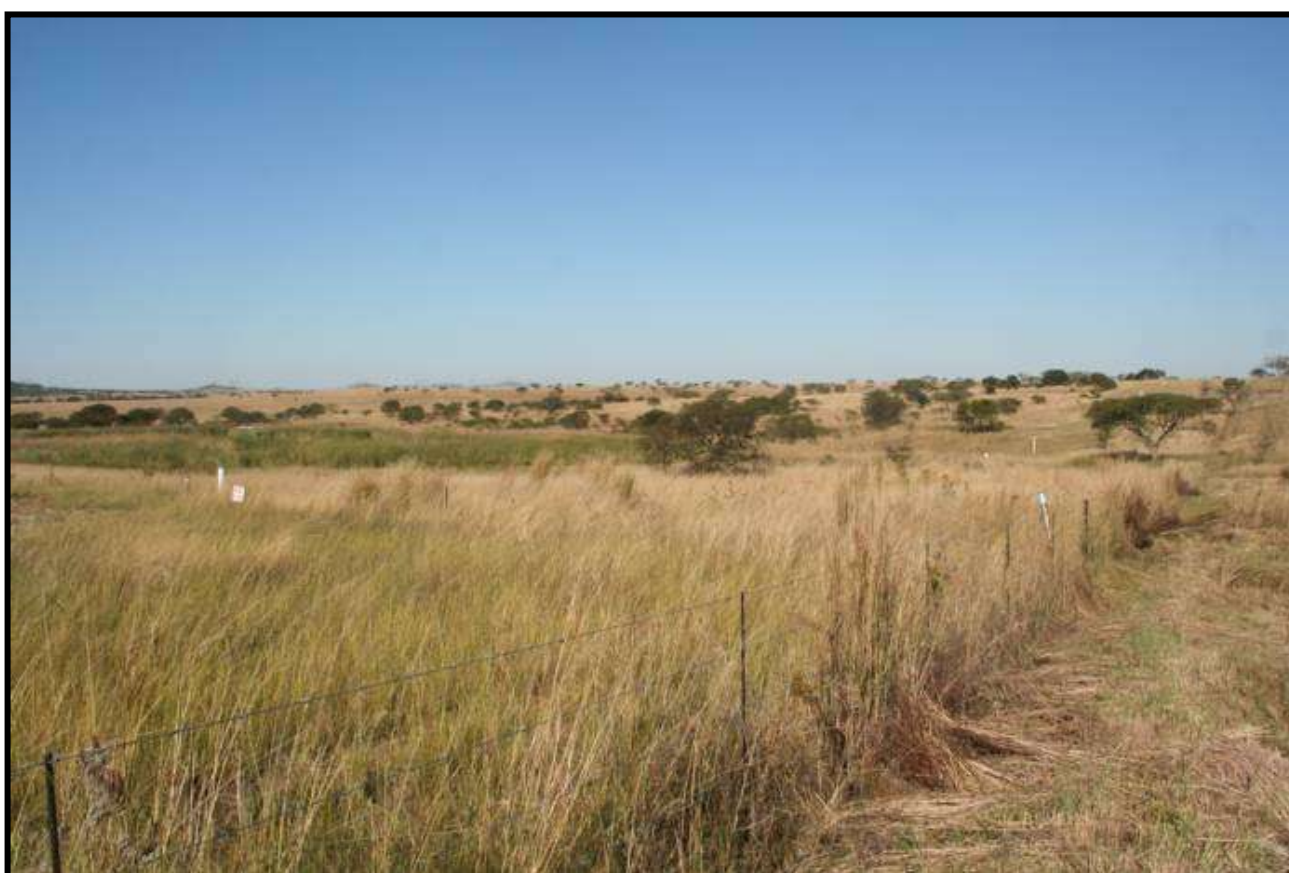
Fig. 38: Graves at 314 -315

These graves and the settlement were noted before RoW clearance (fig. 38). The pipeline line was realigned to avoid the graves. The graves were fenced off and demarcated before RoW clearance. The graves have not been damaged during construction.

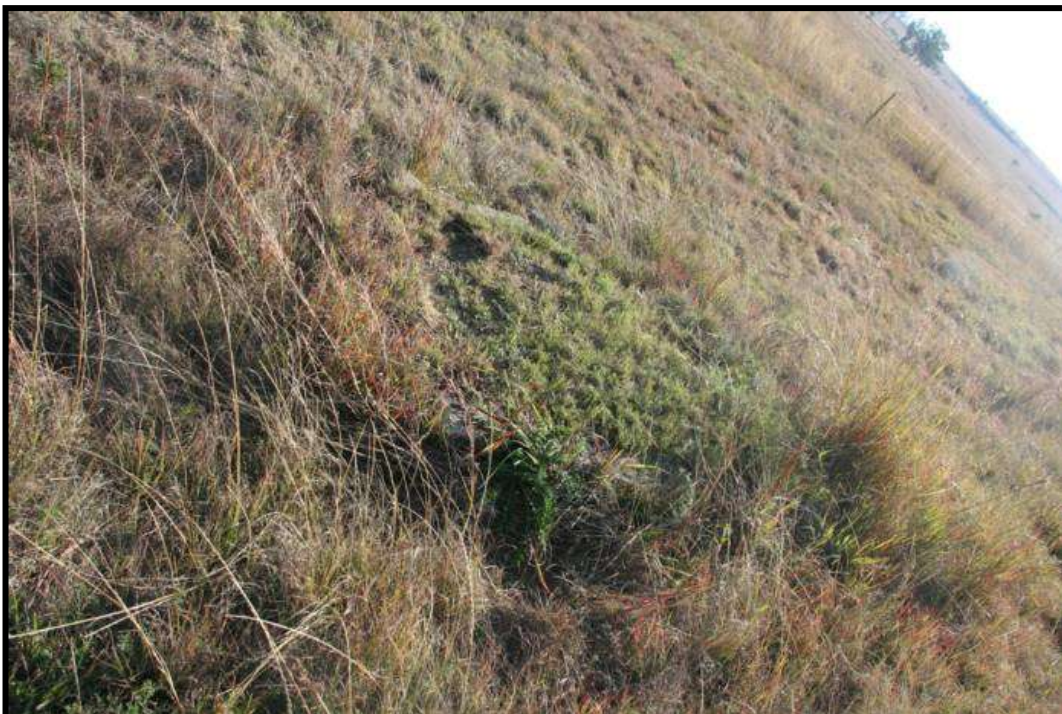
Fig. 39: Possible Grave at GLK090

GLK090 was a feature with Coronation bricks and with possible lime plaster (fig. 39). The feature was fenced off before RoW clearance and not damaged during construction.

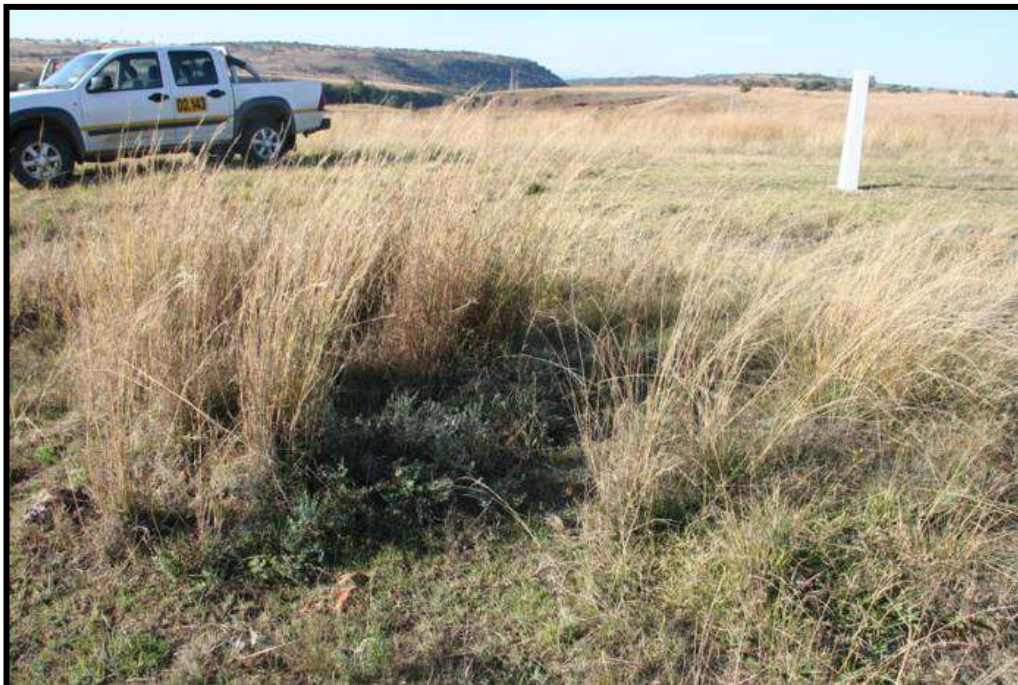
Fig. 40: Grave at Feature 321

The grave was recorded before RoW clearance. The grave was fenced off and demarcated (fig. 40). No damage occurred to the grave.

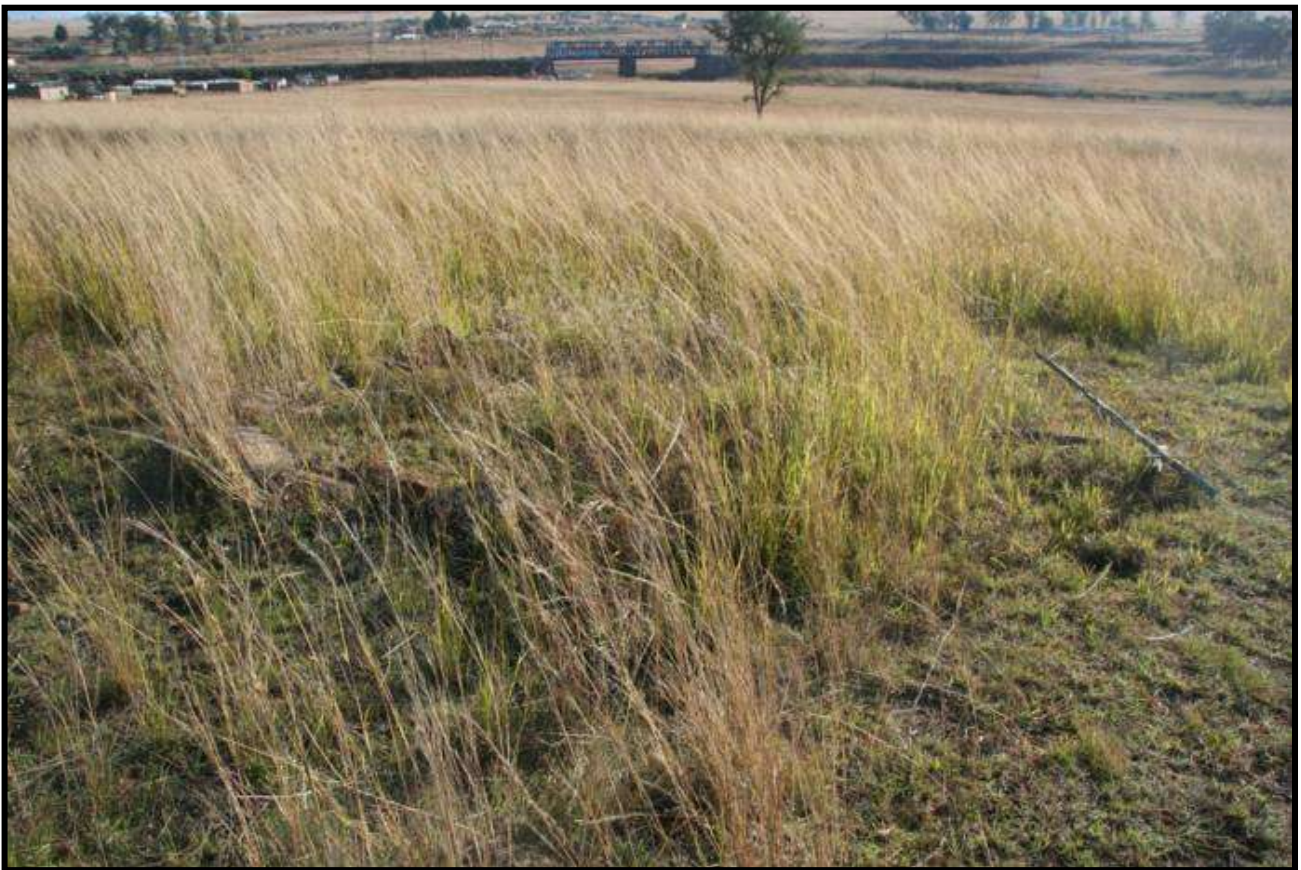
Fig. 41: Grave at Feature 322

The grave was recorded before RoW clearance. The grave was fenced off and demarcated (fig. 41). No damage occurred to the grave.

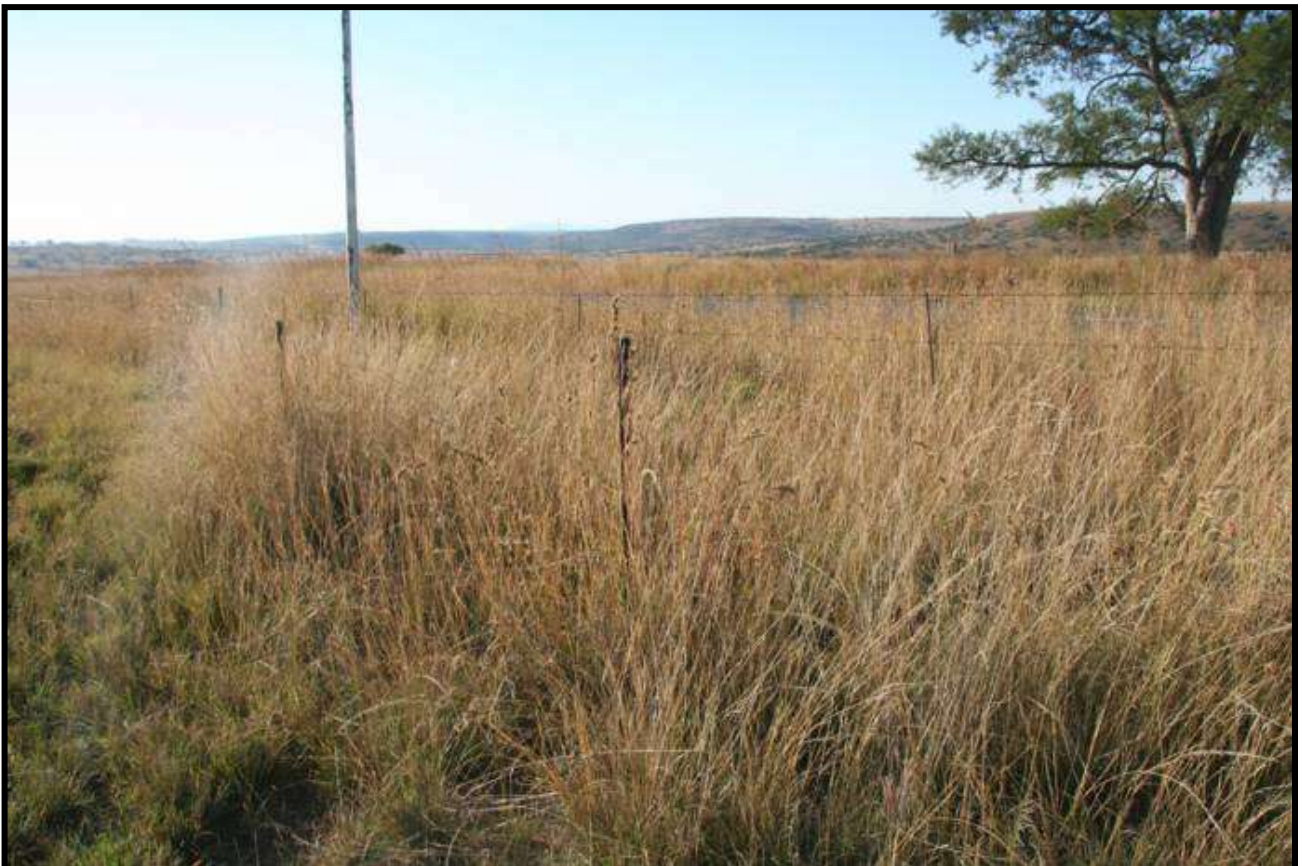
Fig. 42: GLK092 –Grave Feature 559

One grave was fenced and demarcated near the edge of the RoW (fig. 42). The grave was not damaged.

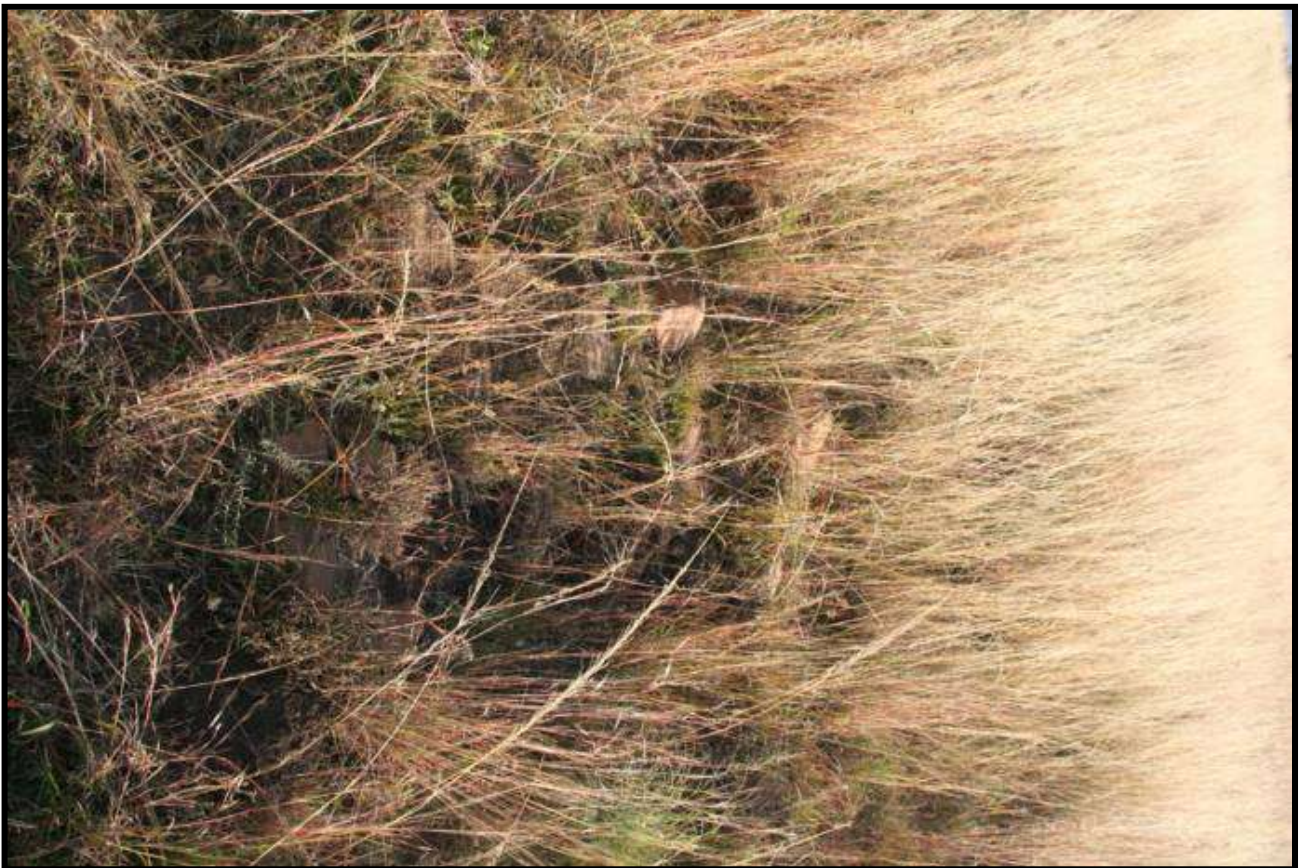
Fig. 42: Stone Feature at B04a

B04a is a small collapsed feature that appears to be a grave. The feature was fenced was demarcated with wooden poles (painted blue) before RoW clearance. The feature has not been damaged, but there are currently no metal poles to demarcate the feature.
