**New Multi Product Pipeline
(NMPP) Project**

Final Heritage Audit

2684358-J-A00-AM-ST-004-12

June 2013

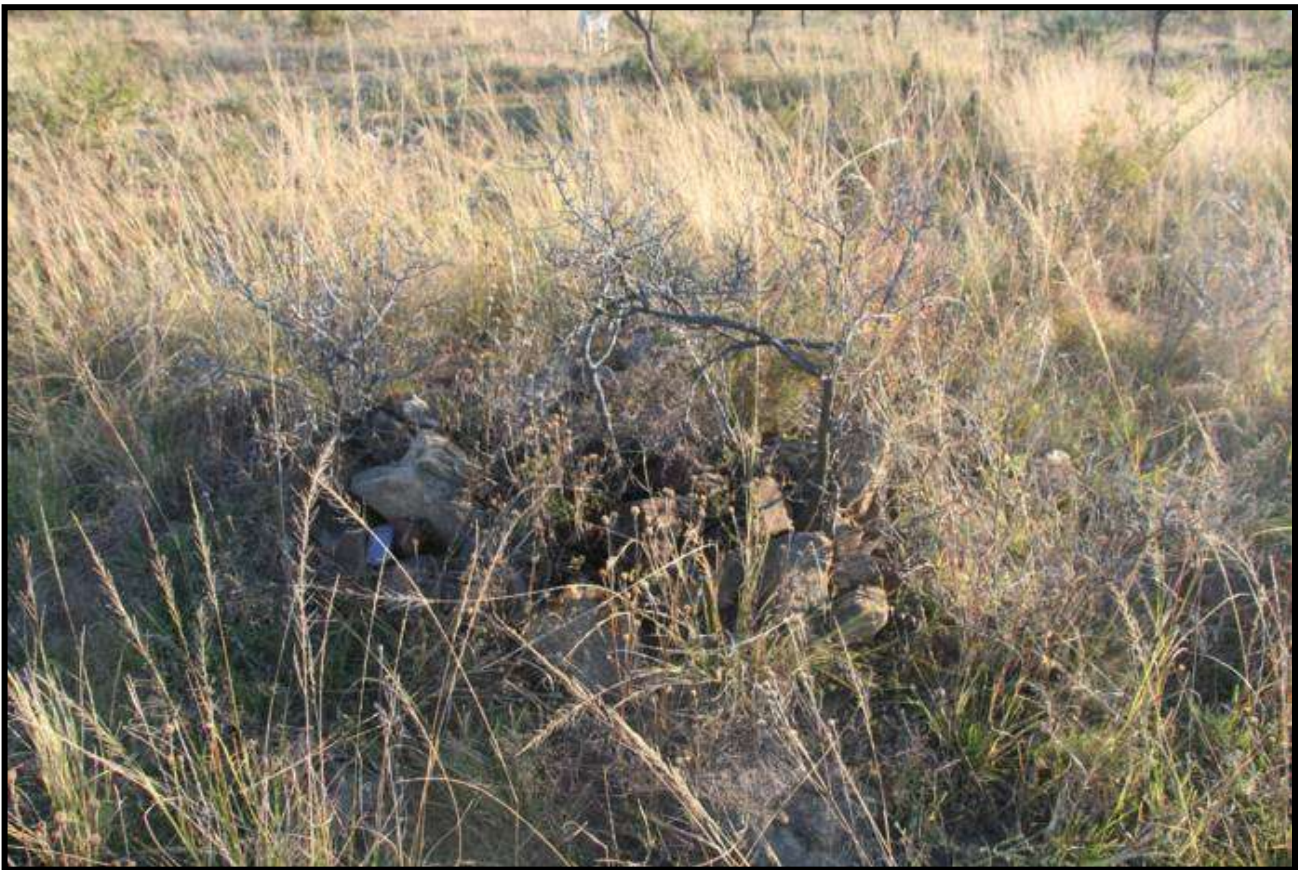
Fig. 43: Graves at KP200.260

These two graves were noted by the ECO for this area before RoW clearance. The graves were demarcated and fenced before ROW clearance. There has been no damage to the graves.

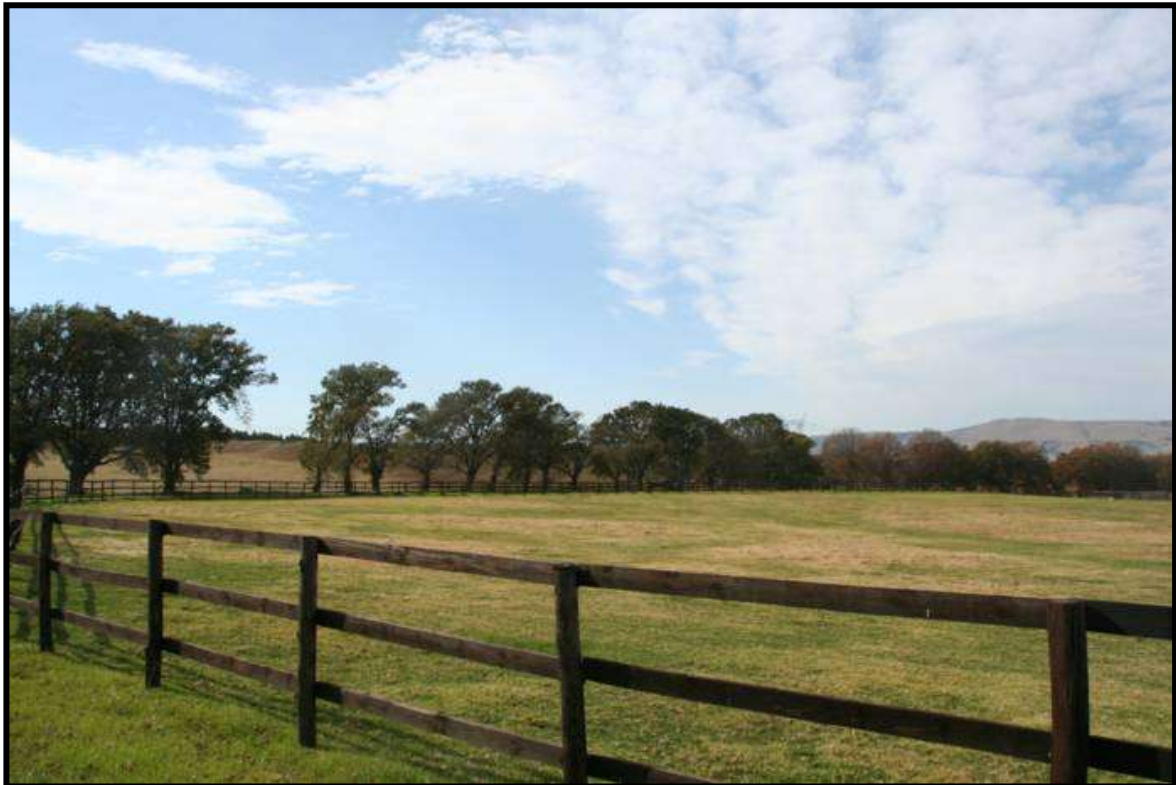
Fig. 44: GLK104 Trees

GLK104 formed part of the cultural landscape, as did GLK103. The trees were not damaged during RoW clearance nor construction. Some trees were cut down in Weston College during the monitoring of the area; however, this was not by the NMPPP.

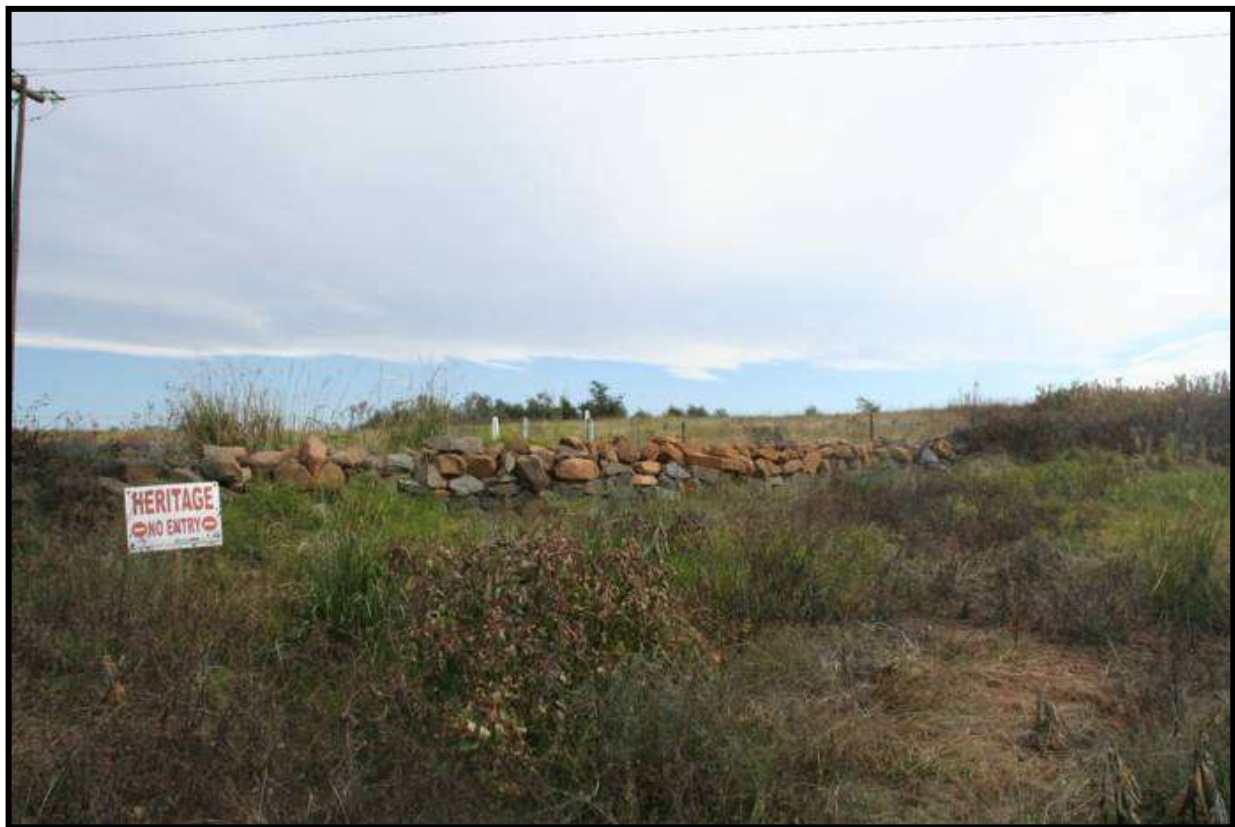
Fig. 45: Historical Walling At GLK097

GLK097 consists of historical stone walling either dating to the original farm or the 1930s. The pipeline was given permission to go through two sides of the wall, provided that the wall was rebuilt. A width of 6m was given for machinery to pass through. To keep some form of authenticity, each rock was mapped and labelled, and placed to the side. The wall was not damaged during RoW clearance; however, construction removed ~15m of walling on each side of the wall.

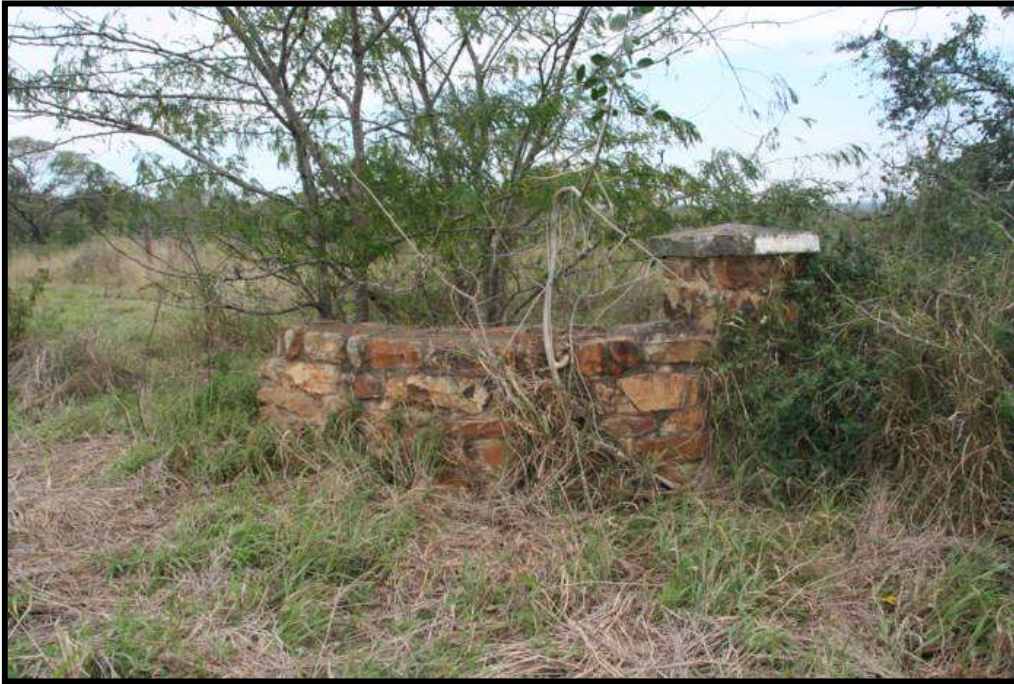
Fig. 46: Ashburton House Gate Entrance

The Ashburton house is currently in ruins. The gate entrance is still visible as are some of the foundations and the overgrown garden. The main house and gates (fig. 46) did not occur in the RoW, and were not affected. The gates have been slightly damaged, subsequent to RoW and construction. A tree has fallen onto the one wall; however, this appears to be a recent activity and not associated with the project as it is well outside of the RoW servitude..

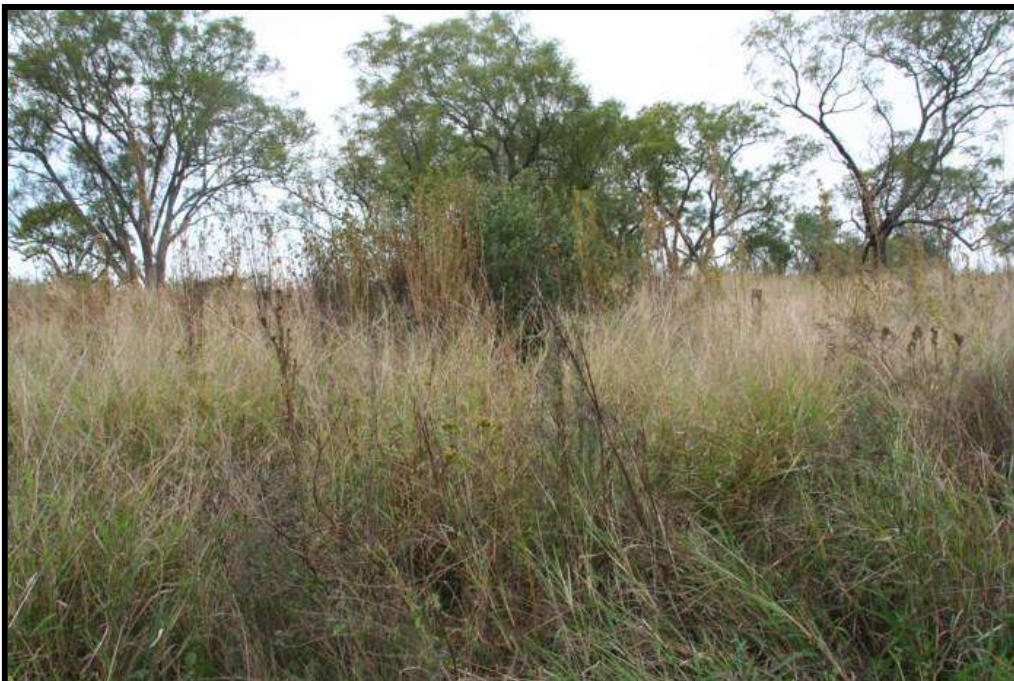
Fig. 47: Drainage Feature at Ashburton House

There is a small part of a feature within the RoW along the north-western part of the property (fig. 47). This was fenced off and demarcated before RoW clearance. This was not damage during construction. The site was monitored during RoW clearance.

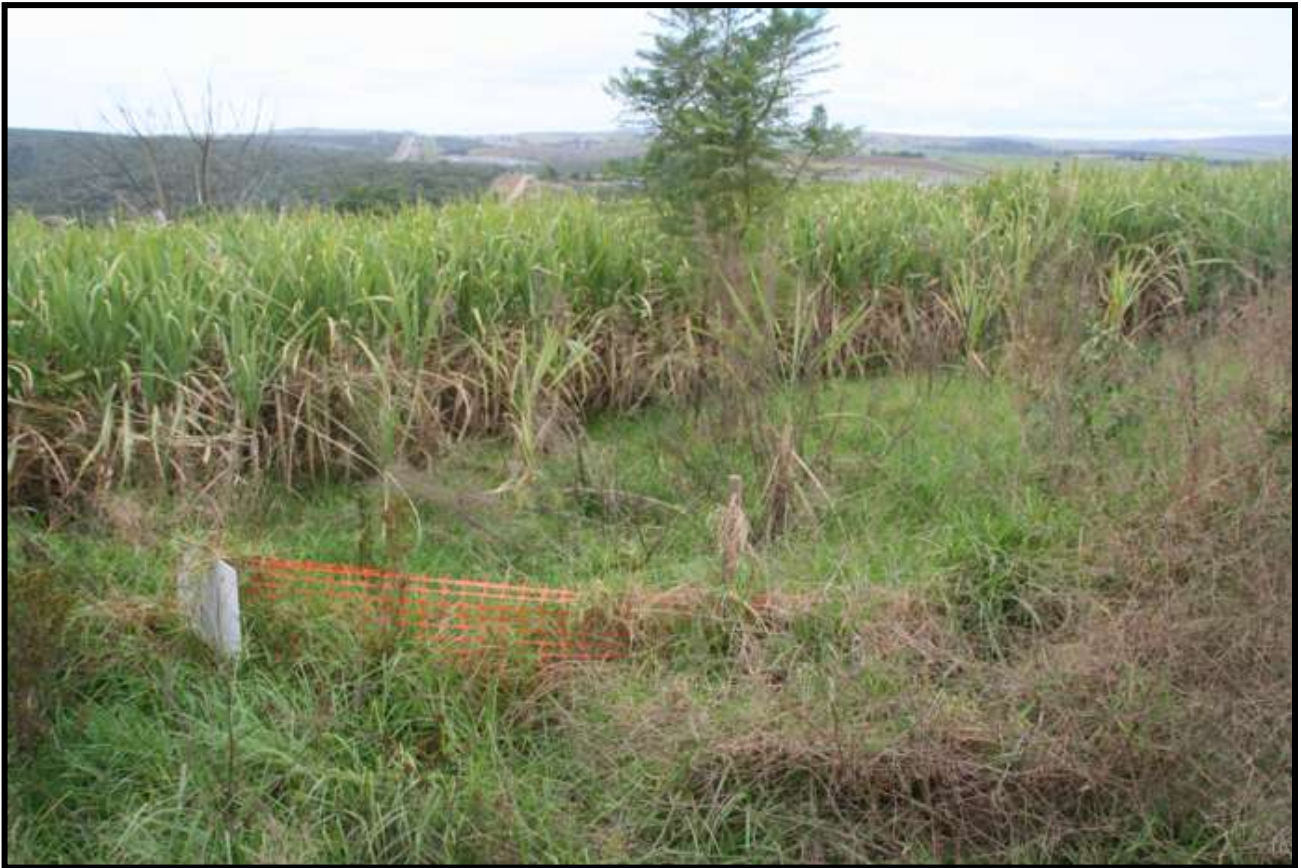
Fig. 48 Graves at KP75.601

This site consists of farm labourers' graves outside of the RoW. The graves were demarcated before RoW clearance and have not been damaged (fig. 48).

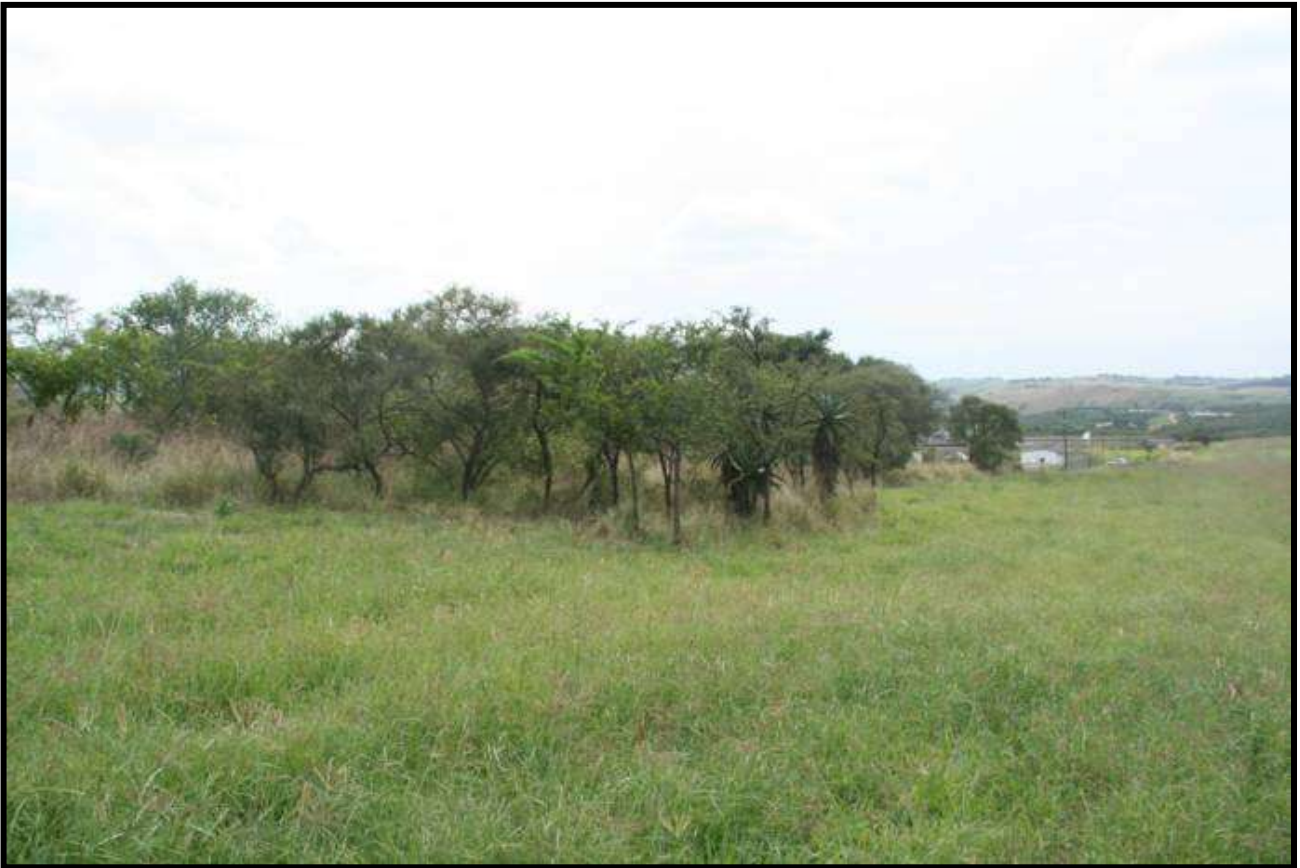
Fig. 49: Possible graves at KP73.2

KP73.2 are stone cairns that appear to be graves. The area was fenced off and demarcated before RoW clearance (fig. 49). The possible graves have not been damaged.

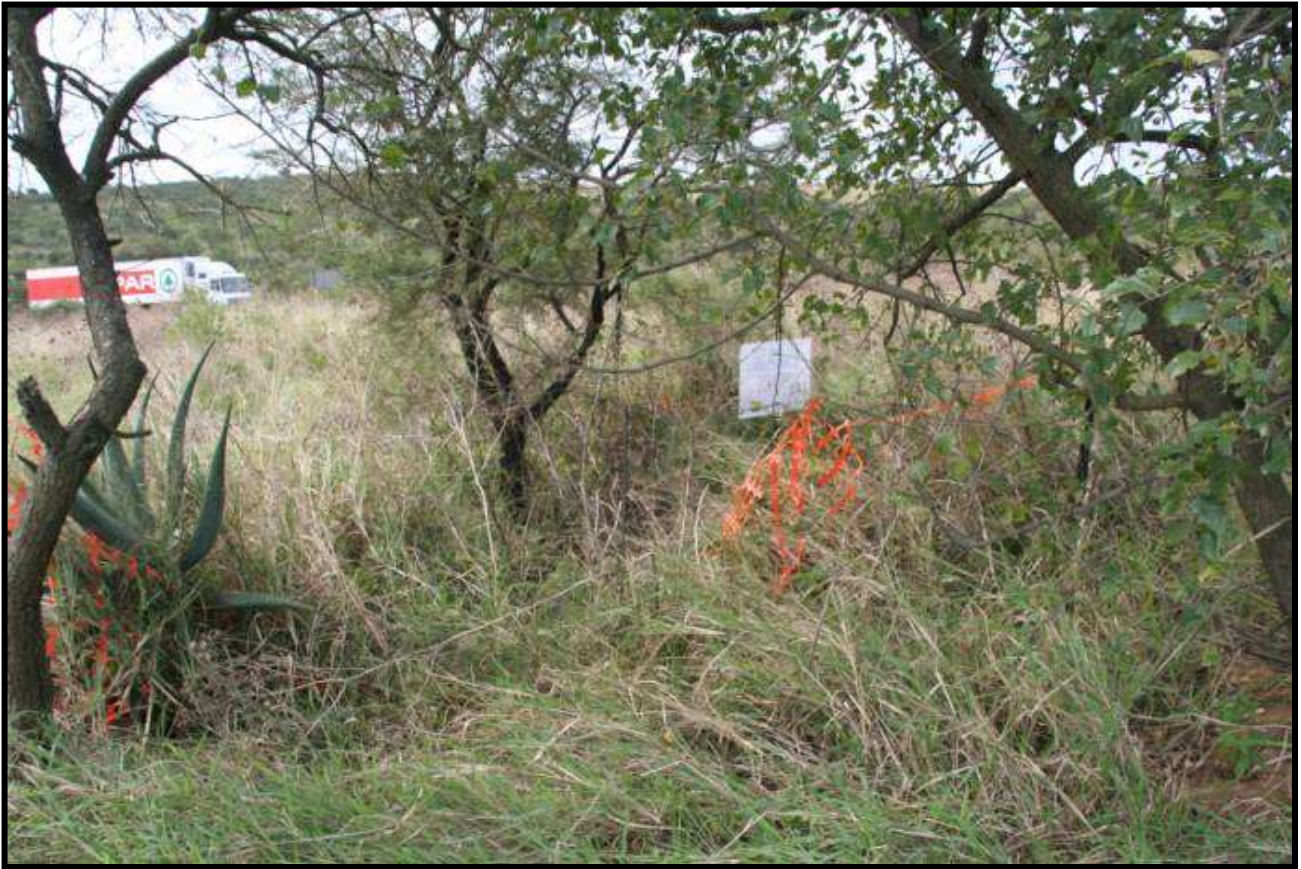
Fig. 50: Possible graves at KP73.1

KP73.1 are stone cairns that appear to be graves. The area was fenced off and demarcated before RoW clearance (fig. 50). The apparent graves have not been damaged.

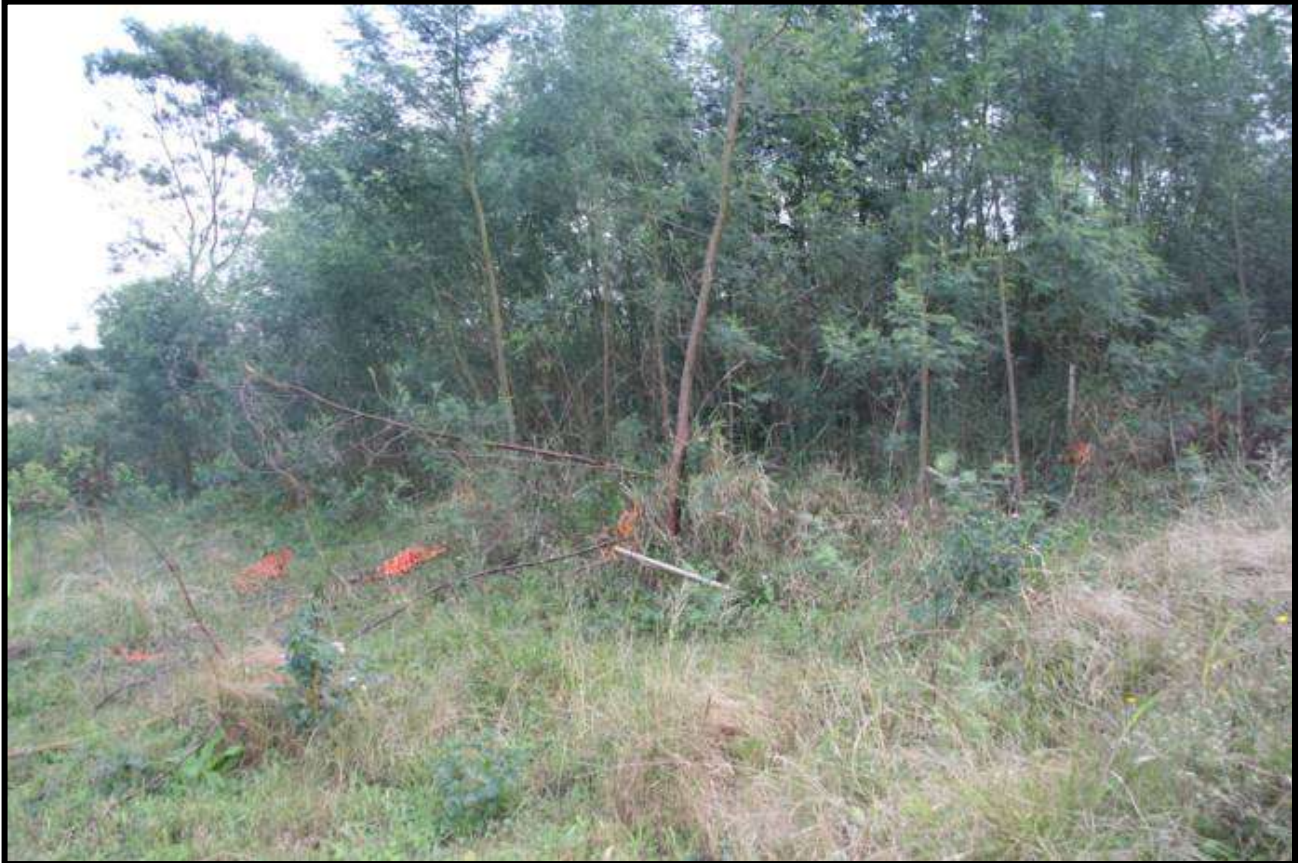
Fig. 51: Community Graves at KP48.250

KP48.250 is an area identified by the community as having graves (fig. 51). The area was demarcated before RoW clearance. No damage has occurred to the area.

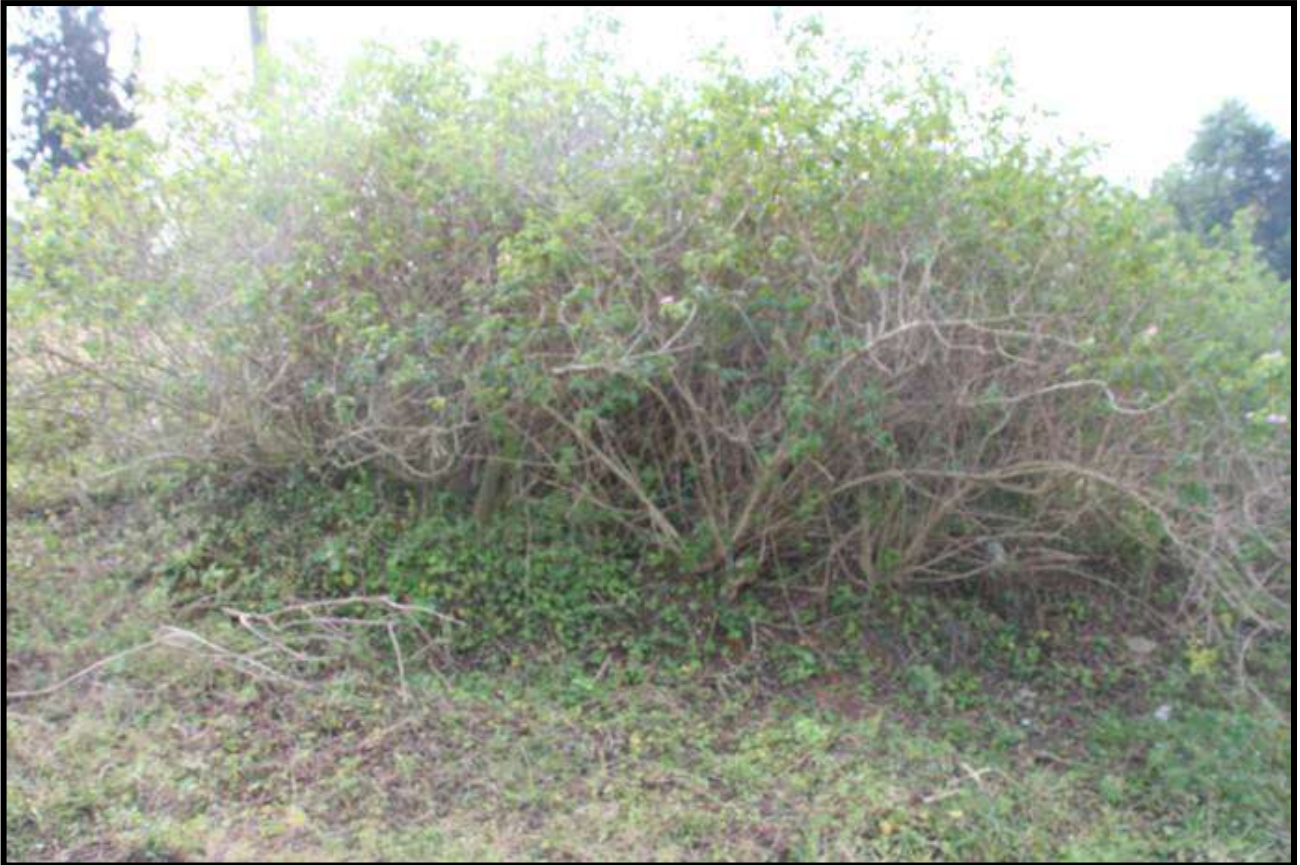
Fig. 52: Community Graves at KP37.200

KP37.200 is an area identified by the community as having graves (fig. 52). The area was demarcated before RoW clearance. No damage has occurred to the area.
