Bo-Kaap Erf 149970, 27 Pentz Street

Section 34 Application to Heritage Western Cape in terms of the National Heritage Resources Act

Report on Existing Housing Condition and Assessment of Recommended Work on City Owned House in Bo-Kaap.

April 2018.

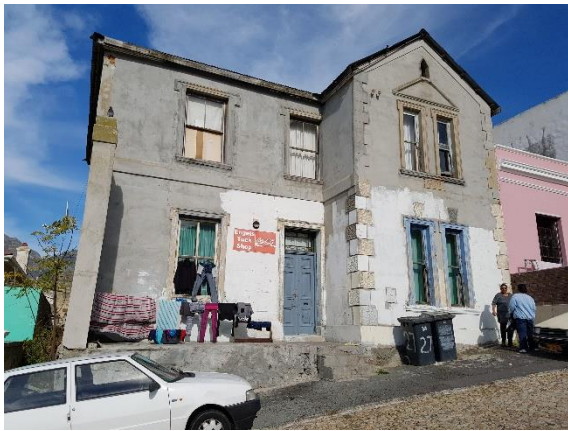
Pentz Street façade

Plastered walls, unpainted

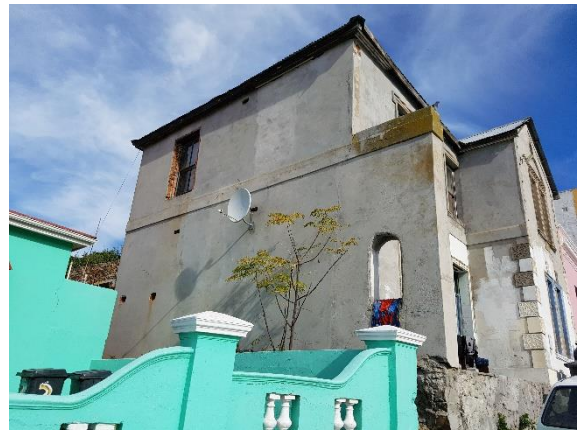
North east facade

Plastered walls unpainted, bedroom 3 window reveal is unplastered.

Plaster reveals of bedroom 3 window, repairs holes in east wall and paint walls.

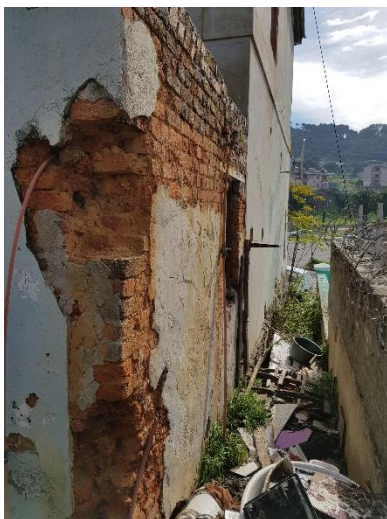
Bathroom wall

Partly exposed brick, unplastered.

Repair brick work at kitchen and bathroom, plaster and paint walls

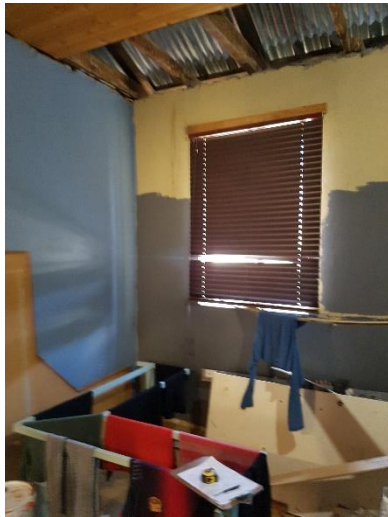
Bedroom (new ceiling in progress)
