02 November 2021

Heritage Report:

Proposed alterations and remedial work to Erf 12714 (Erf R/1452 and 1/1452) , 34 Bishop Road, Windermere, Berea, Durban, EtheKwini, KwaZulu-Natal

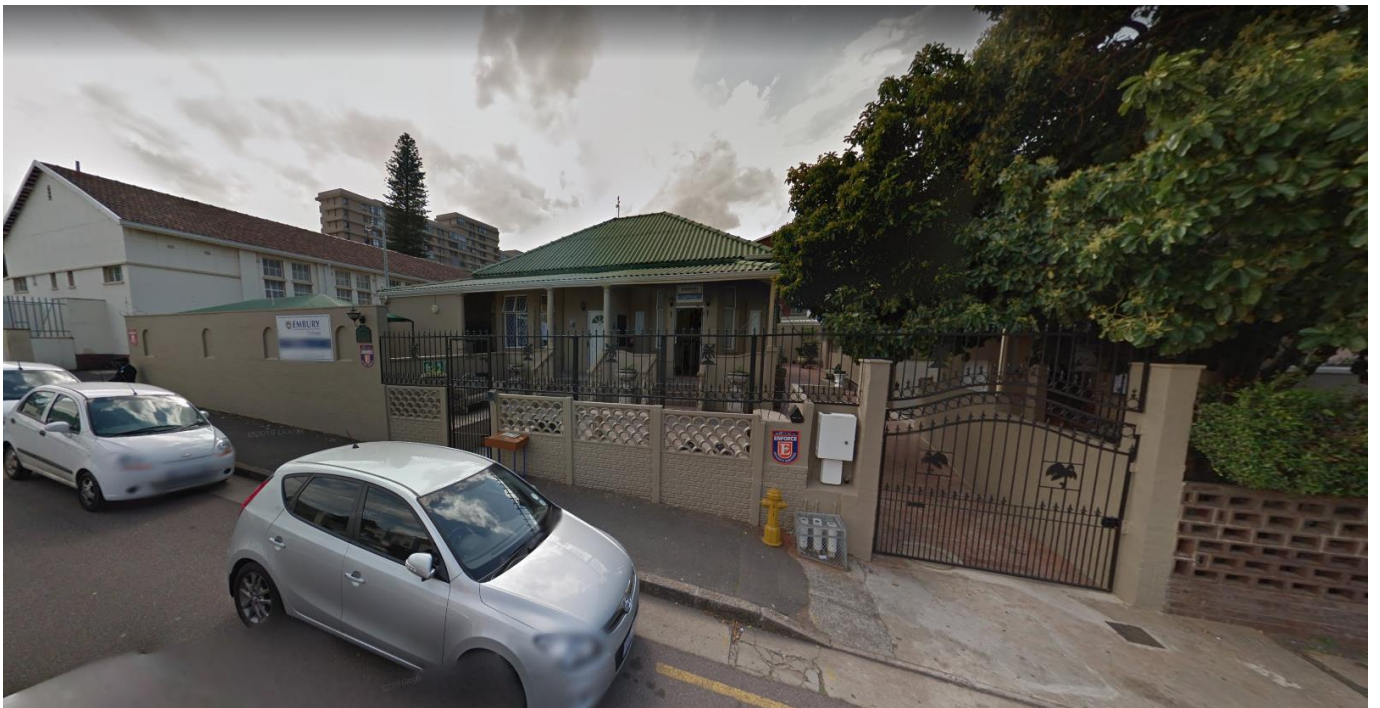
Figure 10: Street view of the building 2019

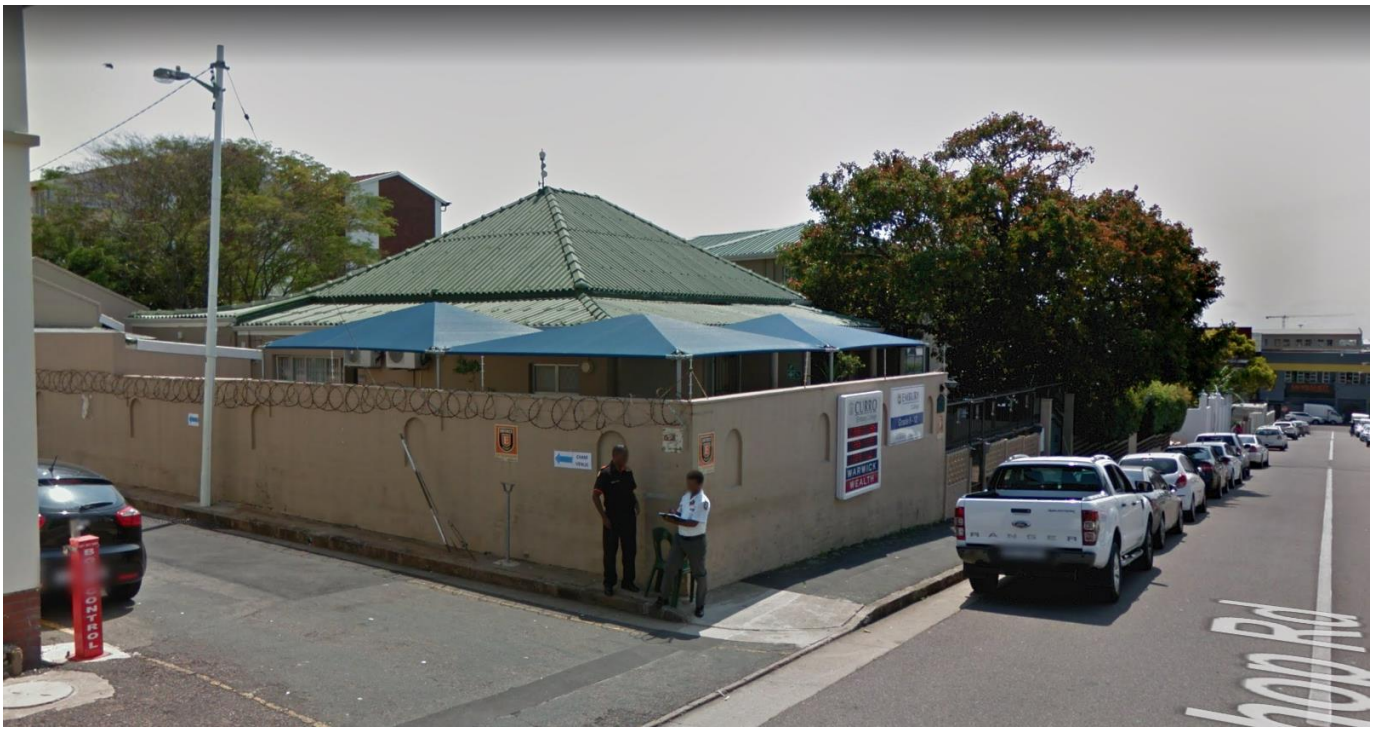
Figure 11: Corner view of the building 2019

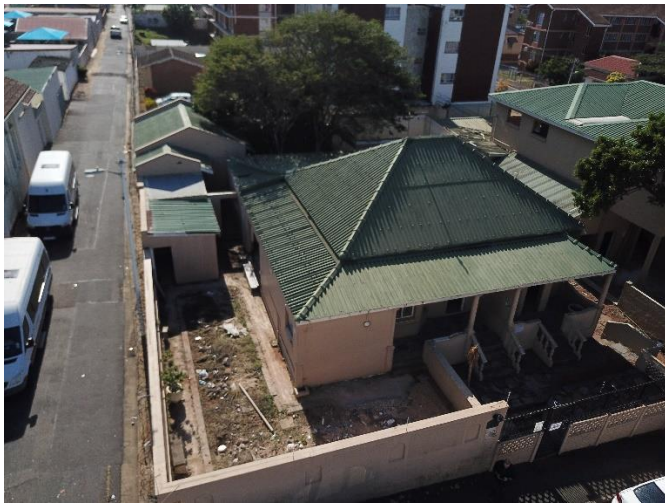
Image 1

Image 1: Aerial view from Yule and Bishop Street	Image 7: Internal view of the historic building
Image 2: Aerial view from Bishop Street	Image 8: View of the porch and the bay window of the historic building
Image 3: Street Elevation – Bishop Street	Image 9: Internal view of the additions made to the historic building – 1994
Image 4: West elevation	Image 10: Internal view of the additions made to the historic building – 1994
Image 5: Interior view of the historic building	Image 11: East Elevation
Image 6: Porch of the historic building	Image 12: Boundary wall and fence
