**ARCHAEOLOGICAL IMPACT ASSESSMENT REPORT ON THE REDAN  
ENGRAVING SITE: SPRINGFIELD MINING PROJECT SITUATED  
BETWEEN VEREENIGING AND MEYERTON, IN THE SEDIBENG  
DISTRICT MUNICIPALITY, GAUTENG PROVINCE**

Assessment conducted under Section 38(3) of the National Heritage Resource Act (No. 25 of 1999)

**September 2020 (reviewed April 2022)**

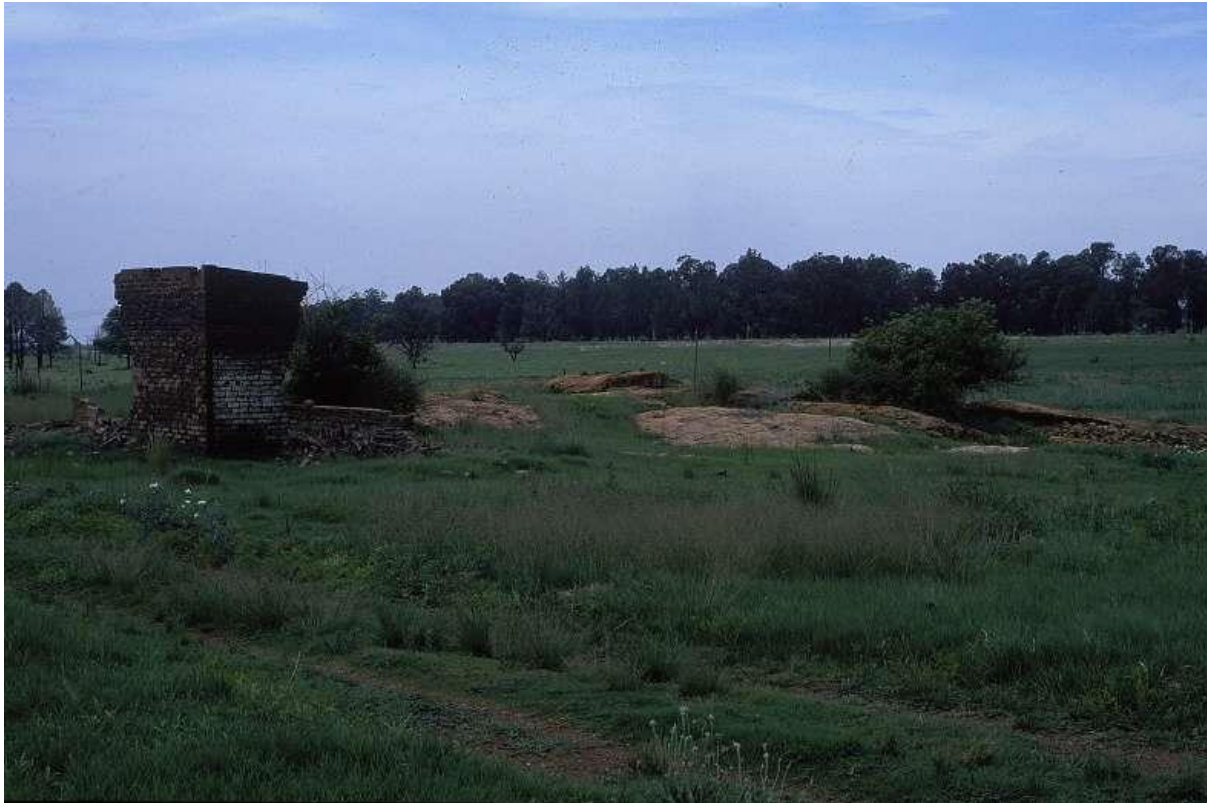
*Figure 6. Ruin next to the Redan engraving site (subsequently destroyed). The engravings are on the sandstone rock outcrops in the middle of the picture. Picture from the African Rock Art Database (<http://www.sarada.co.za/#/library/redan/images/RSA-RED1-143>)*

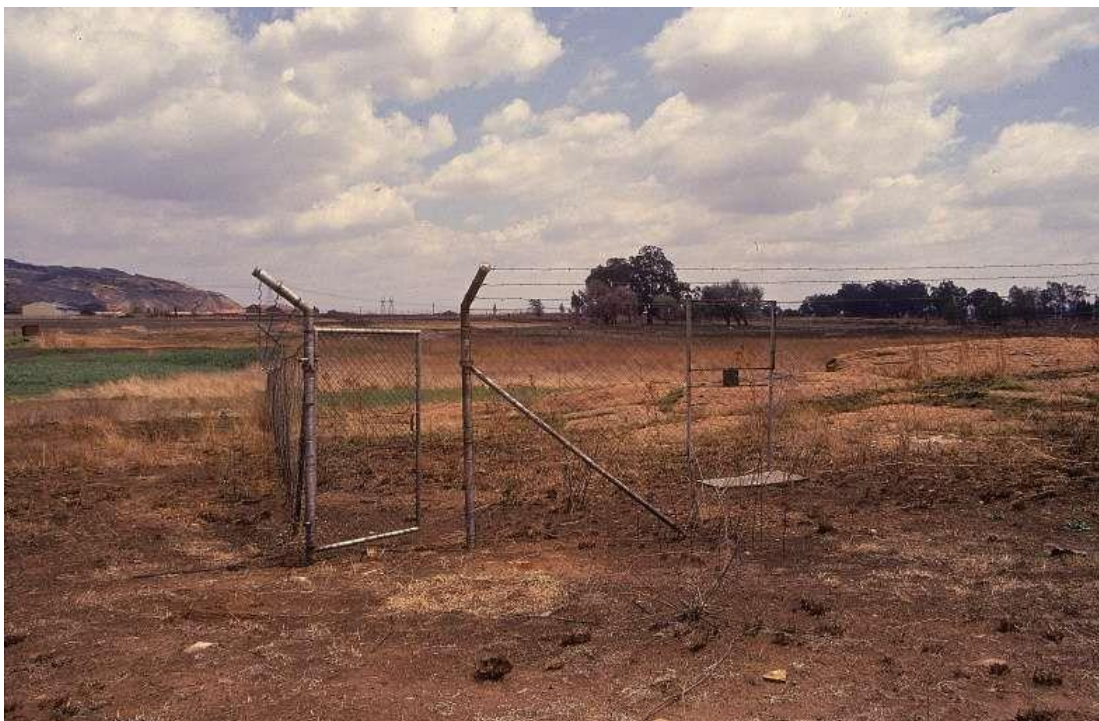
*Figure 11. The Redan engraving site was fenced around the time that it was declared a National Monument in 1971. The fence was subsequently torn down by vandals. Photo credit: African Rock Art Digital Archive RSA RED1 13*

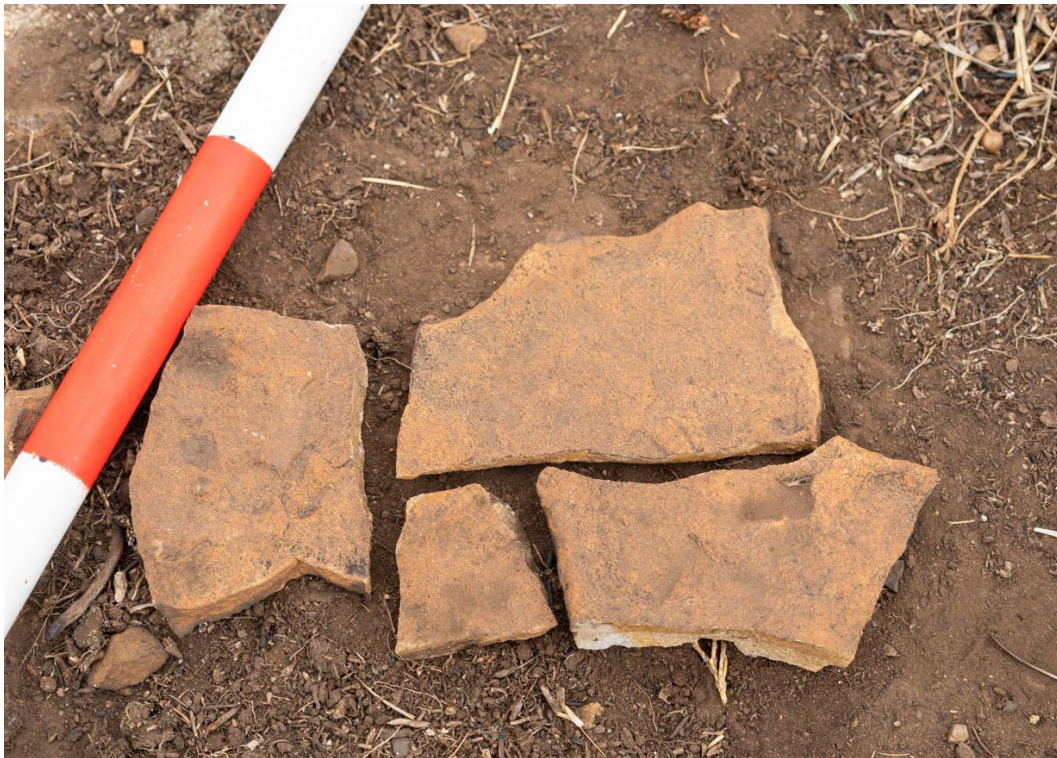
*Figure 13. Fragments of engraved rock found at the base of Rock J on 1 September 2020. The rock surface is cracking as a result of natural weathering*

The surface of the engraved sandstone outcrops consists of an outer crust from about 10 to 20 mm thick. This crust is friable and as a result some of the rock surfaces are breaking off or crumbling to sand. Some of the engravings have been damaged and destroyed as a result of weathering. The engraved surfaces might also be susceptible to cracking caused by alternating heating and cooling of the rock surface in the winter months when freezing temperatures are reached. It is not known how many of the 273 engravings have been and are being destroyed in this way.

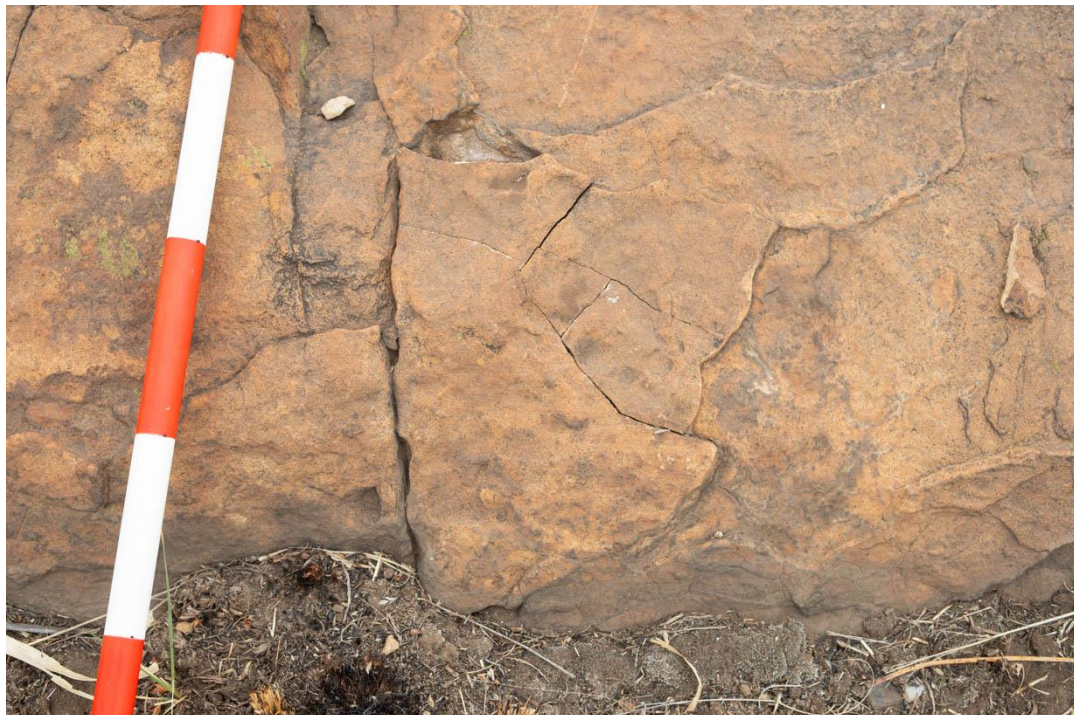
*Figure 14. The fragments could be refitted onto the part of the rock from which they originated*

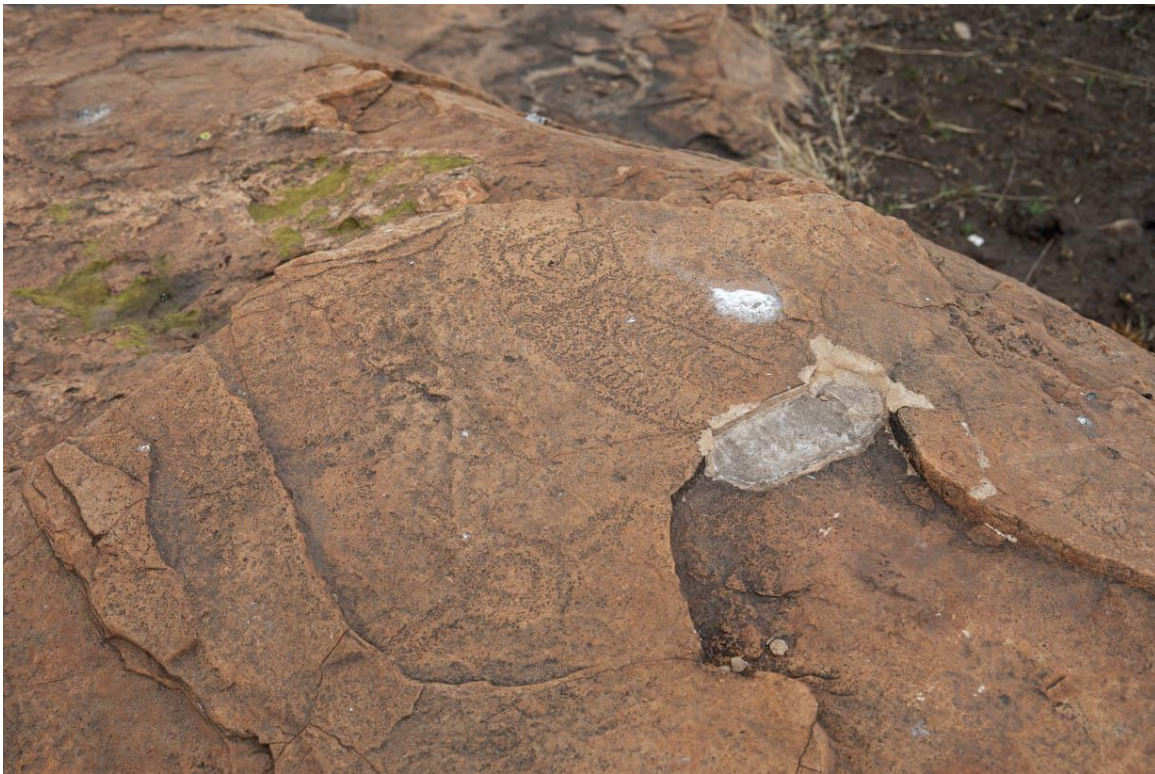
*Figure 15. Natural weathering is a severe threat to the Redan engravings. It has caused part of this engraving to crack and crumble. This process is occurring on many of the rocks on the outcrop. Rock L*

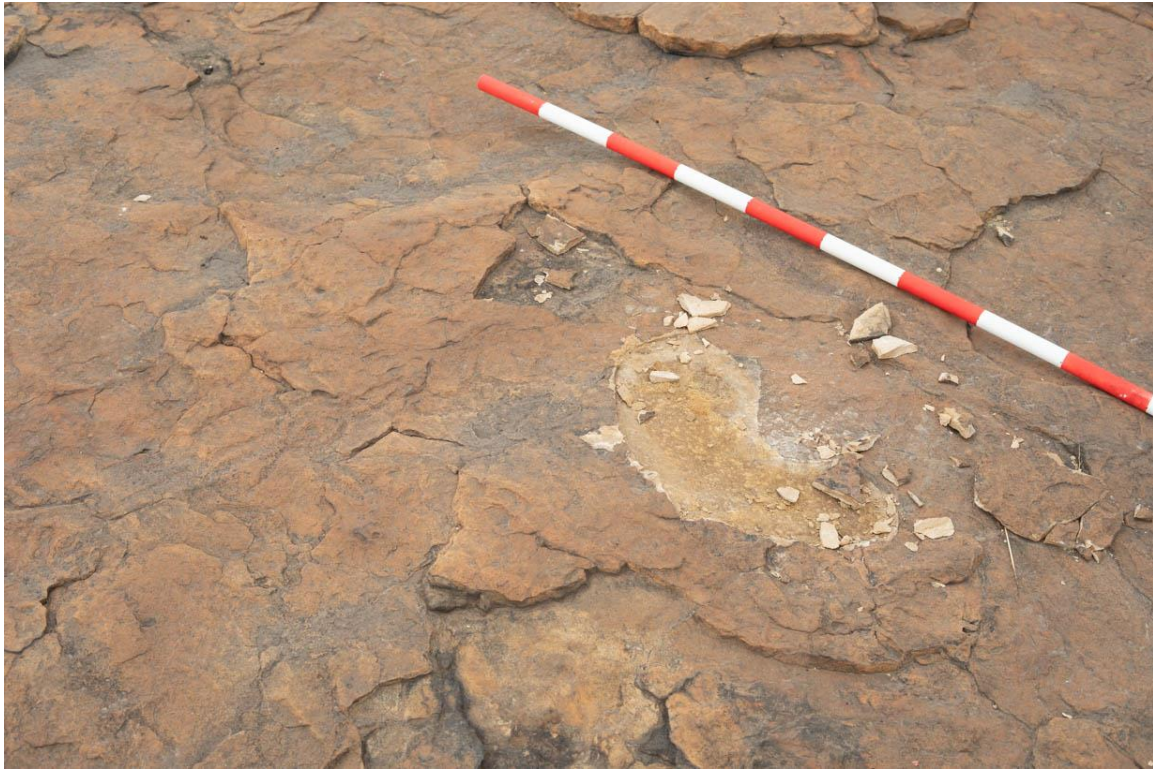
*Figure 16. Another example of natural weathering on an engraved surface. Notice the engravings immediately to the left of the damaged surface. Rock Q*

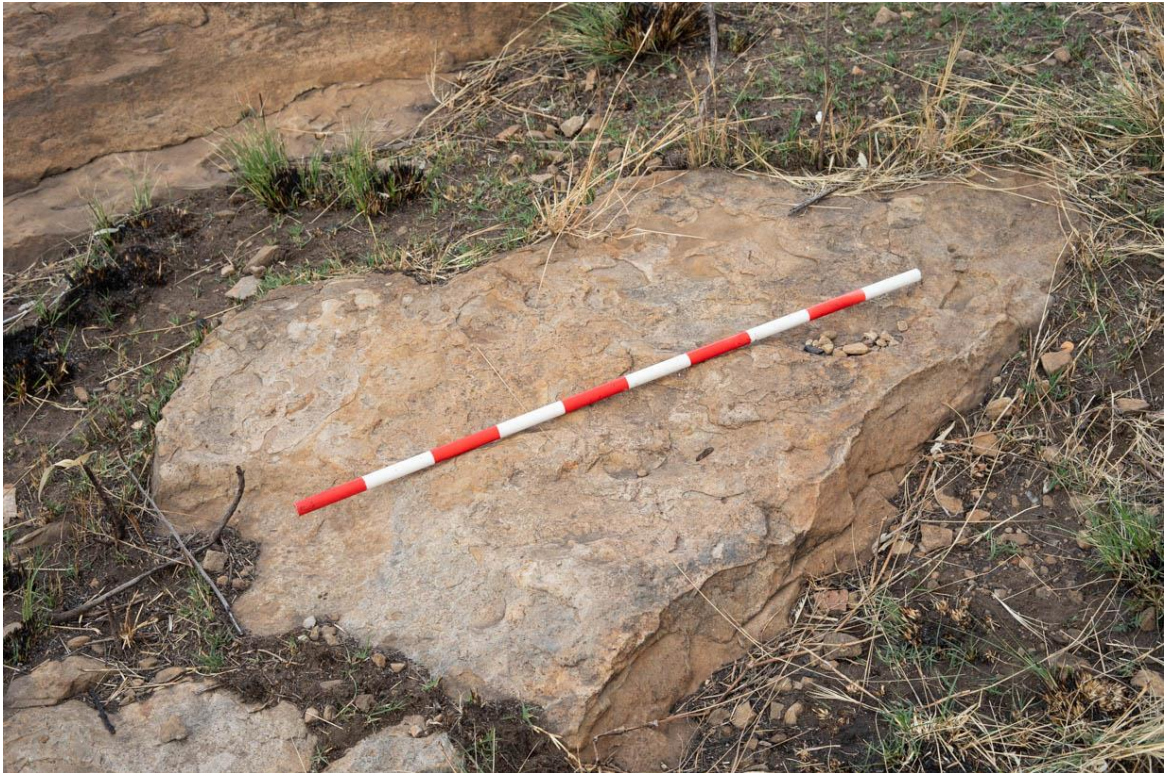
On the day of the on-site inspection it was noted the veld had been burnt fairly recently (within the past month). Photographs of the Redan engravings from the African Rock Art Database ([www.sarada.co.za](http://www.sarada.co.za)) from the late 1960s to 2000 show that the veld surrounding the site was burnt. A review of the area over the past 30 years using Google Earth shows that fires could be annual occurrences at the Redan engraving site (see Chan 2017). Sandstone surfaces flake and crack under high temperatures caused by fires. It appears that at Redan the engravings made on rock surfaces close to ground level have been damaged by fire. Photographs of Rocks G and H, for example, taken on the on-site visit in 2020 shows that they have probably flaked extensively as a result of fire damage.

*Figure 17. Rock G appears to have flaked extensively, most likely because the heat of fires has caused the surfaces to flake off*

The destruction caused by fire could be reduced or eliminated by controlling the growth of vegetation (grass and shrubs) in and around the engraved outcrops. Grass growing in between and around the outcrops must be kept short so that fire cannot come close to the engravings. This is especially important in the autumn and winter months when the grass is dry and flammable. The relatively few shrubs and small trees and their position in relation to the engraved outcrops do not appear to be a threat to the engravings. They should therefore not be pruned or removed.

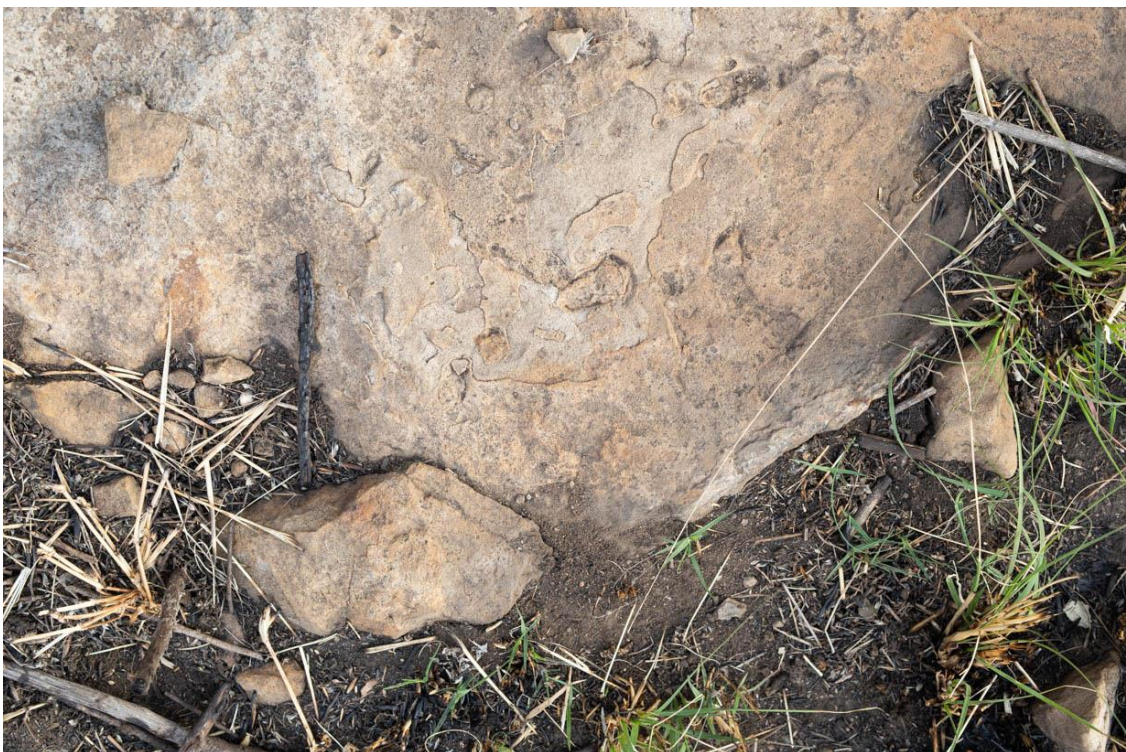
*Figure 18. Close up photograph of the damage caused to the engraved rock by the heat of fires. Rock G*

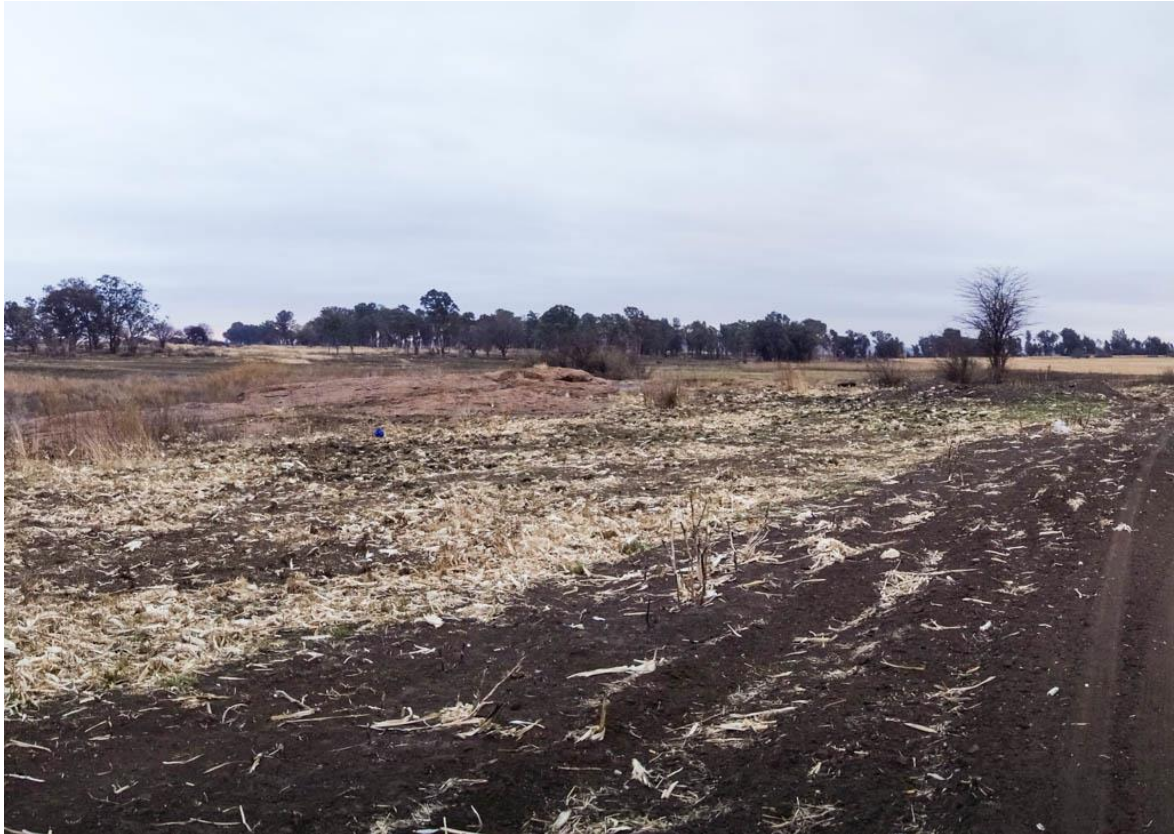
There is currently no access control to the engraving site. There is a dirt track off the M61 immediately south of the Springfield Junior Secondary School that passes west of the agricultural field and within a few metres east of the engraving site. A farm road passes a few metres from the site, so it is very easy to access. The site is therefore very vulnerable to theft, vandalism and any other damage.

*Figure 19. View of the outcrops of sandstone that comprise the Redan engraving site and the farm road that passes within a few metres of the site*

In order to combat graffiti, littering and theft, people should not be permitted to visit the Redan engraving site without the knowledge and permission of the landowners or their designated representatives. Further measures and arrangements regarding access to the site should be addressed in the CMP. It is important that other stakeholders, including tourism authorities, are considered in compiling the CMP.

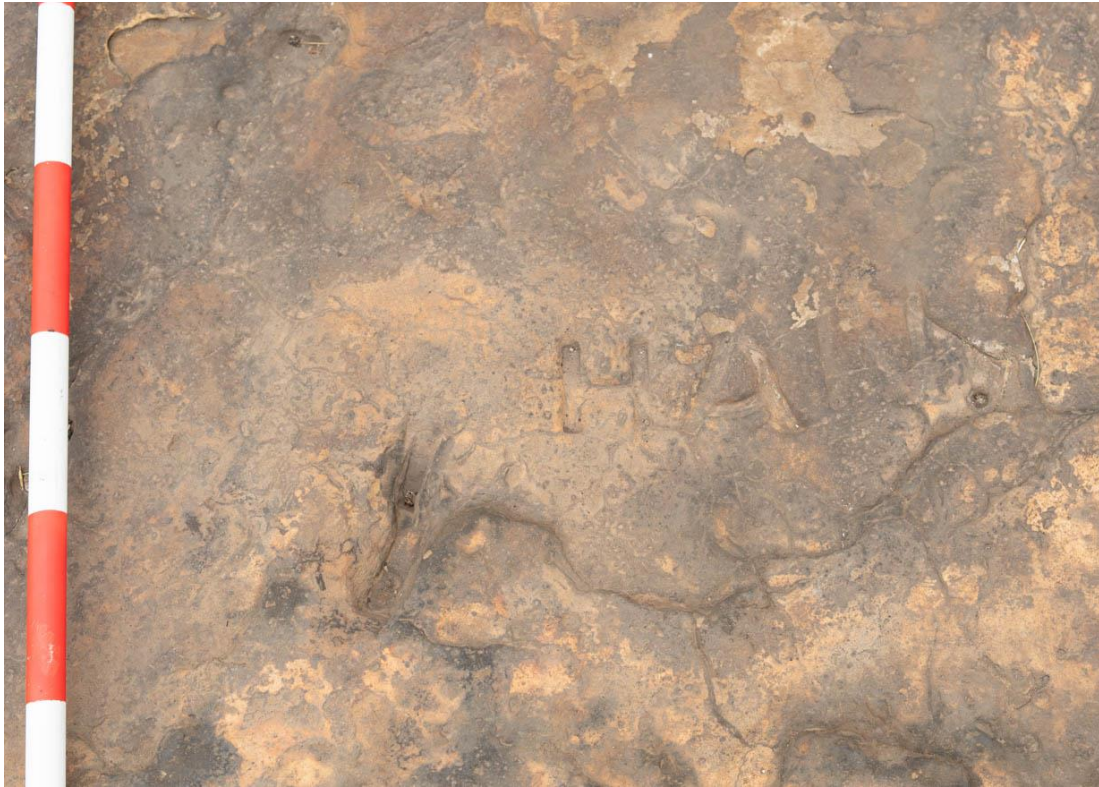
On the day of the site inspection vehicle tracks were noted around the engraving site and in one area it seemed that a vehicle may have driven on some of the rocks (fortunately not engraved). A few scratches were noted on one of the engraved outcrops. There are some engraved initials on one surface that are probably historical in nature (i.e. older than 60 years).

*Figure 20. Historic graffiti at Redan engraving site. The initials 'HAW' have been carved into the rock*
