**TRIAL EXCAVATION TO EXAMINE STATE OF
HISTORIC FURROW (*LEIWATER*) AT ERF 162247,
SILLERY, CONSTANTIA, SOUTH WESTERN CAPE
PROVINCE.**

January 2004

Archaeology Contracts Office

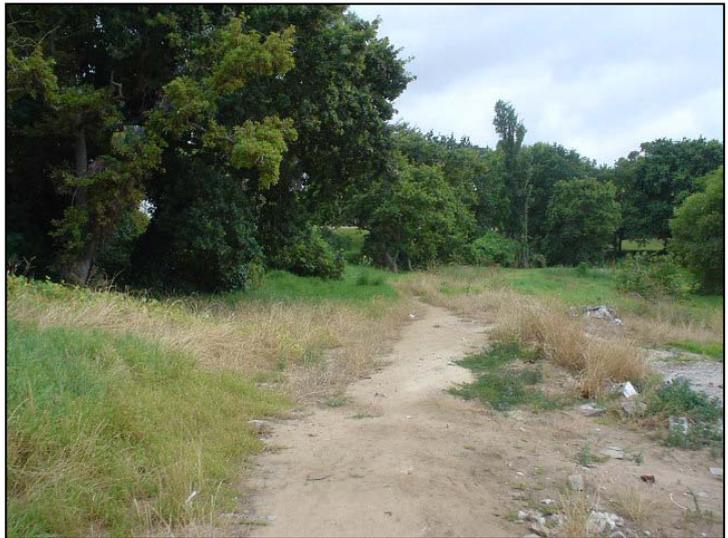
Figure 2

The alignment of the furrow lies roughly on the left hand side of this path along the northwest border of the erf. The furrow remains visible on the border of the property in the distance.

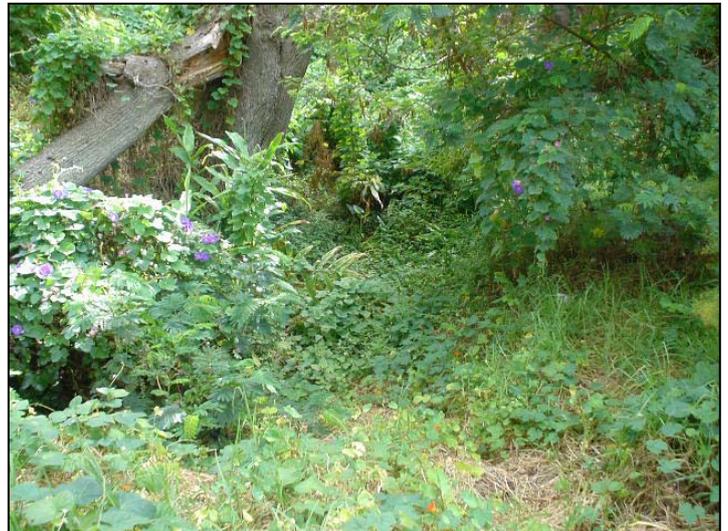
Figure 3

All that is visible of the furrow in the public open space is a sunken area over grown with vegetation.

- It must be noted that the furrow is visible in Public Open Space. It is however, un-commemorated and choked with vegetation. An option that should be considered is to focus on a portion of the furrow in this area by creating a purpose built path, brush clearing and information signage to explain the significance of the feature (see Figure 3).
- Opening of the furrow within the development area is not a conservation necessity (as the feature is stable while buried) but an option that could be considered by the developer in negotiation with the local community and Heritage Western Cape.
- In terms of conservation of the furrow in its buried state, it is recommended that any future property owners should be made aware of its presence and be discouraged from building foundations across the alignment or establishing services in its immediate vicinity.

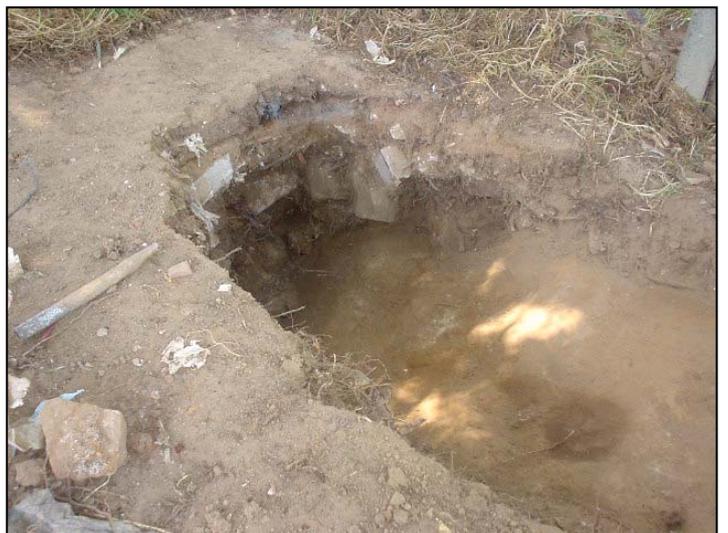
Figure 4

The furrow is a visually unspectacular structure and fairly informal, but is nevertheless very well preserved as a result of its buried state (Figure 4). It is highly likely that aspects of the furrow are present across the northern edge of the proposed

The clay bottom and side of the furrow is clearly visible in the trial excavation. The rubble fill is easily distinguishable.

The furrow is well conserved by virtue of the fact that it is buried. From a long-term conservation point of view this is a desirable situation provided that any services or foundations do not impact the alignment during future development activities.

Opening the furrow is optional. In conservation terms this is not considered a necessity, but will have benefits in terms of education, and adding value to the neighborhood. Along with reuse of the feature are measures that must be put in place with respect to its future operation. Erosion of the earth banks will have to be controlled and debris/pollution will have to be removed from time to time. An additional water source will need to be identified with which to feed the furrow. If opening the furrow is considered, only a limited stretch should be put into use and the rest retained as an archaeological archive in its currently buried state.

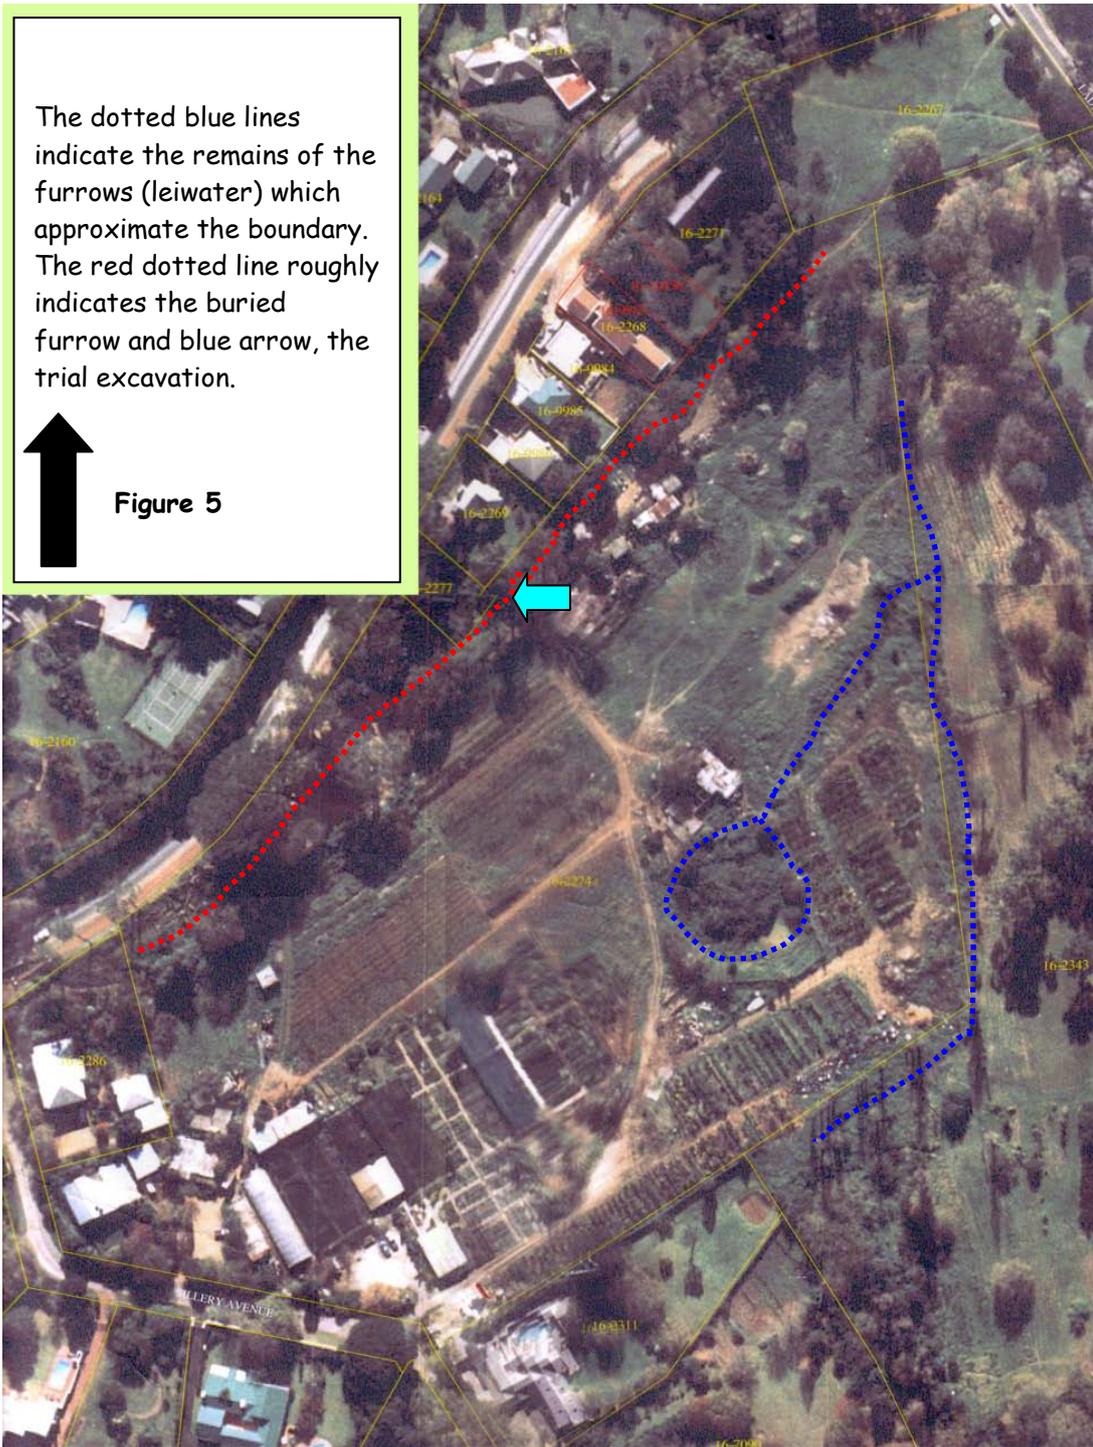
Figure 5

The archaeological trial excavation took the form of a single transverse cut across the alignment of furrow a resident of the area (see Figure 5). After some 5 hours of excavation the furrow was clearly visible. It took the form of a large “v” shaped ditch cut into the surrounding clays. There was no evidence of any stone lining on the base or sides of the feature. The ditch was filled with recent debris including glass bottles, plastic bags, blocks of concrete and other builder’s rubble.

The dotted blue lines indicate the remains of the furrows (leiwater) which approximate the boundary. The red dotted line roughly indicates the buried furrow and blue arrow, the trial excavation.
