**A REPORT ON MONITORING OF EARTHWORKS
IN SECTIONS OF PARLIAMENT AND CASTLE STREETS,
CENTRAL CAPE TOWN, ORIGINALLY THE SITE OF
WAGENAER'S DAM**

Prepared for
Stocks and Stocks
September 1998

Prepared by
Archaeology Contracts Office
Department of Archaeology
University of Cape Town
Private Bag Rondebosch
7700

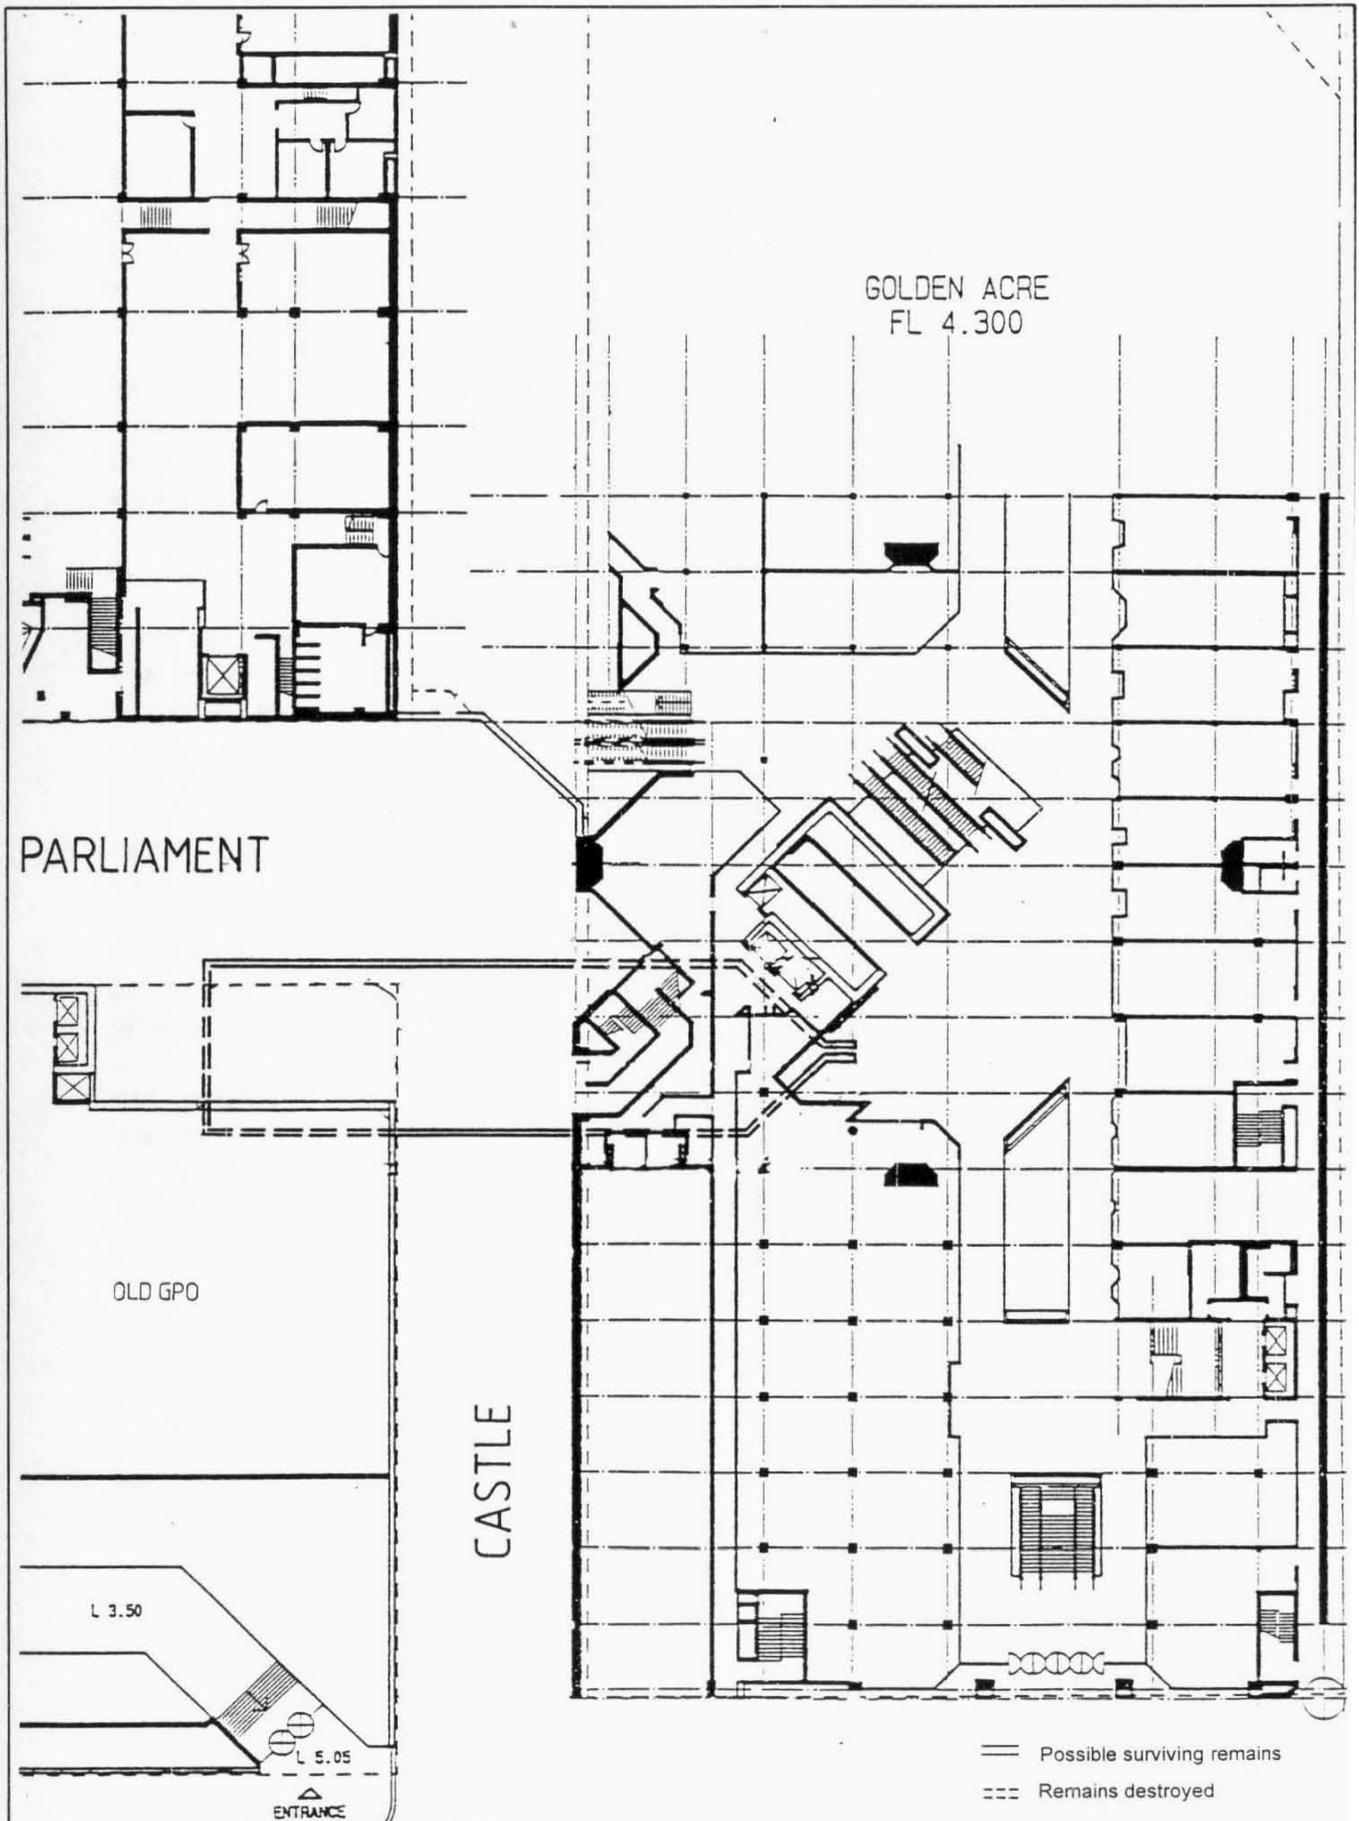
1

Excavation took place in two phases. The first phase was the excavation of Castle Street and the second phase, being the excavation of Parliament street, took place some time later. The initial phase of excavation was intensively monitored while the second phase was monitored intermittently (as by this time it seemed highly unlikely that anything would be found). The position of sections of the dam on modern plans is shown in Figure 1.

Approximate location of Wagenaer's Dam
